Recognizing Leaks and Problems

CAA Seminar – Increasing Your Property Value
March 23, 2004

Recognizing Leaks and Distress

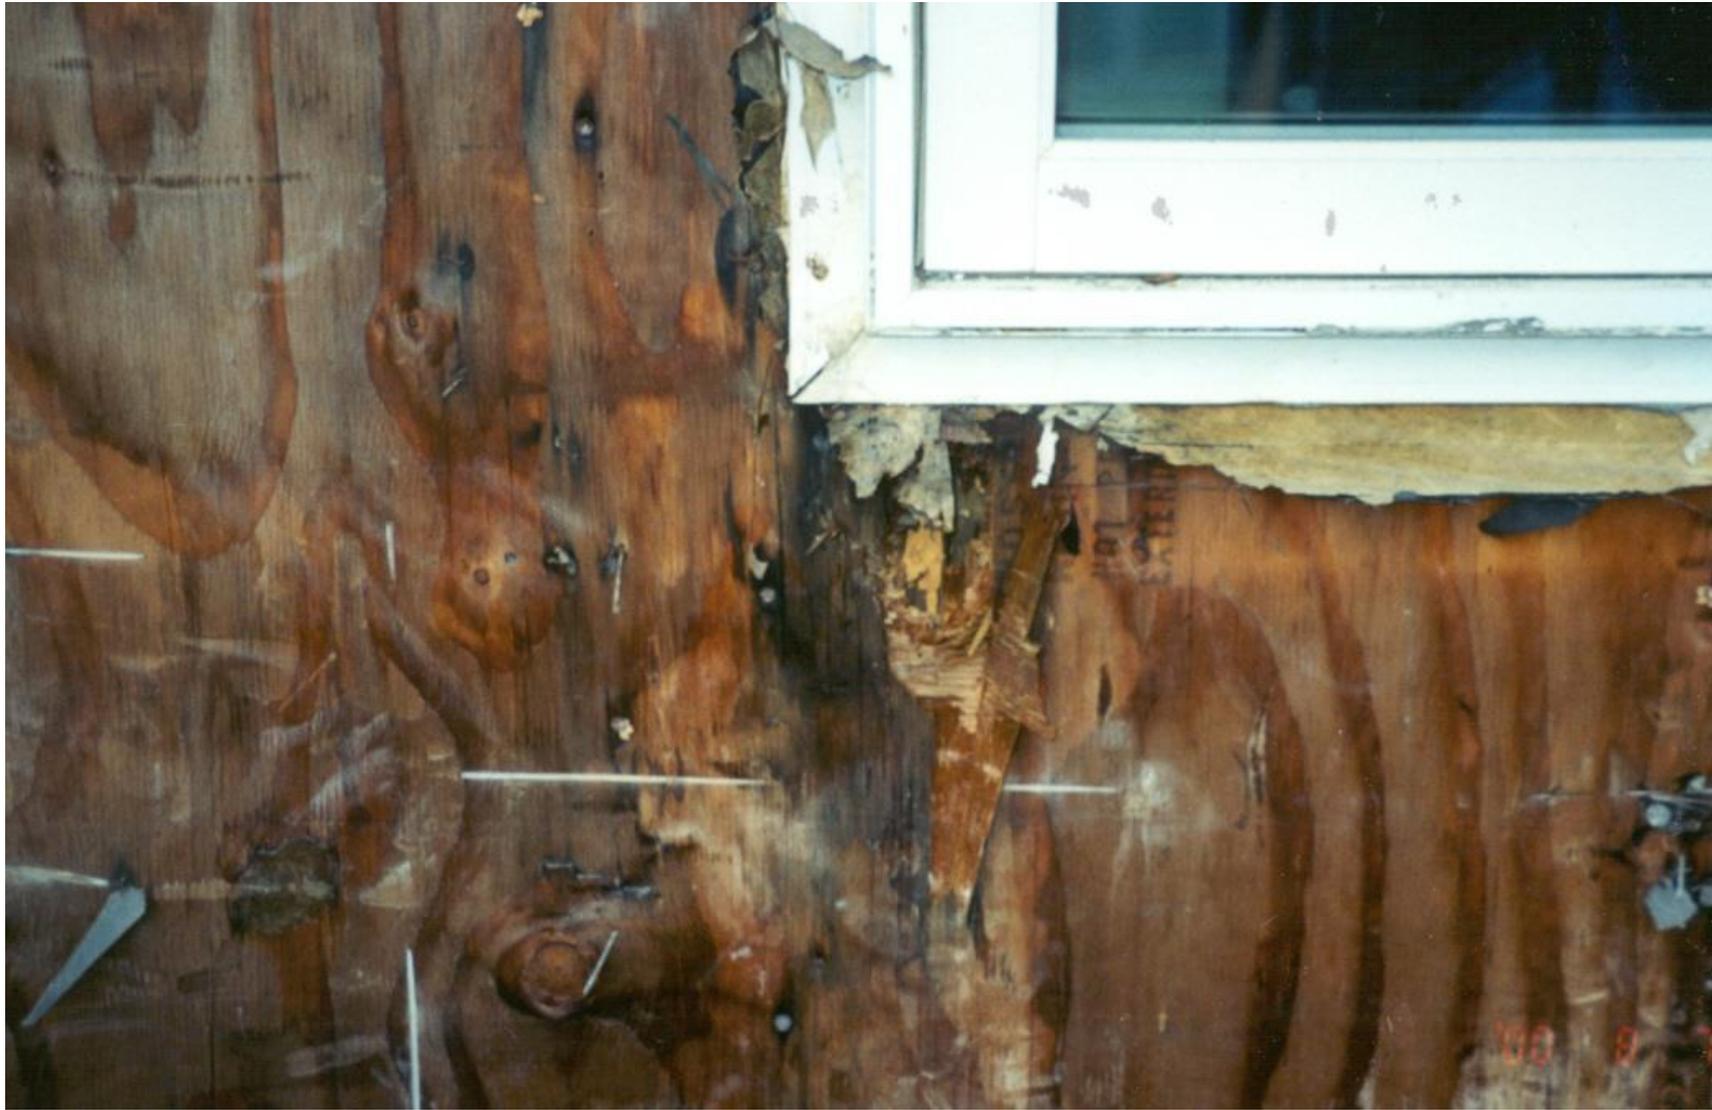
**Cracks and
sealant failure
around window**

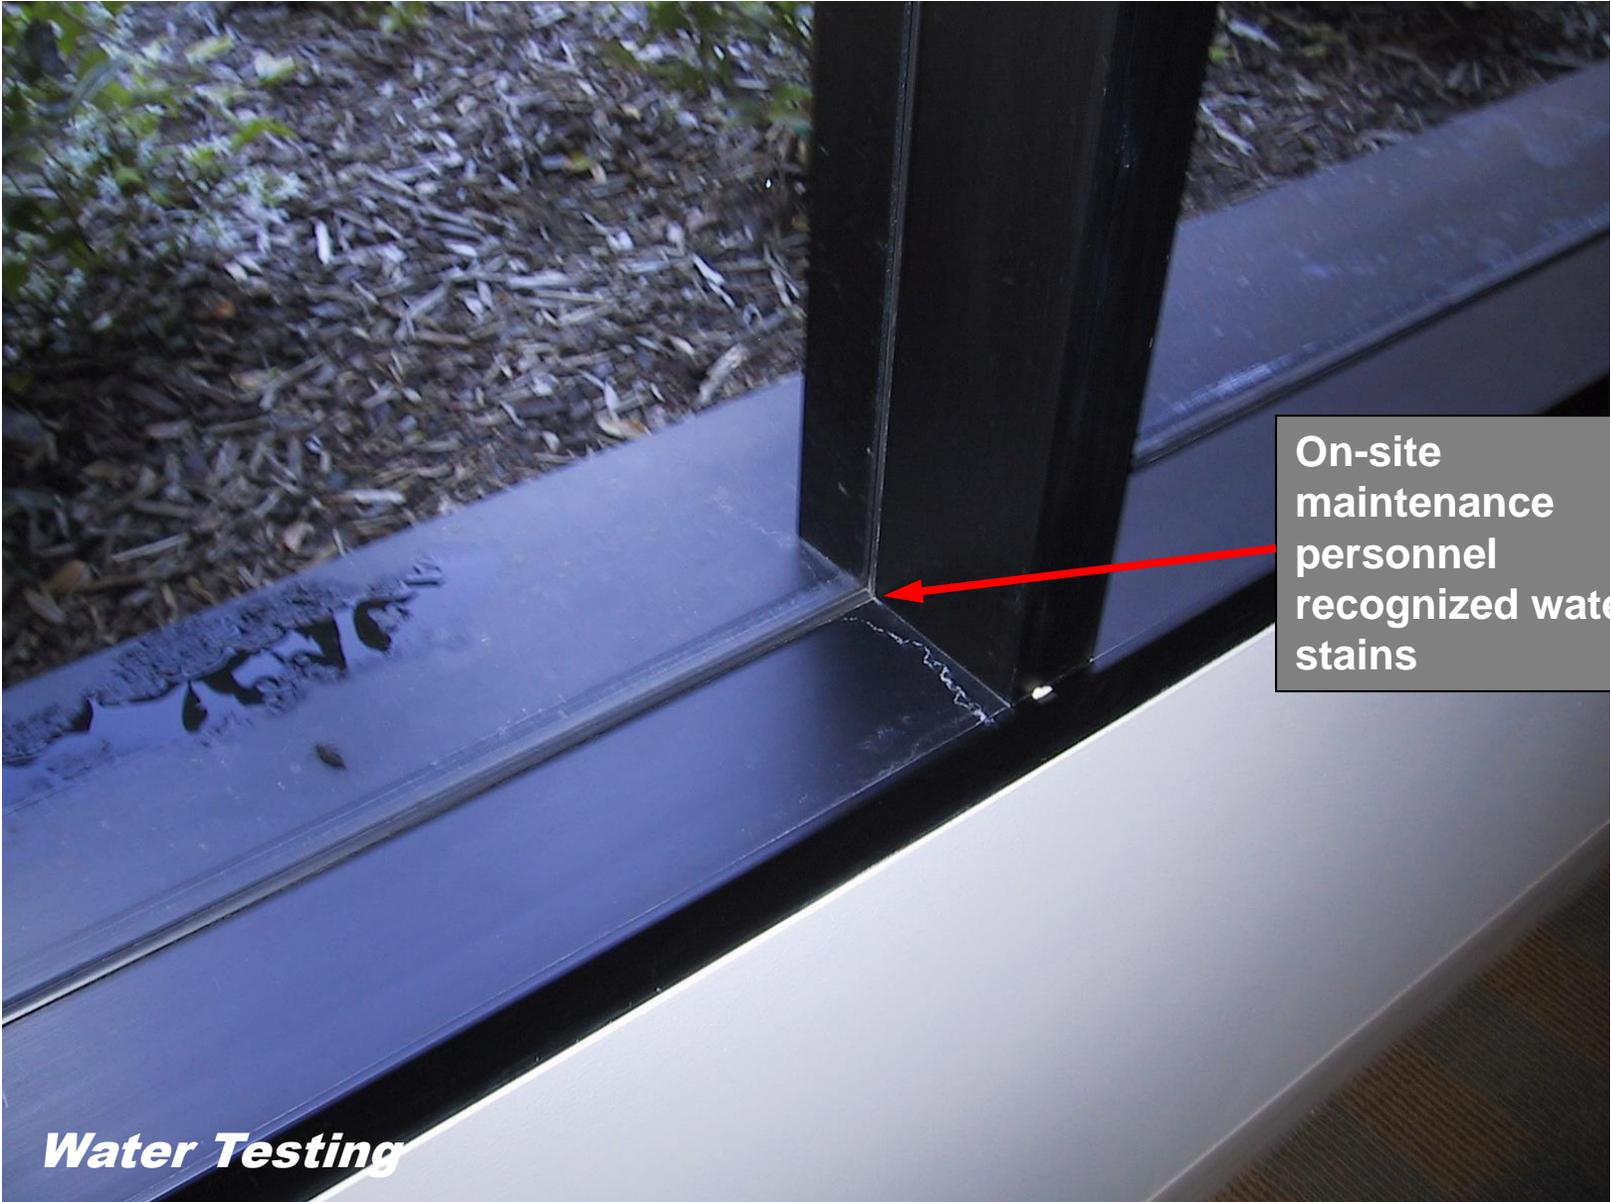
On-site
maintenance
personnel
recognized water
stains

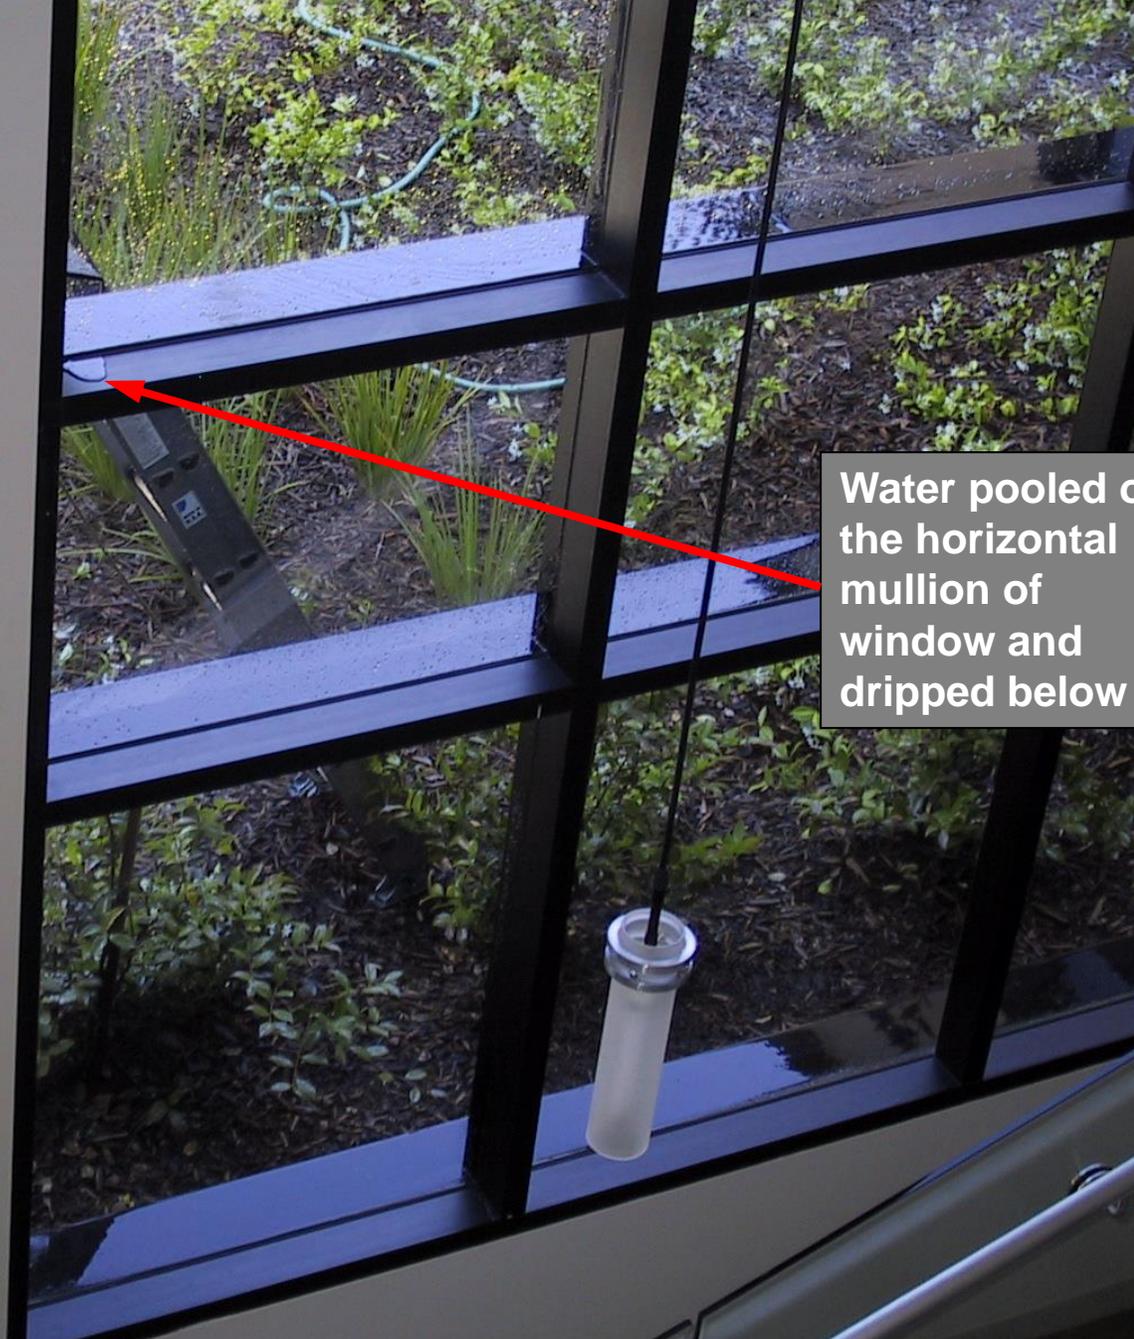
Water pooled on the horizontal mullion of window and dripped below

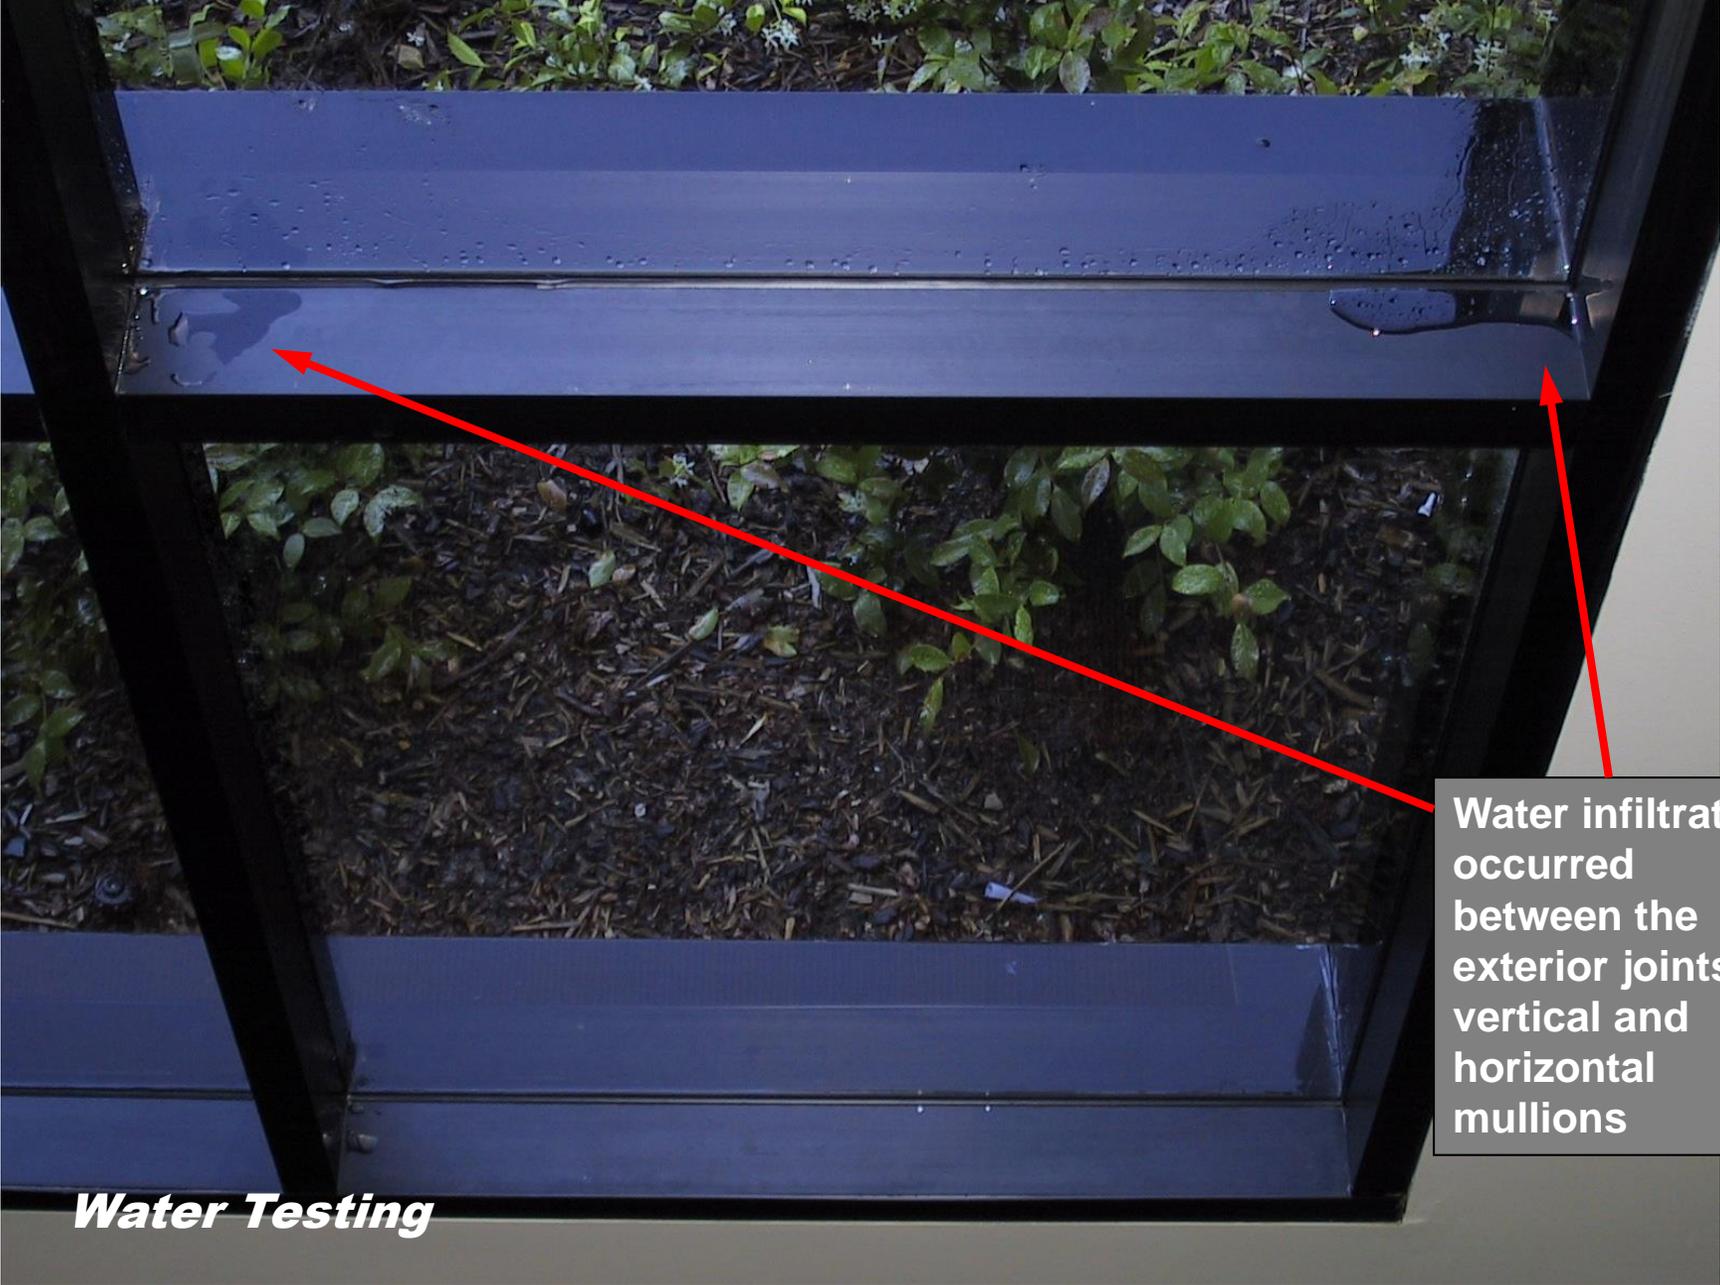
Water infiltration occurred between the exterior joints at vertical and horizontal mullions

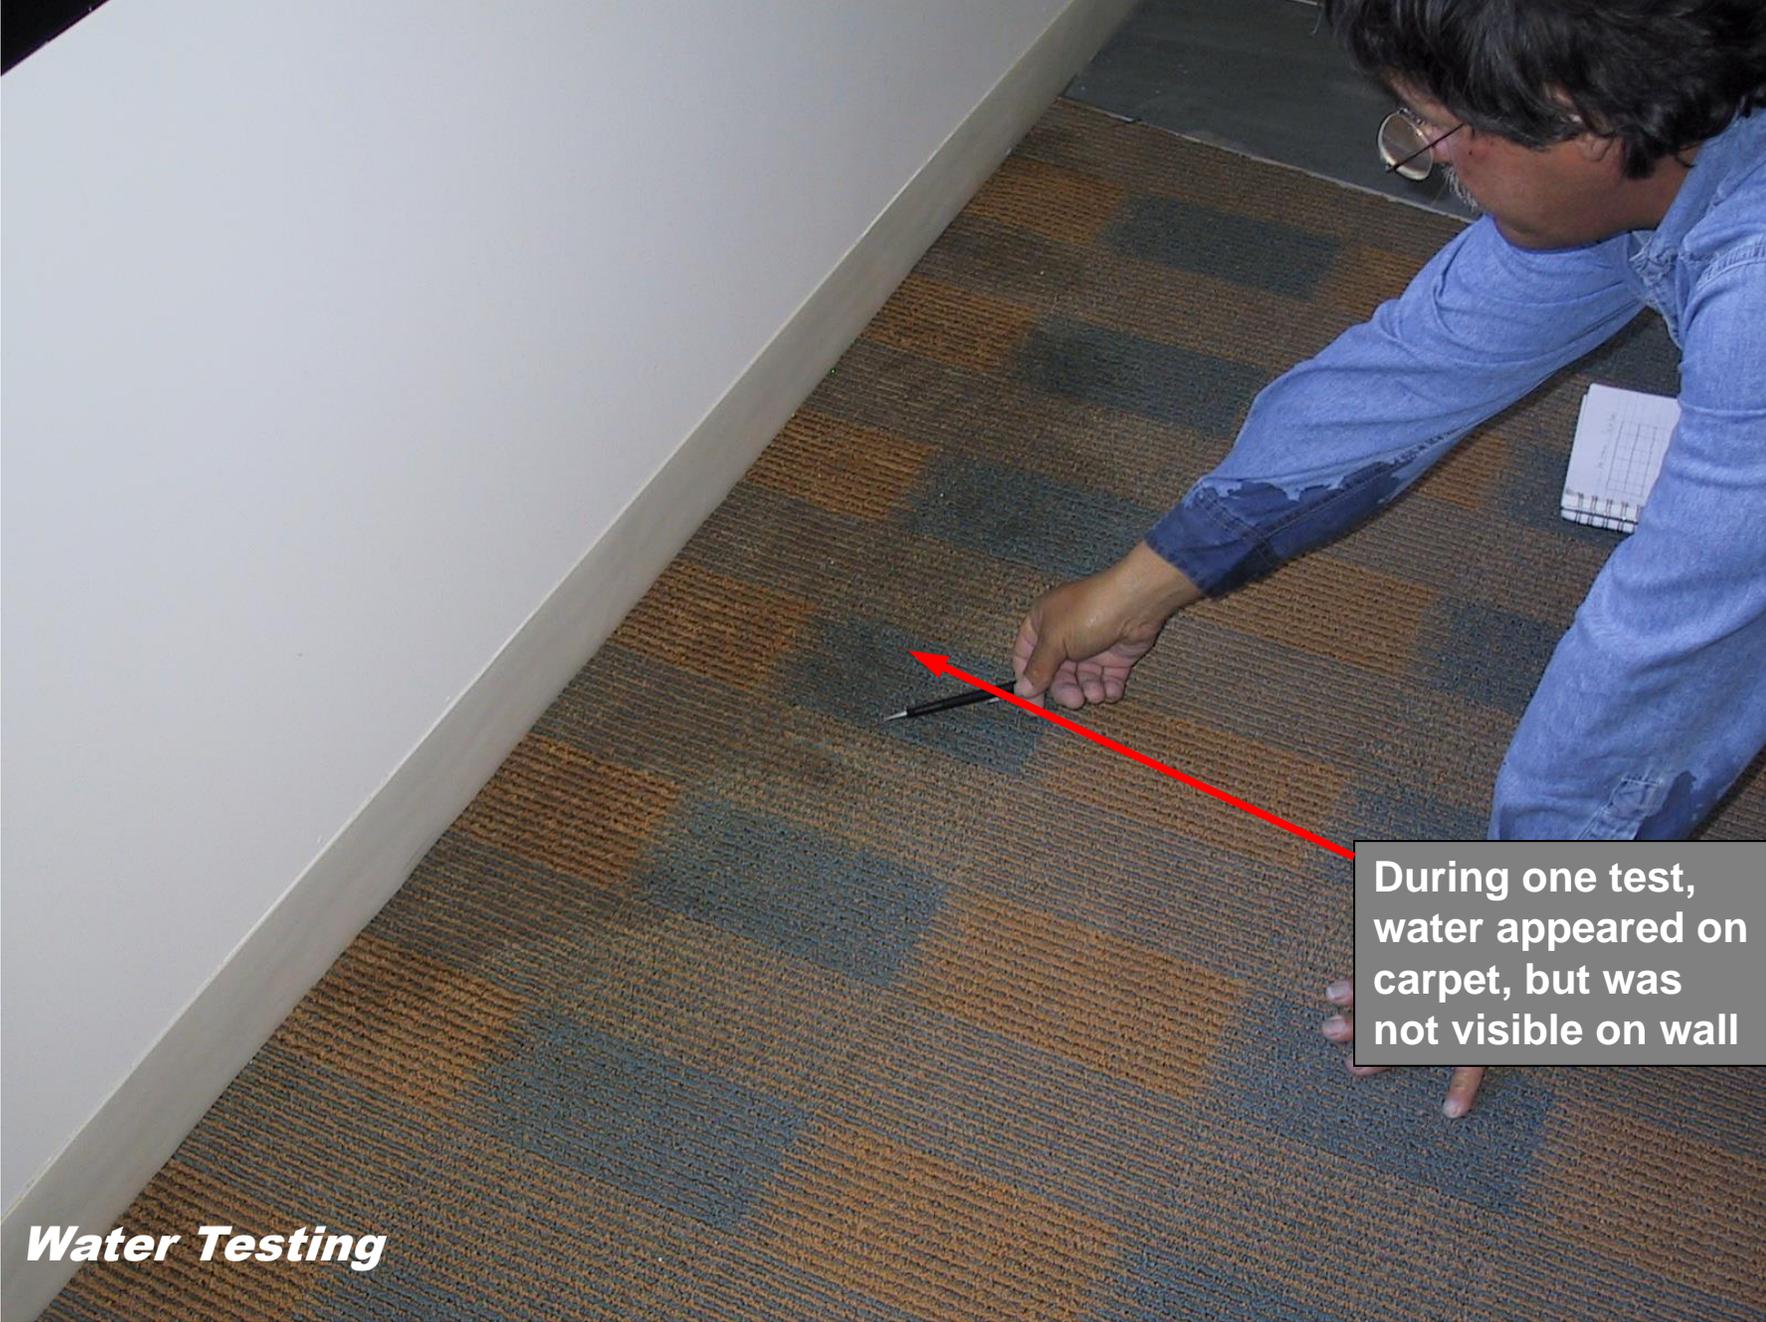
During one test, water appeared on carpet, but was not visible on wall

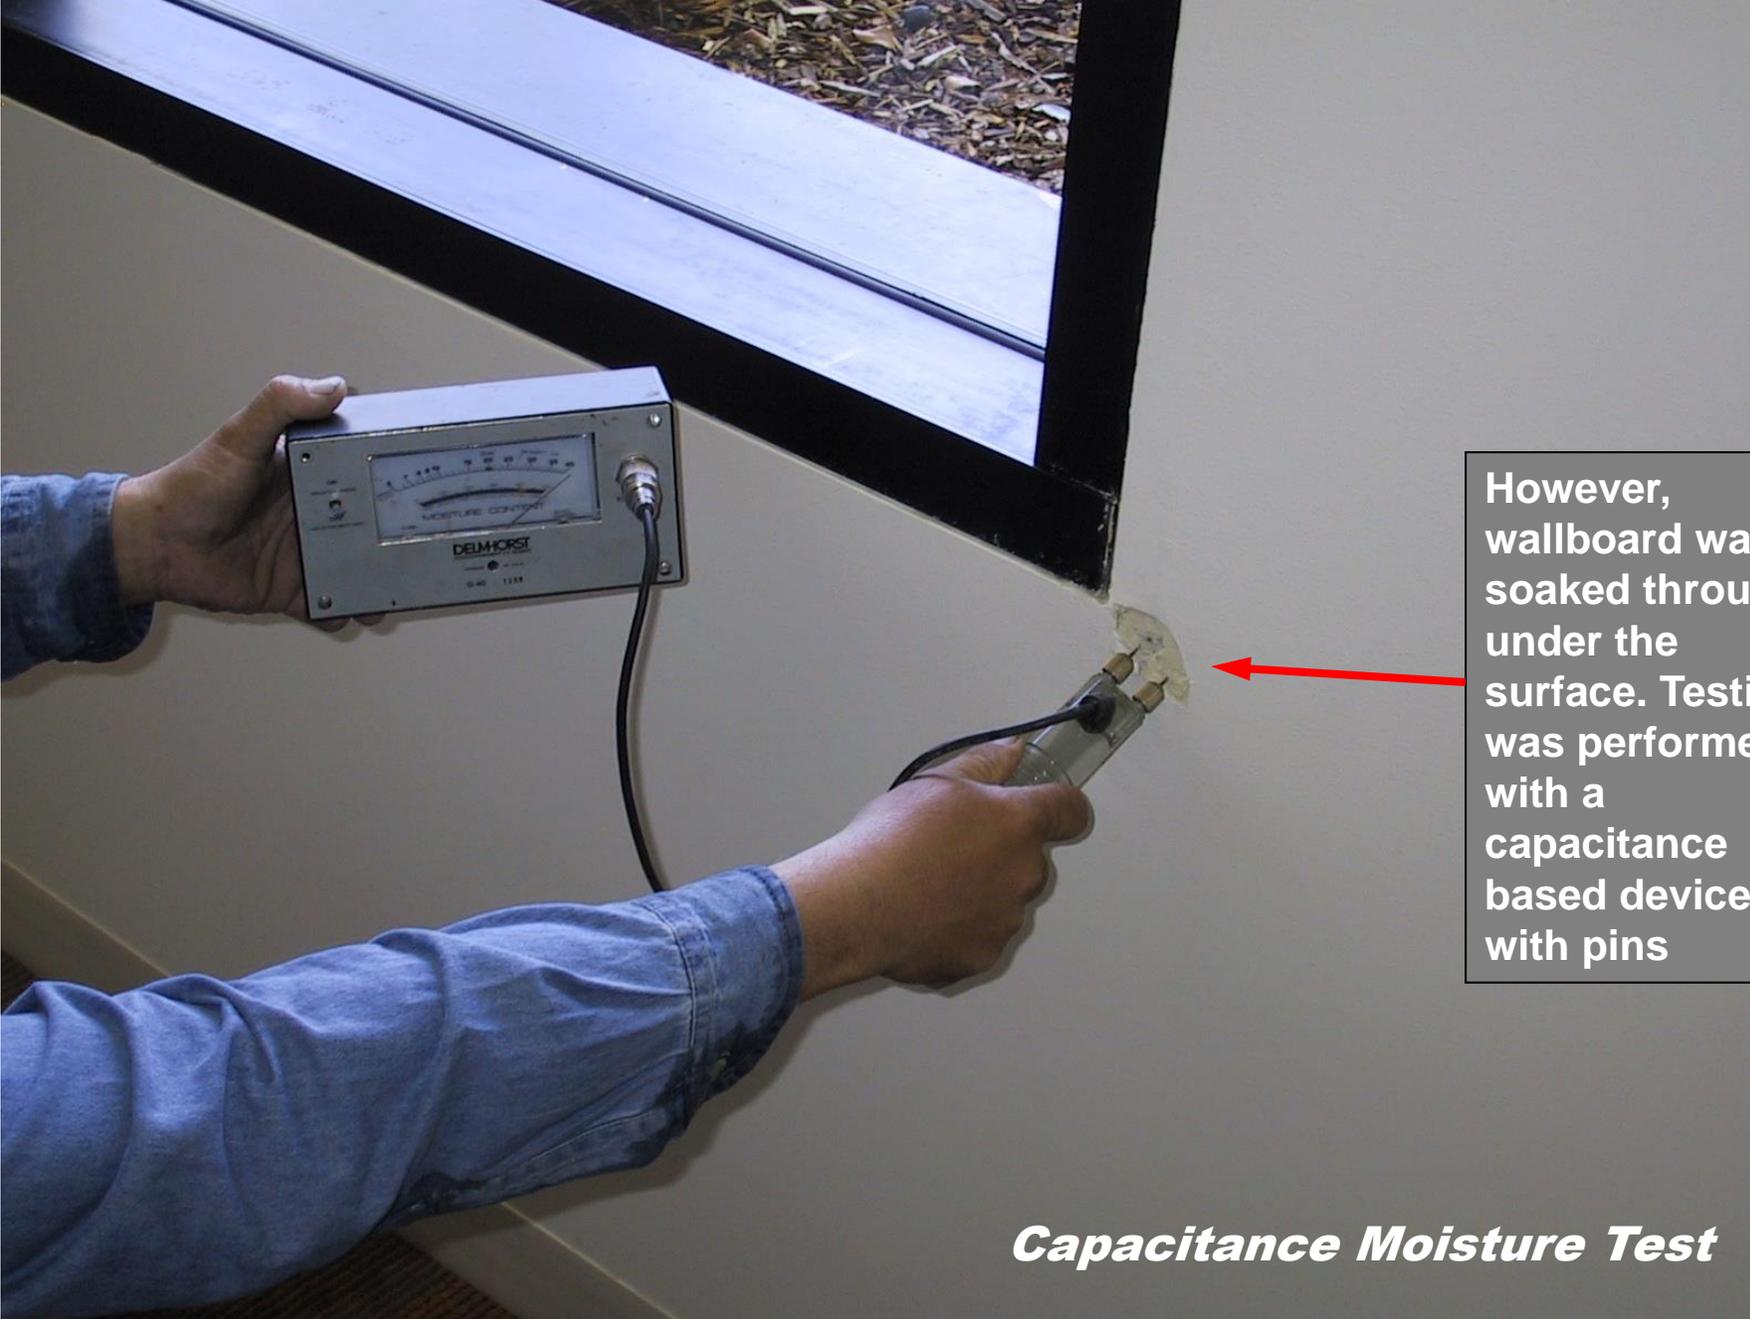
However, wallboard was soaked through under the surface. Testing was performed with a capacitance based device with pins

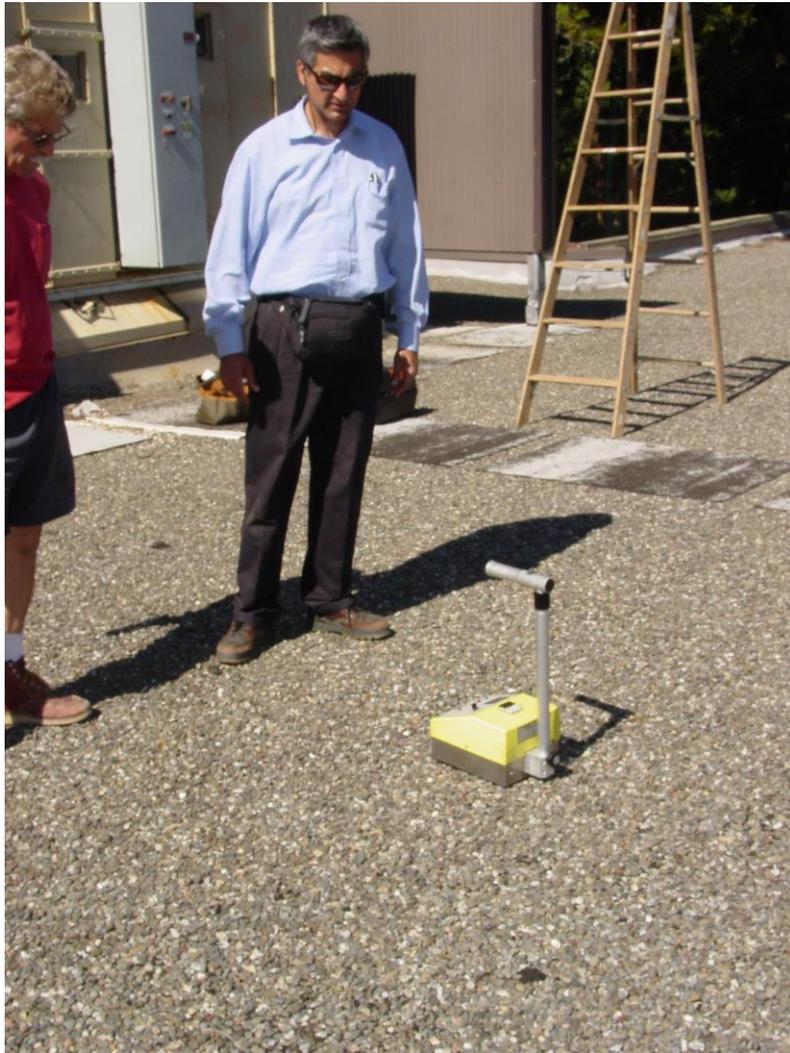
Nuclear troxler testing equipment

LEFT: Taking measurements

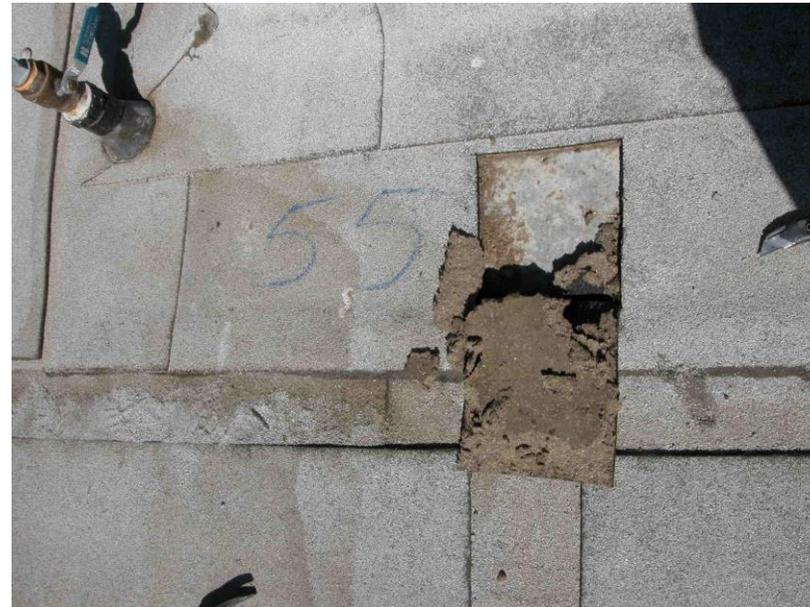
RIGHT: Test cut to corroborate result, saturated insulation
