# Roof, Exterior Wall and Waterproofing Design Issues + Construction Defects

BAFAC

May 13, 2003

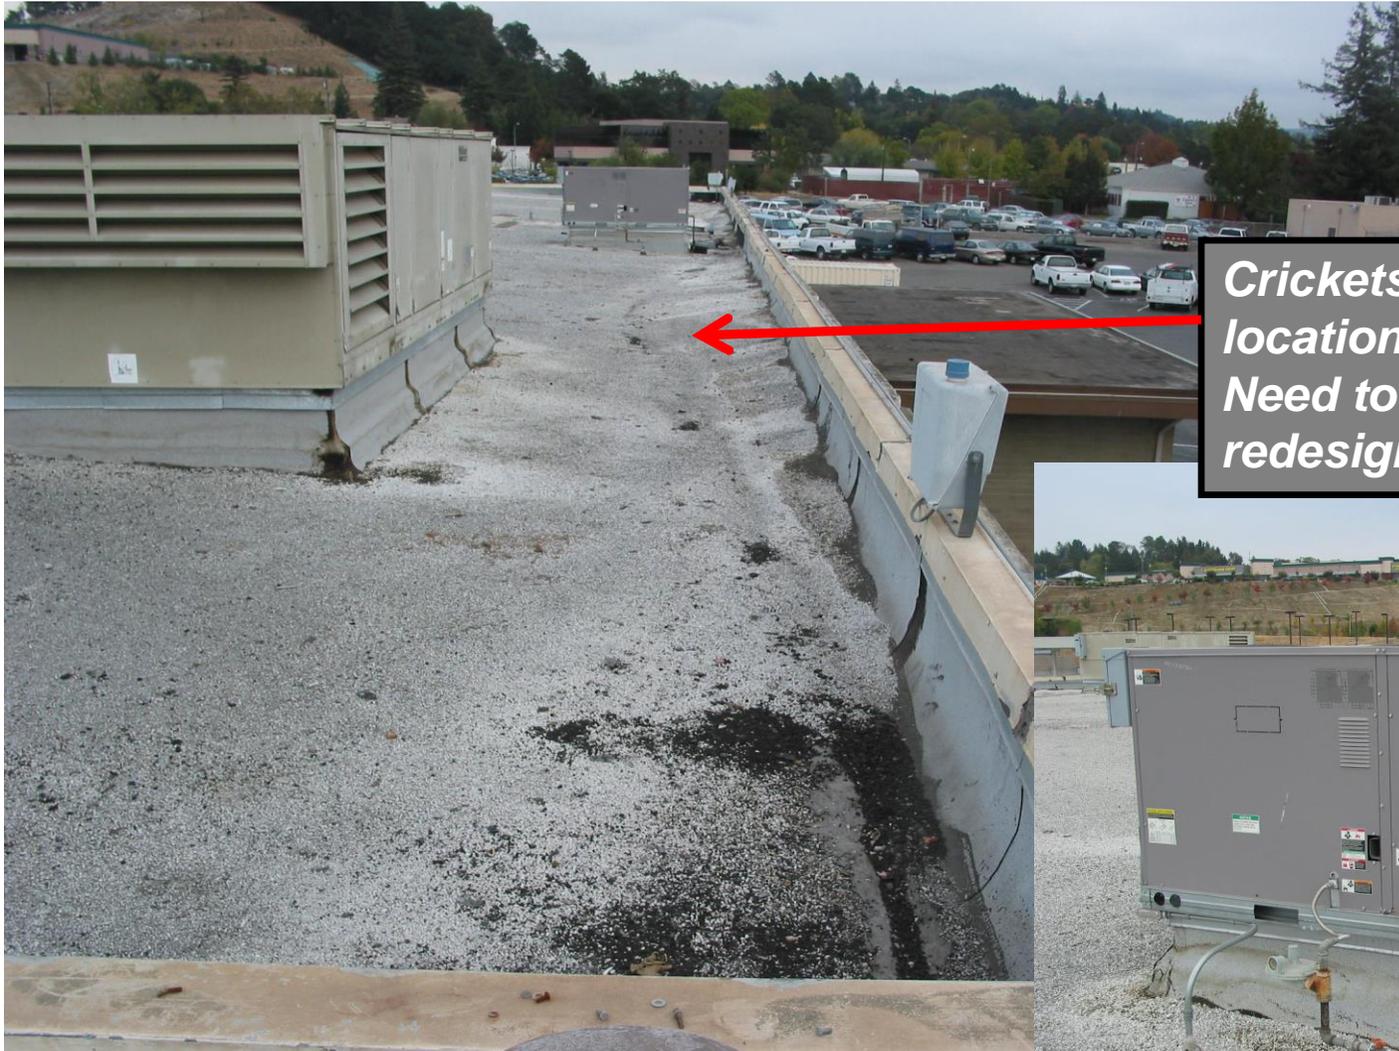
***Cricket is undersized in some locations, or not provided at all. Need to be deeper and redesigned. Note deterioration.***

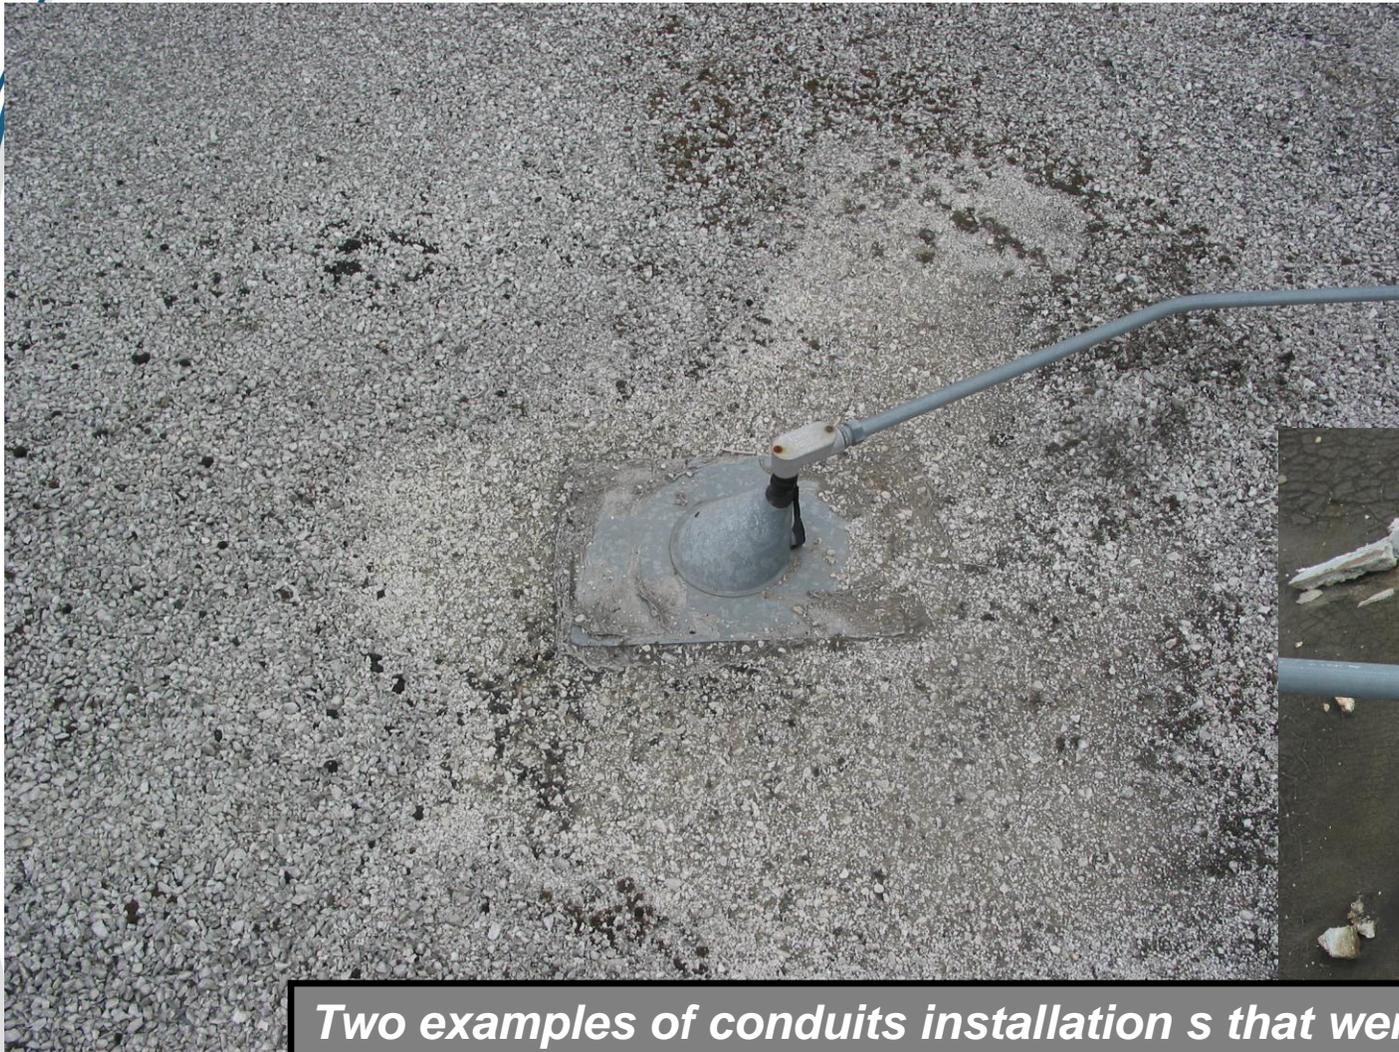
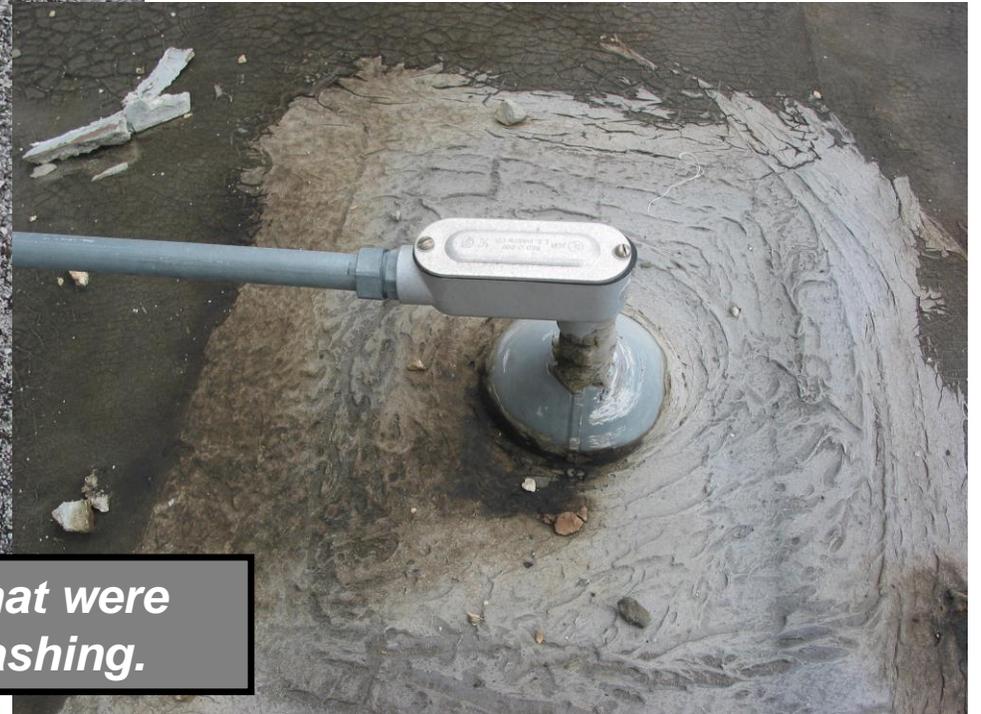
***Two examples of conduits installations that were not designed – installed without proper flashing.***

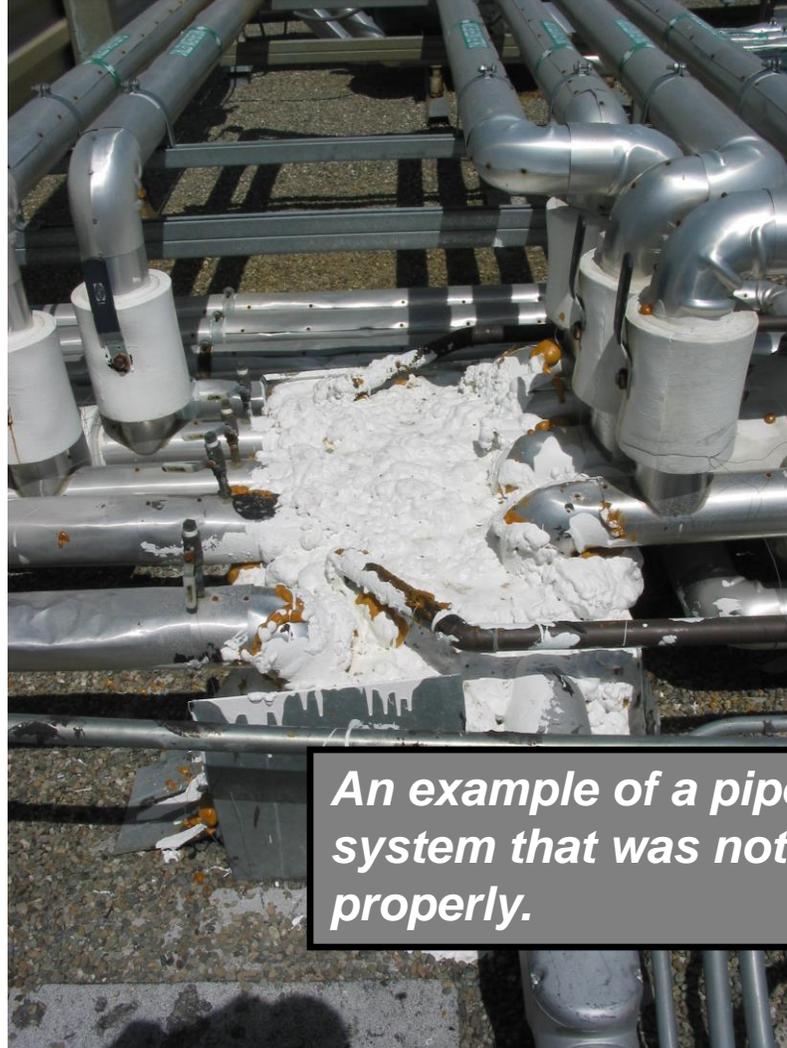
*An example of a pipe penetration system that was not designed properly.*

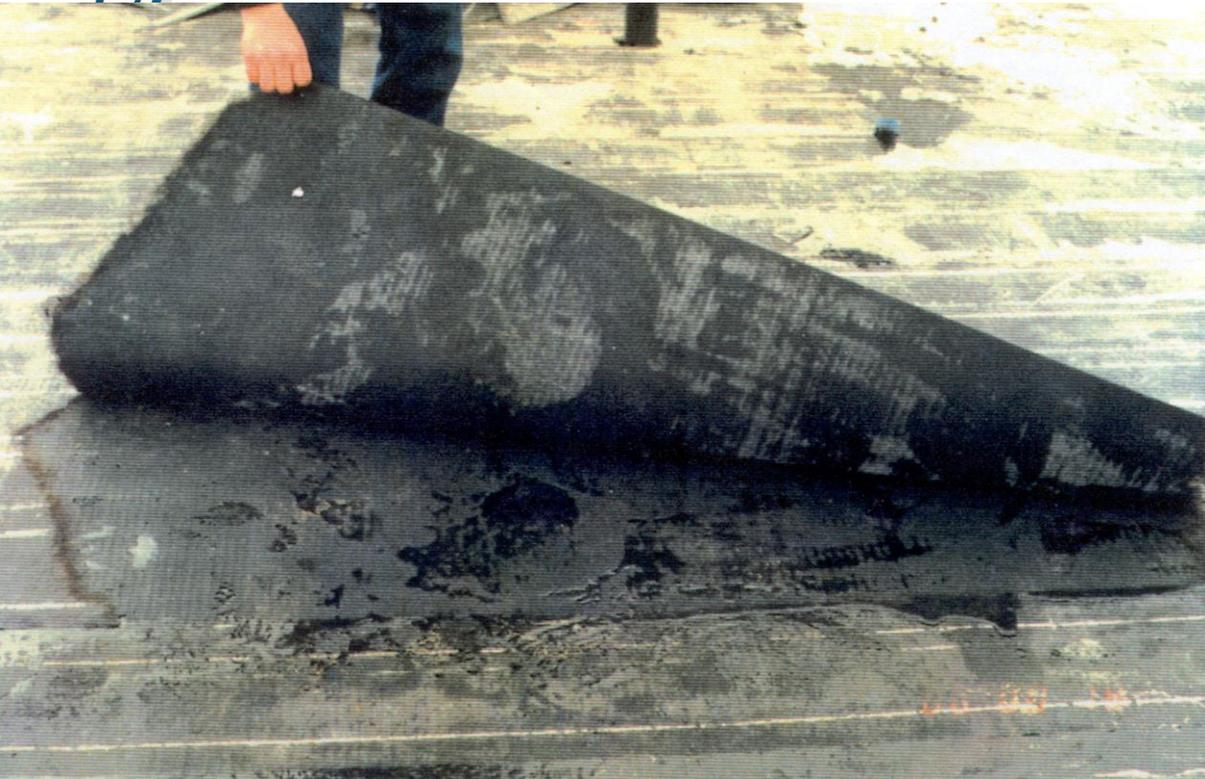
*In built up roofs, bitumen is more than just adhesive – it should flow through pores in felt, to form a system.*

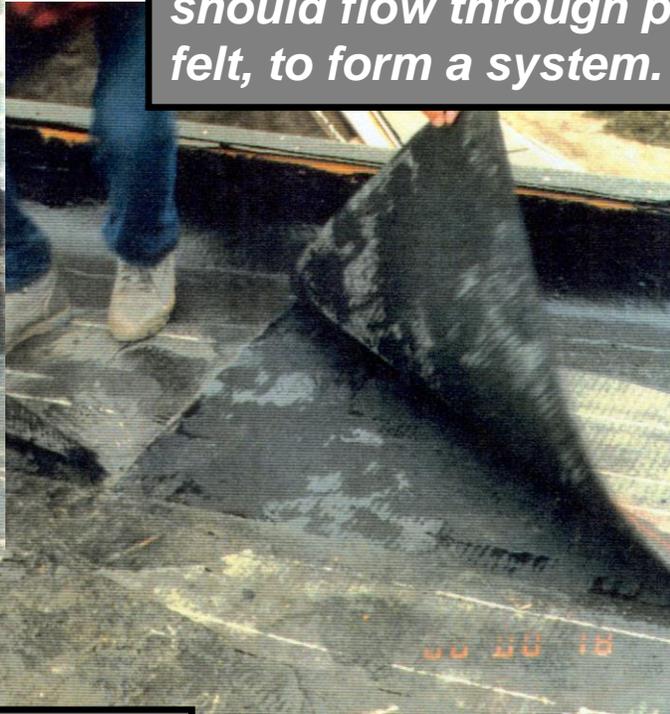
*Lack of brooming results in poor adhesion.*

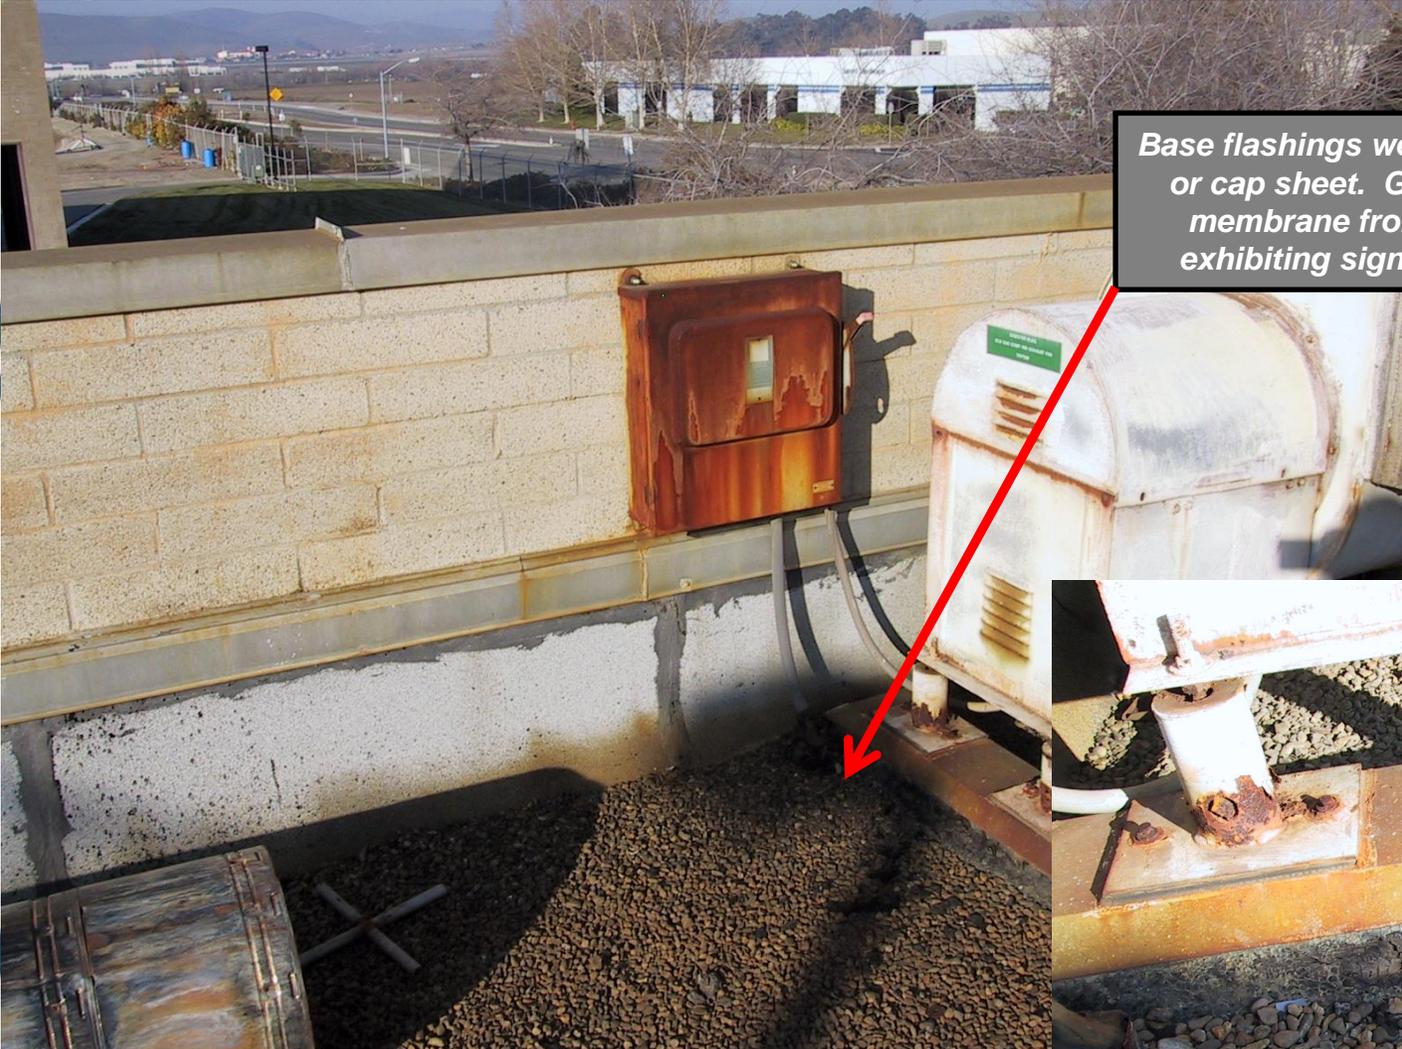
*Base flashings were not surfaced with a protective layer or cap sheet. Granules on the cap sheet protect the membrane from UV rays. Base flashings are also exhibiting signs of deterioration. See photo below.*

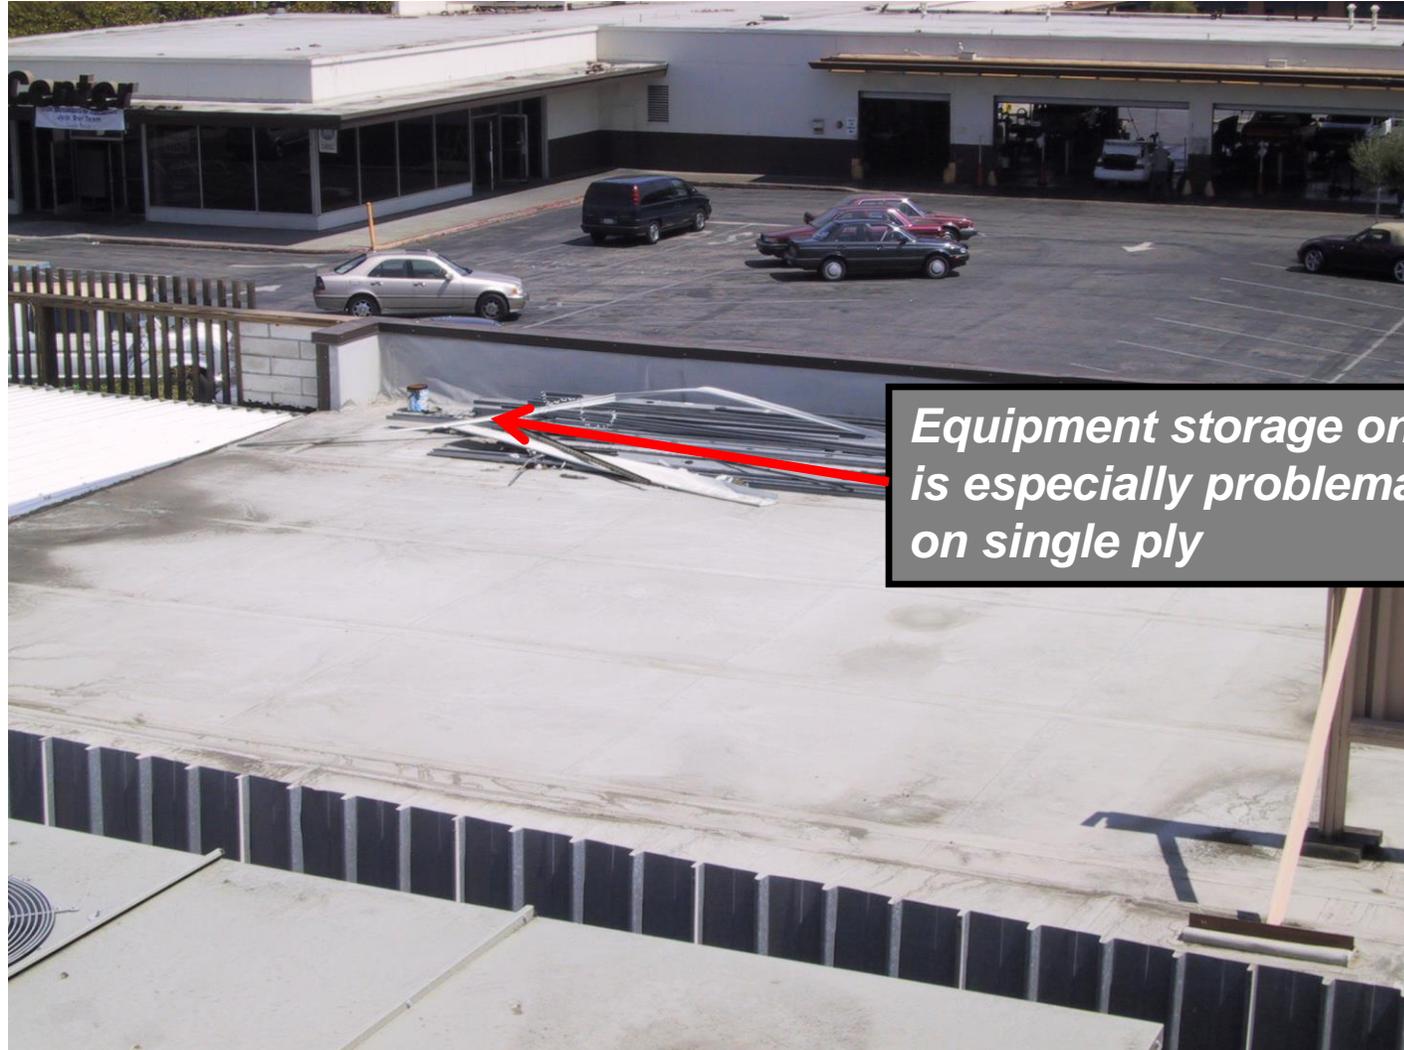
*Equipment storage on roof is especially problematic on single ply*

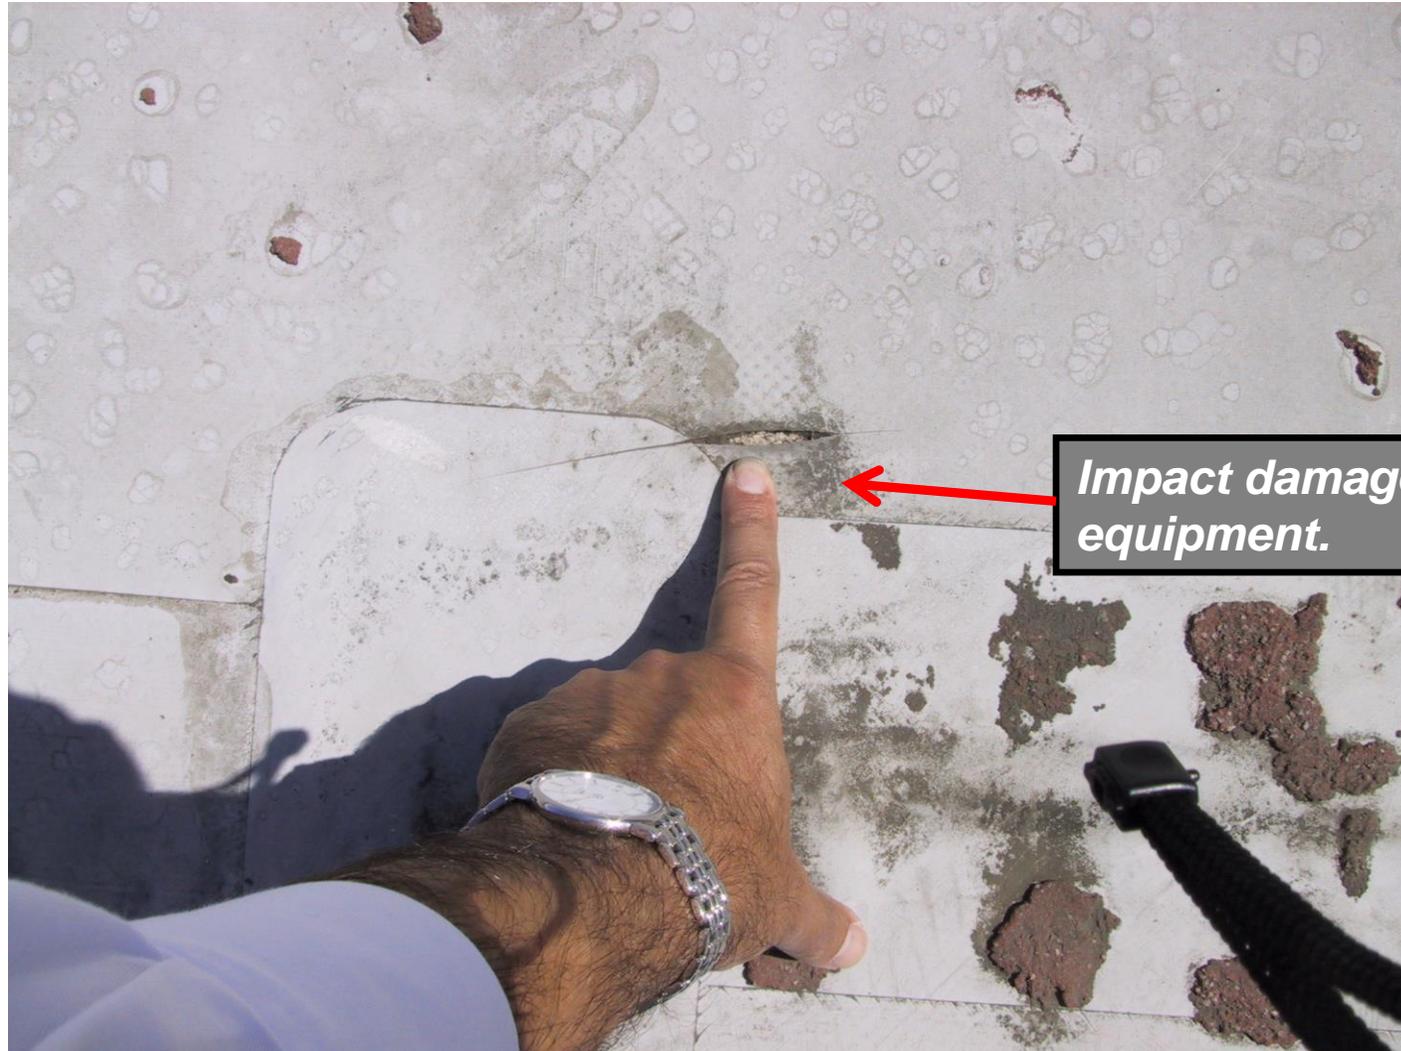
***Impact damage from dropped equipment.***

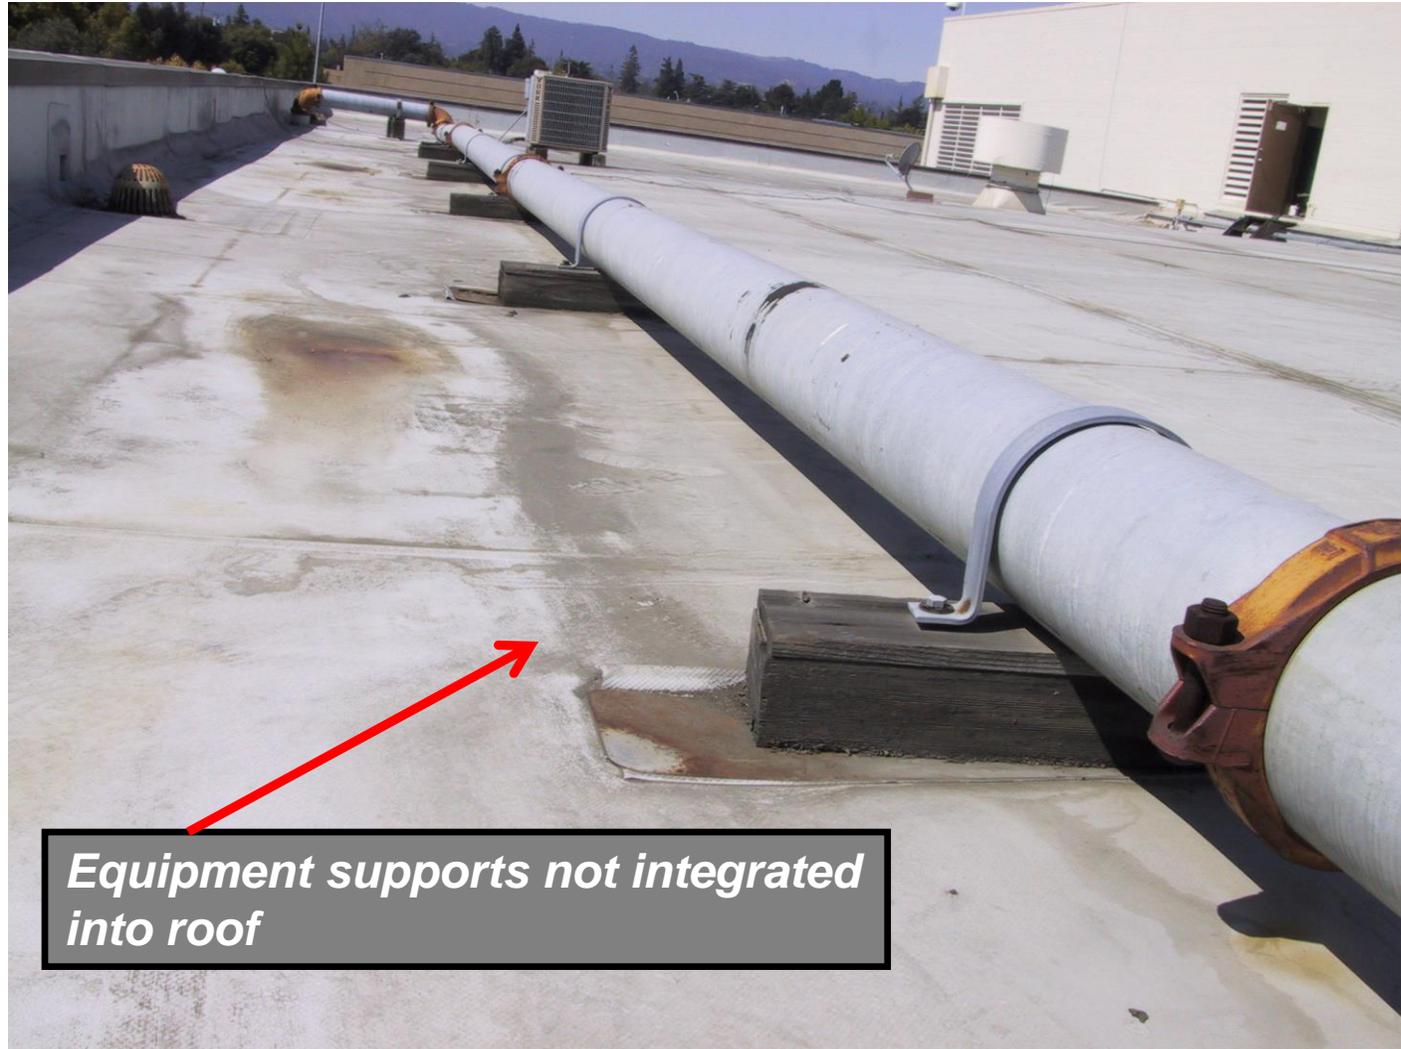
***Equipment supports not integrated into roof***

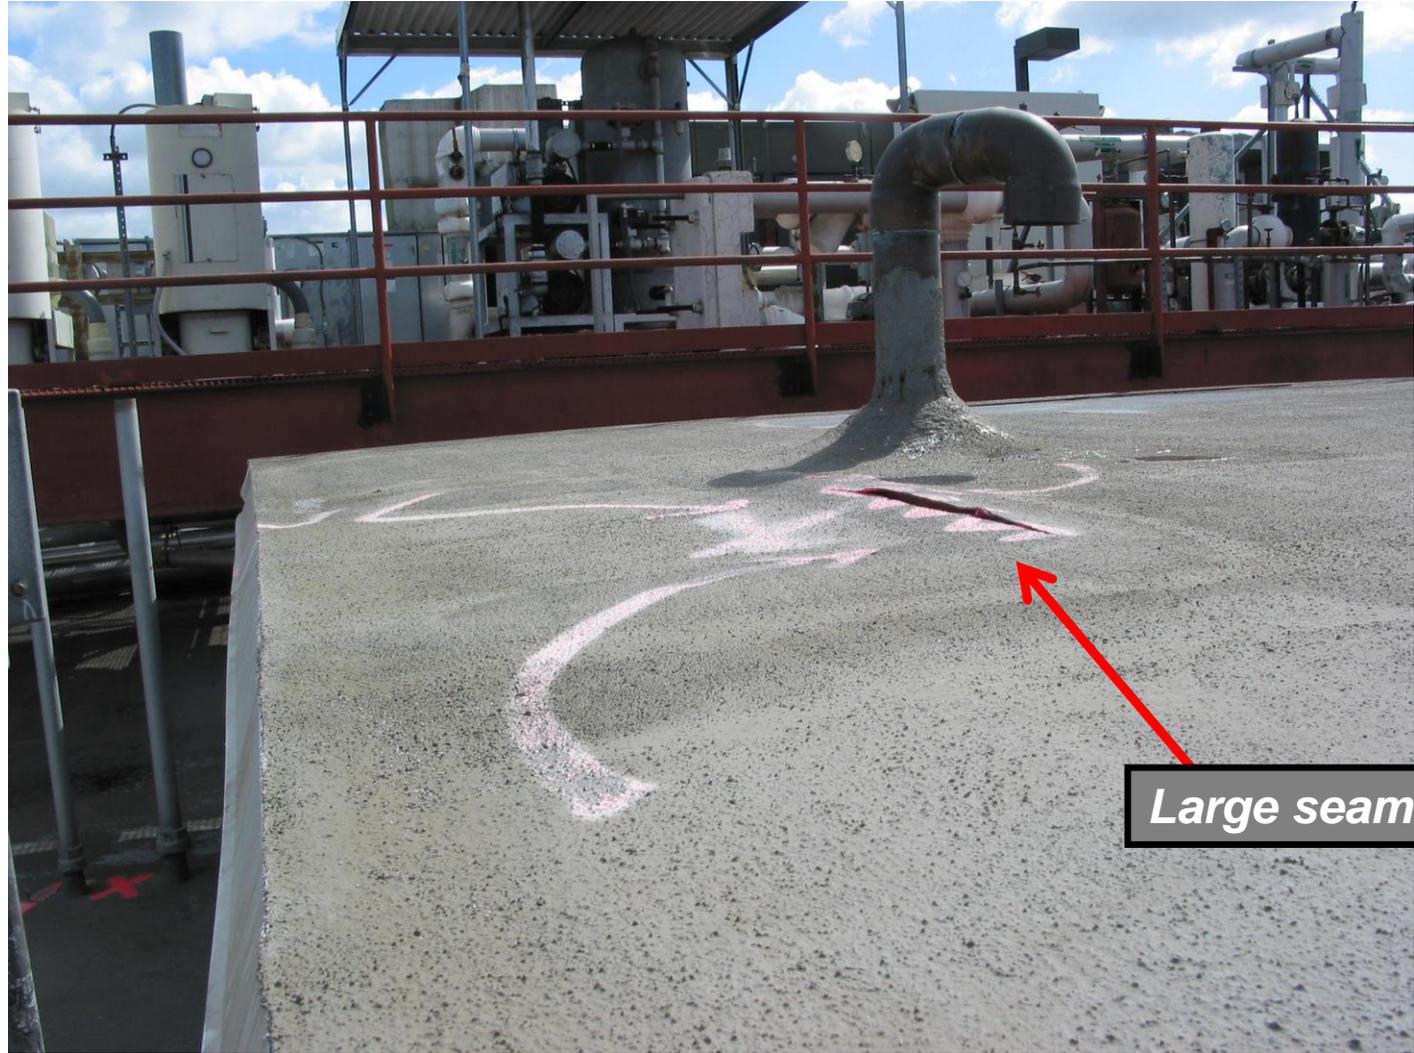
*Large seam split*

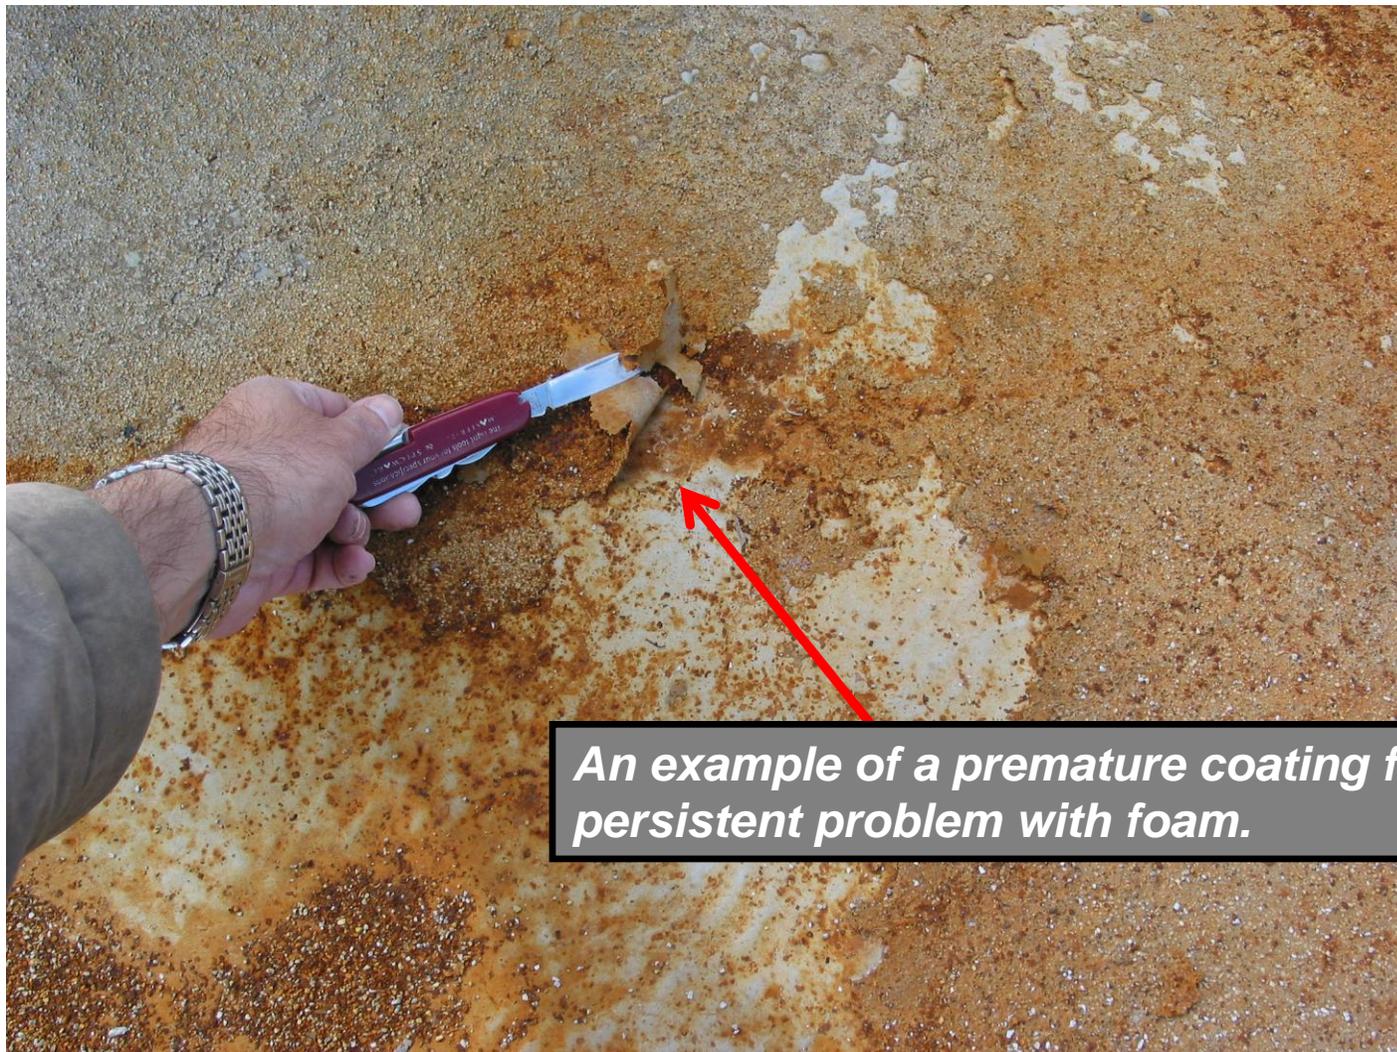
***An example of a premature coating failure – a persistent problem with foam.***

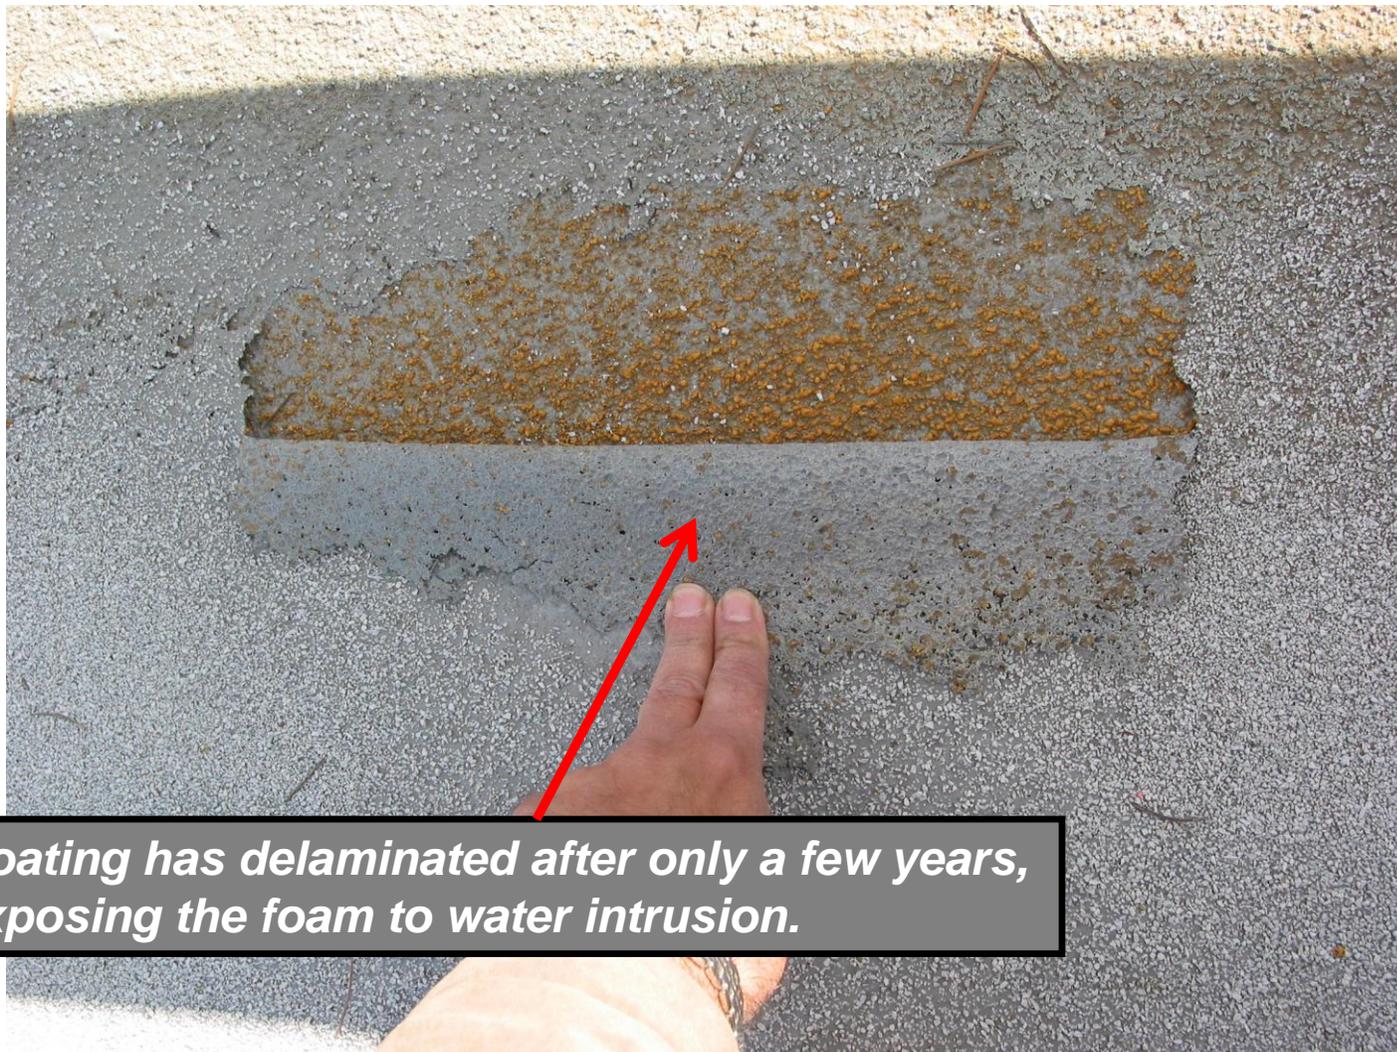
***Coating has delaminated after only a few years, exposing the foam to water intrusion.***

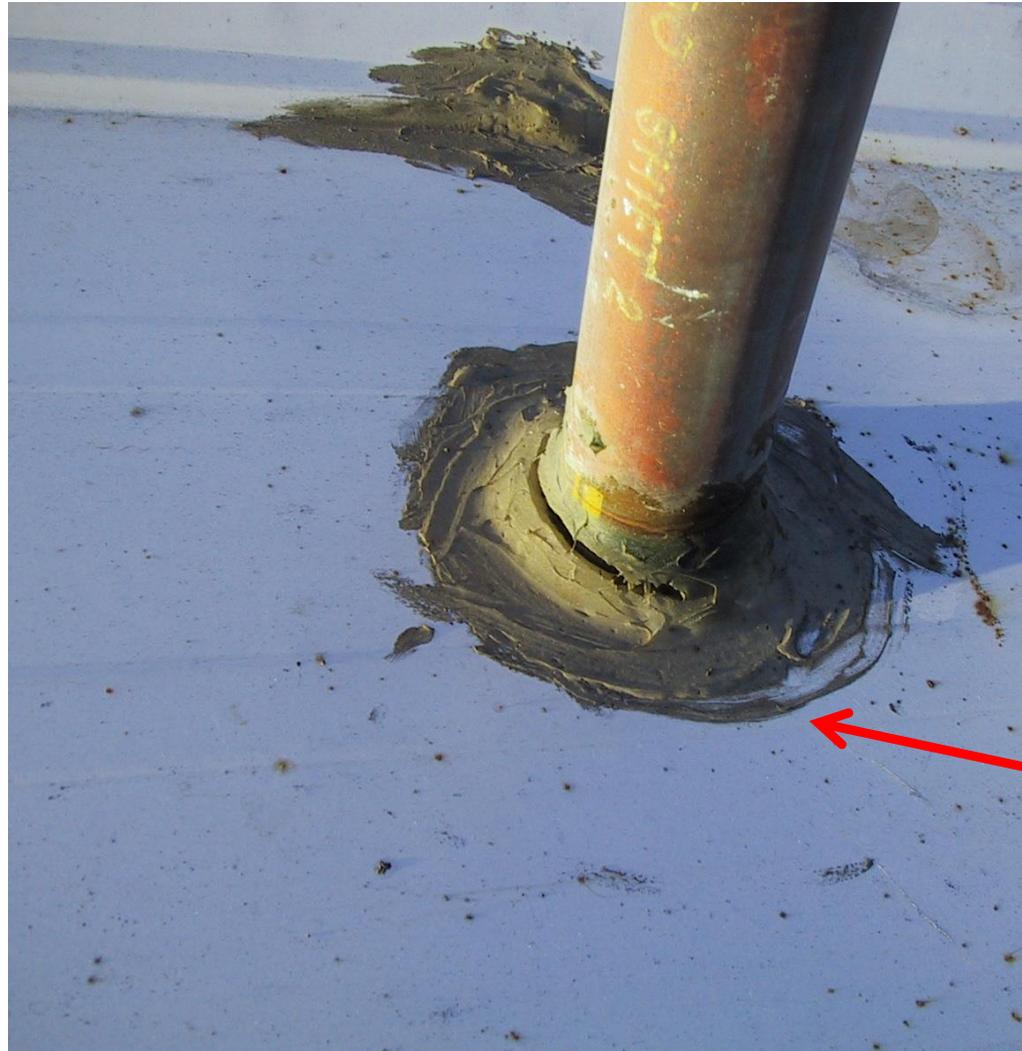
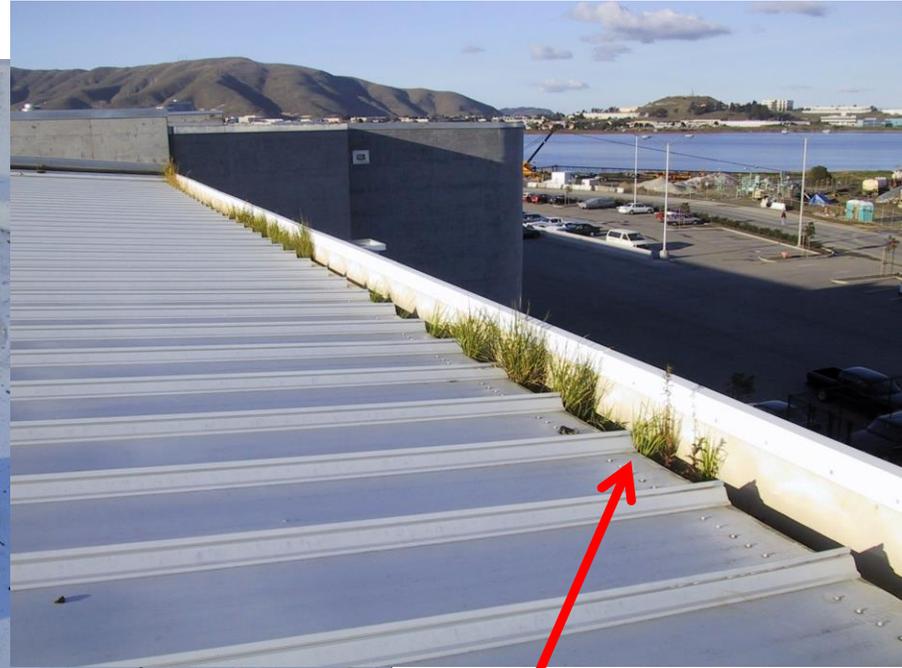
***Improper design leads to Failures***
