The Time is Now: Structural Issues Building Envelope Components

Eugene Buick, PE
Principal, Allana Buick & Bers, Inc.
ECHO Maintenance Seminar
October 23, 2004

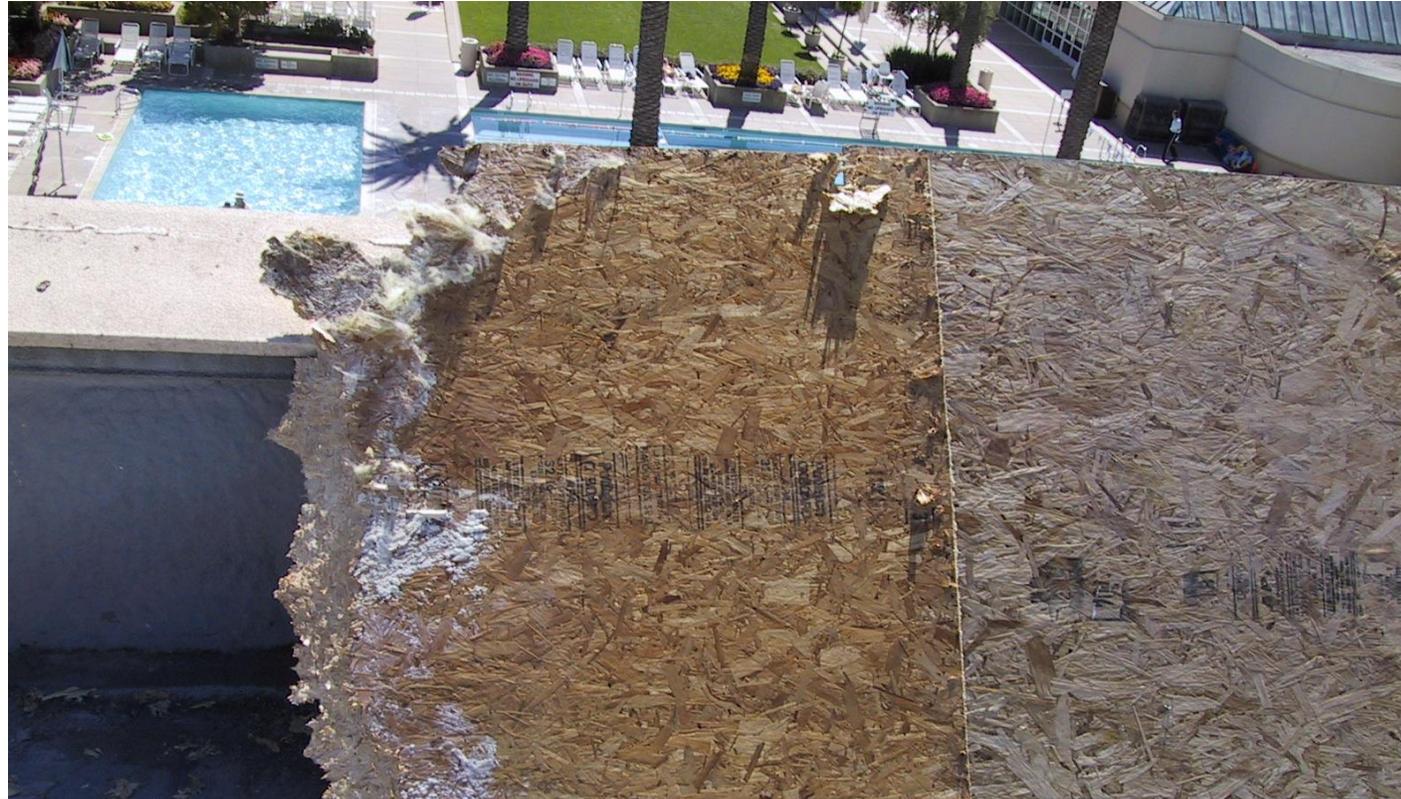
Severe damage to OSB Decking, due to leaks and condensation

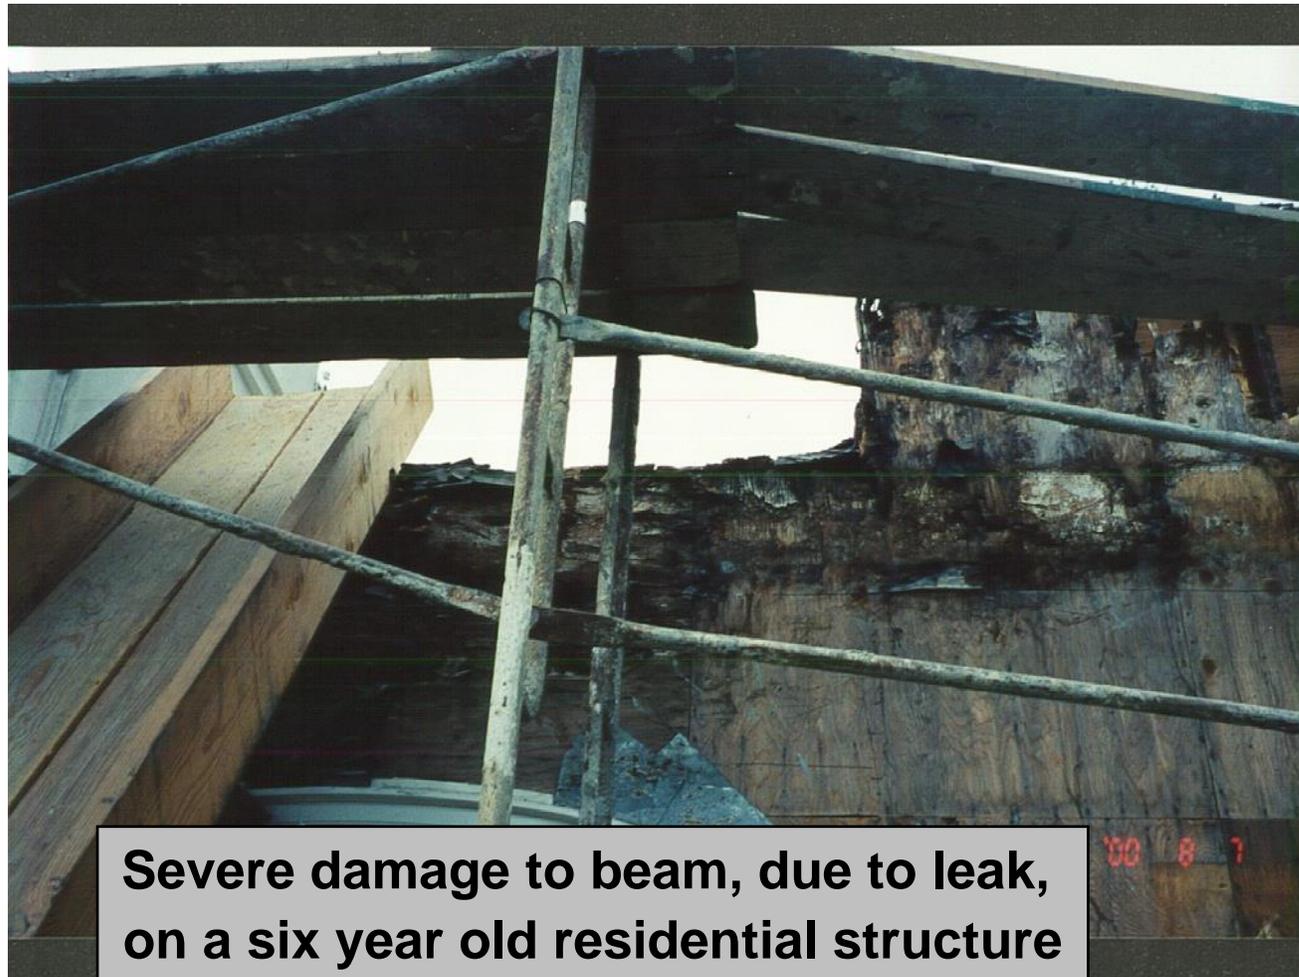
**Severe damage to beam, due to leak,
on a six year old residential structure**

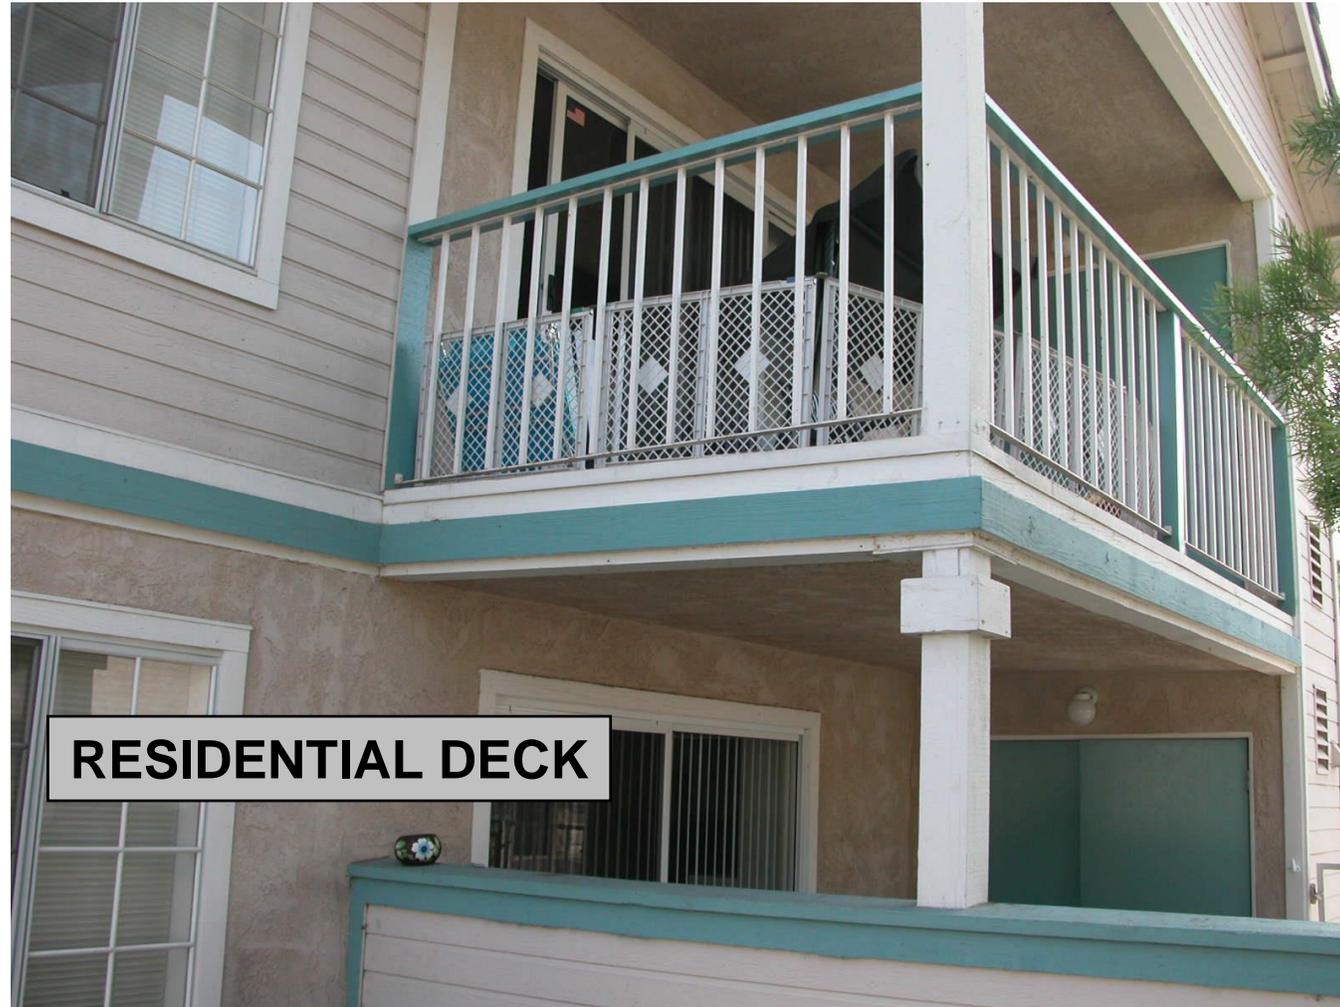
RESIDENTIAL DECK

Wood to wood contact traps water and promotes decay

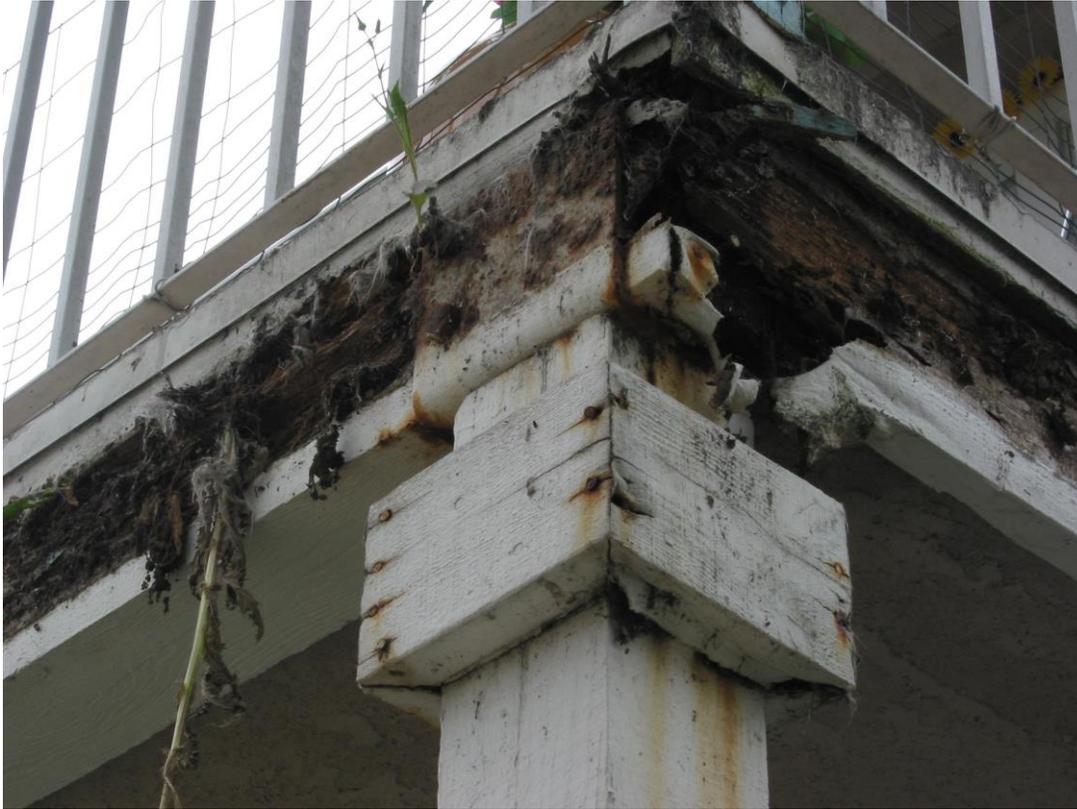
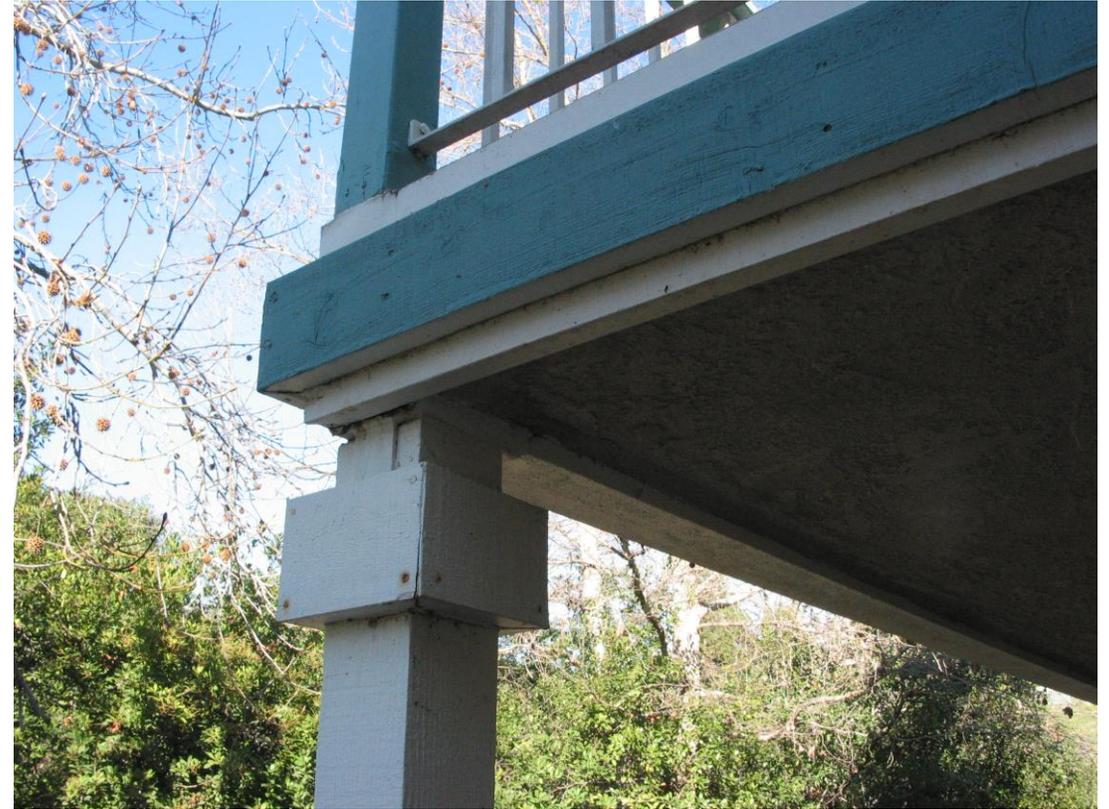
DECKS

Wood bands over wood beams, plus landscaping on deck..... bad idea!

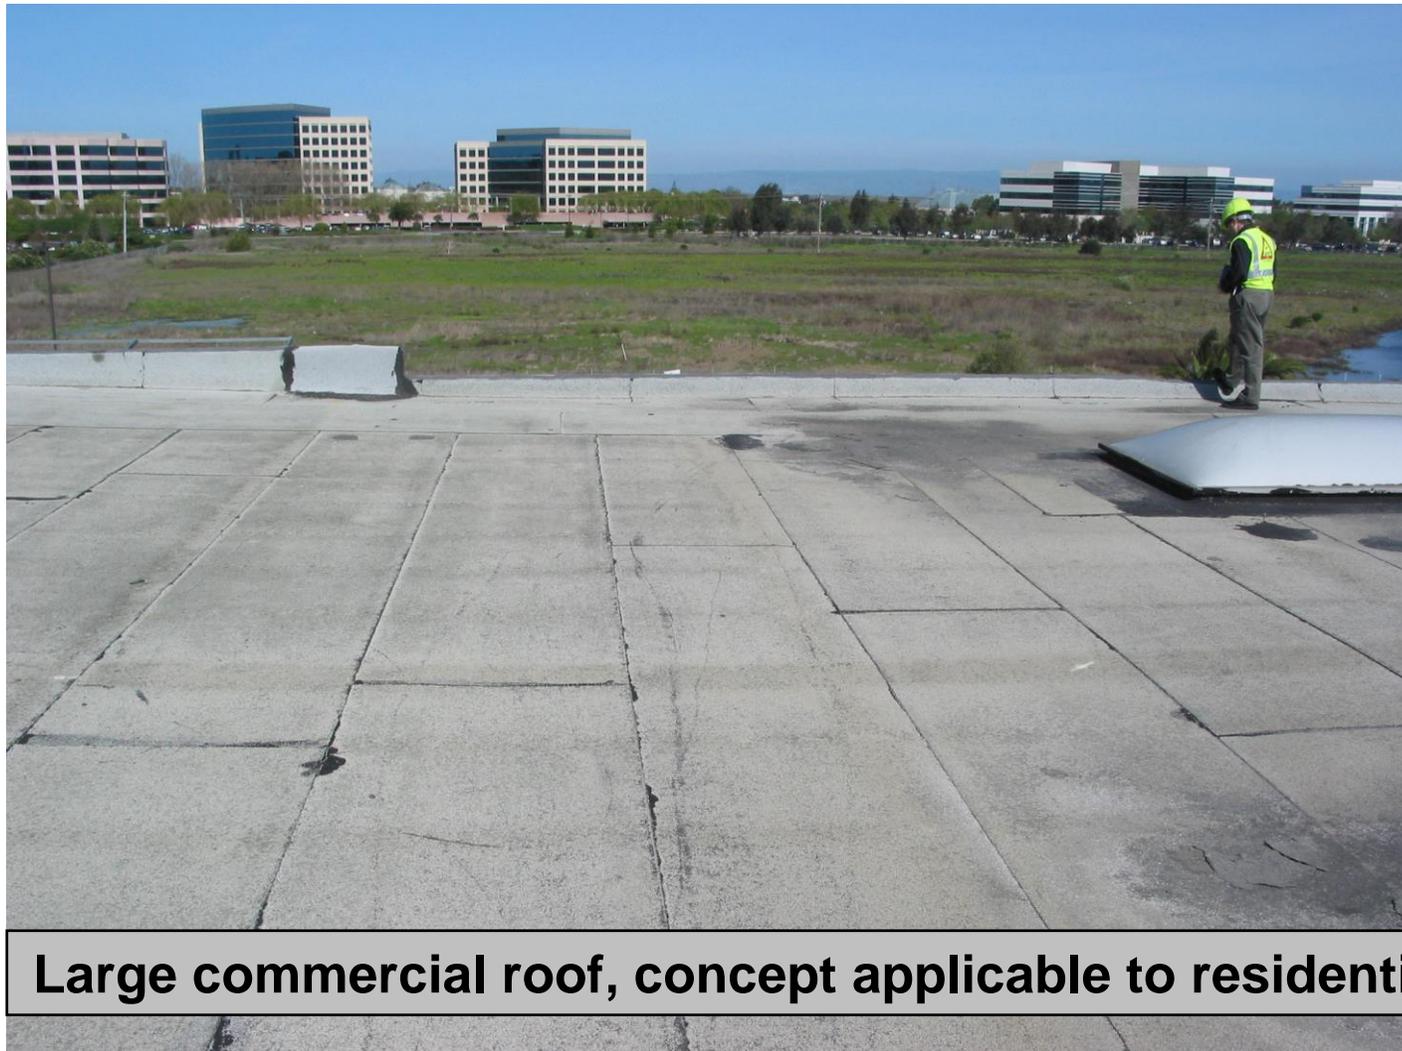
Large commercial roof, concept applicable to residential

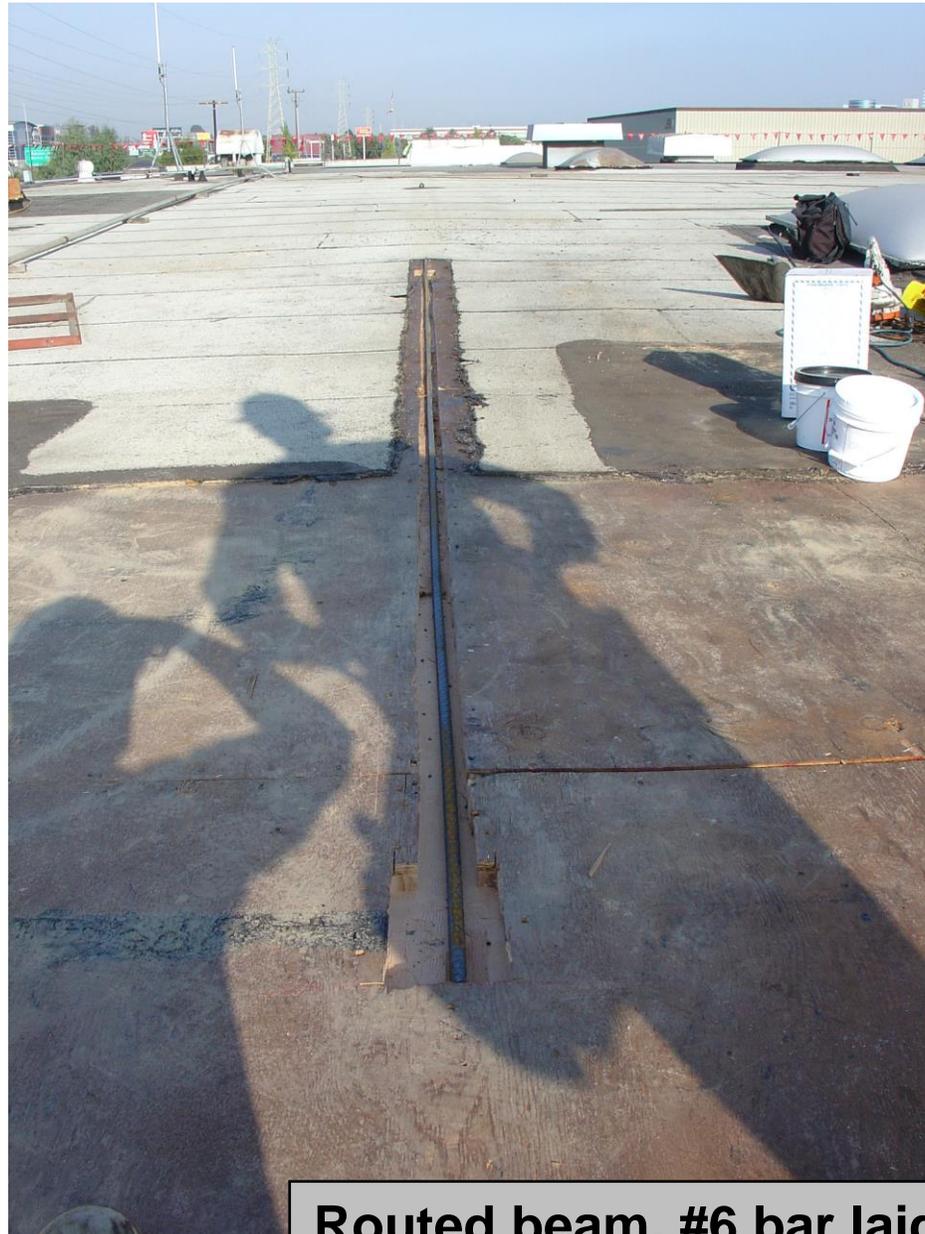
Routed beam, #6 bar laid in groove

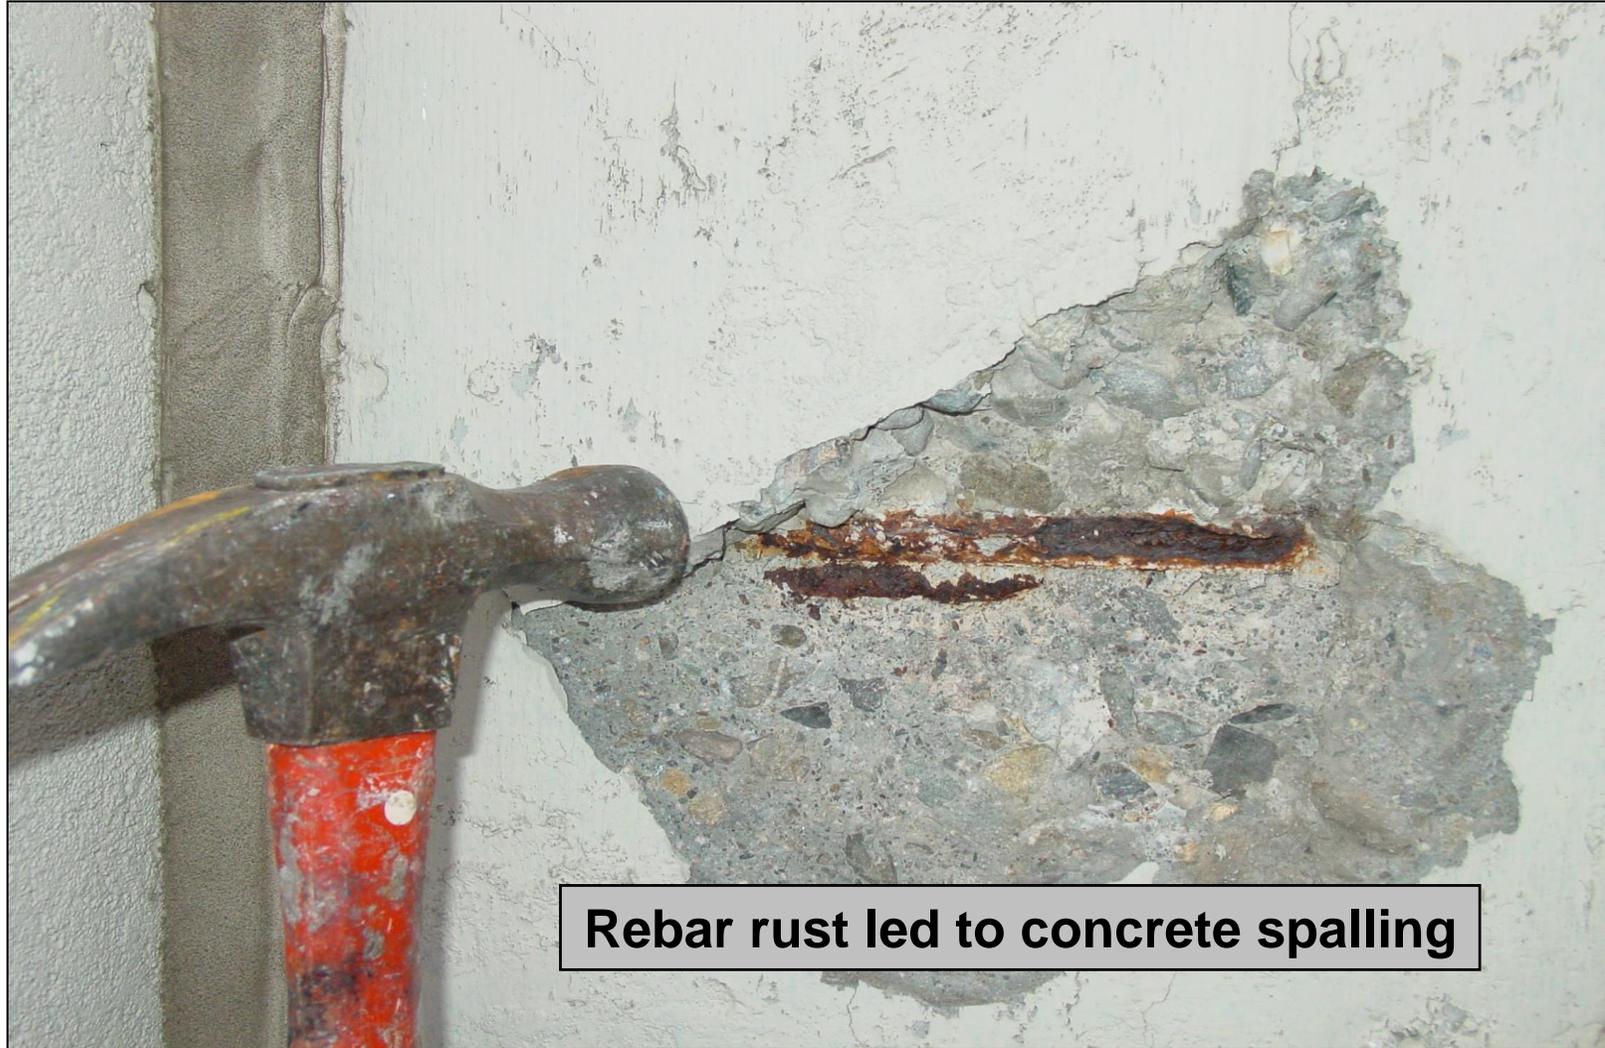
Rebar rust led to concrete spalling

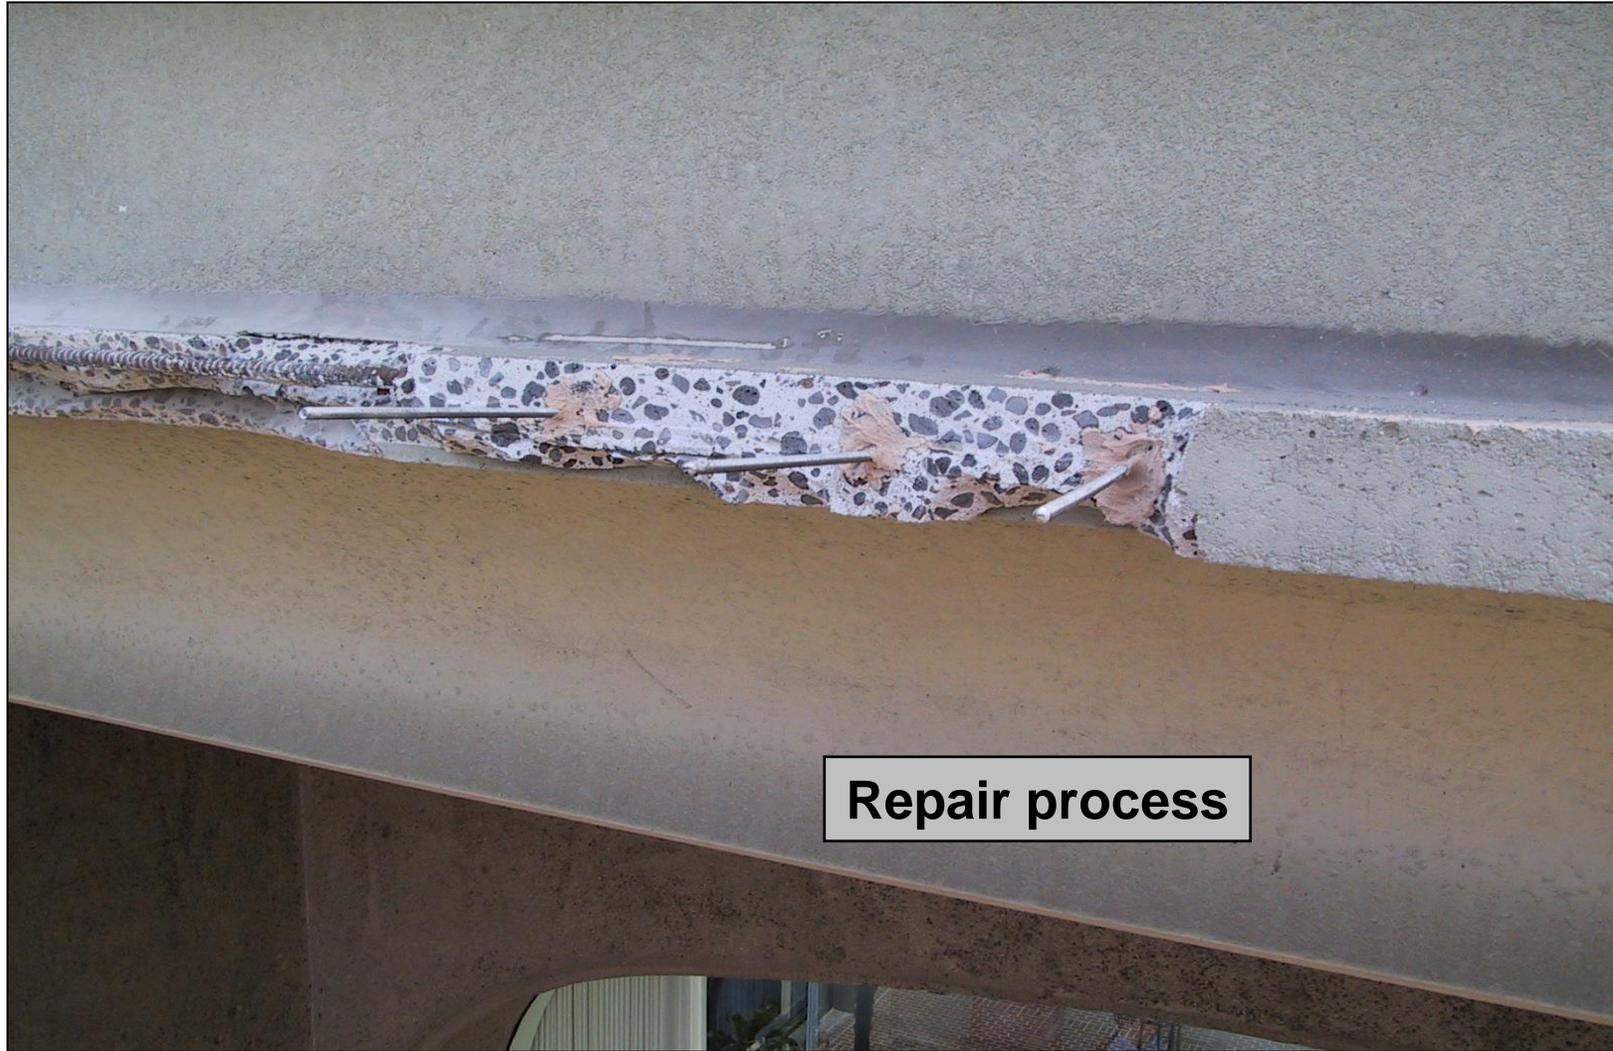
Repair process

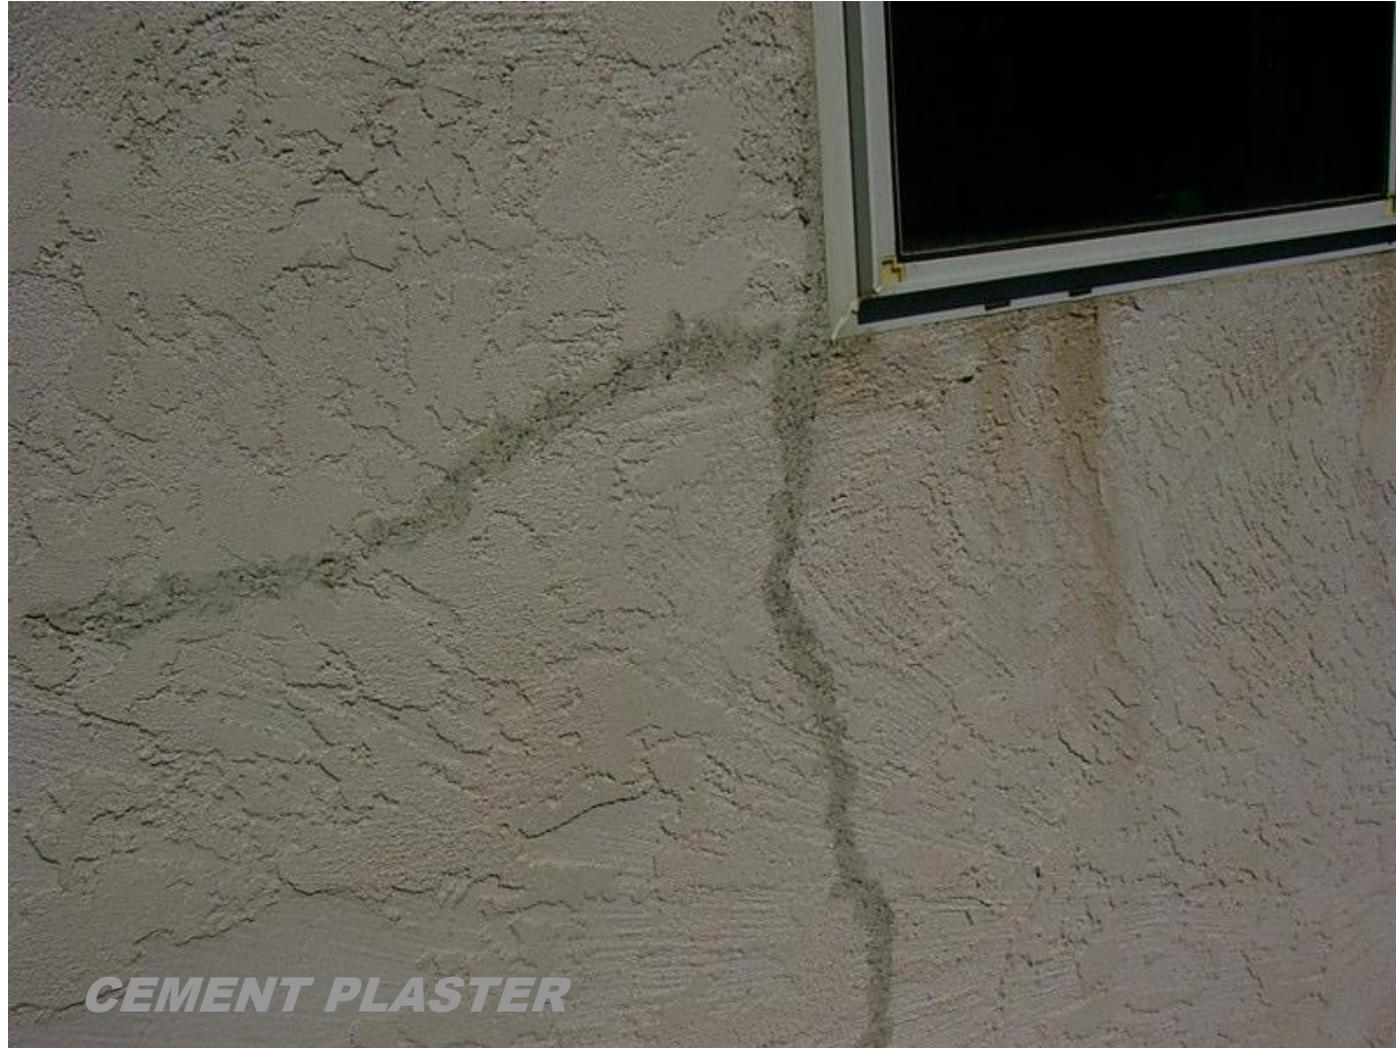
Look for water stains or unusual cracks in cement plaster

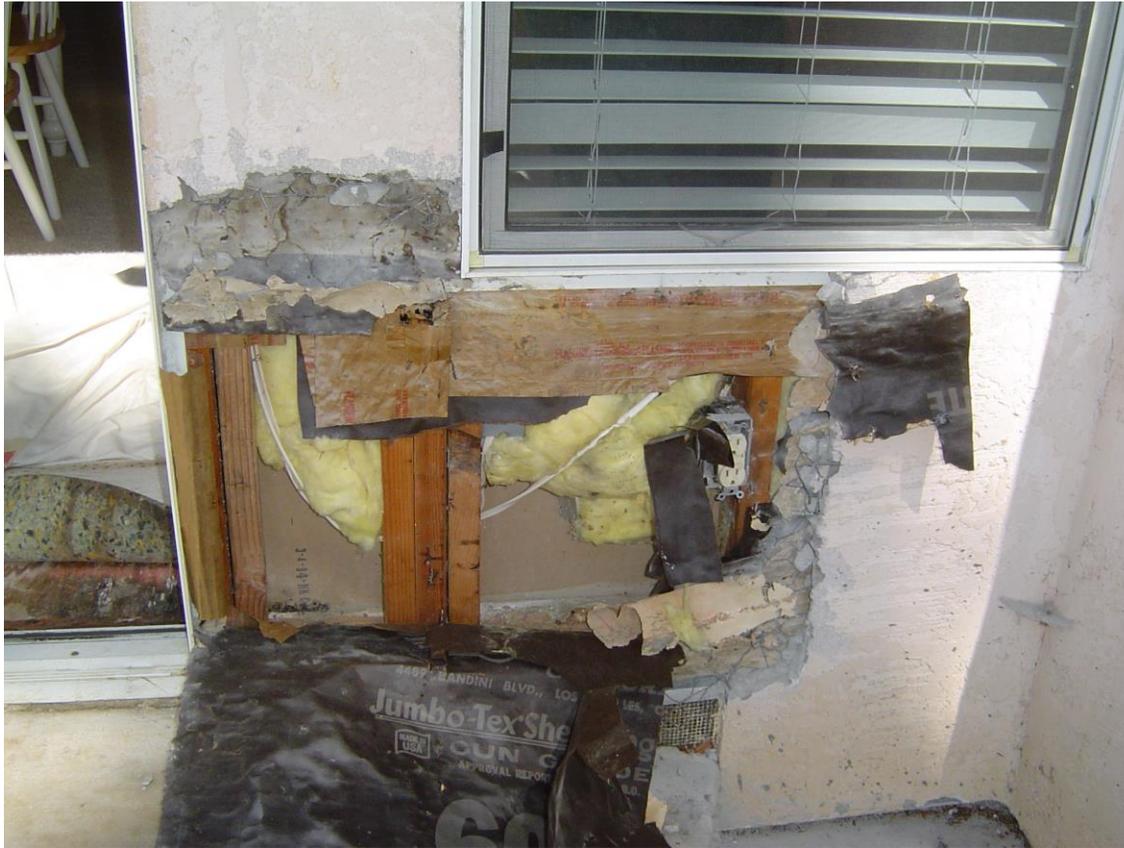
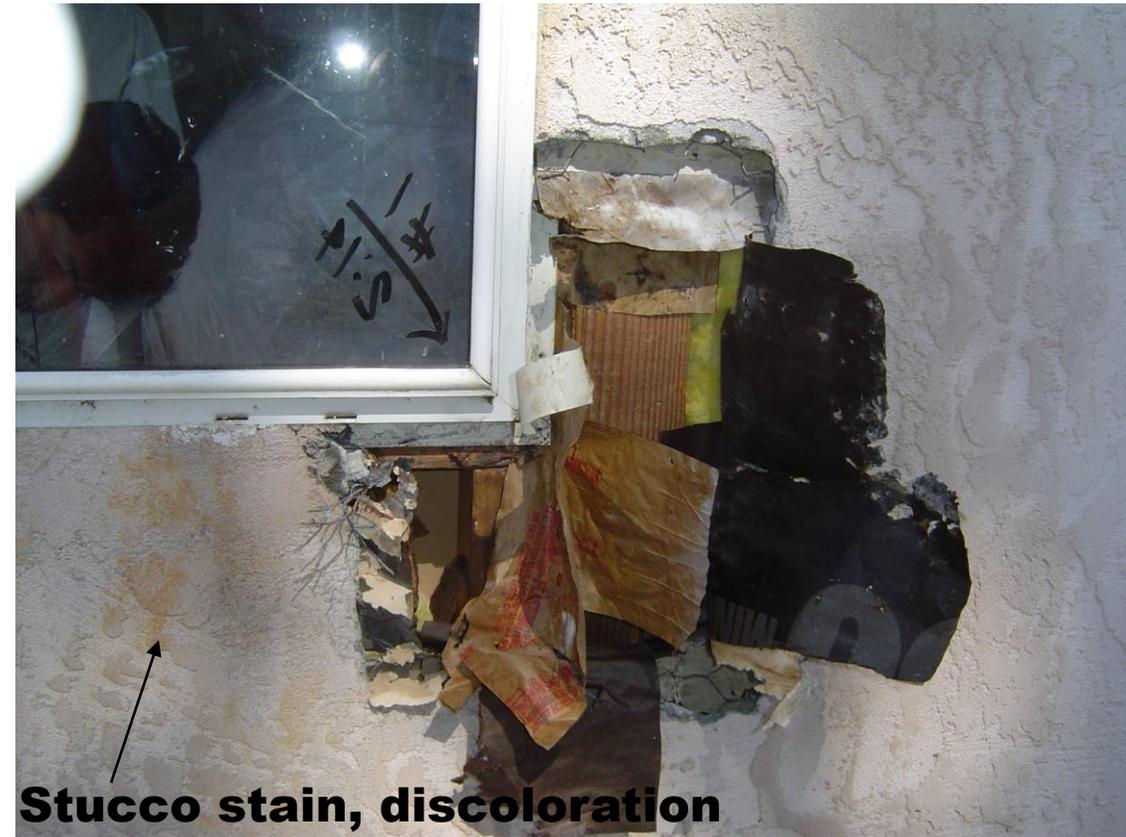
Typical window frames in cement plaster allow water intrusion. Seal edges of window and exterior plaster

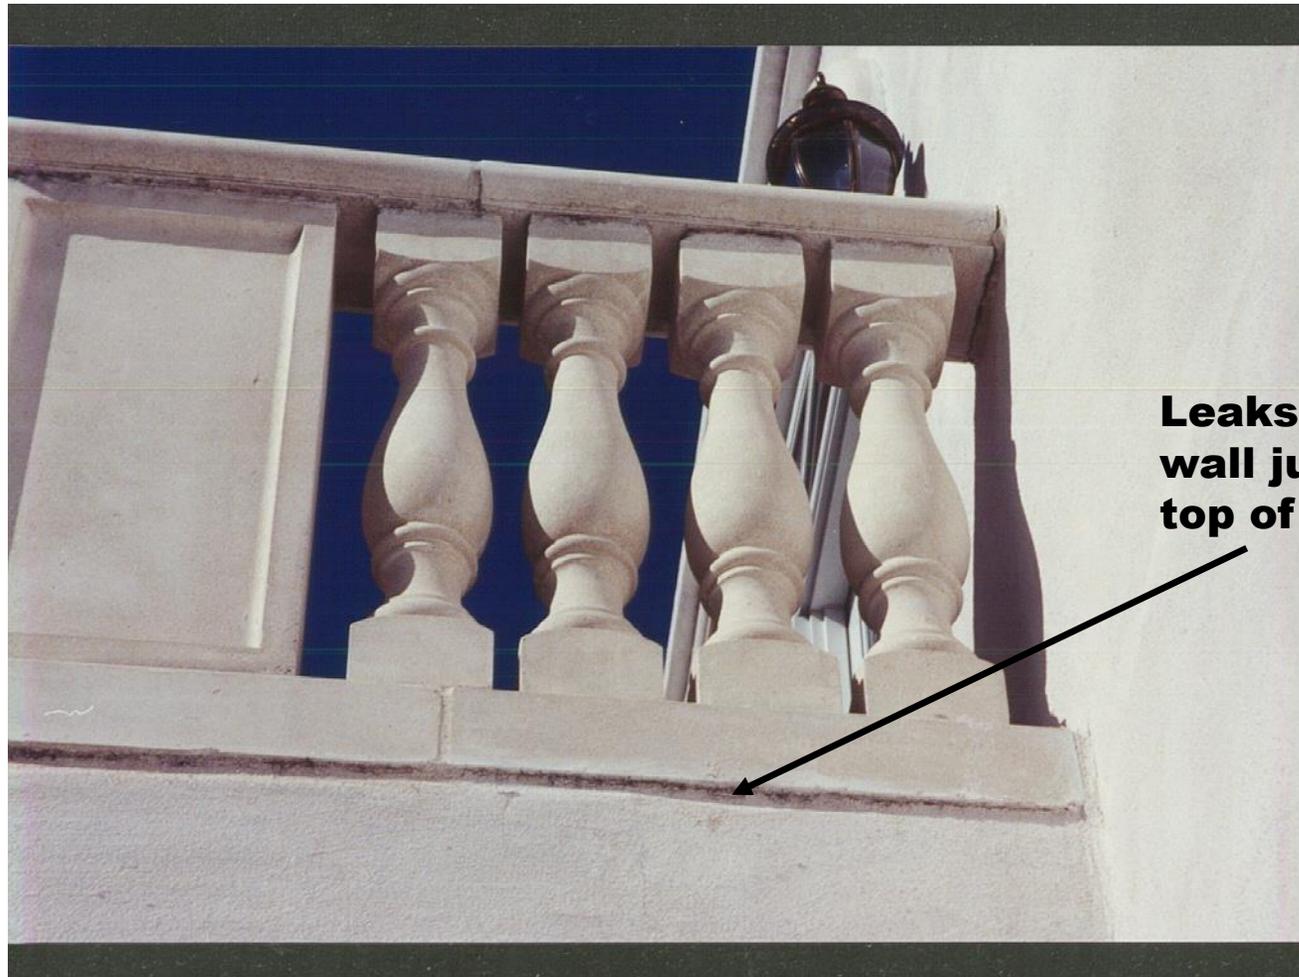
CEMENT PLASTER

**Leaks from rail
wall junction at
top of plaster**

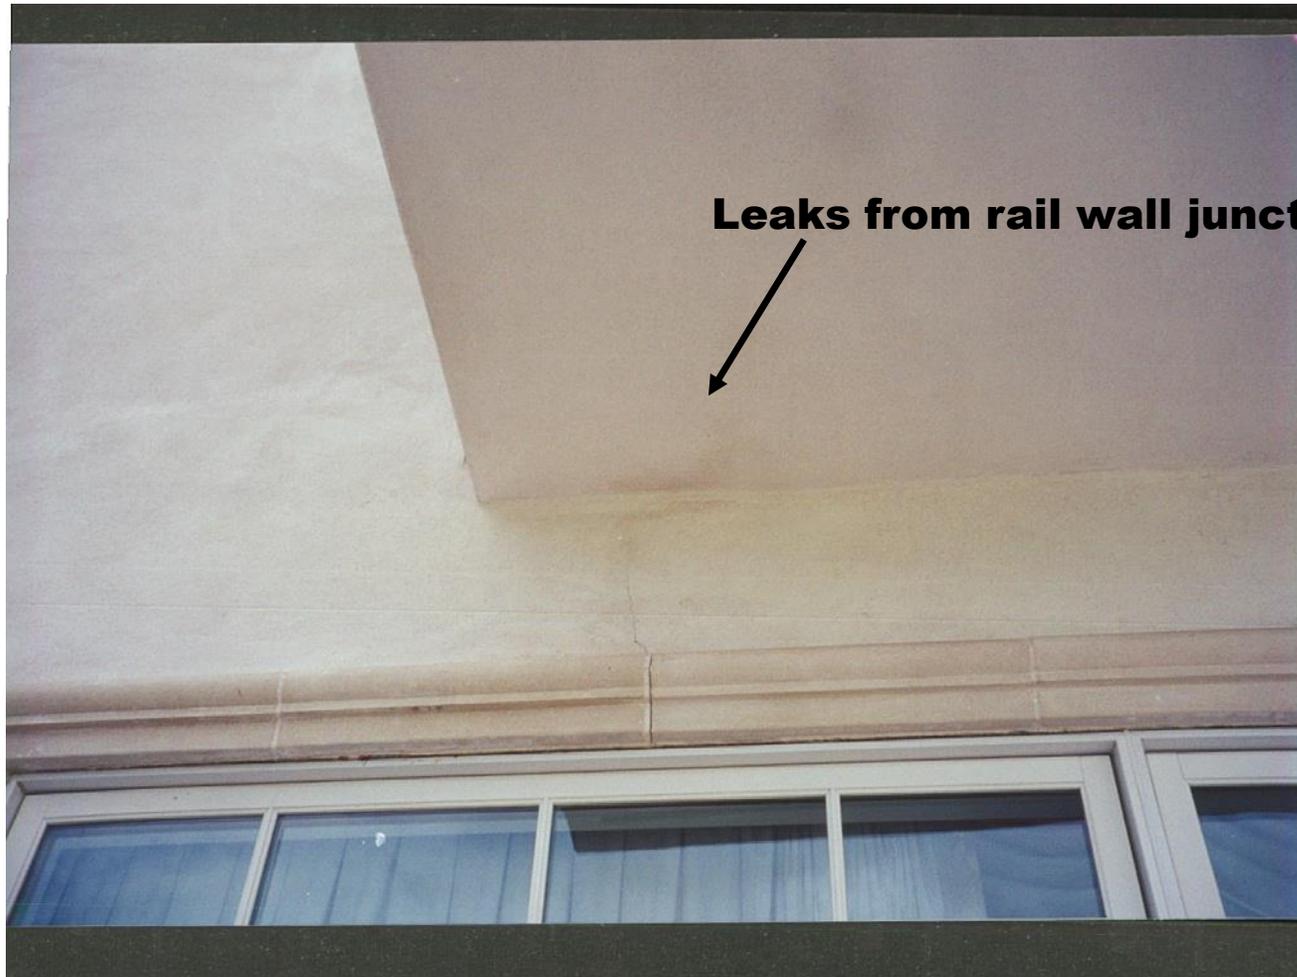
Leaks from rail wall junction

This innocent looking leak caused a lot of damage

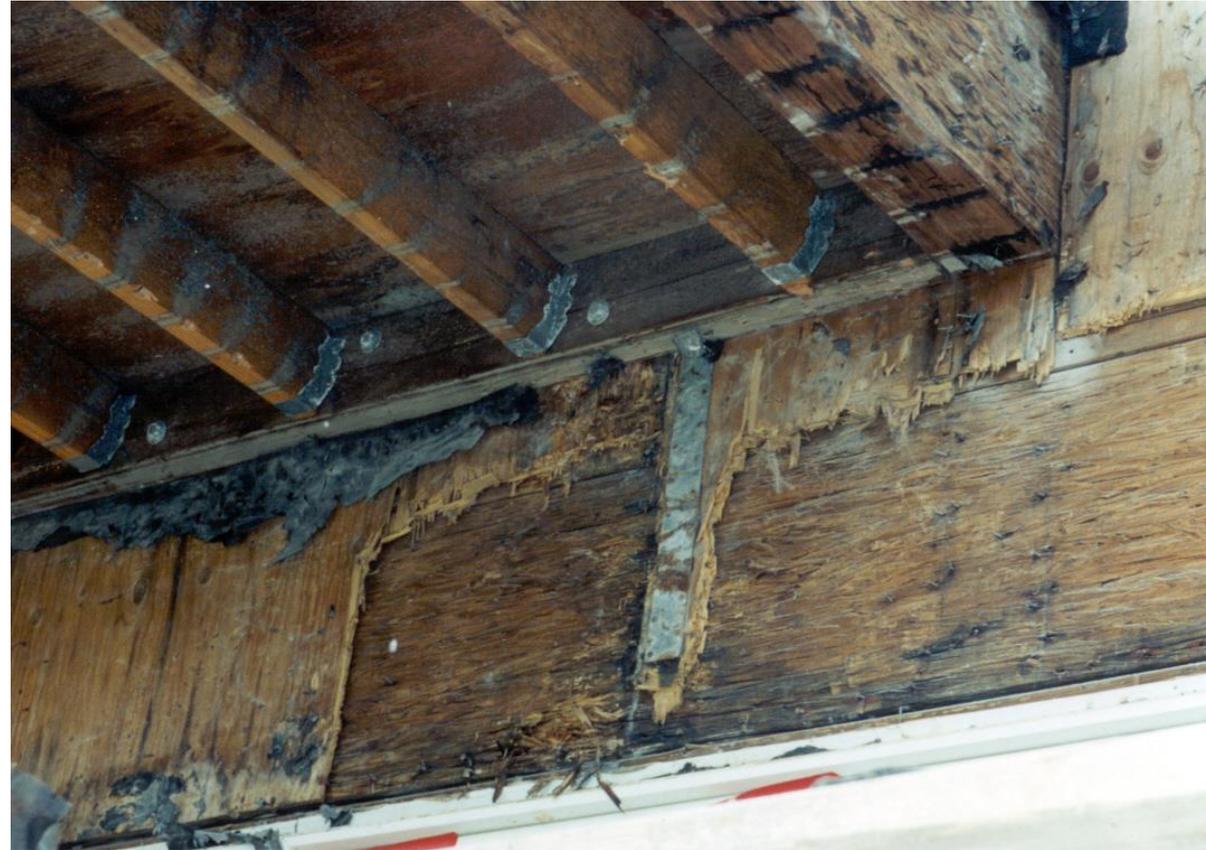
Stucco leak from top of rail wall

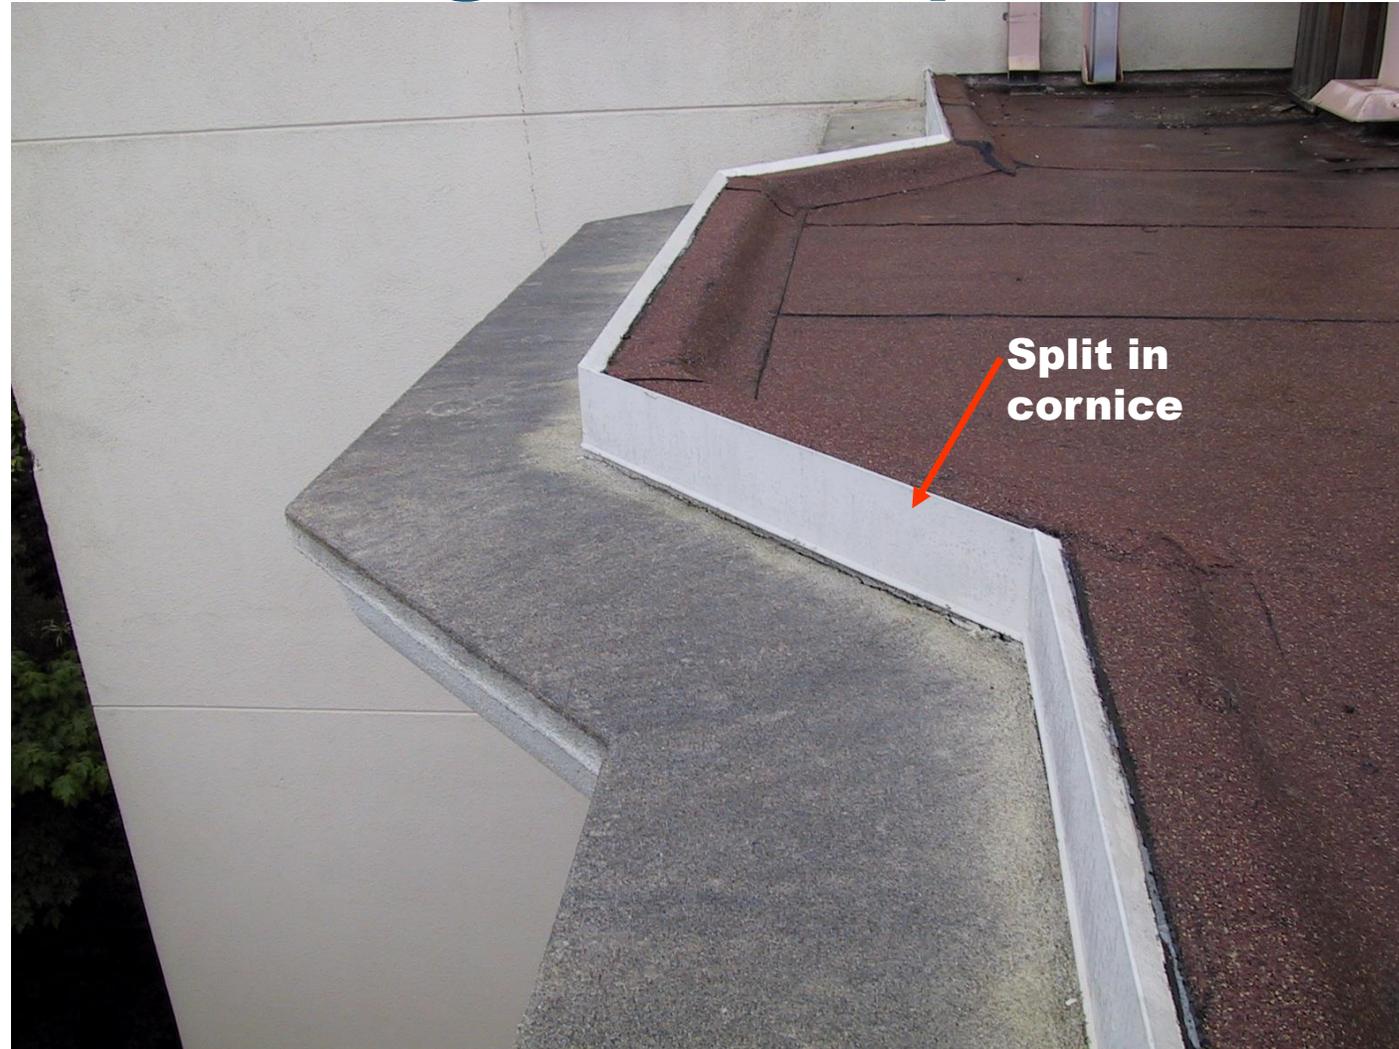
EIFS cornice (lack of slope) allowed this water intrusion
