Understanding the Common Causes of Condensation

Case Study: EIFS Bull Nose, Pleasanton CA

4- Story Office Building Pleasanton, CA

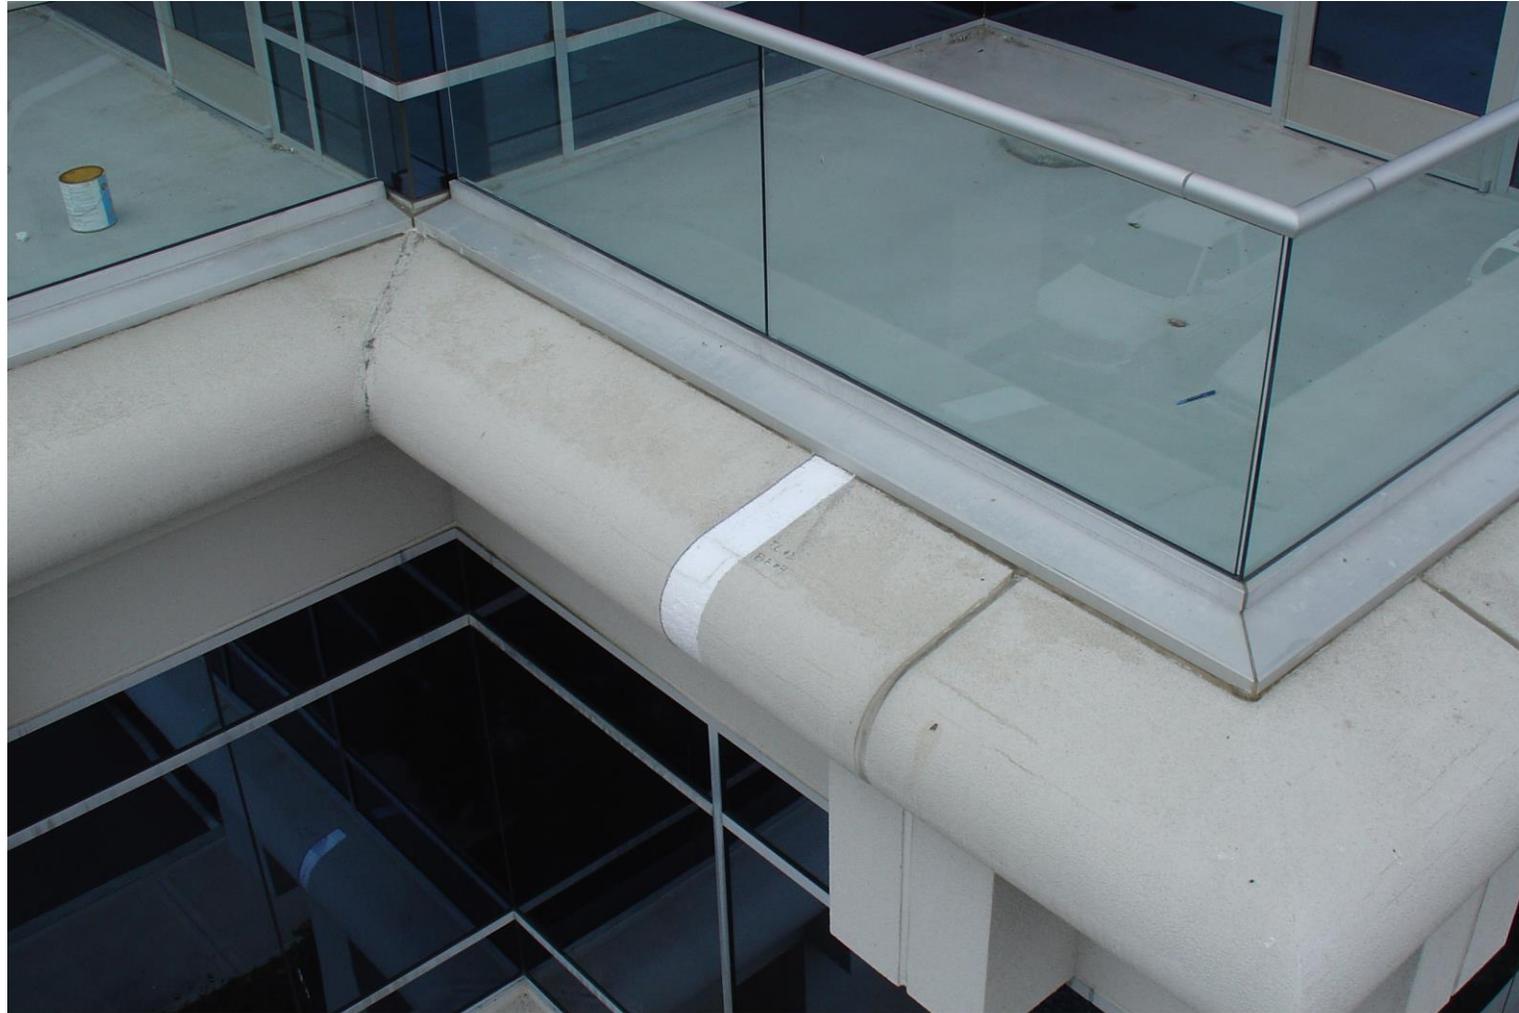
CHA-AL04351

Typical Crack in EIFS Bull Nose

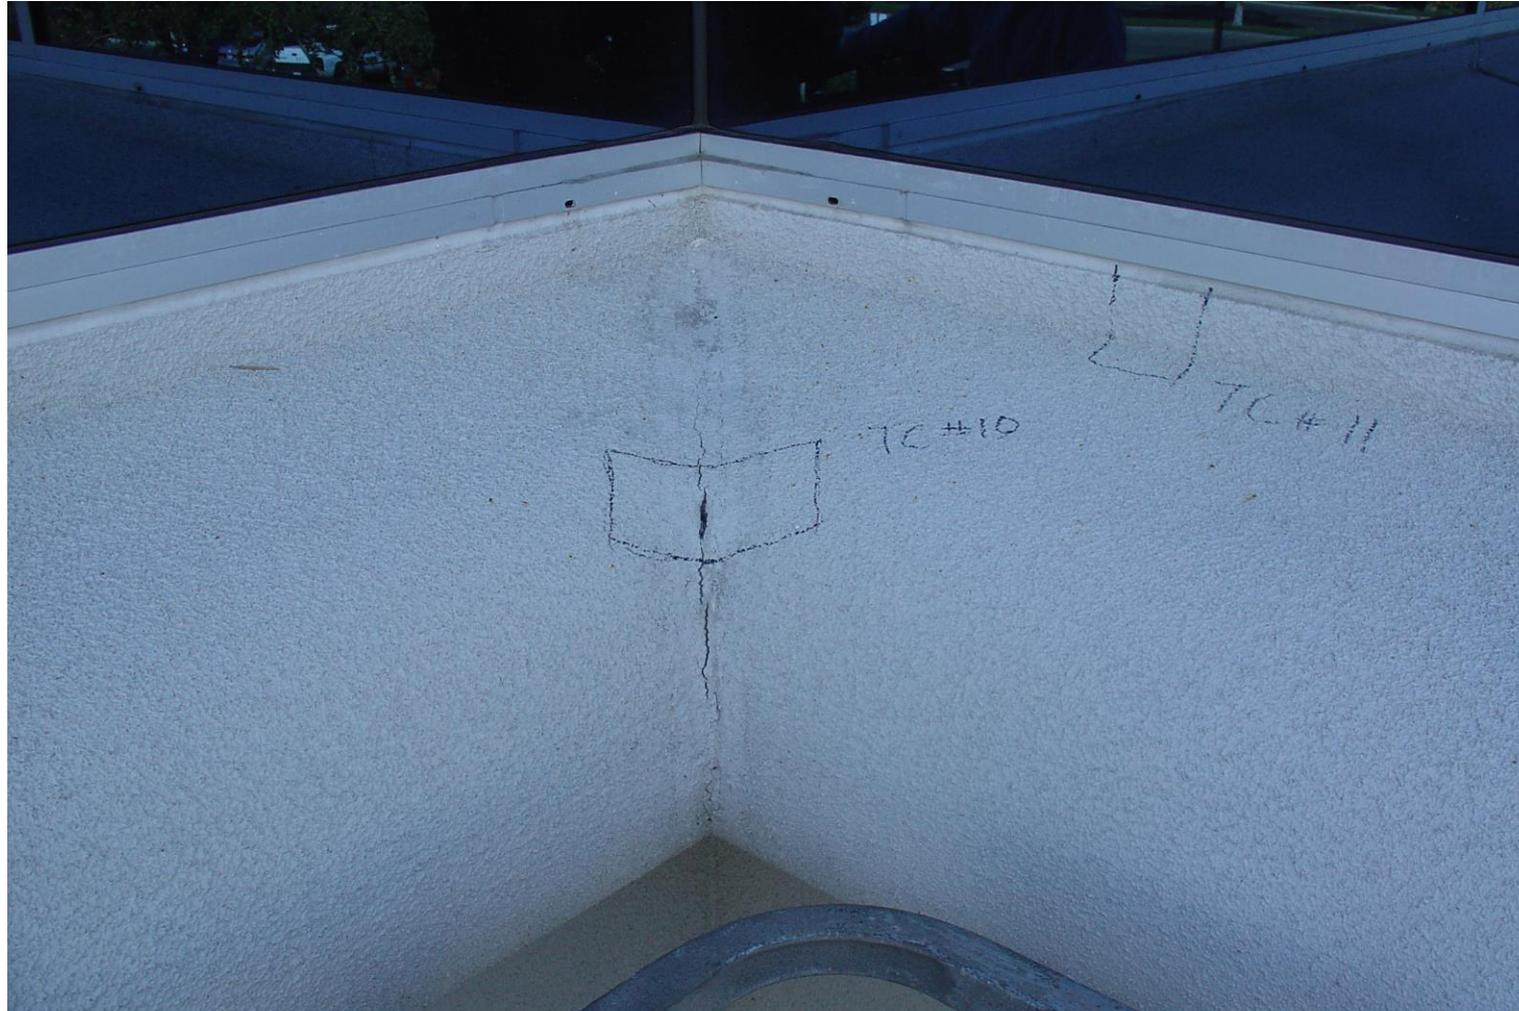
CHA-AL04435

Vertical Crack at inside Corner

DEFECT: Lack of expansion joint at inside corners

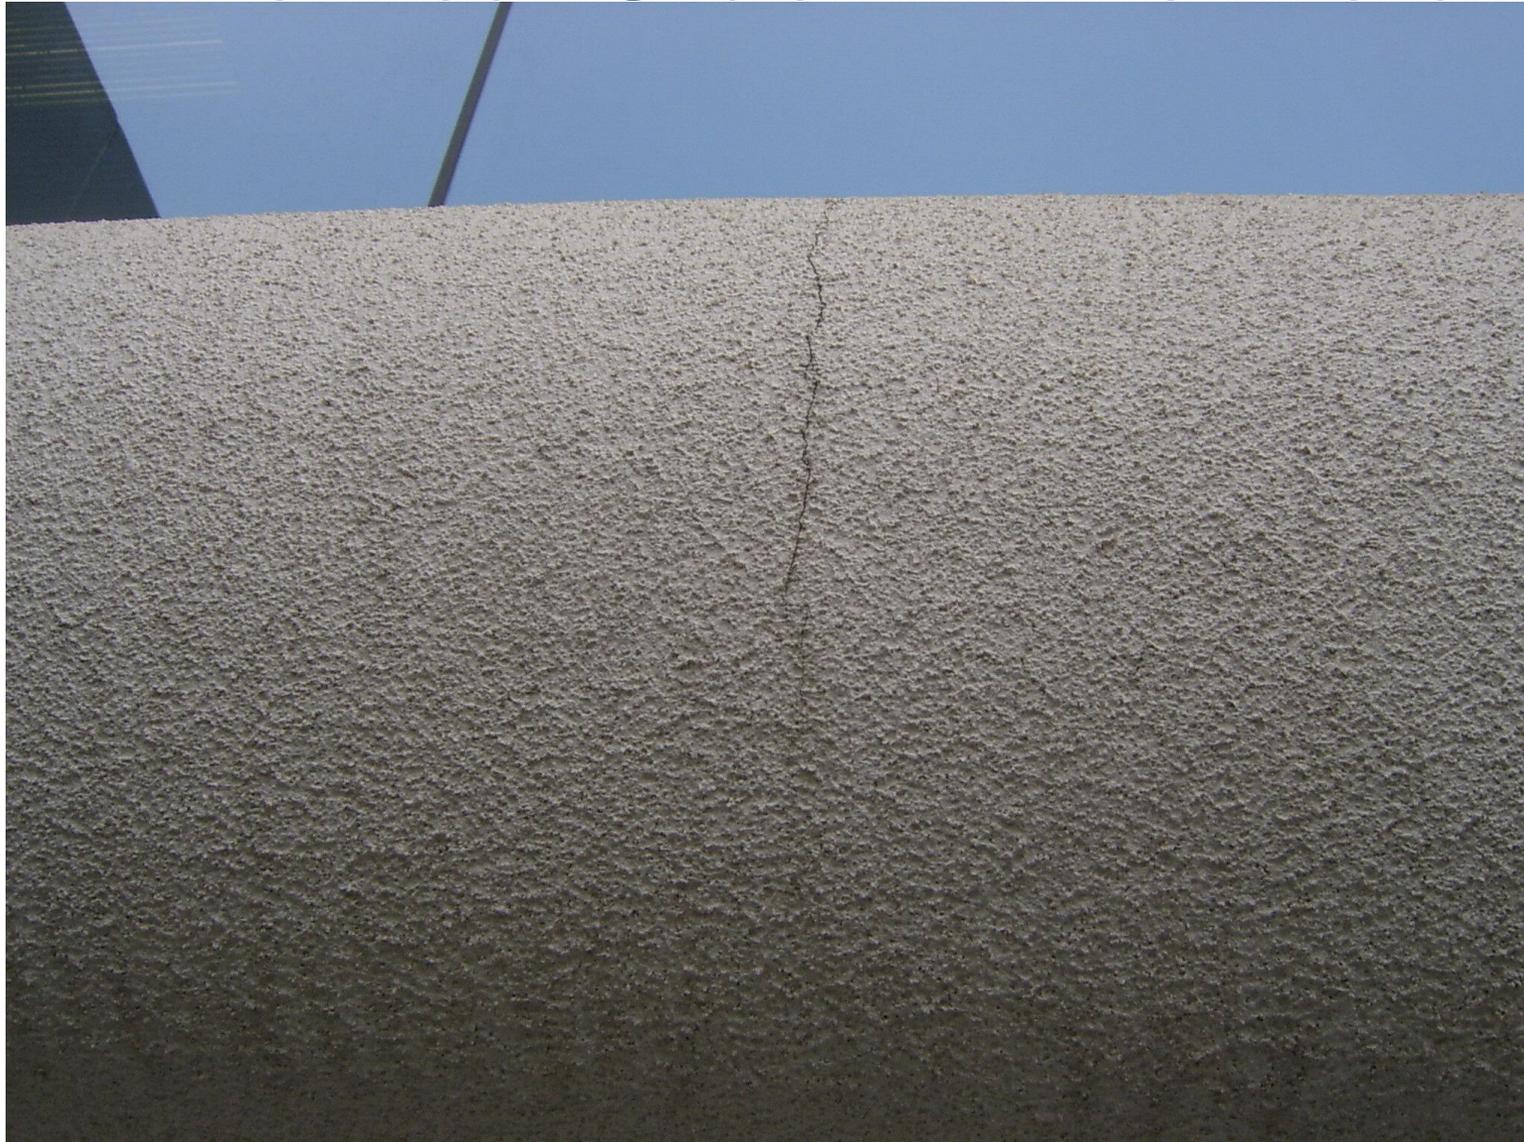
CHA-AL03186

Vertical Crack in the Field

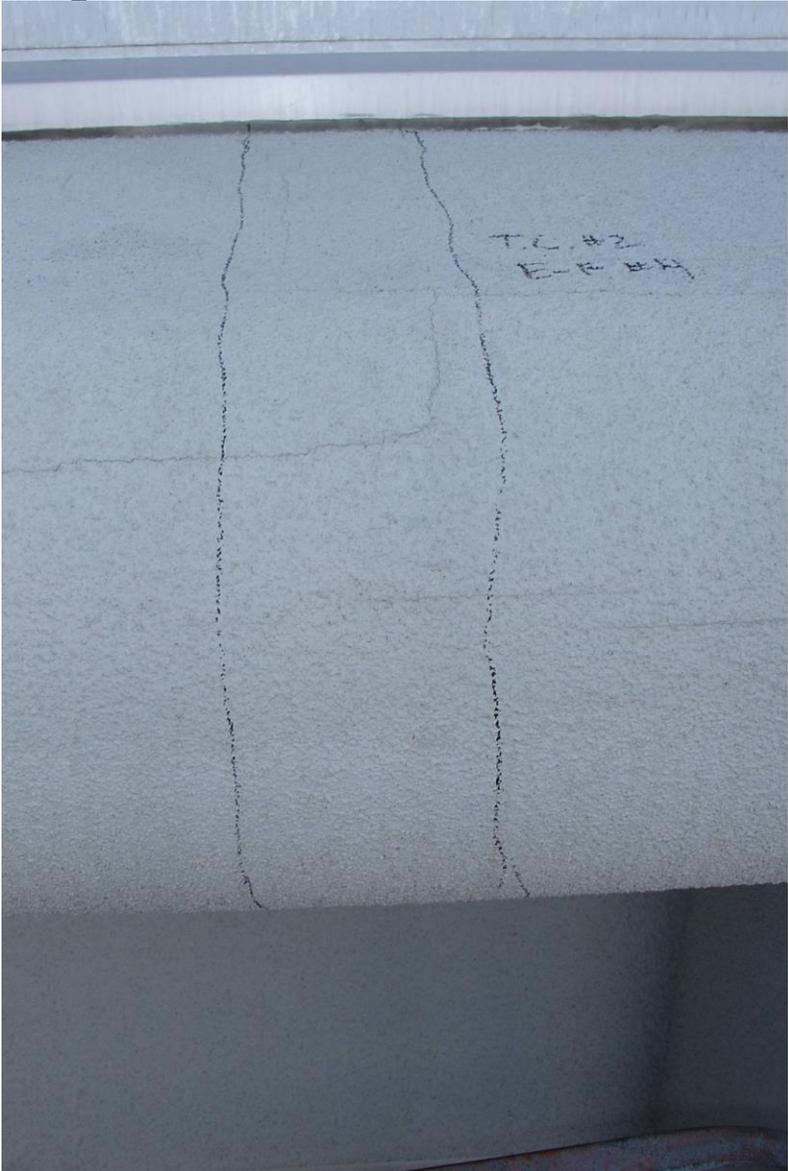
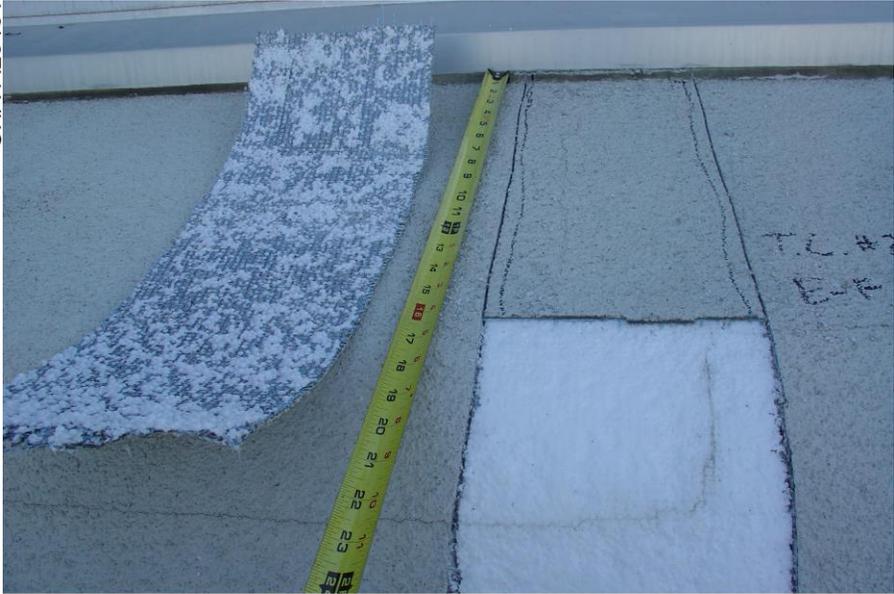
Multiple Cracks, Horizontal and Vertical

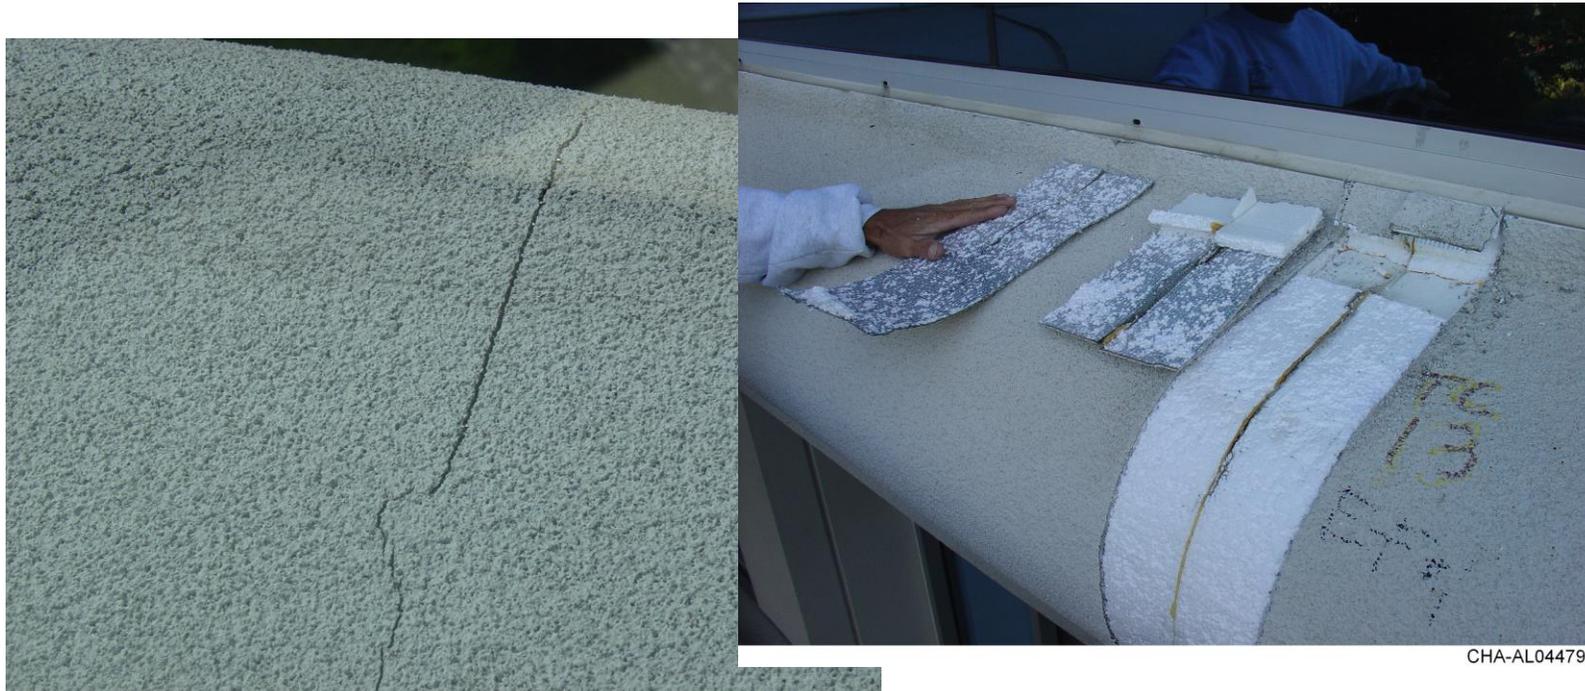
Reasons for Vertical Cracks (Defect)

- Generally, vertical cracks were caused by “gaps” in EPS insulation. Gaps create areas where the cementitious base coat collects and creates a discontinuity for thermal movement, causing a split
- In some cases, vertical cracks resulted due to lack of mesh embedment

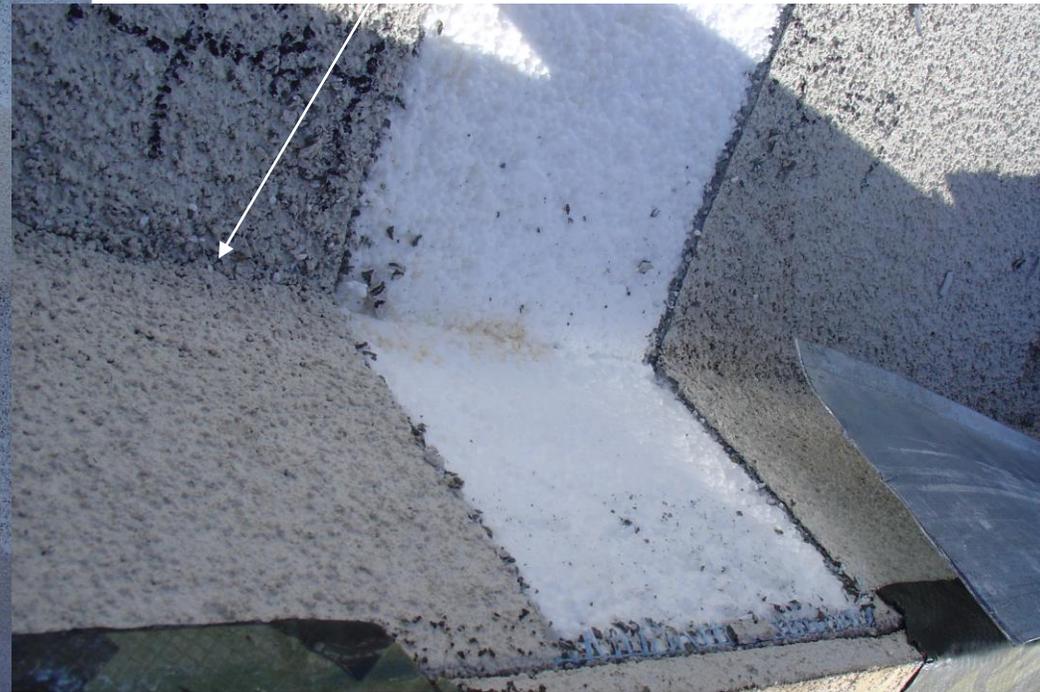
Vertical Crack at inside corner

Horizontal Crack at inside corner. Notice water stains.

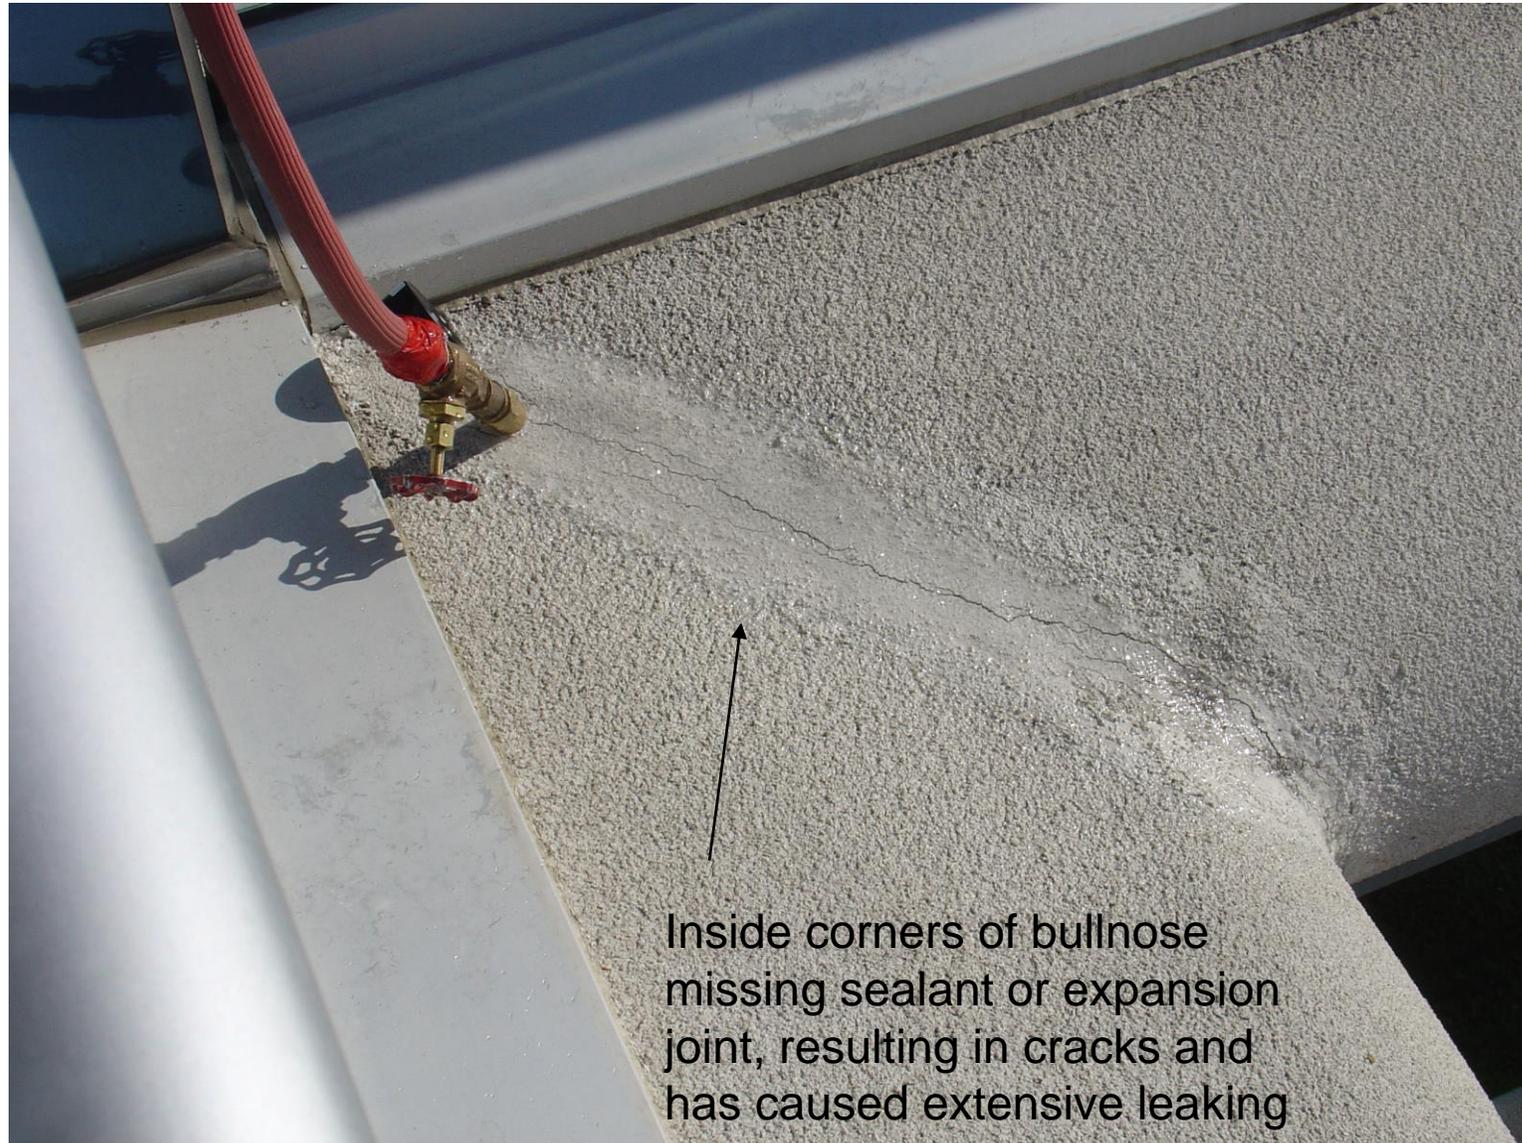
CHA-AL05487

Cracks and leaks at Inside Corner of bull nose

Leak Test Location #4 – Southeast Elevation – above 2nd floor

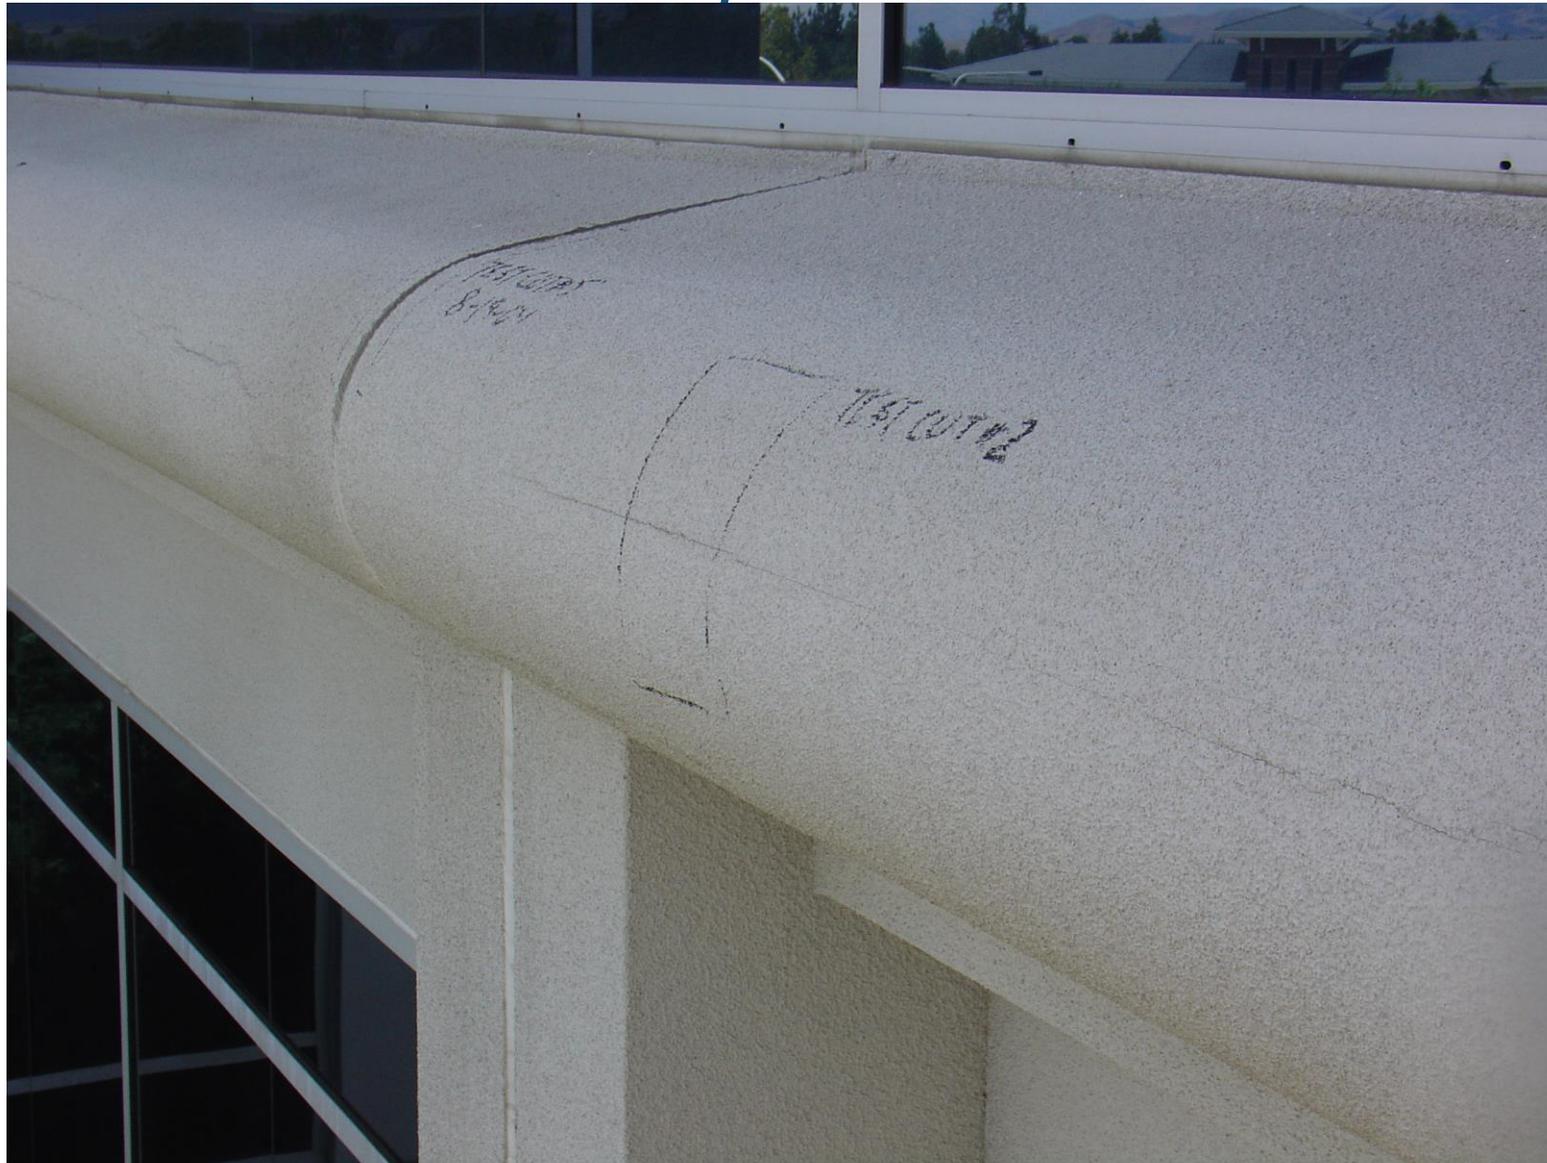
Test Cut # 2, East Elevation.

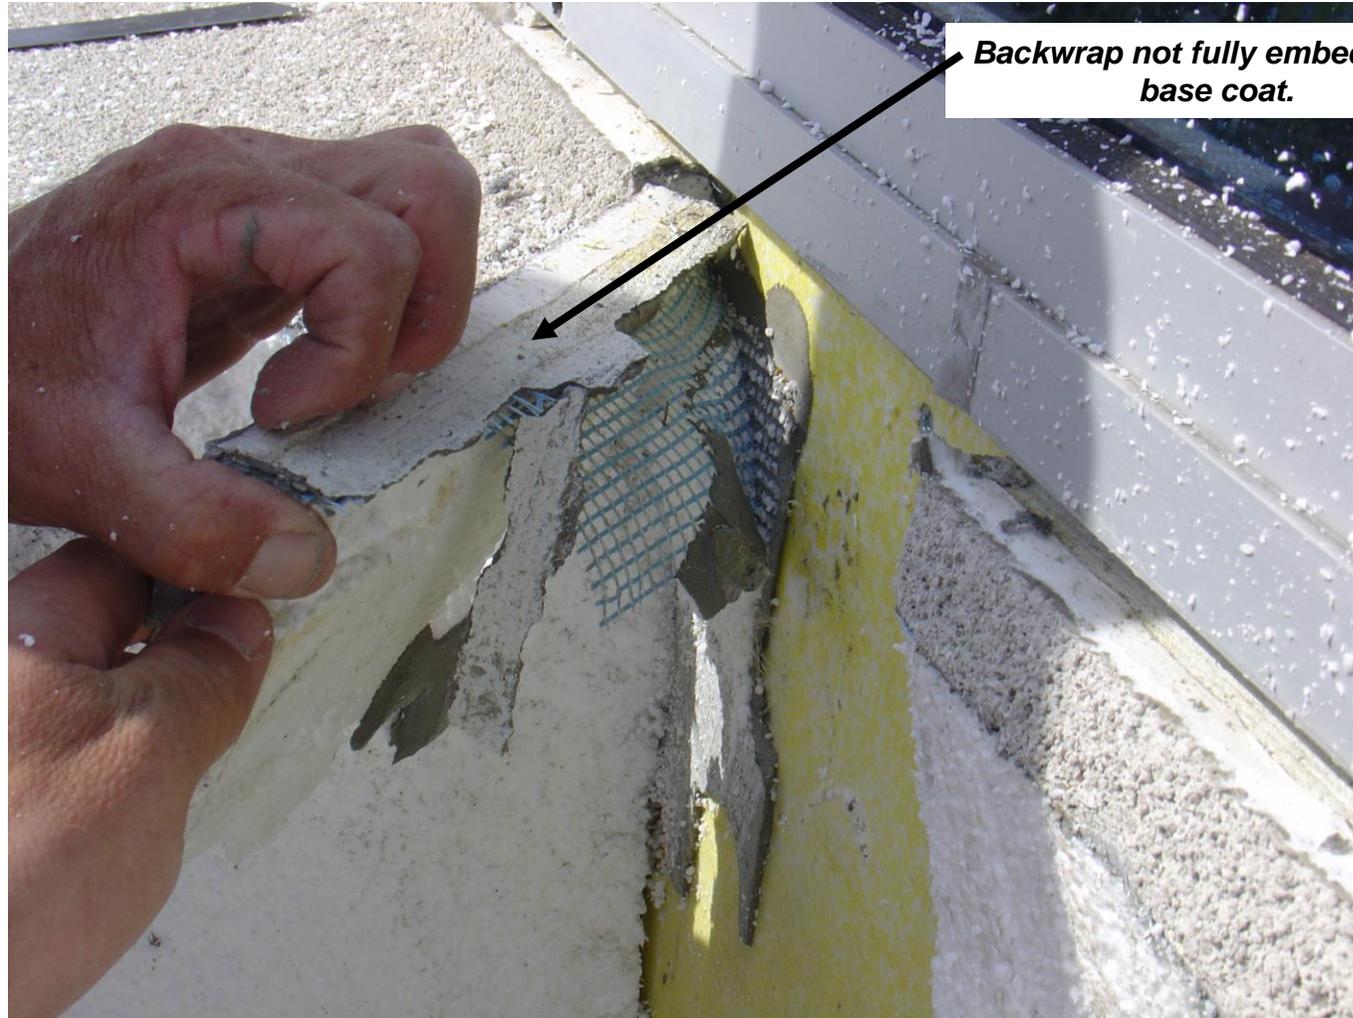
CHA-AL05207

EIFS Defect: Lamina is not backwrapped

Test Cut #3– East Elevation – 4th floor line EIFS Bullnose. Required by Dryvit
