DRAFT: FENESTRATIONS – VINYL WINDOWS

Karim Allana, PE, RRC, RWC

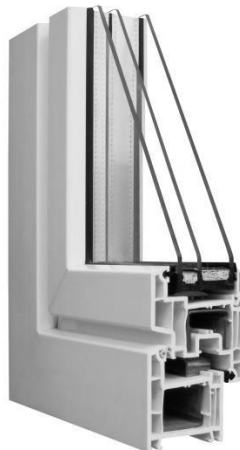
Figure 1A – Vinyl Windows

Vinyl windows (Figure 1A) have grown in popularity over the past twenty years and now over 18 billion pounds of vinyl account for 67% of all conventional residential windows in the United States because they are a good thermal insulator, fire resistant, and are low maintenance, as they do not require any painting or finishing. In fact the Federal Trade Commission issued a publication endorsing vinyl-frame windows precisely because they "insulate well and don't need painting." Modern vinyl window frames are extruded creating linear air chambers which provide additional resistance to heat transfer. The thermal insulating properties of vinyl windows can also be further boosted by filling in the non-draining hollow cavities, or insulating air pockets, with additional insulation in

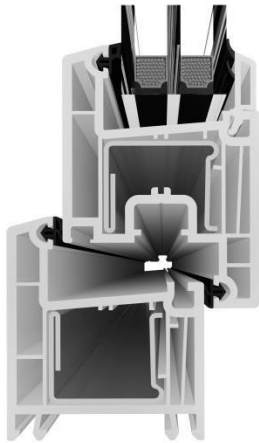
Figure 1B – Vinyl Windows

addition to using high performance glazing such as double or triple insulated glazed sash, or panes of glass, as shown in Figure 1B. These insulated glazing units (IGU) serve as an additional insulator from both heat and sound transmission.
