COMMON DEFECTS AND FAILURE MODES IN CEMENT PLASTER

Karim P. Allana, P.E., RRC

Symposium on Building Envelope Technology
Coral Springs Marriot at Herron Bay, Florida
November 14th & 15th 2002

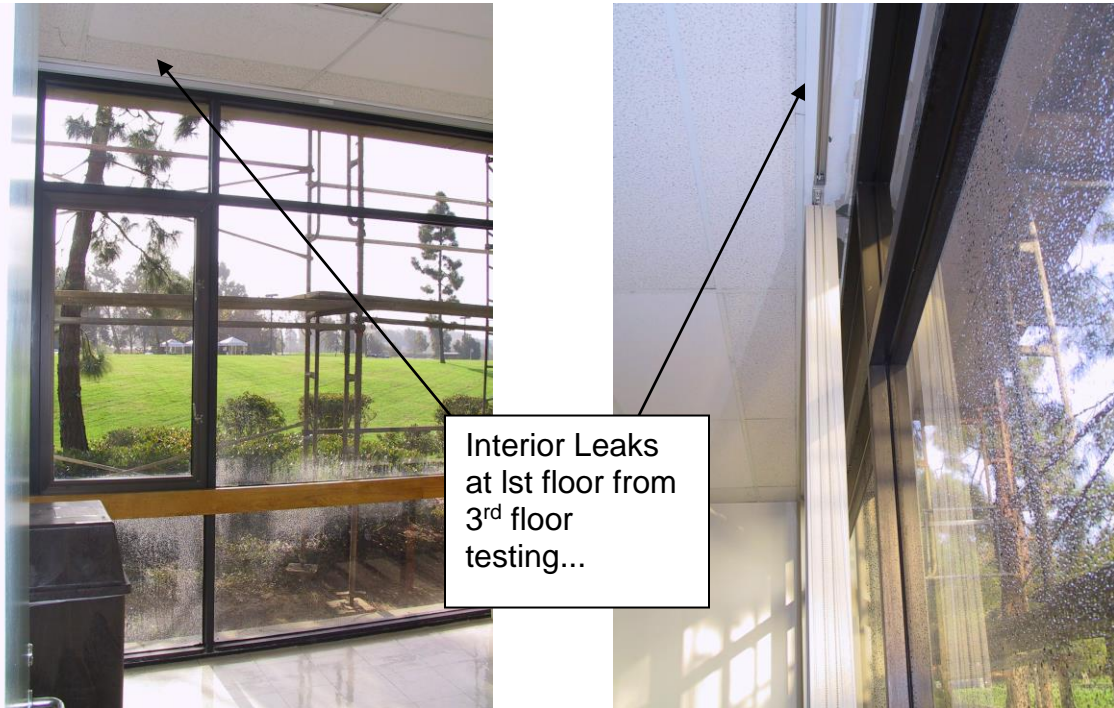
TOP: Water testing and destructive testing of the exterior wall was conducted on the south side of the building. The area selected for testing included, brick veneer, cement plaster and typical windows. **BOTTOM:** Water sprayed on third floor leaked through storefront head condition on 1st floor. Water intrusion through the exterior wall is traveling through 3 floors in the wall cavity.

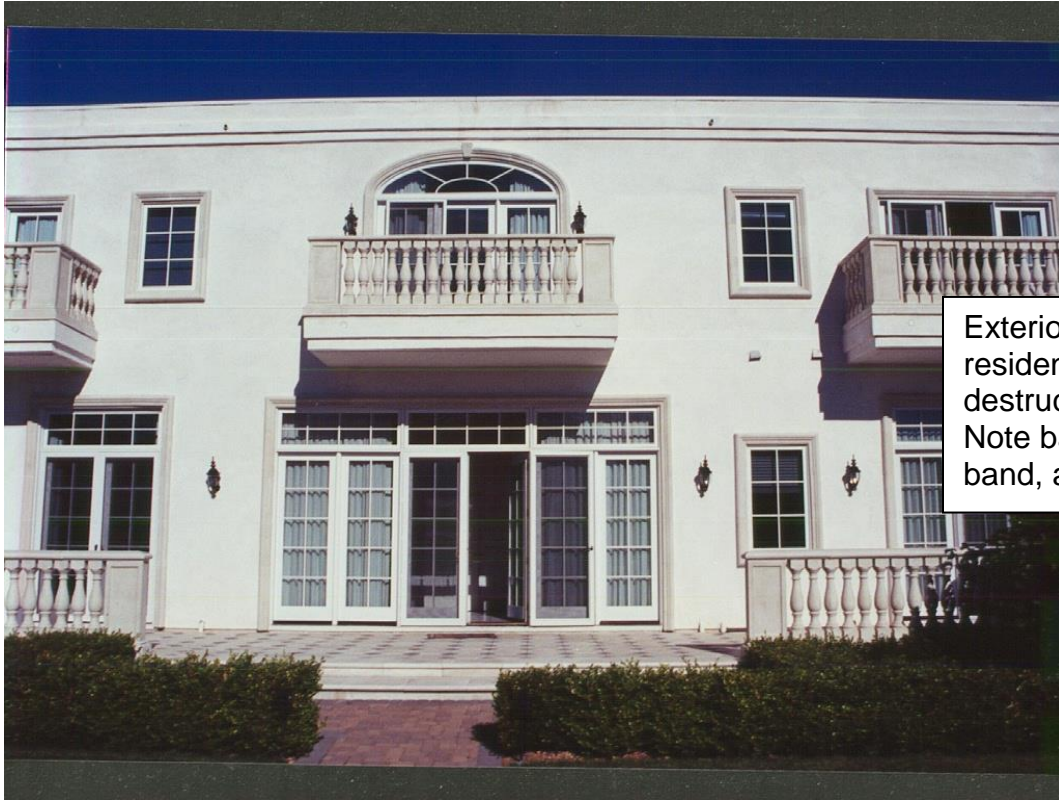
Exterior view of residence prior to destructive testing. Note balcony, stucco band, and windows

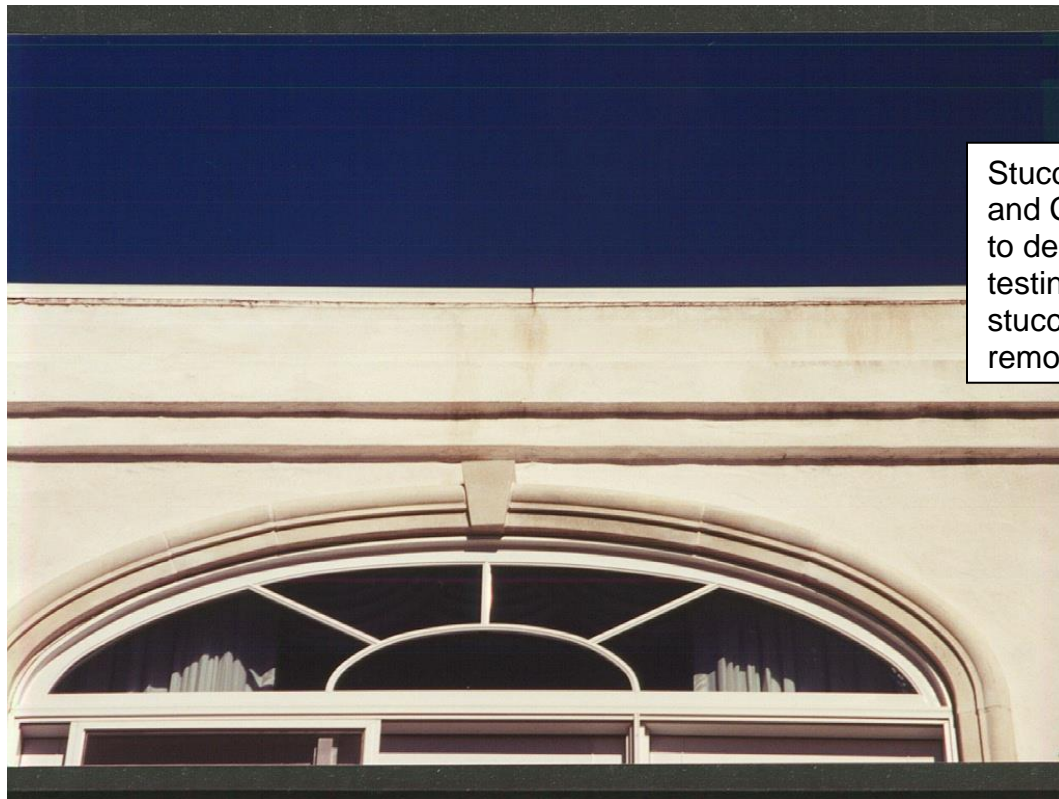
Stucco band and CP, prior to destructive testing and stucco removal.

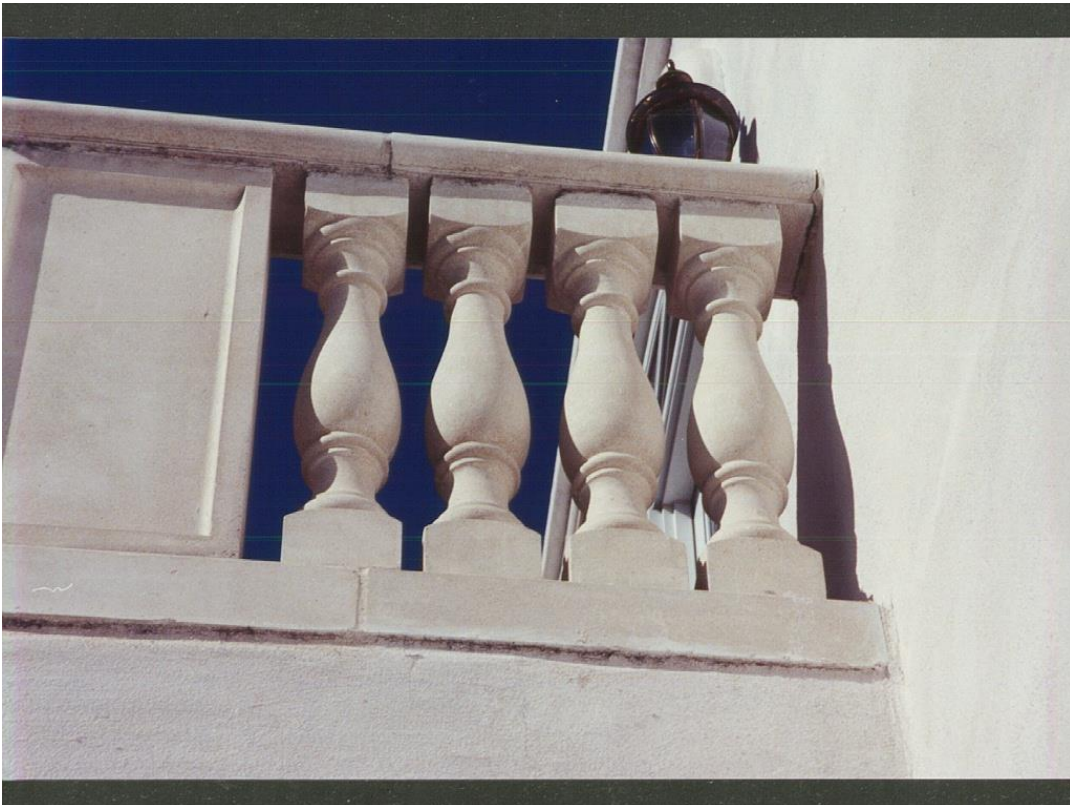
Leaks through balcony created damage to wall and balcony.

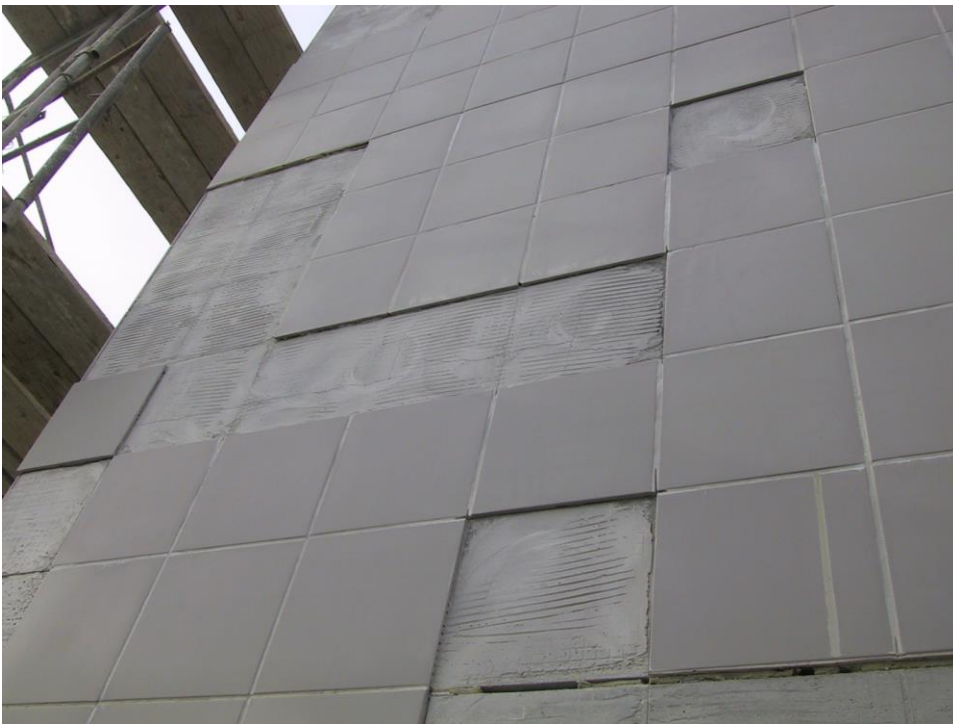
Tiles were falling from the building and could be removed with slight hand pressure – but the pattern of failure did not extend to 100% of the building tiles – and was random.

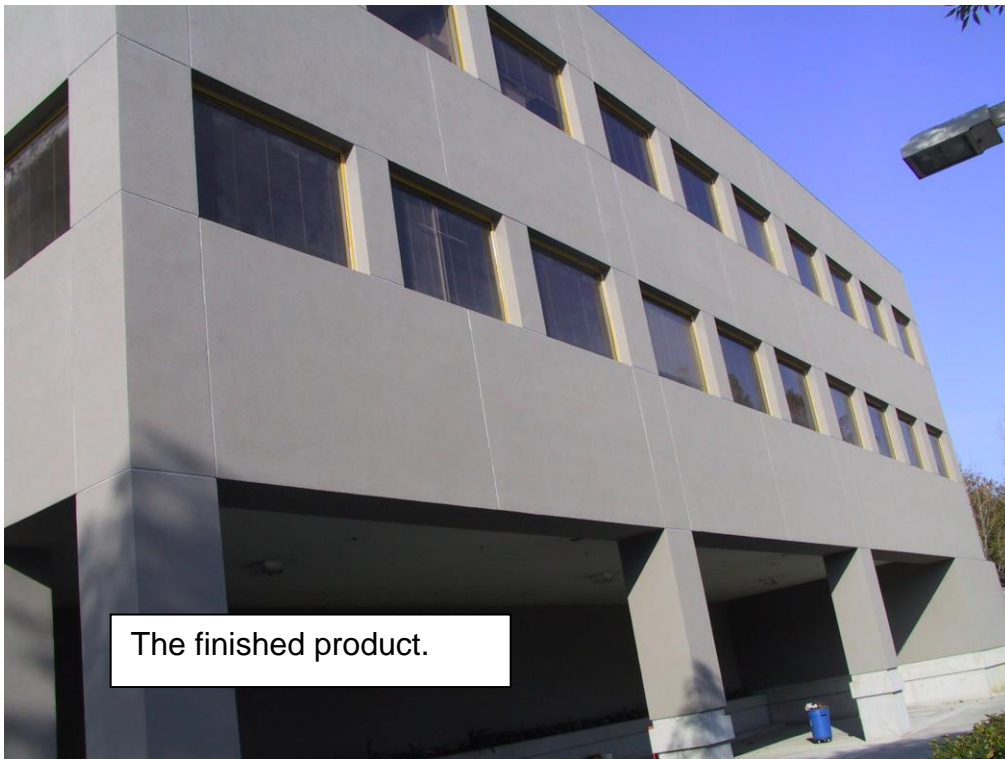
The finished product.

After complete tile removal, webbing embedded in first skim coat, followed by finish coats.

Tiles completely removed, some by hand, some by mechanical means.
