# Roofs Can Last In Excess of 30 Years But Most Do Not

January 24, 2006

Honolulu, Hawai'i

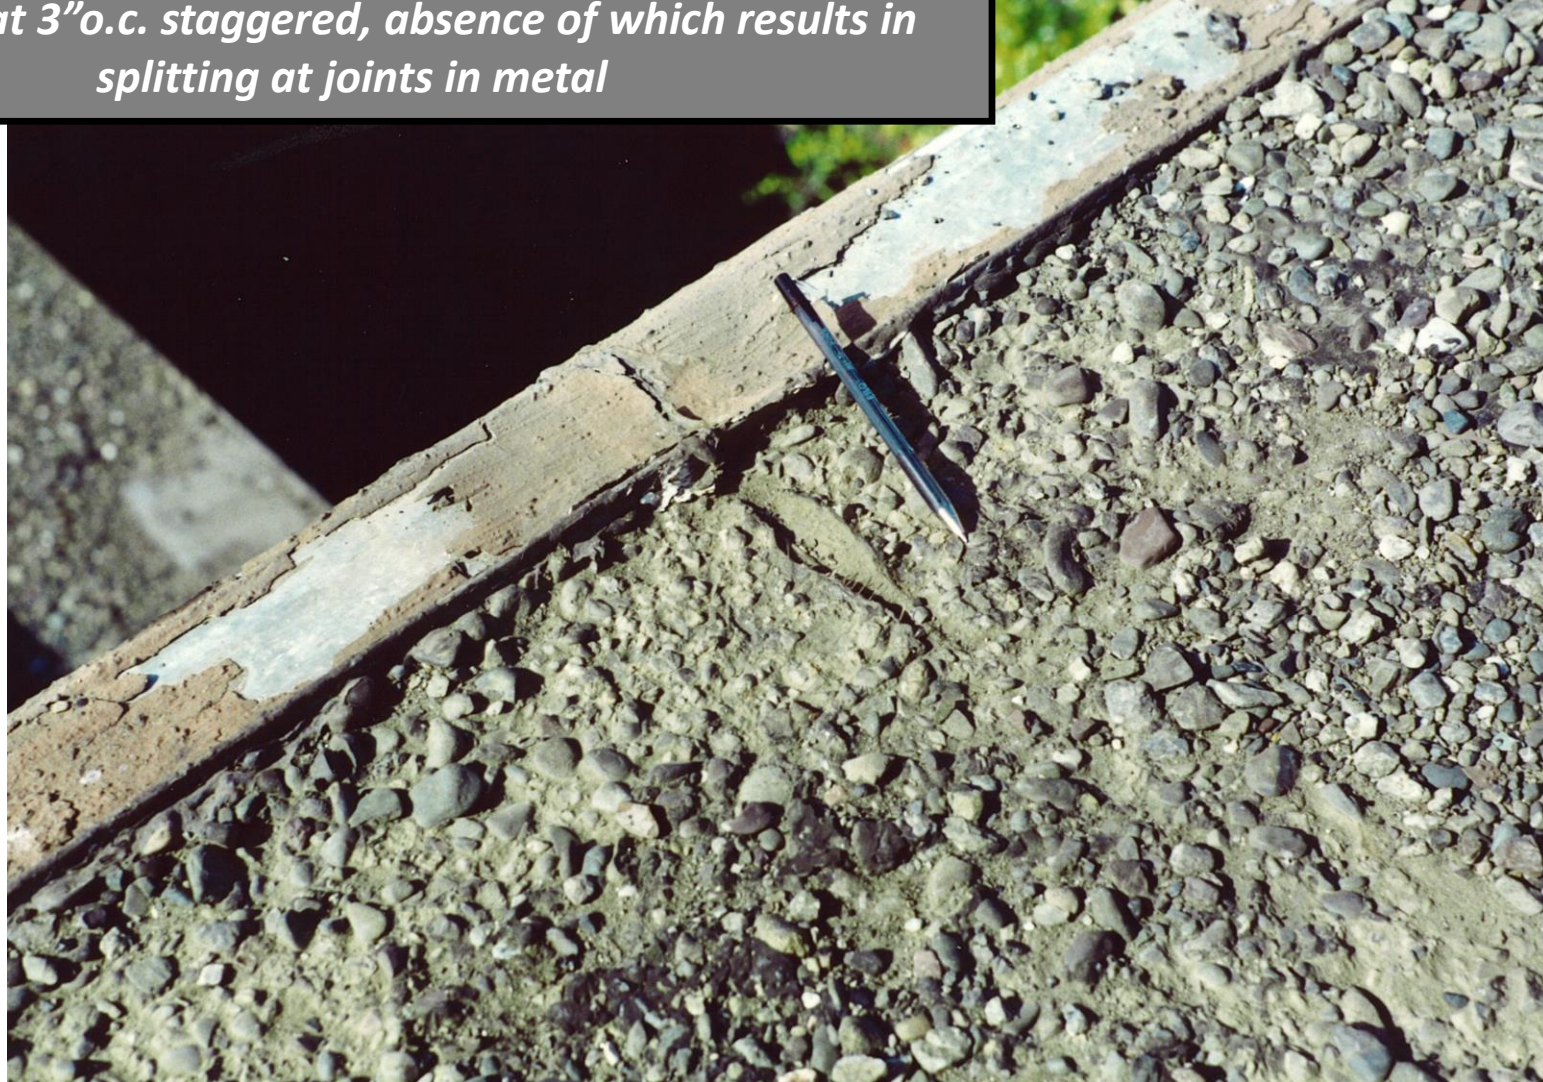
*Edge flashing at 34 year old roof is splitting, due to improper workmanship (fastening). Embedded edge metal require fastening at 3"o.c. staggered, absence of which results in splitting at joints in metal*

- Proper design and construction includes:
  - stripping in the metal with two or three plies
  - priming the metal on both sides
  - setting the flange in mastic on top of the membrane
  - fastening the metal 3” on center.

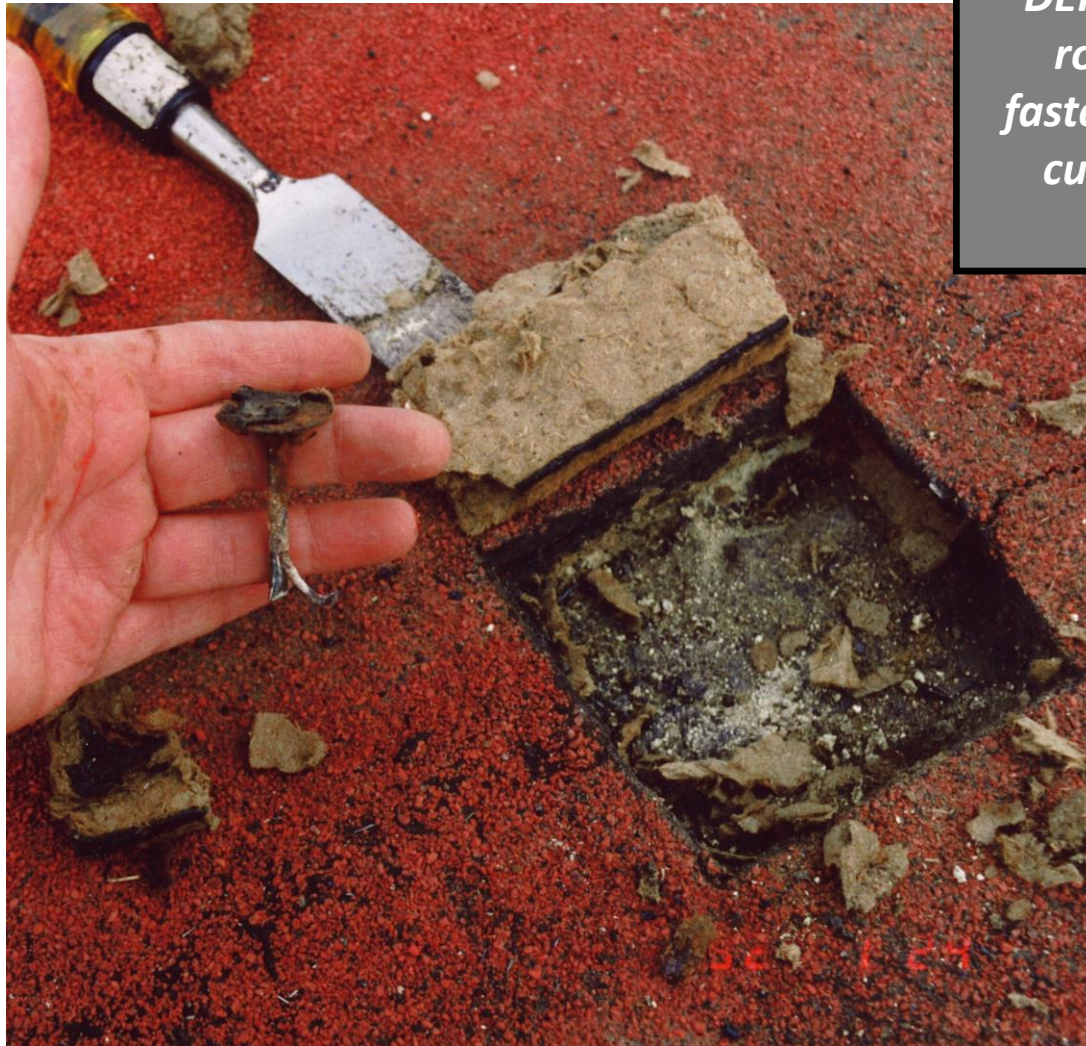
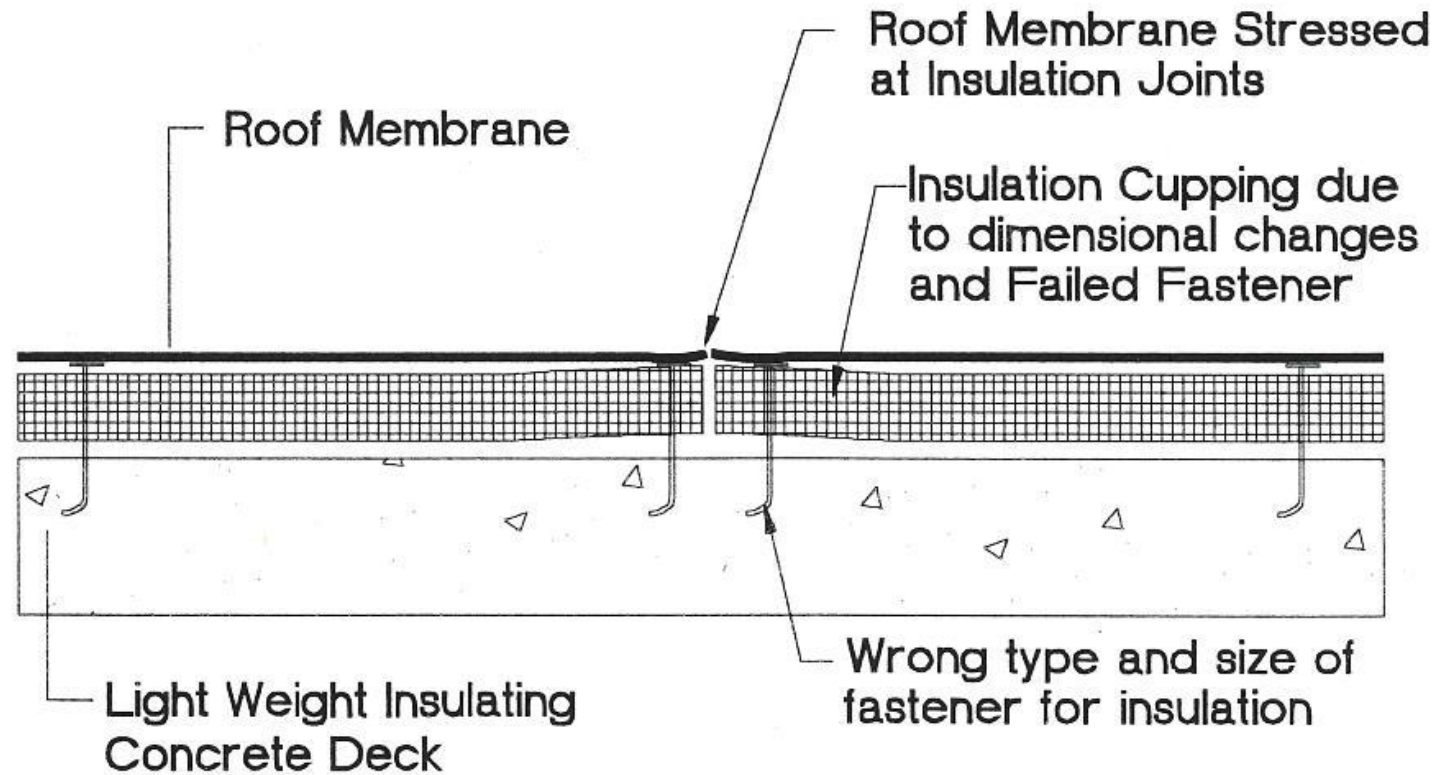
*A very expensive roof at a major west coast university, failing after only five years. Roof is “picture framing” and ridging*

***DEFECT: Improper securement of roof. Inappropriate insulation fasteners, poorly installed, causing cupping of insulation material.***

**PICTURE FRAMING + ROOF SPLITTING CAUSED BY  
POOR FASTENING OF INSULATION BOARD TO SUBSTRATE**

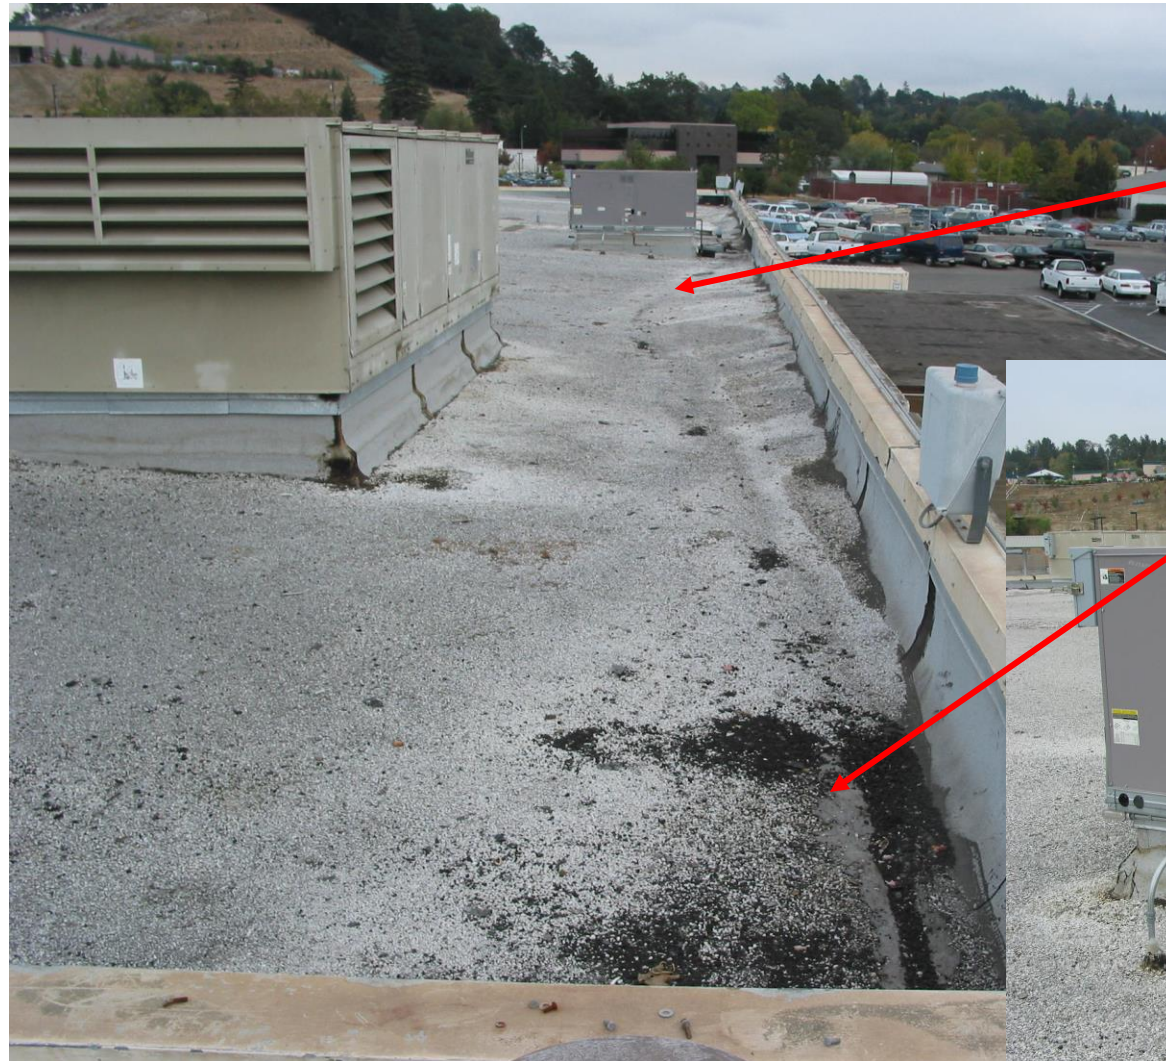
*Crickets are undersized in some locations, or not provided at all. Need to be deeper and redesigned. Note deterioration.*

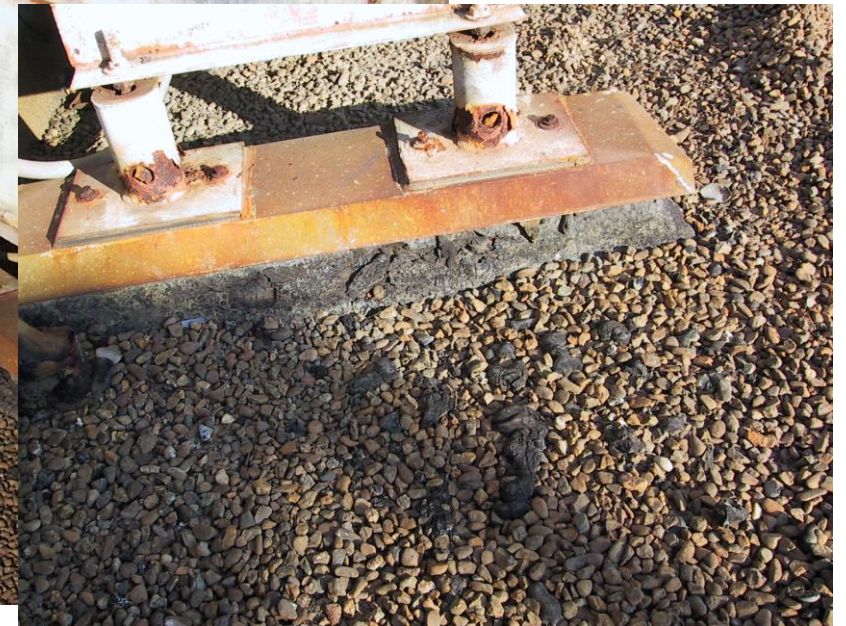
*Base flashings were not surfaced with a protective layer or cap sheet. Granules on the cap sheet protect the membrane from UV rays. Base flashings are also exhibiting signs of deterioration. See photo below.*

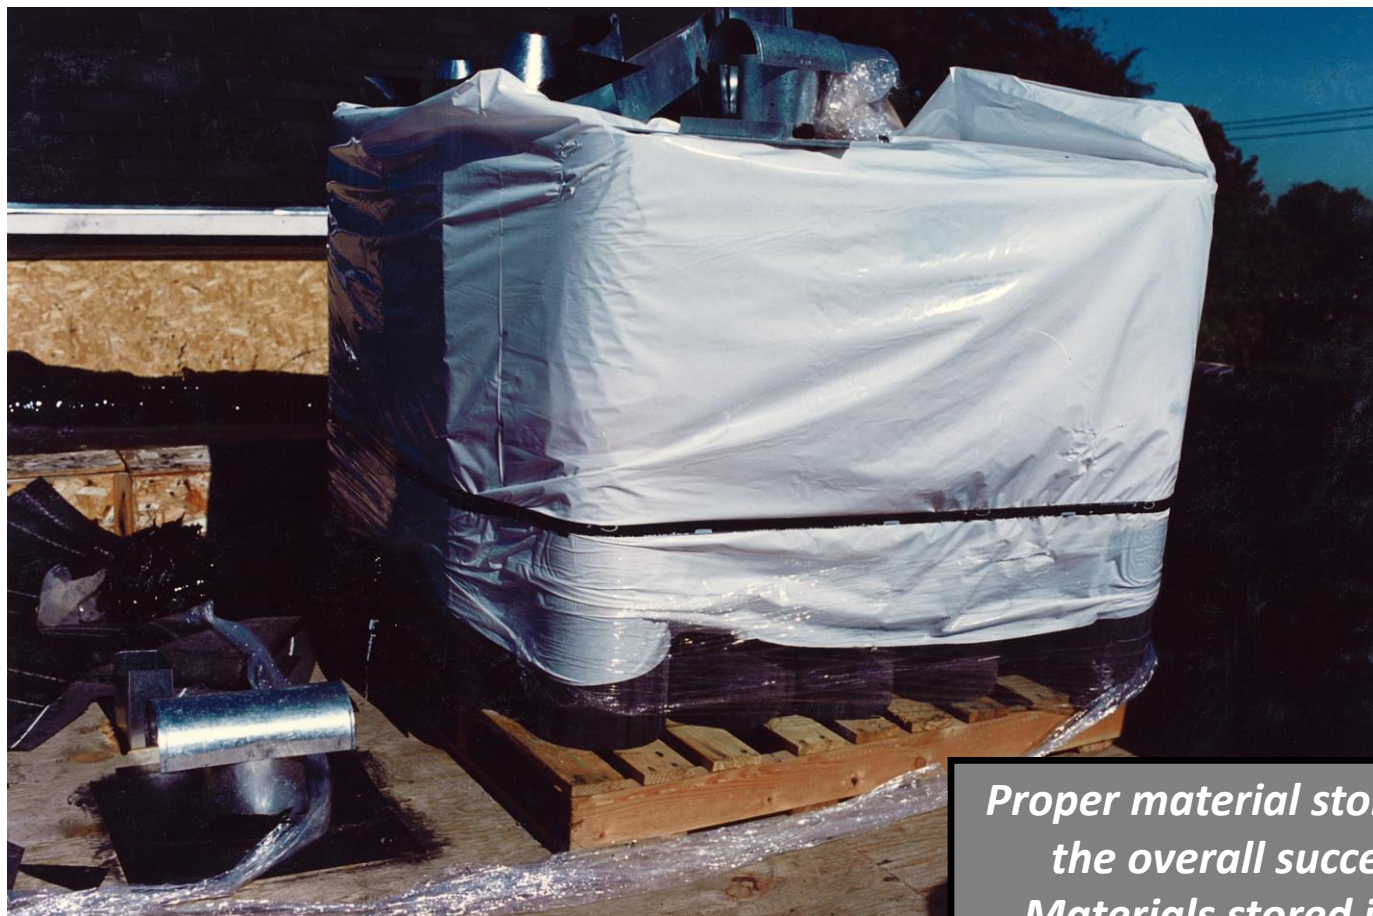
*Proper material storage is critical to the overall success of the job. Materials stored improperly can absorb moisture and cause blisters.*

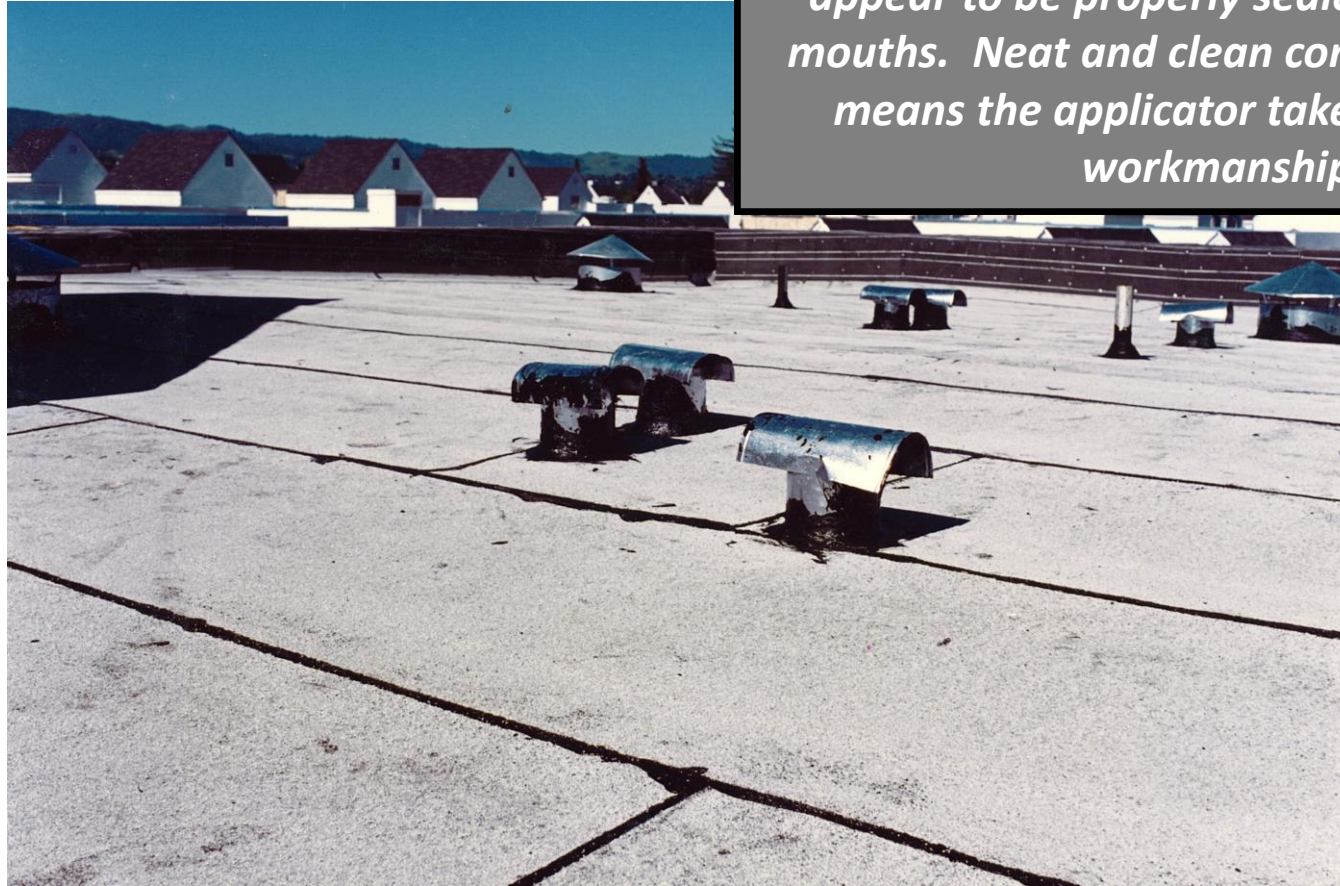
*Cap sheet laps have an even splash line and appear to be properly sealed with no fish mouths. Neat and clean construction often means the applicator takes pride in his workmanship*

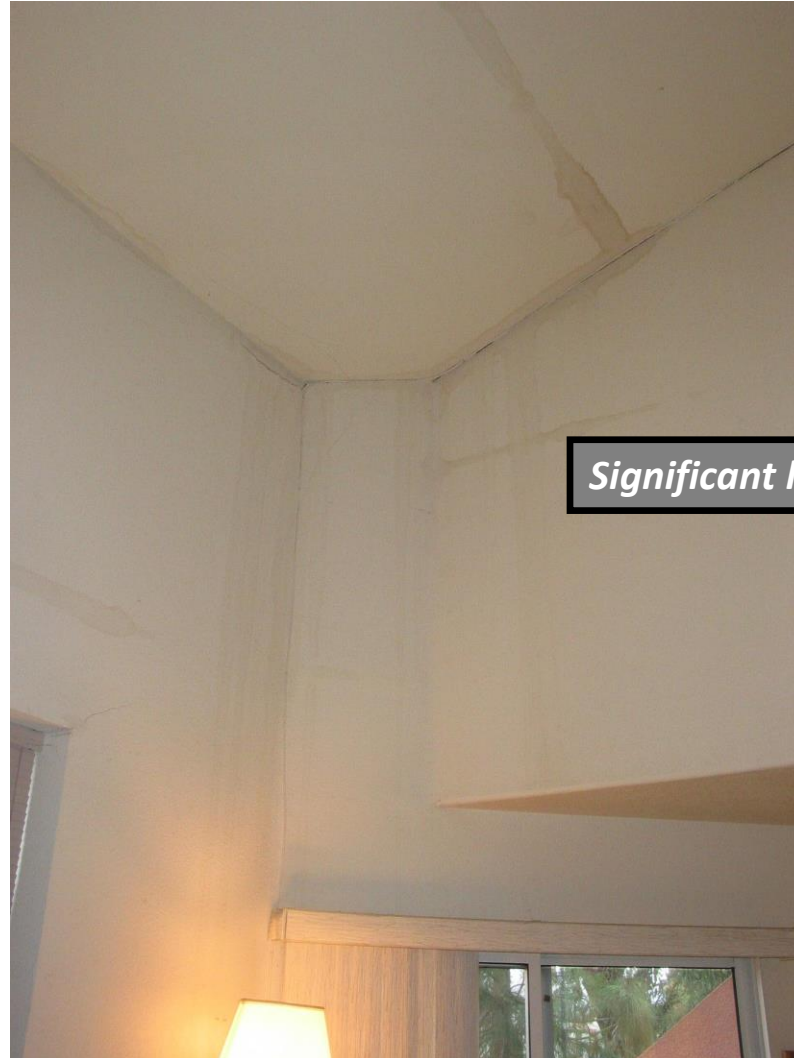
*Significant leaks in ceilings*

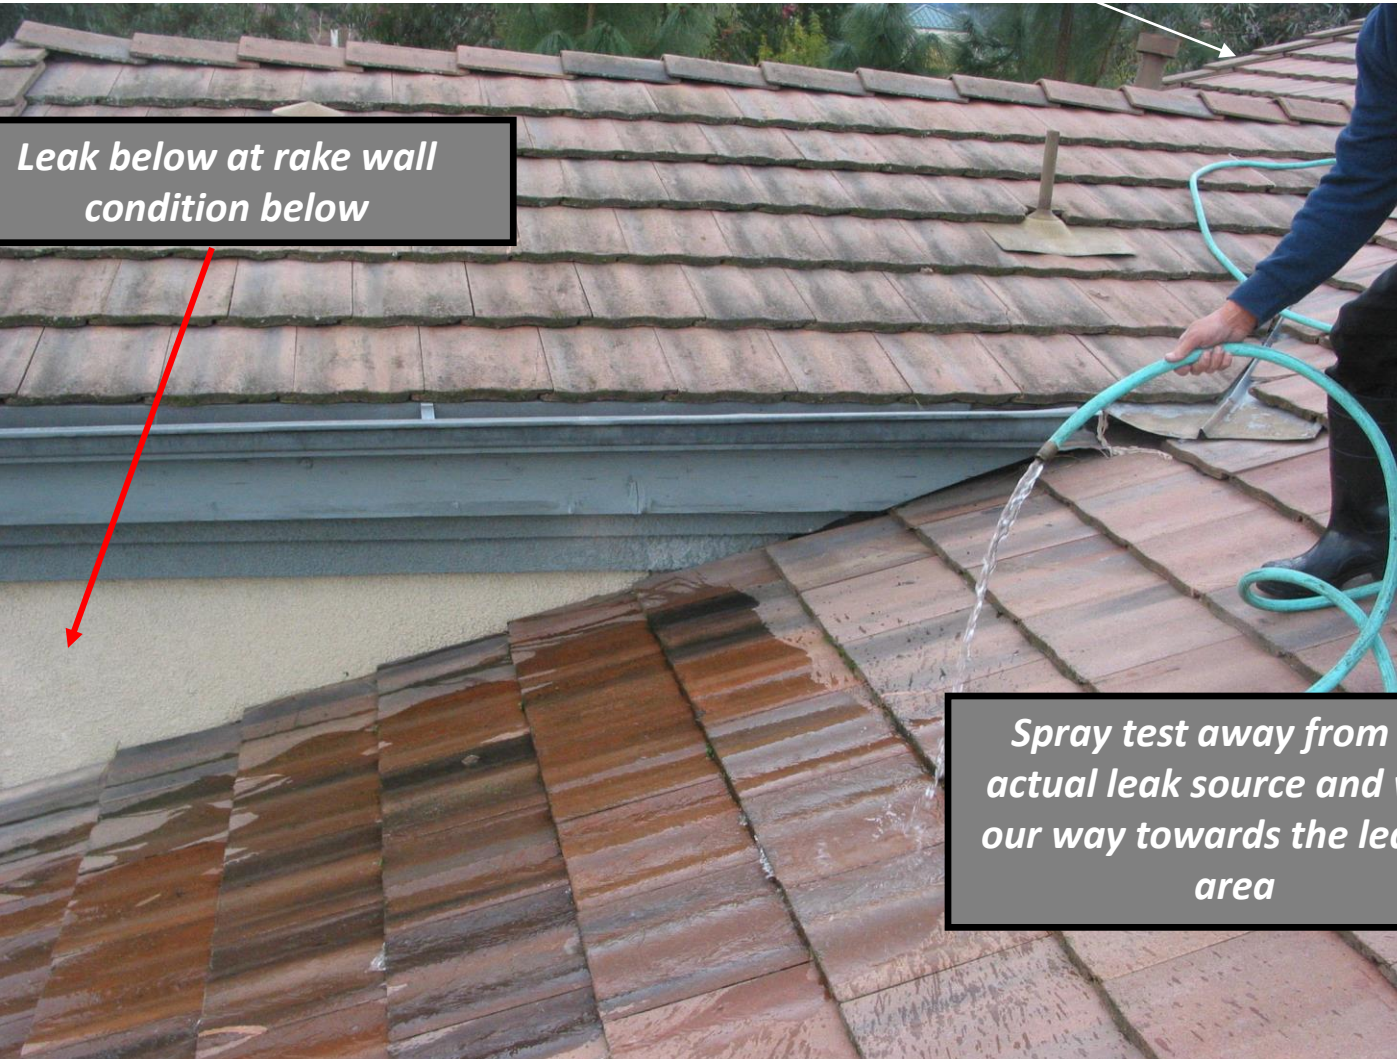
*Leak below at rake wall  
condition below*

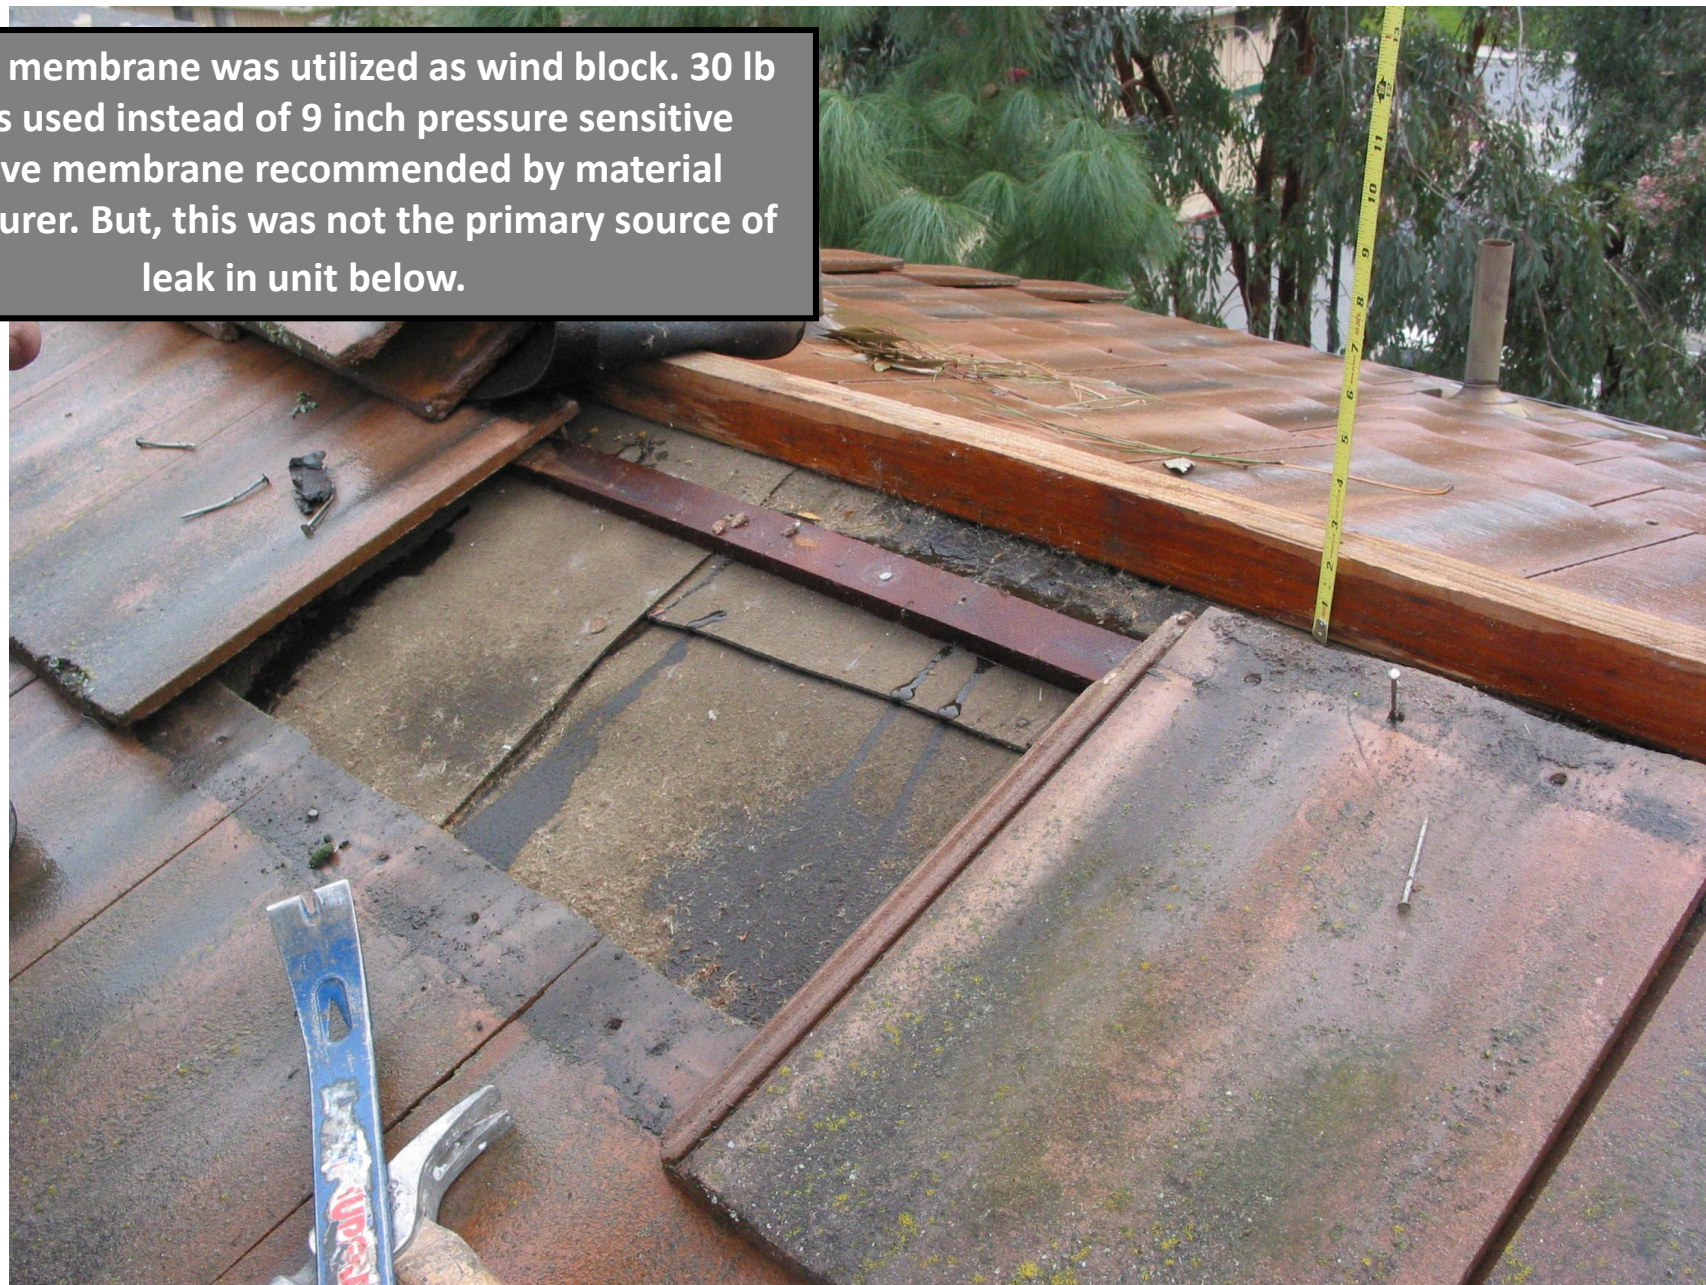
Improper membrane was utilized as wind block. 30 lb felt was used instead of 9 inch pressure sensitive adhesive membrane recommended by material manufacturer. But, this was not the primary source of leak in unit below.

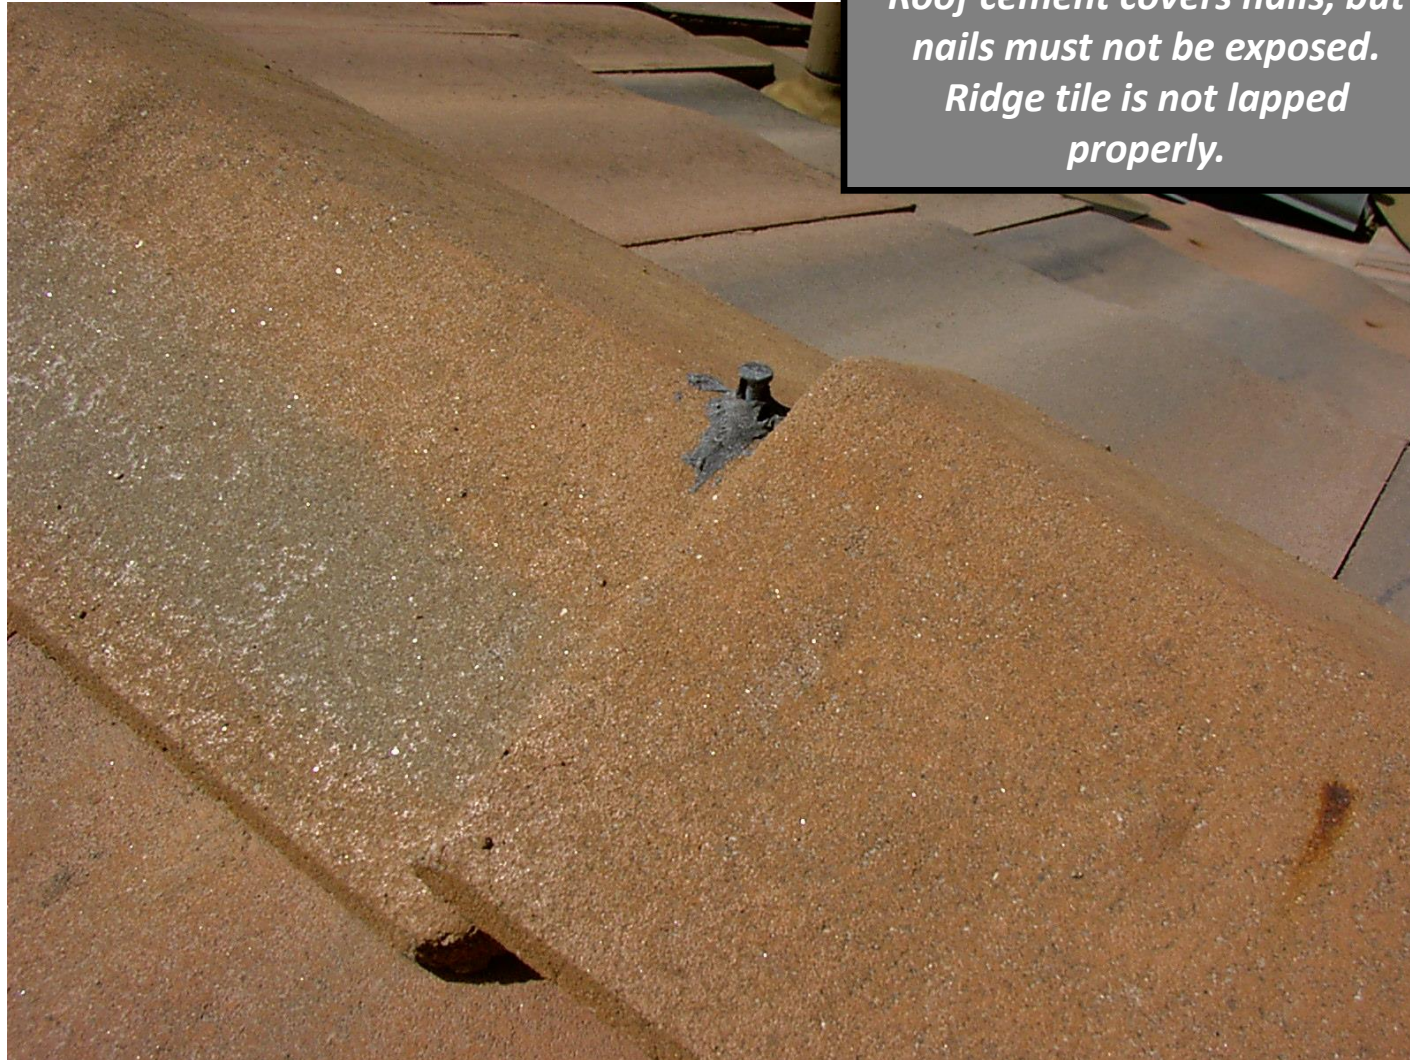
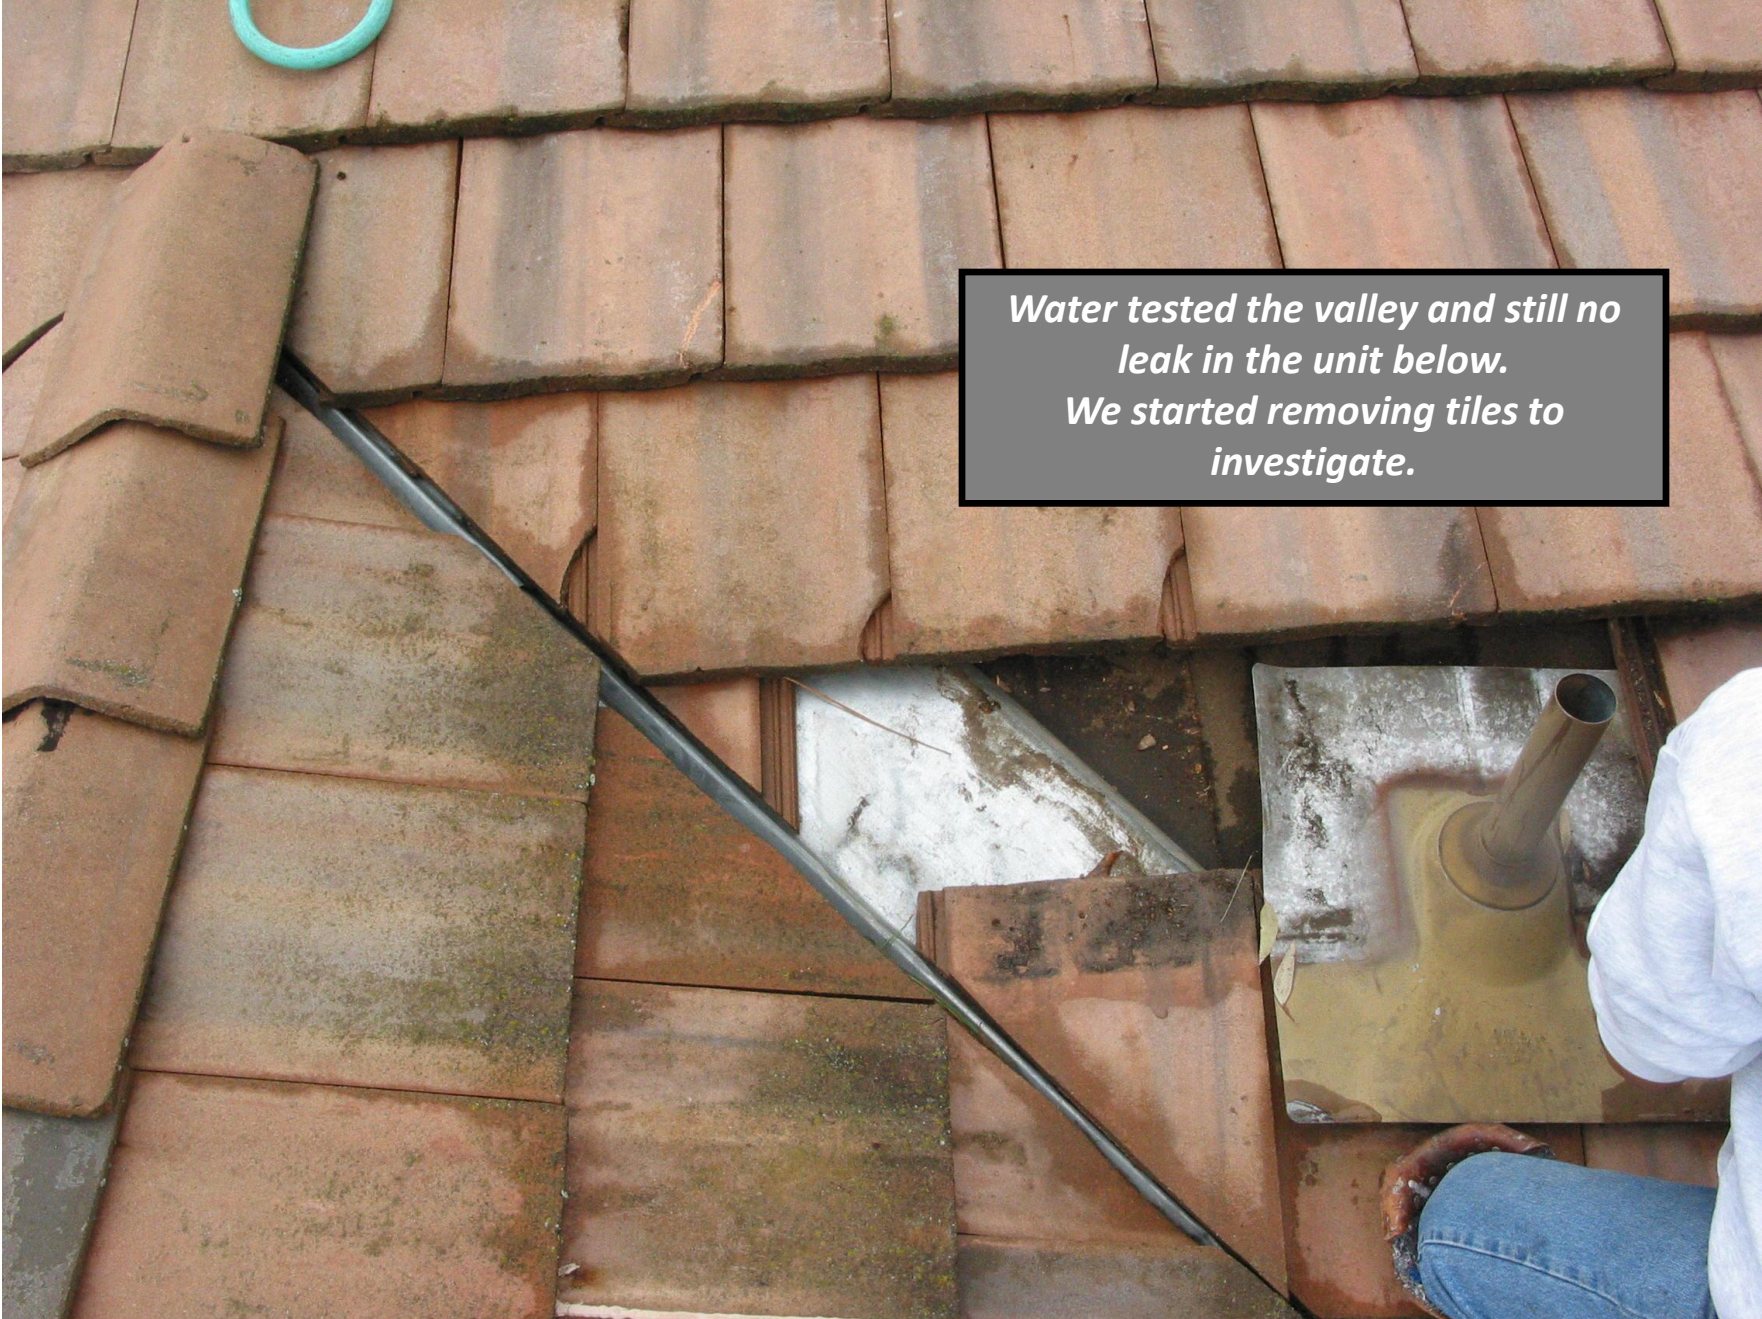
*Poor nailing patterns and  
improperly laid tile.*

*Roof cement covers nails, but  
nails must not be exposed.  
Ridge tile is not lapped  
properly.*

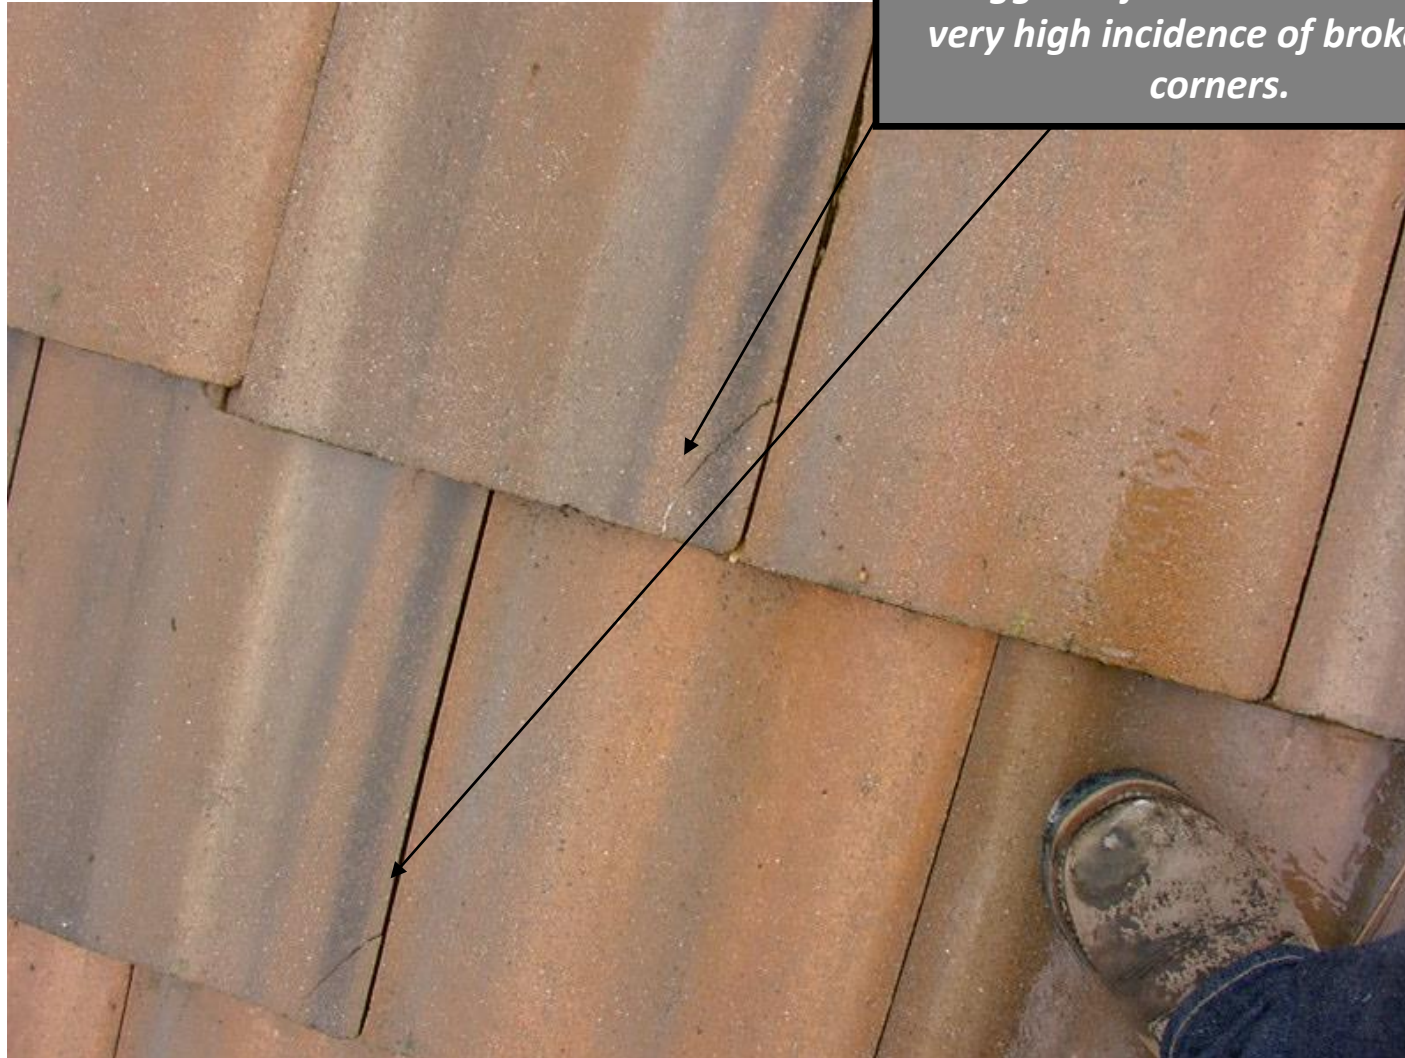
*Much of the tile was installed with staggered joints. We observed a very high incidence of broken tile corners.*

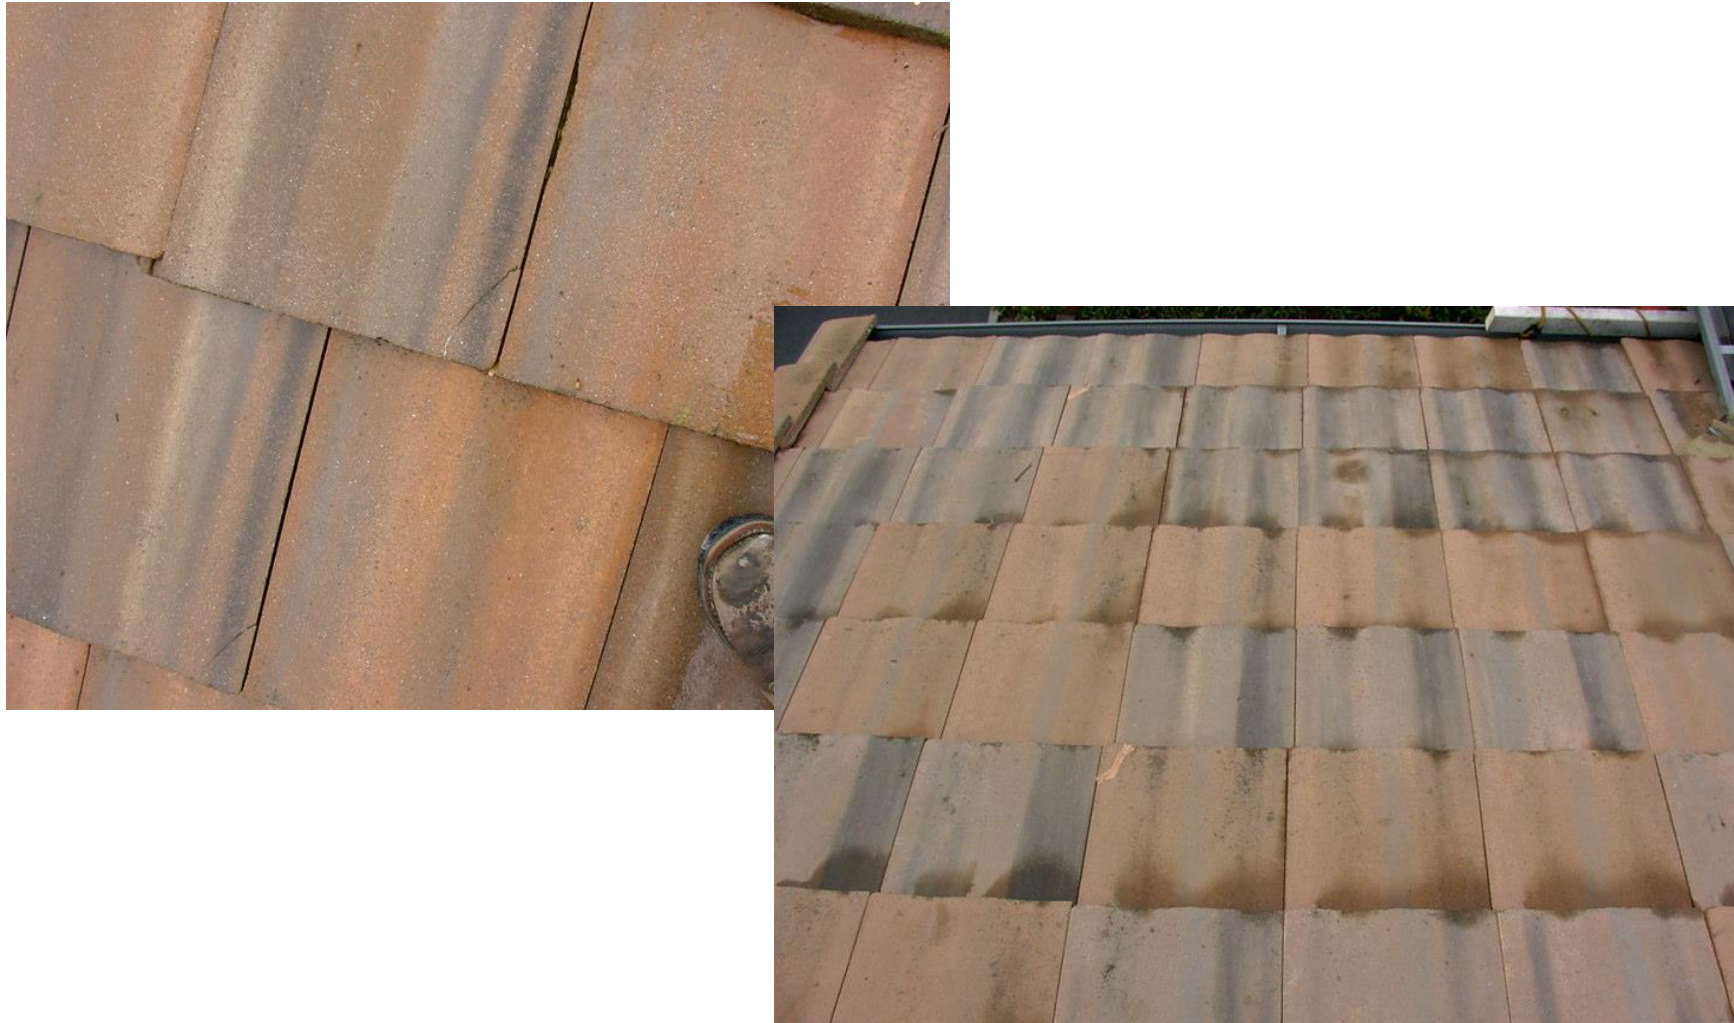
*Some roofs had tile laid in straight bond method, which had fewer broken tiles but instinctively seemed wrong.*

- What is the correct way to install this tile, broken bond or straight bond?

# ANSWER: The manufacturer of this time recommends the straight bond method.

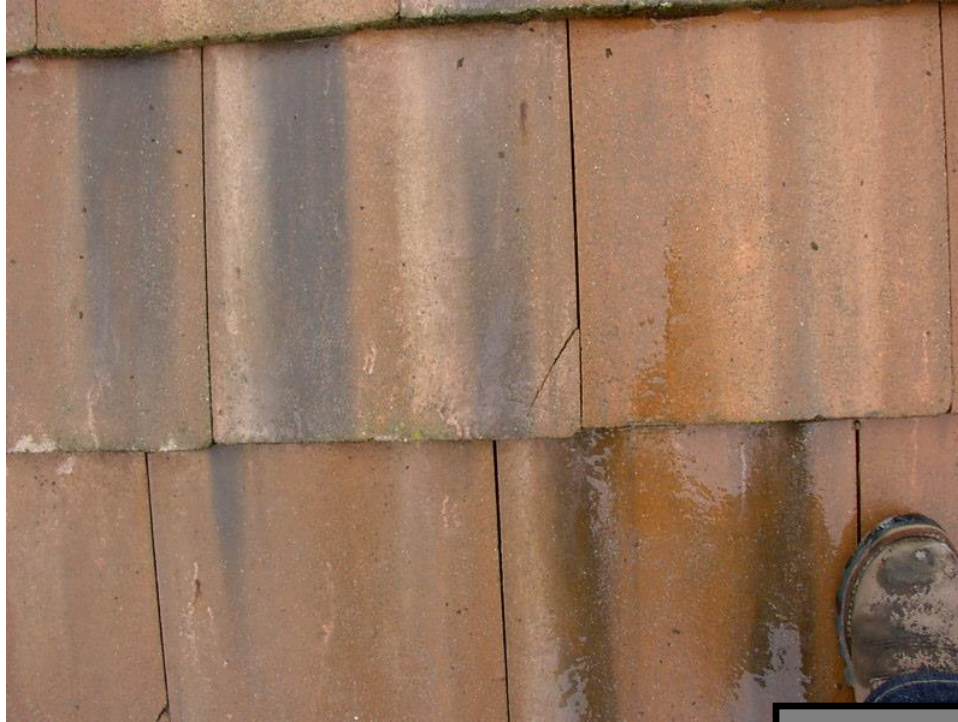
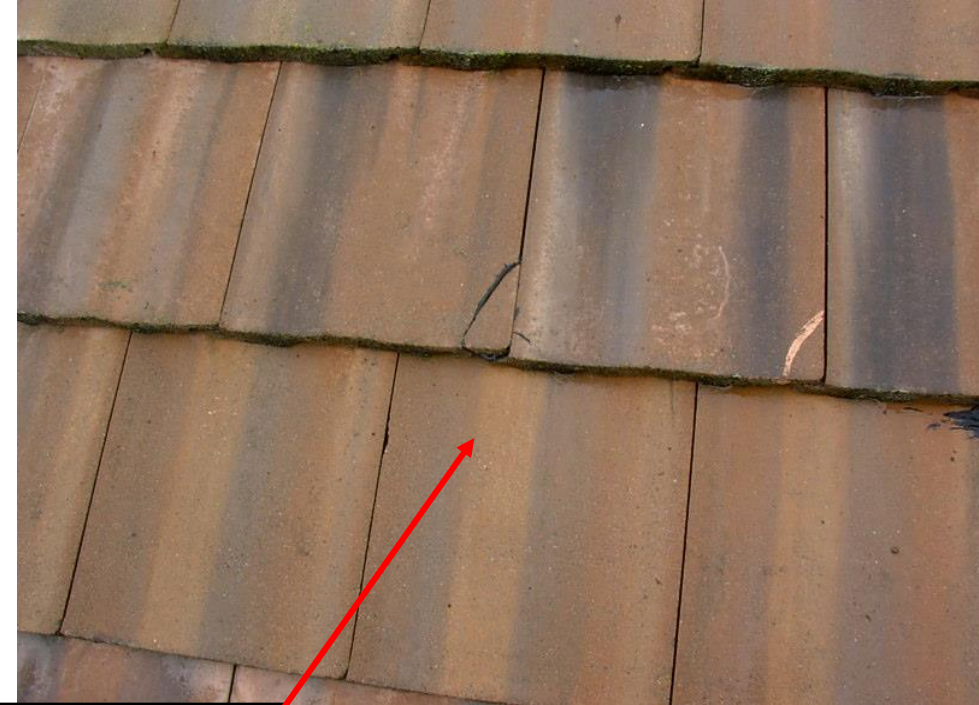
*Joints in tile not parallel  
and are too close, resulting  
in breakage*

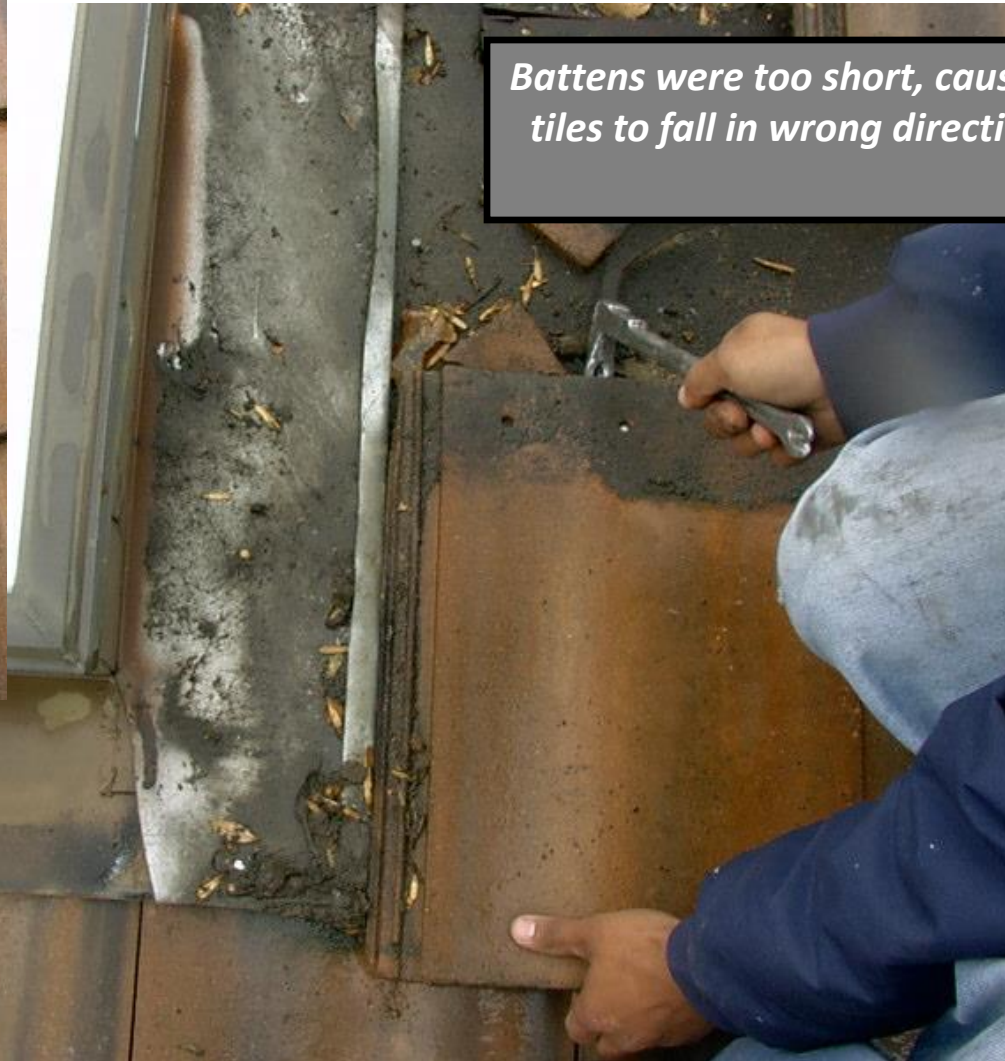
*Battens were too short, causing tiles to fall in wrong direction*
