# Roofs Can Last In Excess of 30 Years But Most Do Not

January 24, 2006

Honolulu, Hawai'i

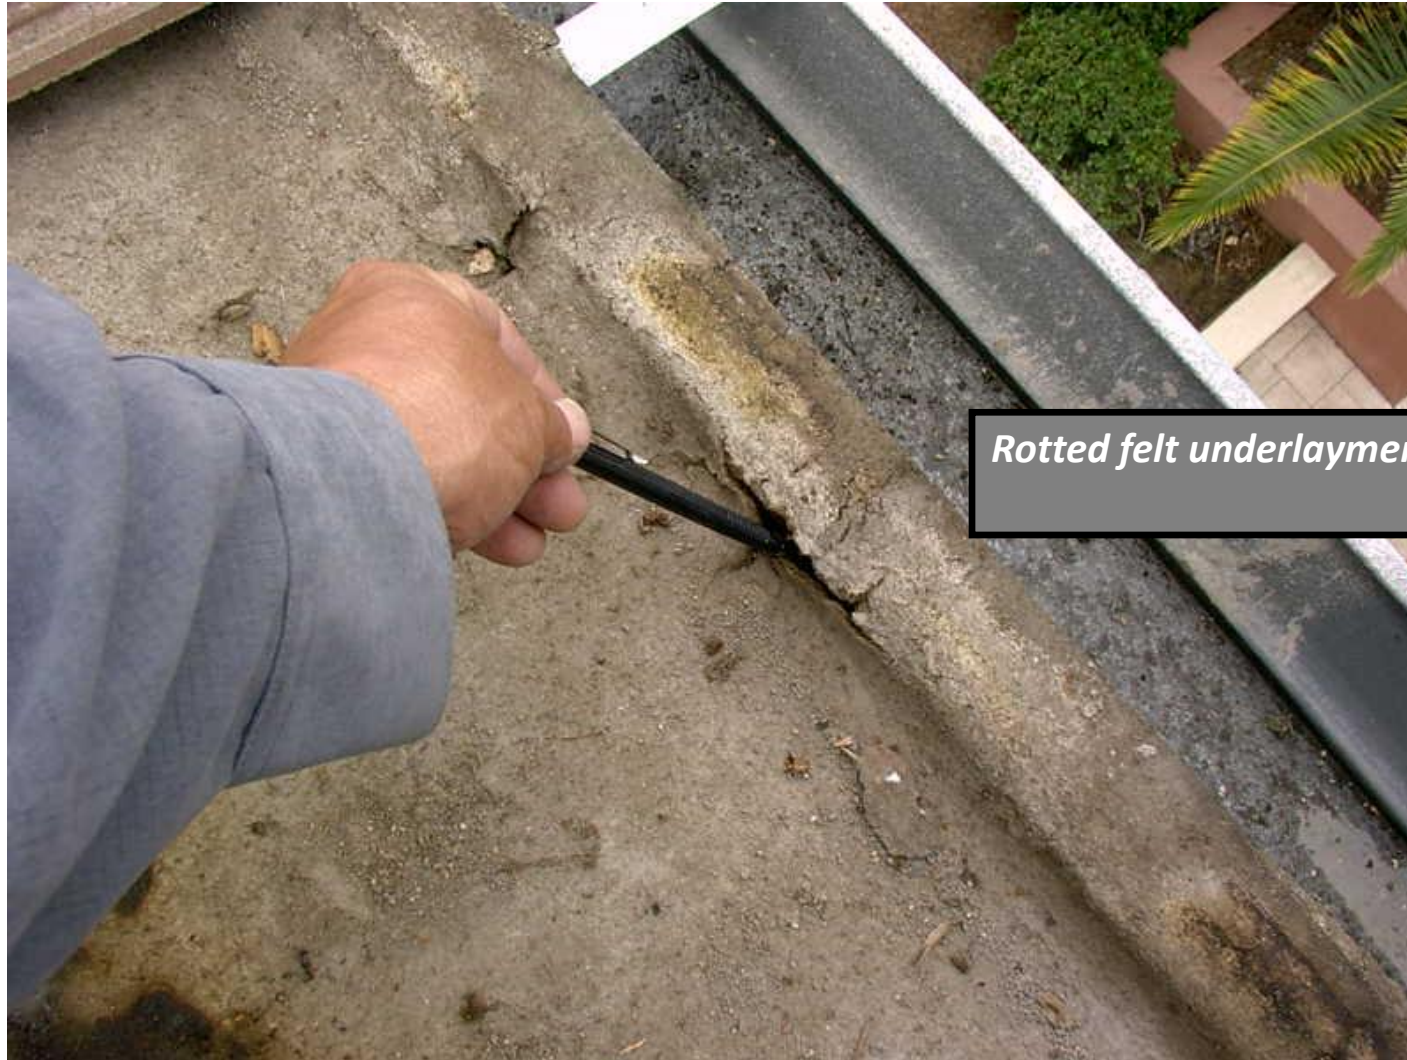
*Rotted felt underlayment*

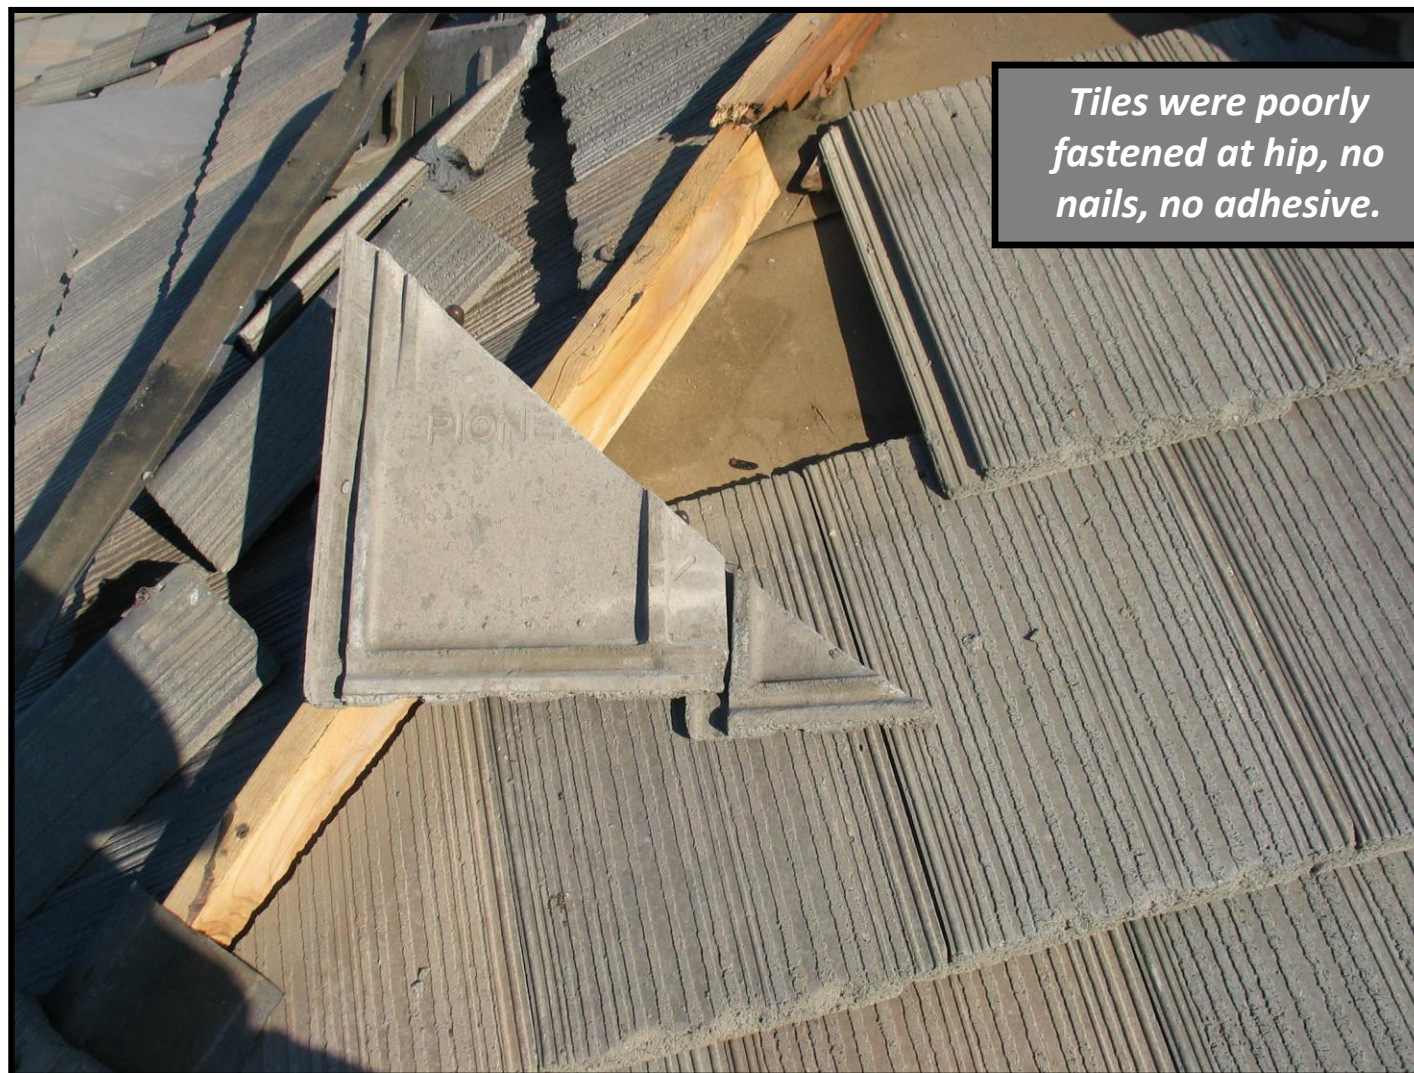
*Tile is cracked,  
exposing the  
underlying felt.*

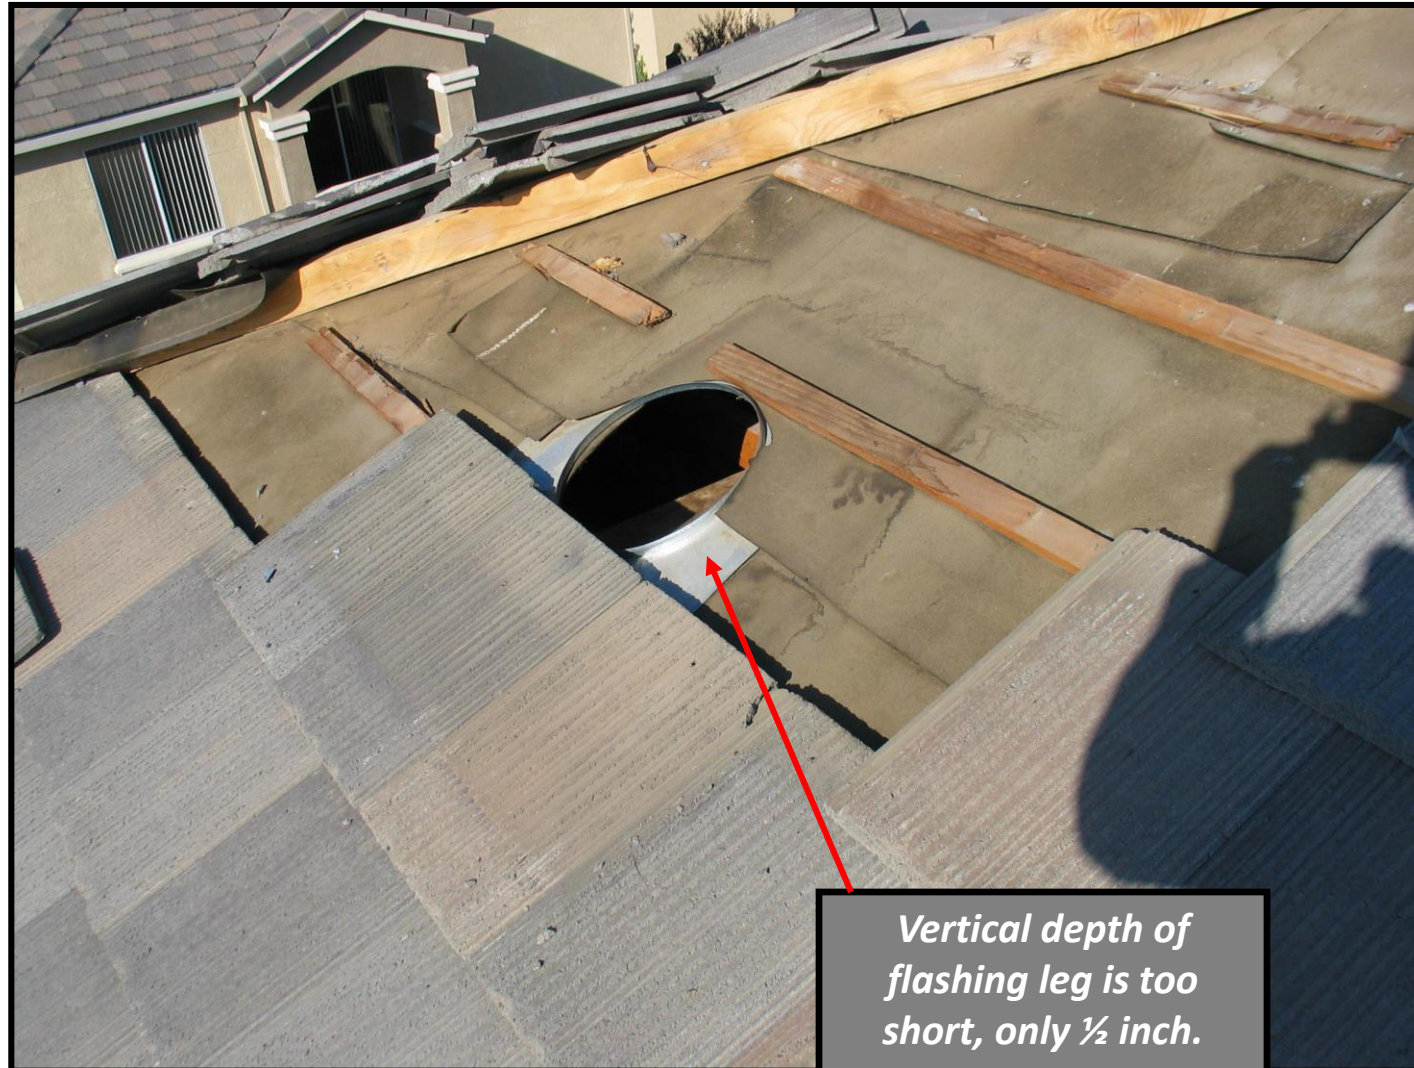
*Vertical depth of  
flashing leg is too  
short, only ½ inch.*

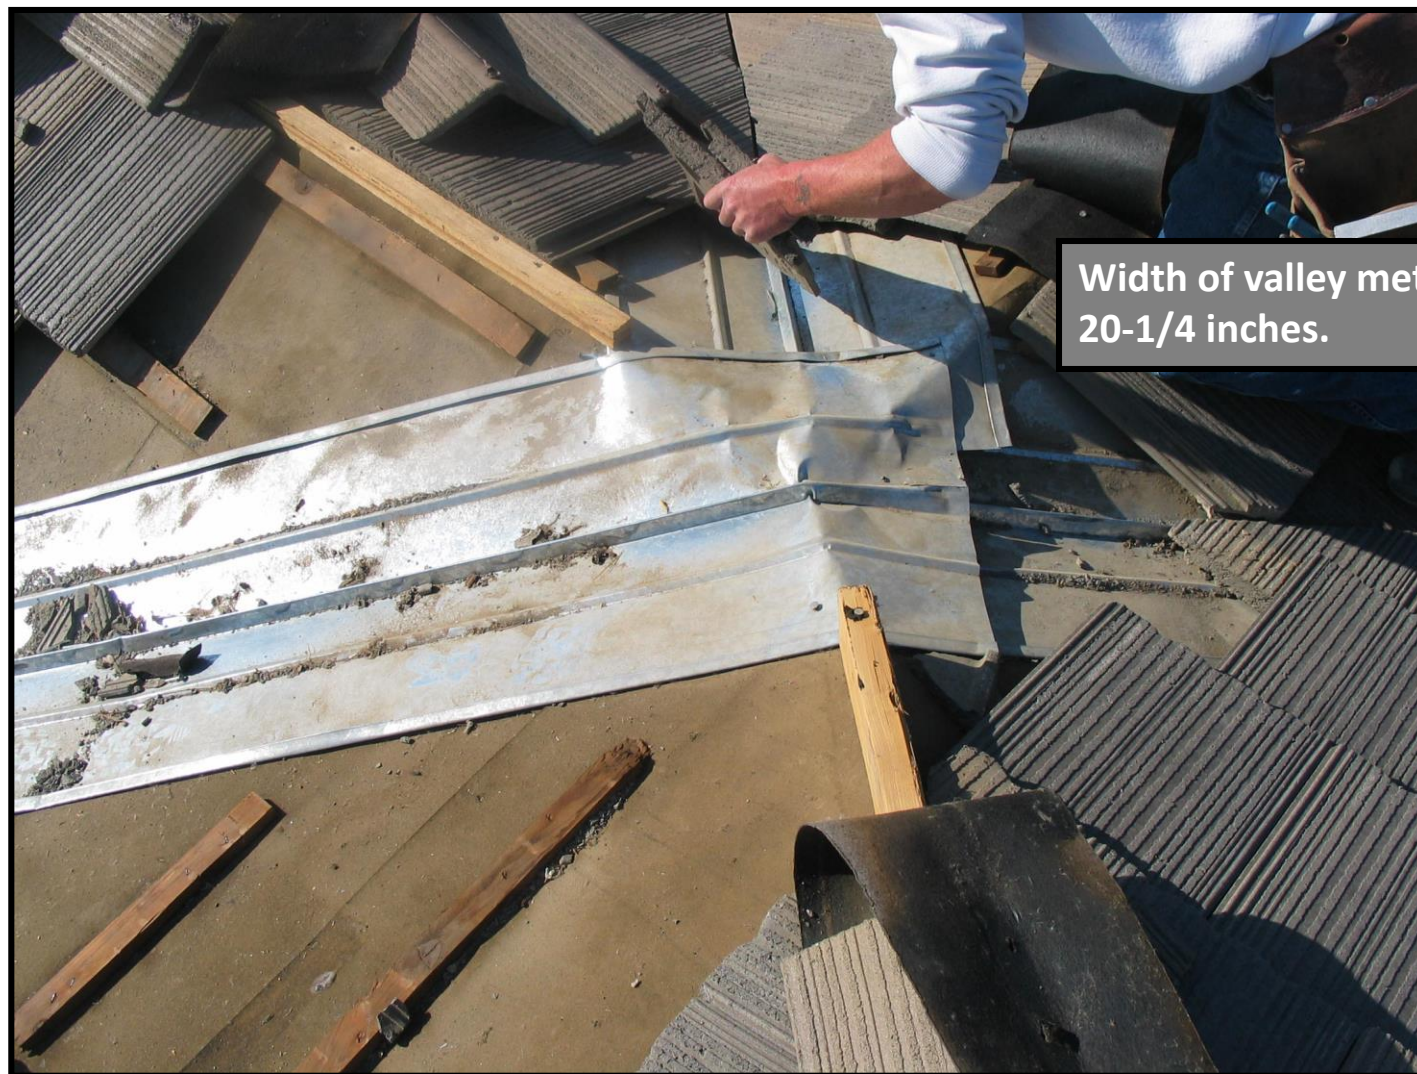
Width of valley metal is 20-1/4 inches.

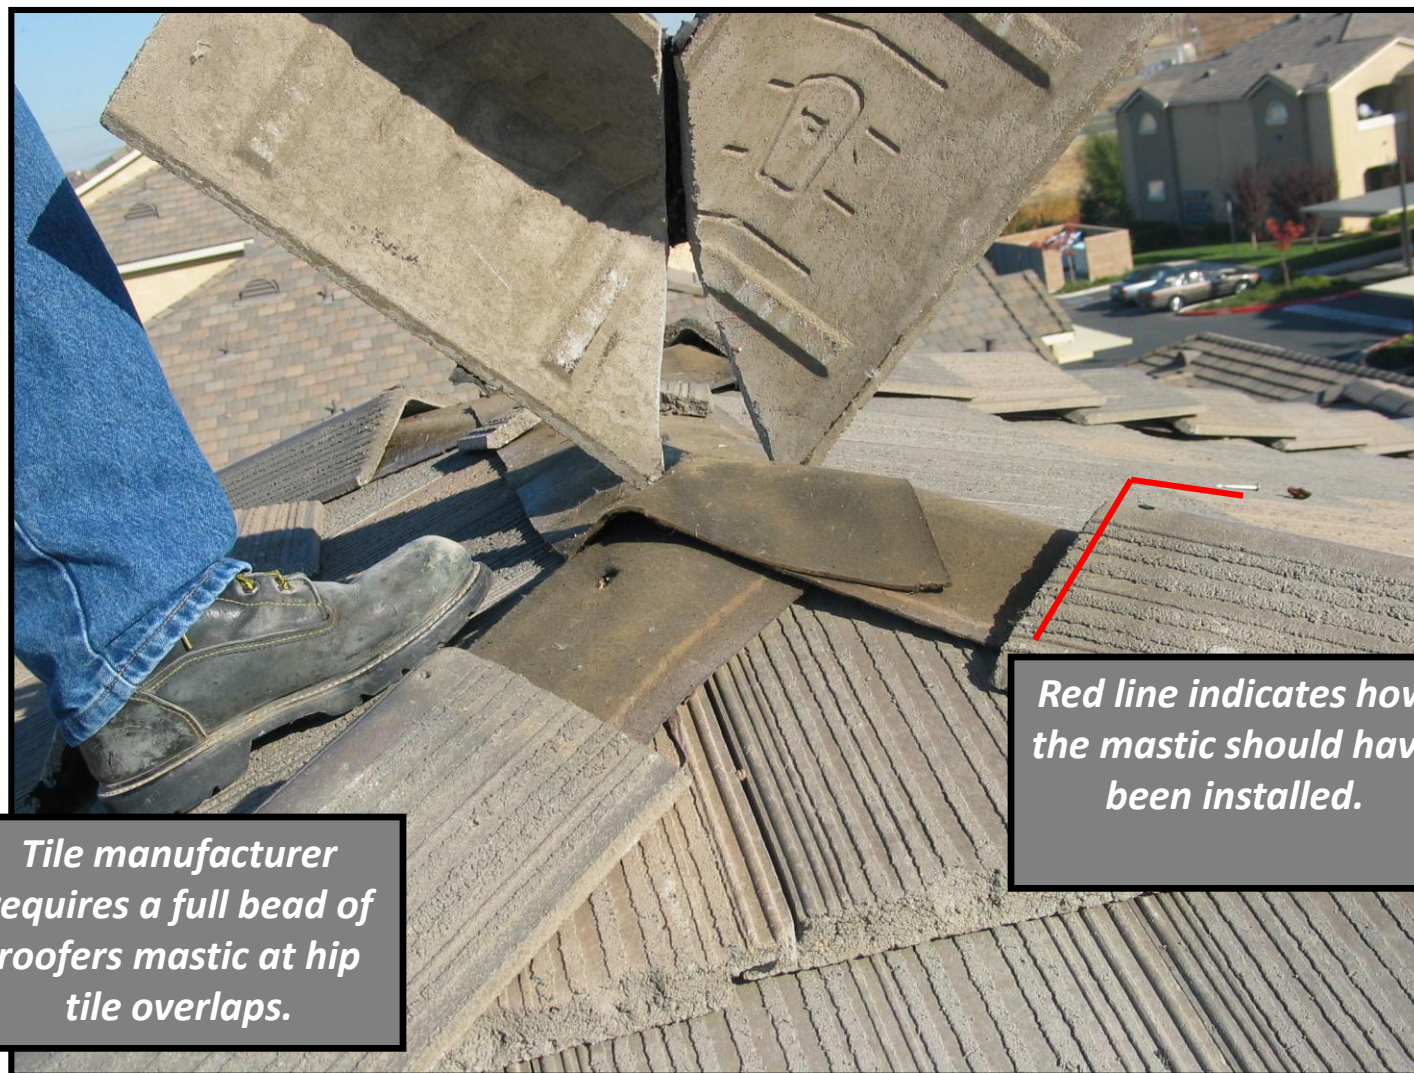
*Tile manufacturer  
requires a full bead of  
roofers mastic at hip  
tile overlaps.*

*Red line indicates how  
the mastic should have  
been installed.*

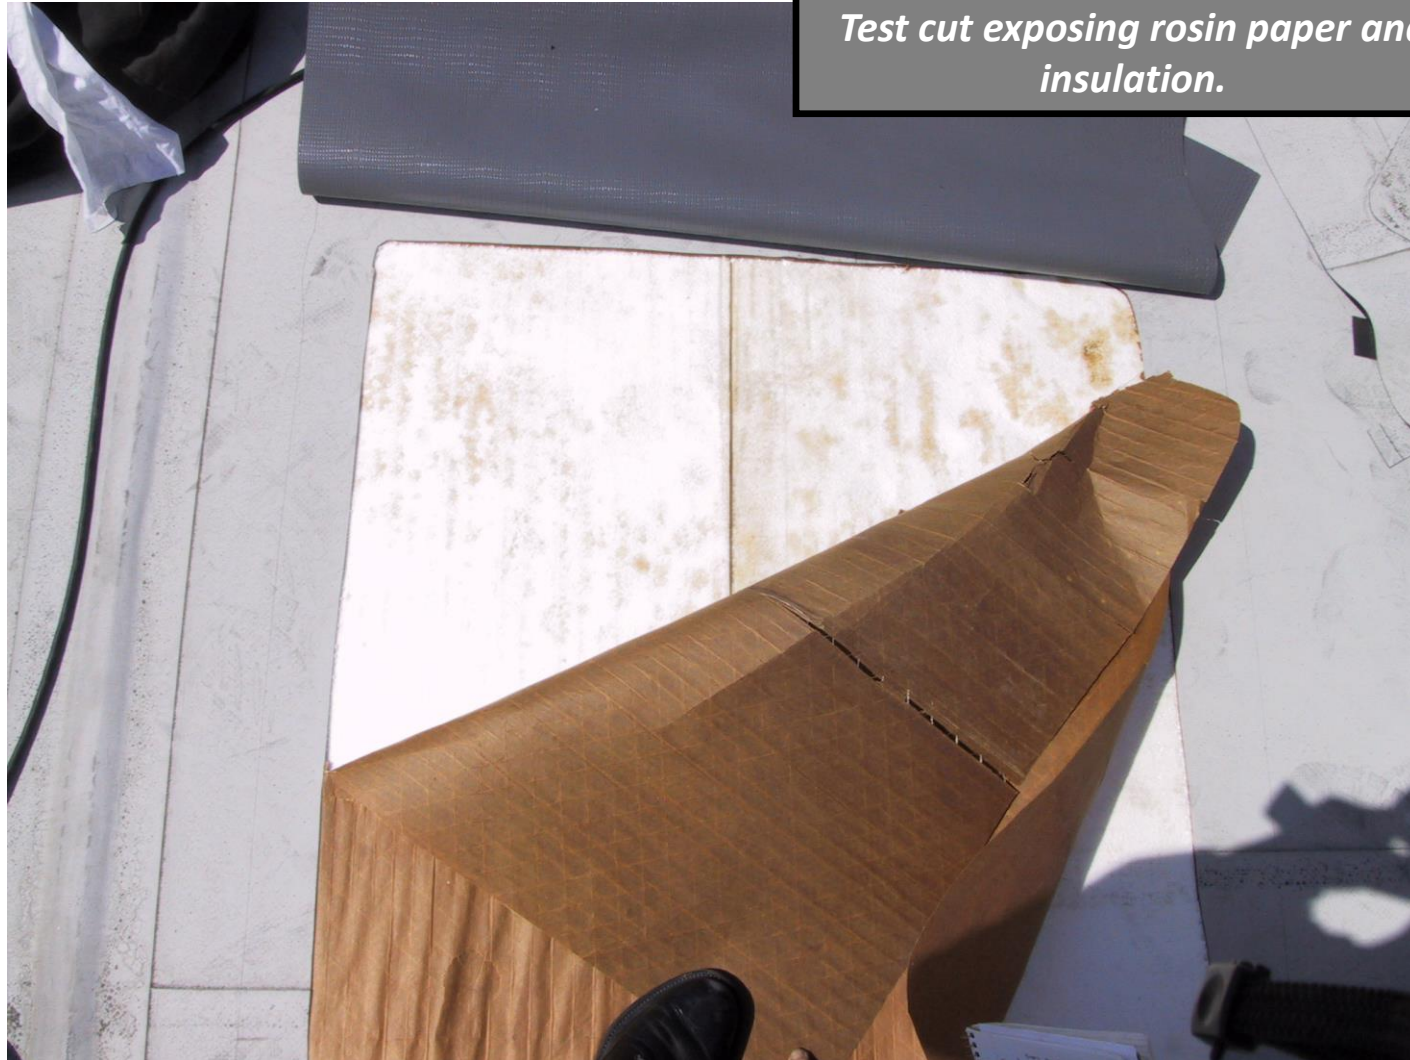
*Test cut exposing rosin paper and insulation.*

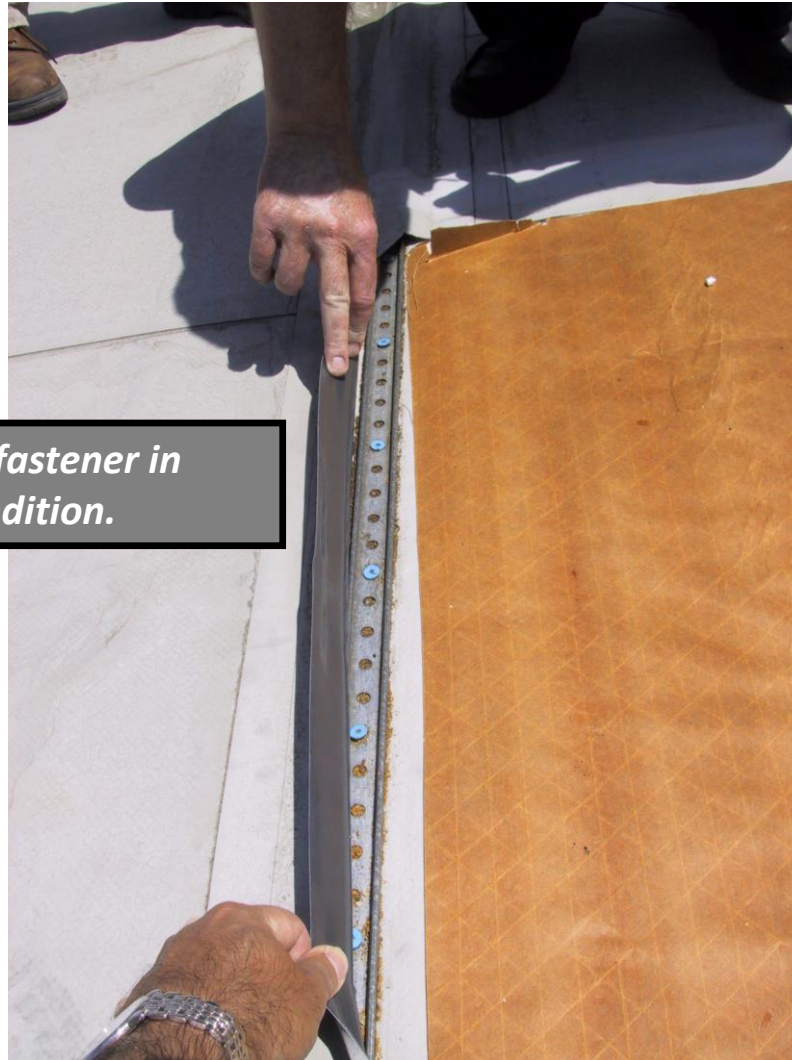
*Mechanical bar fastener in  
excellent condition.*

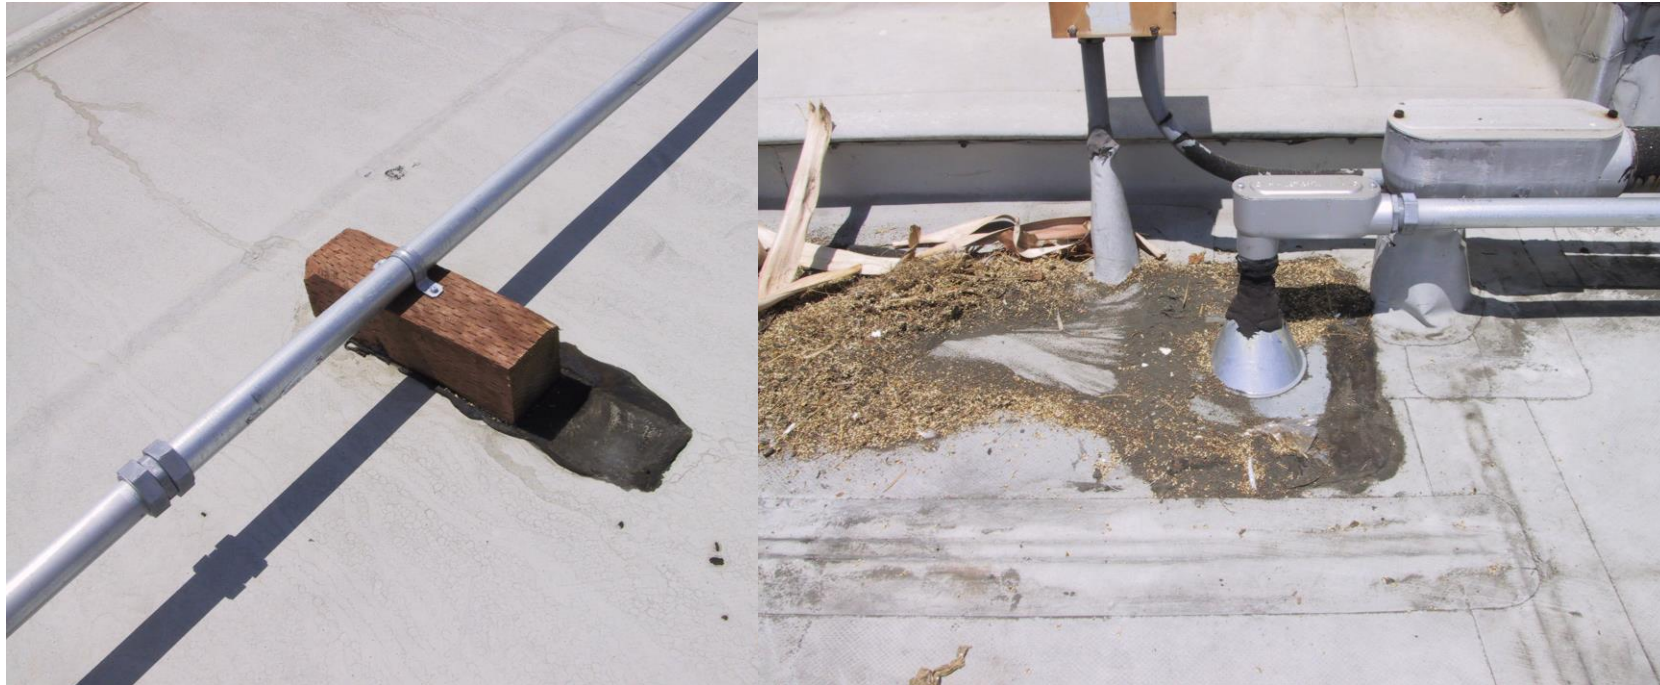
New electrical pipe added, pipe jack set in mastic (not properly flashed with single ply) and wood block set in mastic (incompatible with PVC).

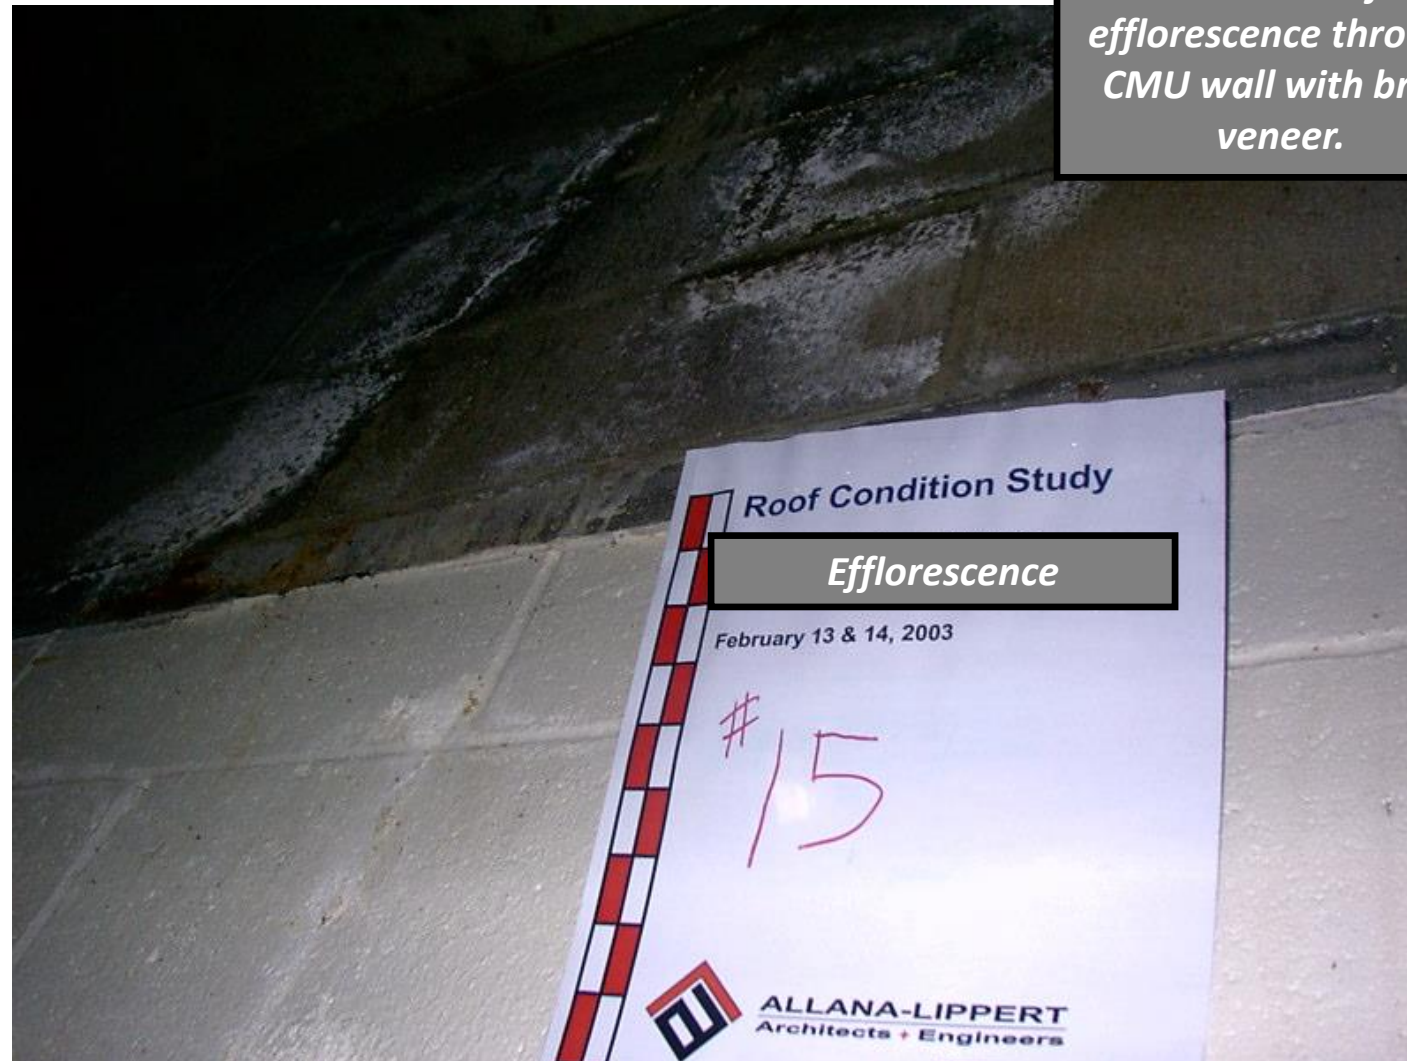
*Evidence of significant leaks in the past, below the internal gutters and confined rake wall that already been repaired, once.*

*Evidence of  
efflorescence through  
CMU wall with brick  
veneer.*

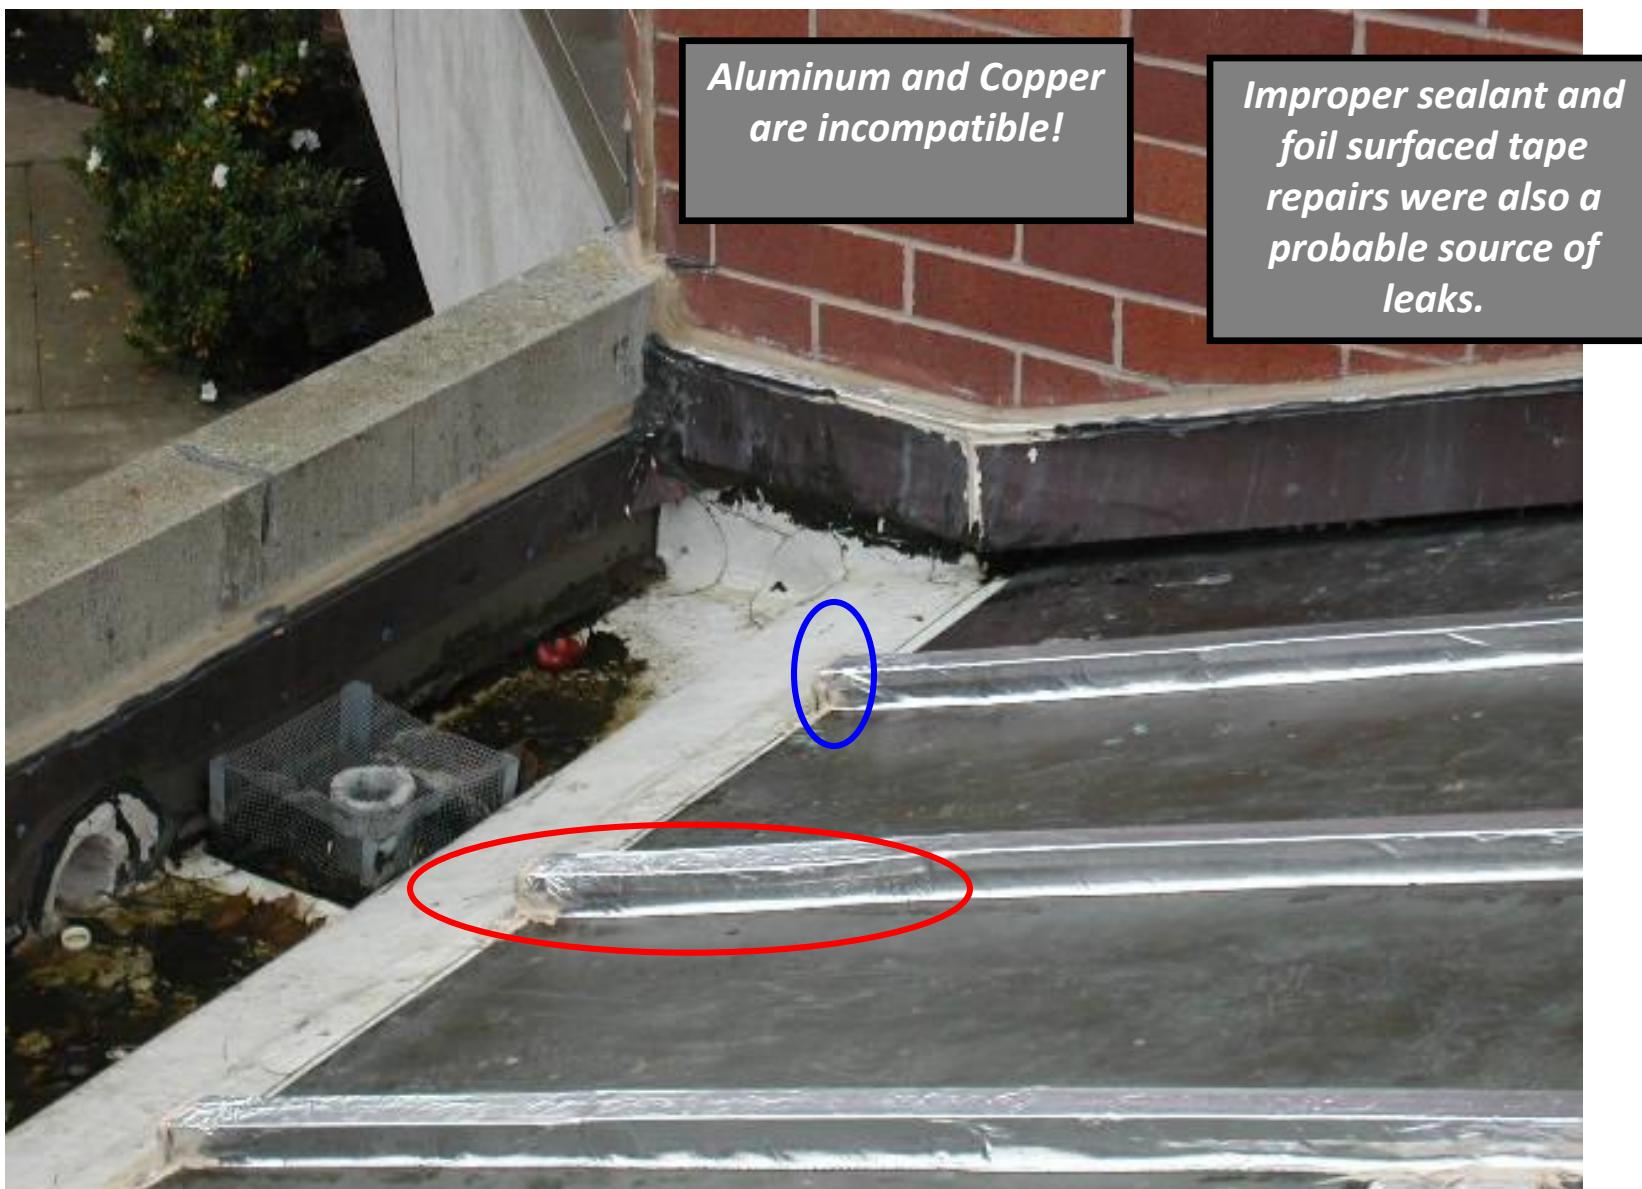
*Metal to single ply transitions were thought to be leak sources.*

*In earlier unsuccessful repairs, metal battens were also thought to be leak source. Note tape on batten and seam on field formed panel.*

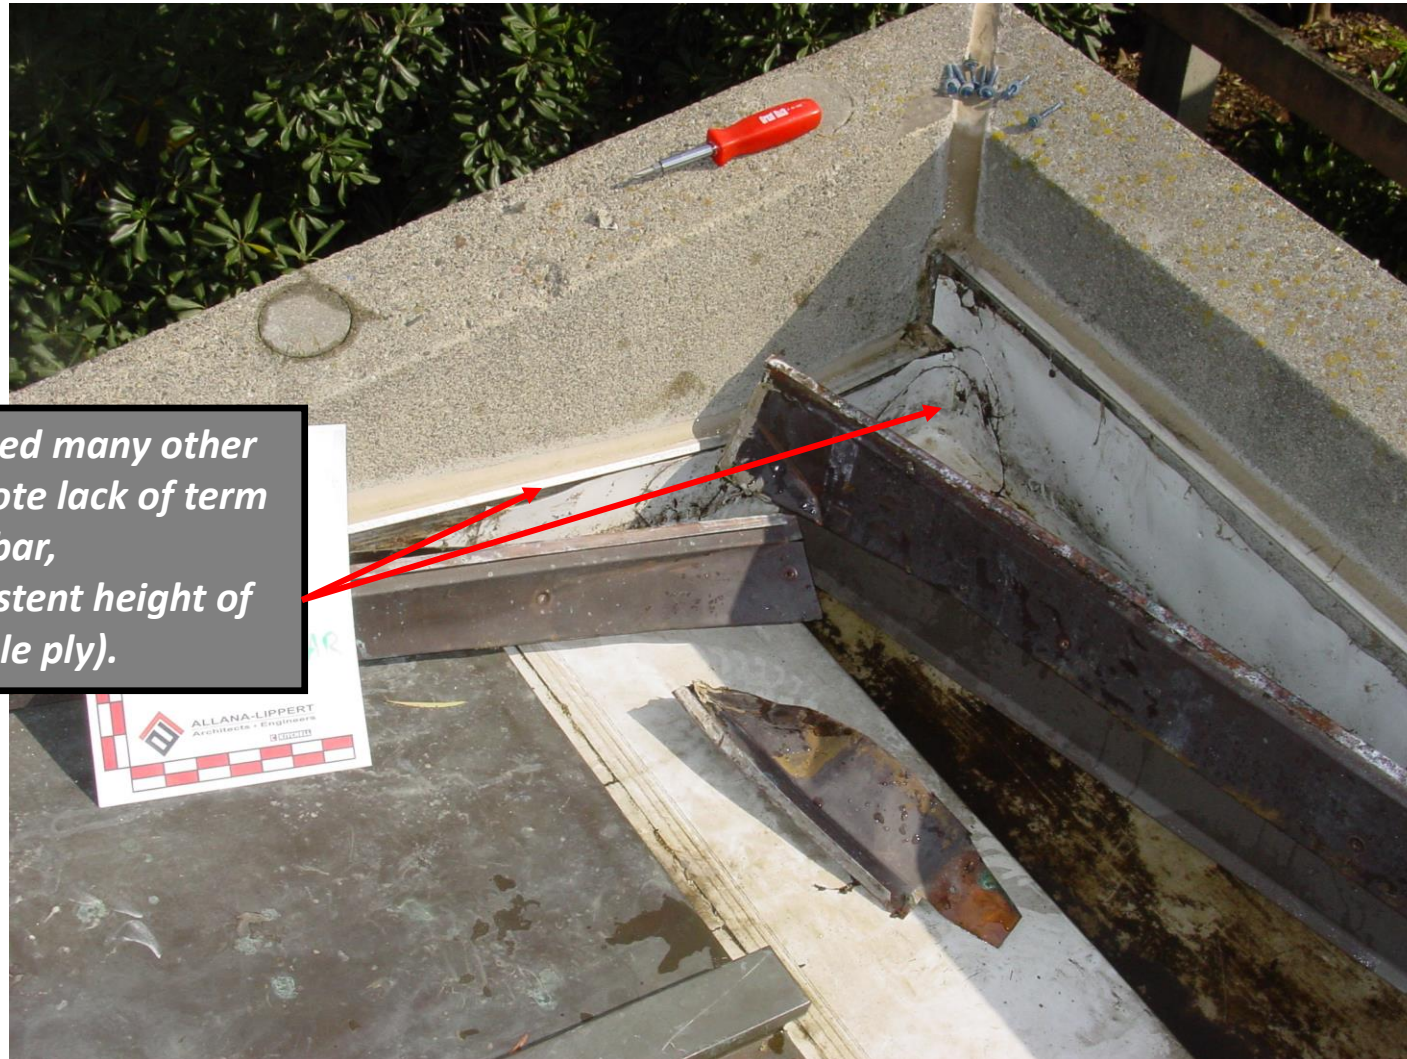
*We uncovered many other problems (note lack of term bar, and inconsistent height of single ply).*

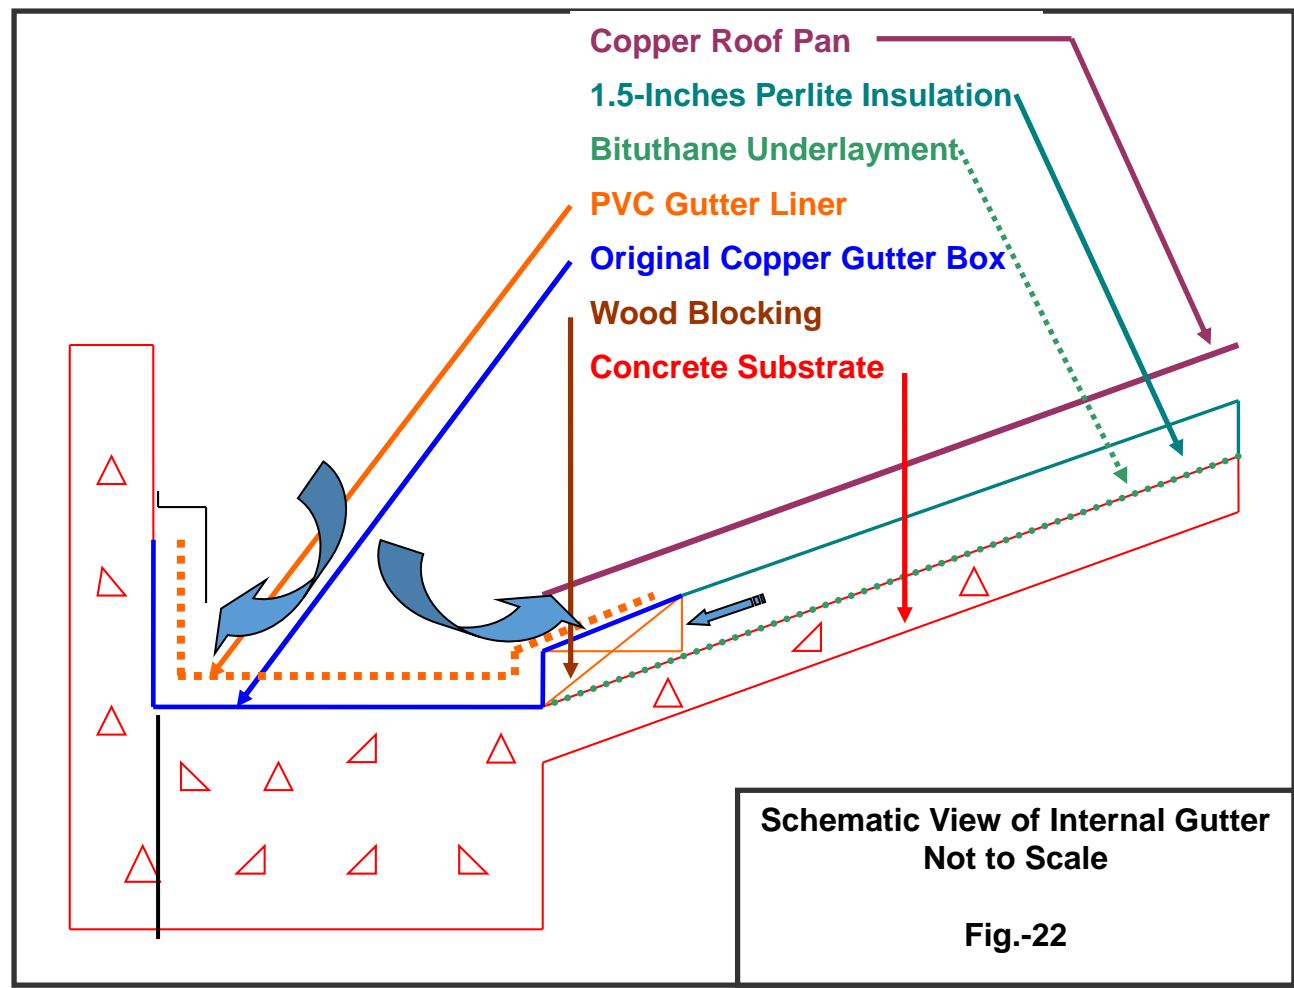
*Water in gutter was found to be running under counter flashing when gutter is full. Additional water is presented from copper roof pans.*

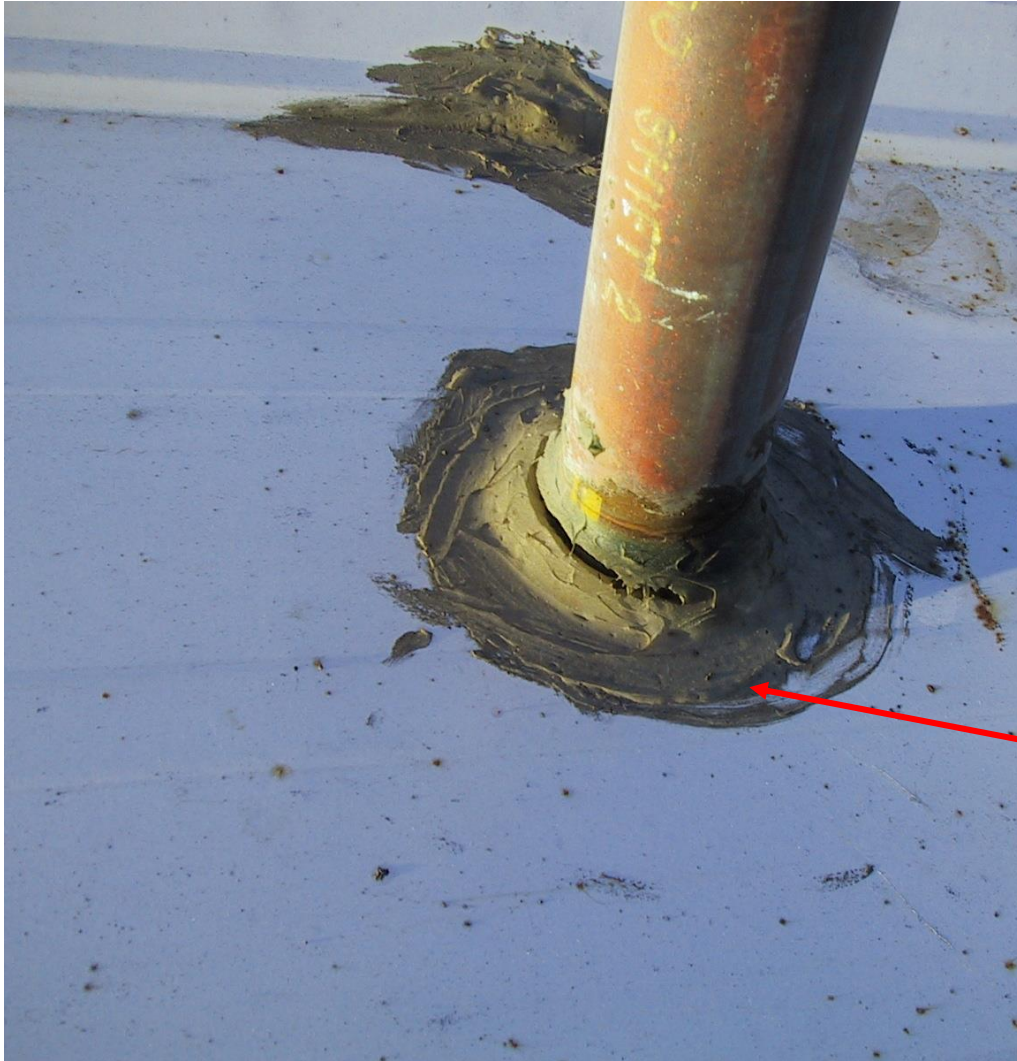
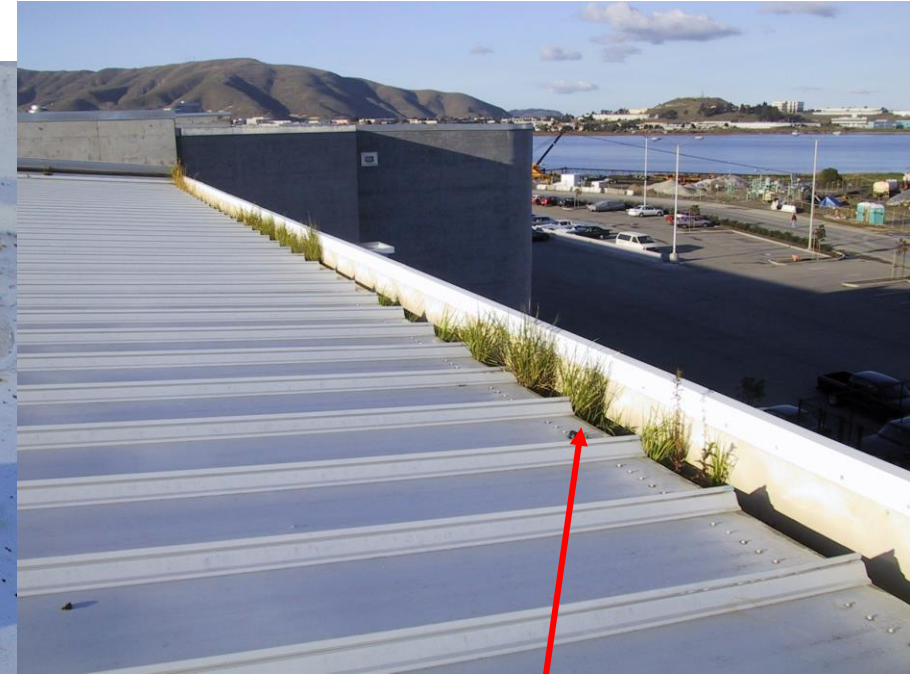
*Improper design leads to failures.*
