**ALLANA BUICK & BERS**

## **Life Expectancy and Longevity of Buildings and Assemblies**

Condo Council of Maui 2016 Seminar  
November 16, 2016

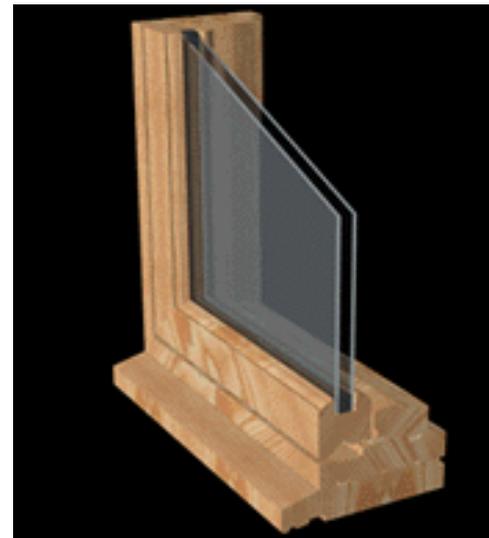
- **Wood**

- The traditional window frame material
- Wood frames are high maintenance, they require sanding and staining, and the outer frame may require re-finishing every few years

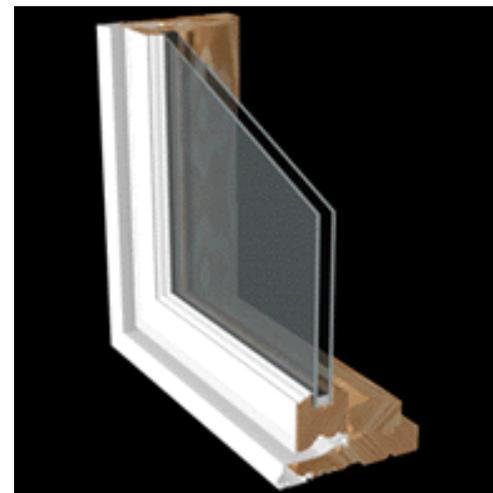
- **Aluminum Clad Wood**

- Clad the exterior face of the frame with either vinyl or aluminum, creating a permanent weather-resistant surface

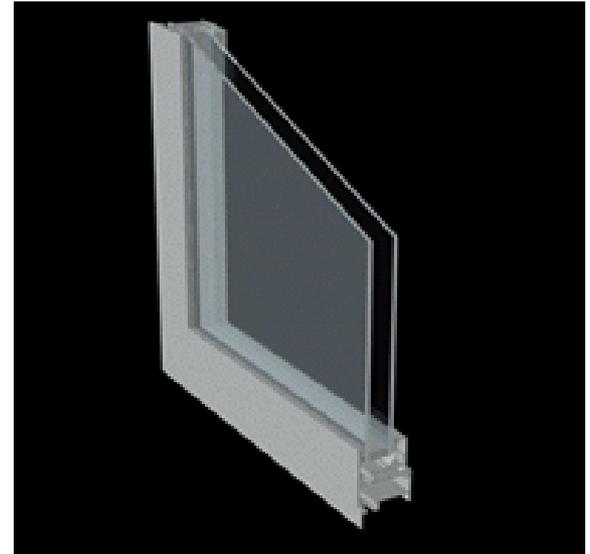
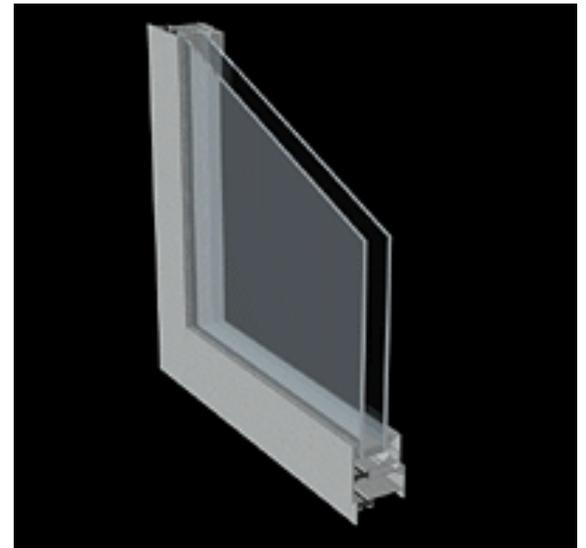
- **Aluminum**
  - Aluminum window frames are light, strong, and durable, but with high thermal conductance. They readily conduct heat, greatly raising the overall U-factor of a window unit

- **Aluminum with Thermal Break**
  - The most common solution to the heat conduction problem of aluminum frames is to provide a thermal break by splitting the frame components into interior and exterior pieces and use a less conductive material to join them

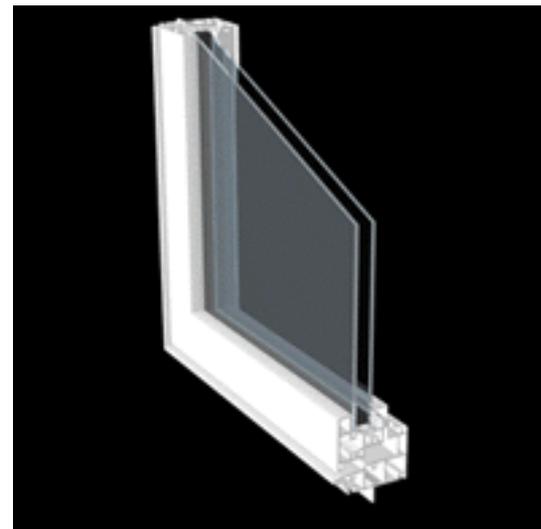
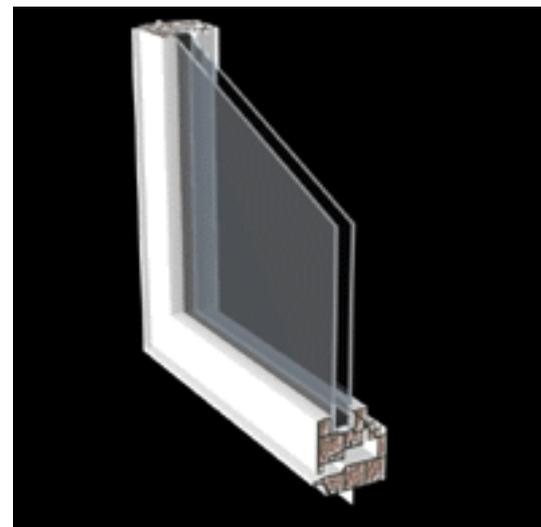
- **Vinyl**
  - Vinyl does not conduct heat very well and is therefore considered a good thermal insulator
  - Vinyl comes in different wood grain finishes and does not require painting or finishing
- **Insulated Vinyl**
  - In insulated vinyl frames, the non-draining hollow cavities of the frame are filled with insulation making them thermally superior to standard vinyl and wood frames. Usually these high performance frames are used with high performance glazing

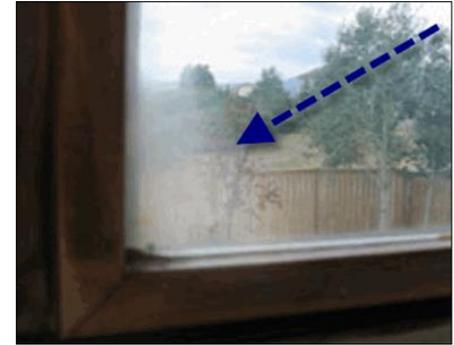
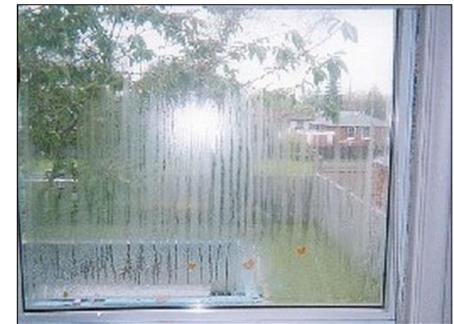
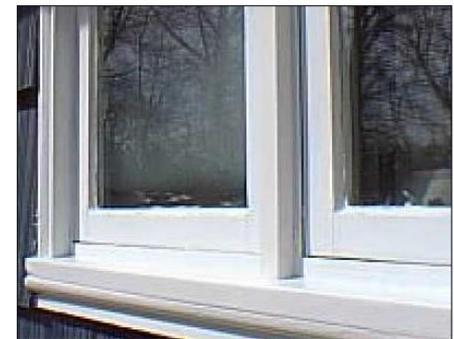
# Insulating Glass Seal Failure

- Dual pane windows are used for insulation
- Dual panes have air gap filled with Argon or inert gas and sealed around perimeter.
- When glazing seal fail, air and moisture moves in and can condense inside panes
- Premature failure of sealed units is usually caused by:
  - Poor design and use of poor quality materials used to seal two panes of glass together
  - Poor workmanship on an individual unit during fabrication
  - Poor frame design which will allow the unit to sit in a high moisture environment

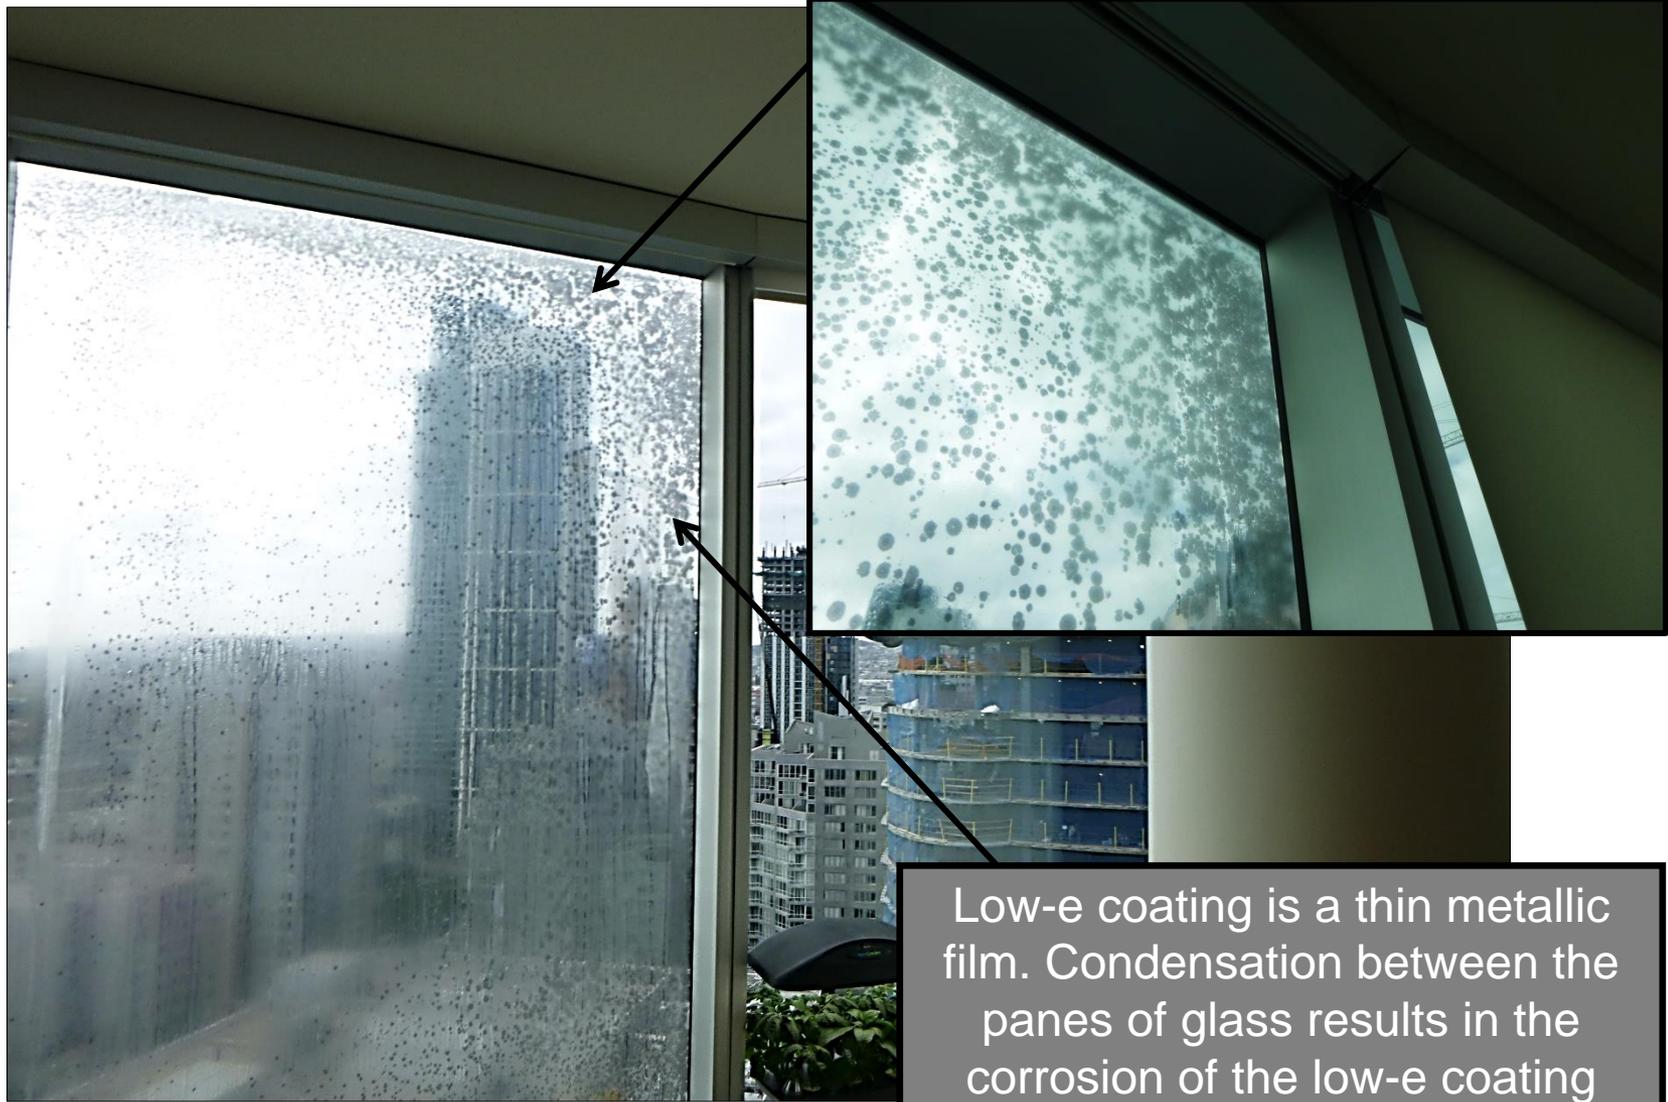
Building D, Unit 28F

# Insulating Glass Seal Failure

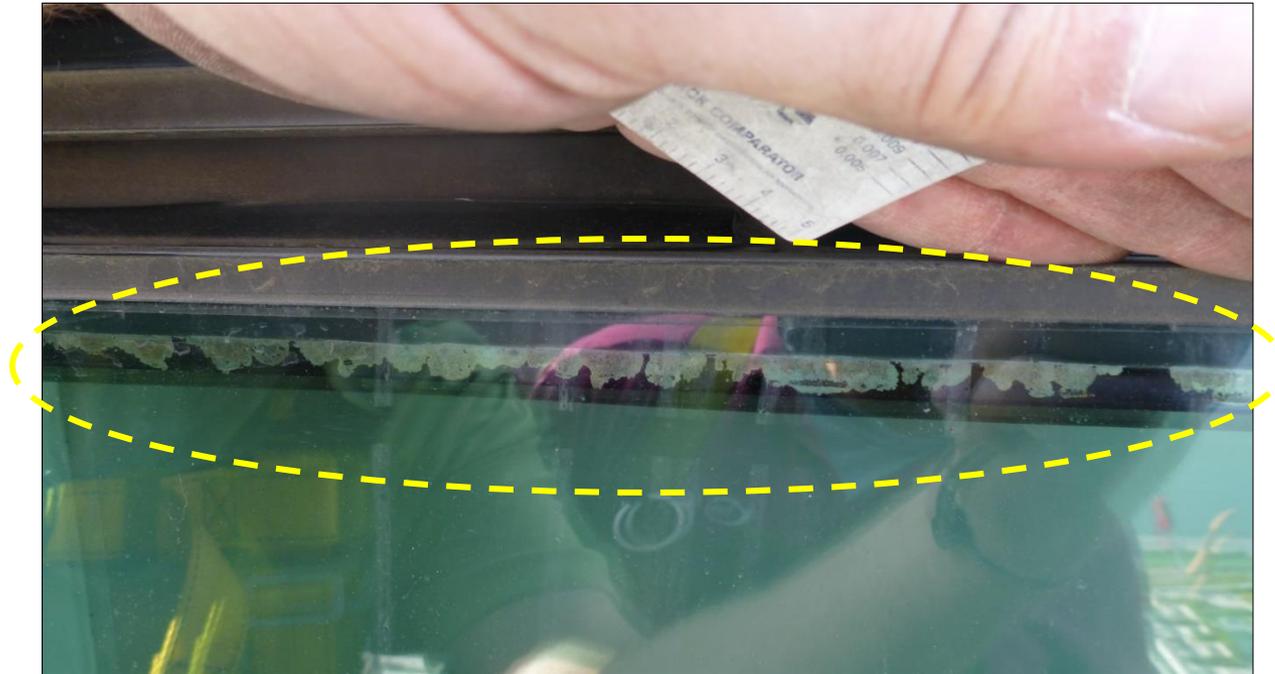
# Glazing Seals Can Fail For A Number Of Reasons

Between panes of glass, the air space is filled with desiccated air or an inert gas like Argon. IGUs are typically composed of a “dual seal” system with a primary seal being P.I.B. (Polyisobutylene) with a secondary seal of silicone (preferred) or polysulfide

Failure can occur if the silver coating is not “edge deleted”. Edge of the glass can start corroding and corrosion can spread to the inside, by-passing the seals

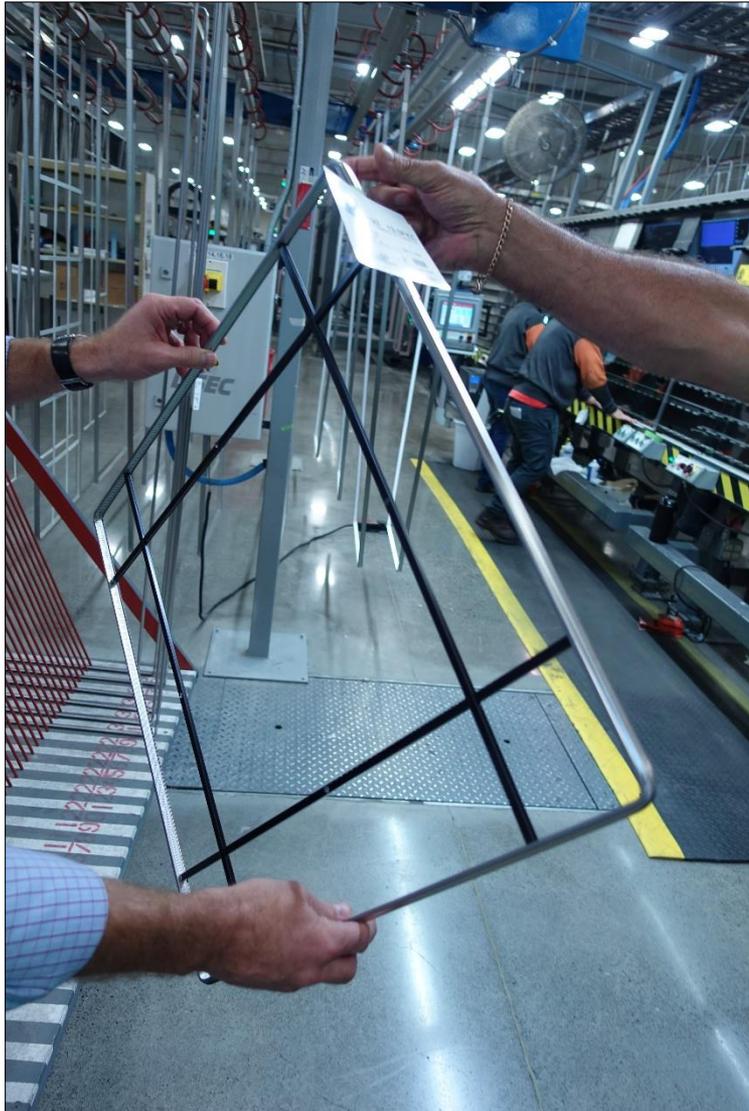
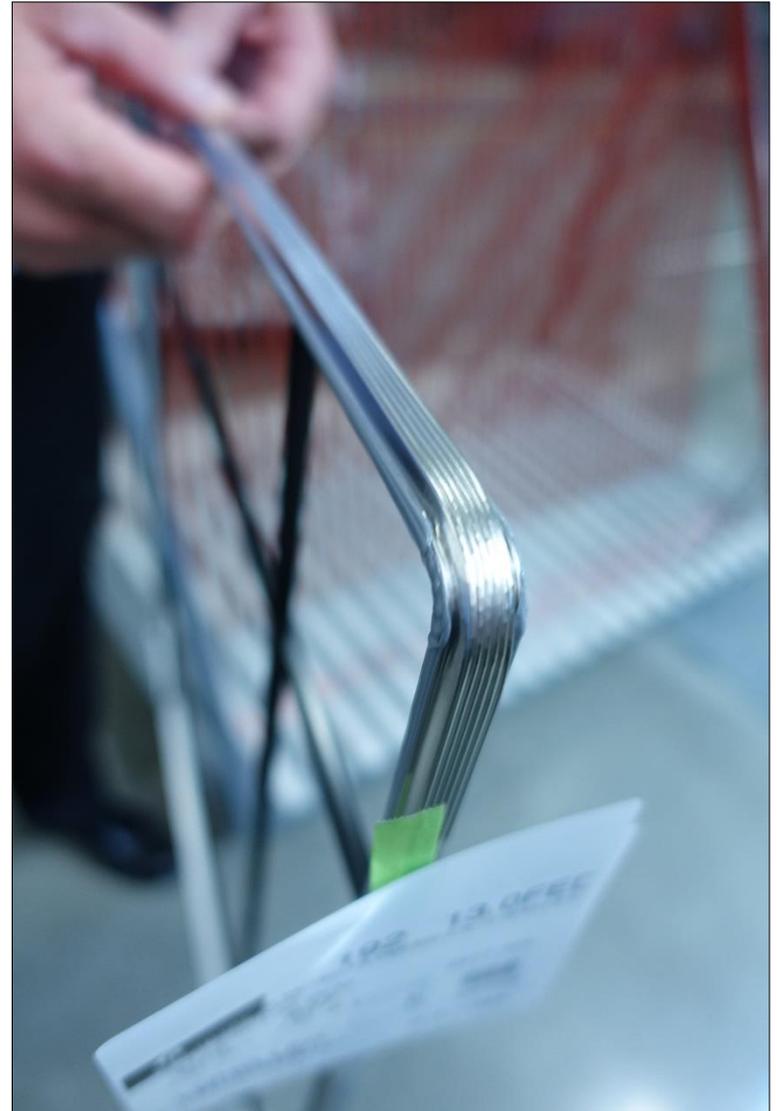
# IGU Seals, Stainless Spacers Last Longer

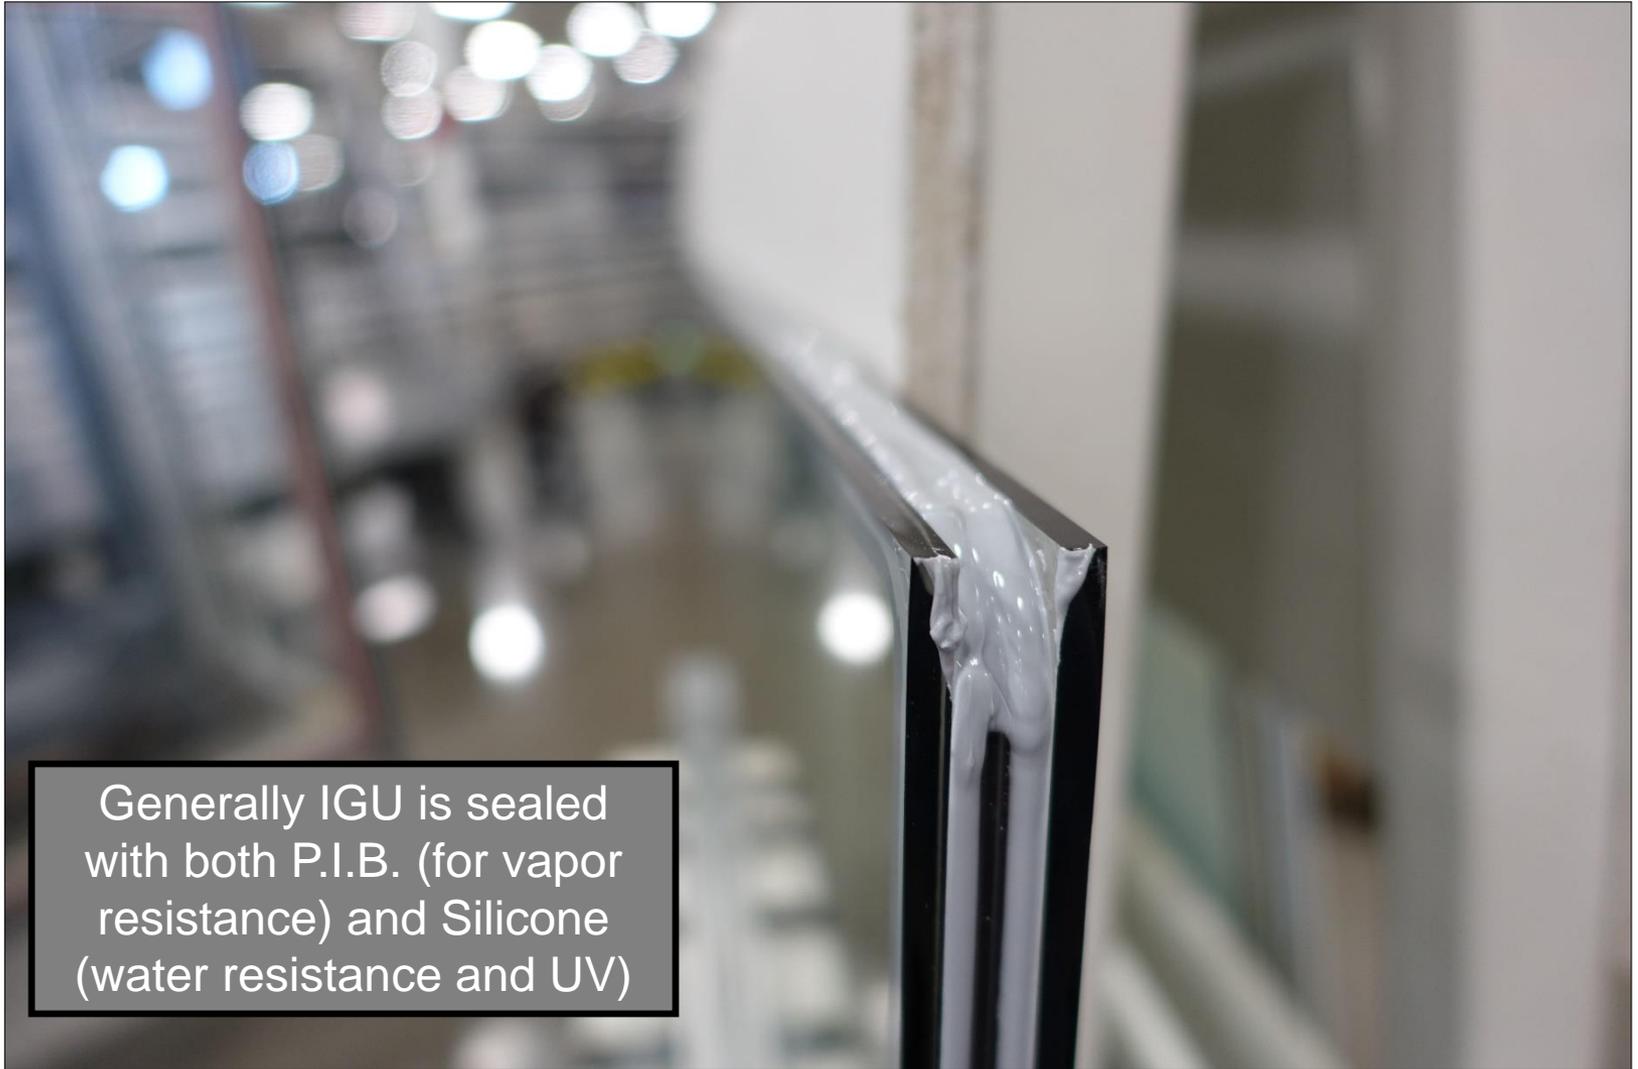
# IGU Units Sealed With Dual Sealants

Generally IGU is sealed with both P.I.B. (for vapor resistance) and Silicone (water resistance and UV)

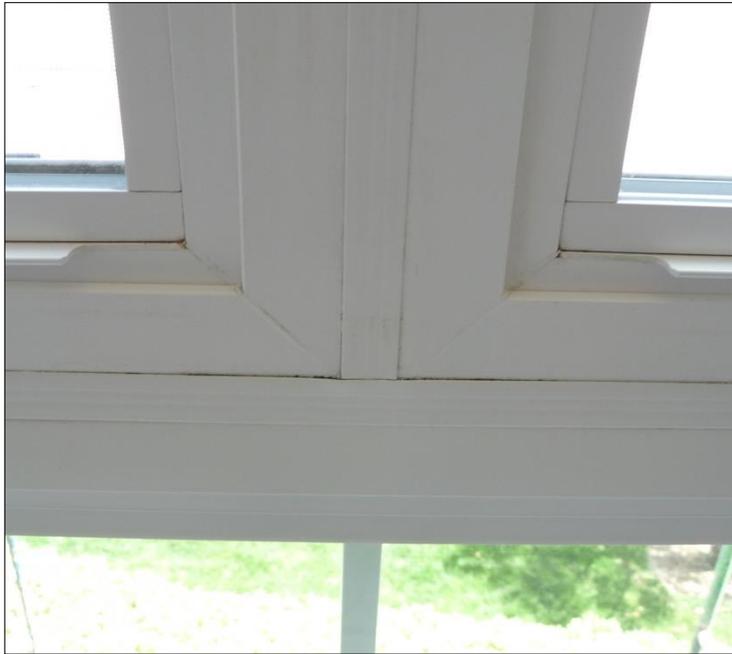
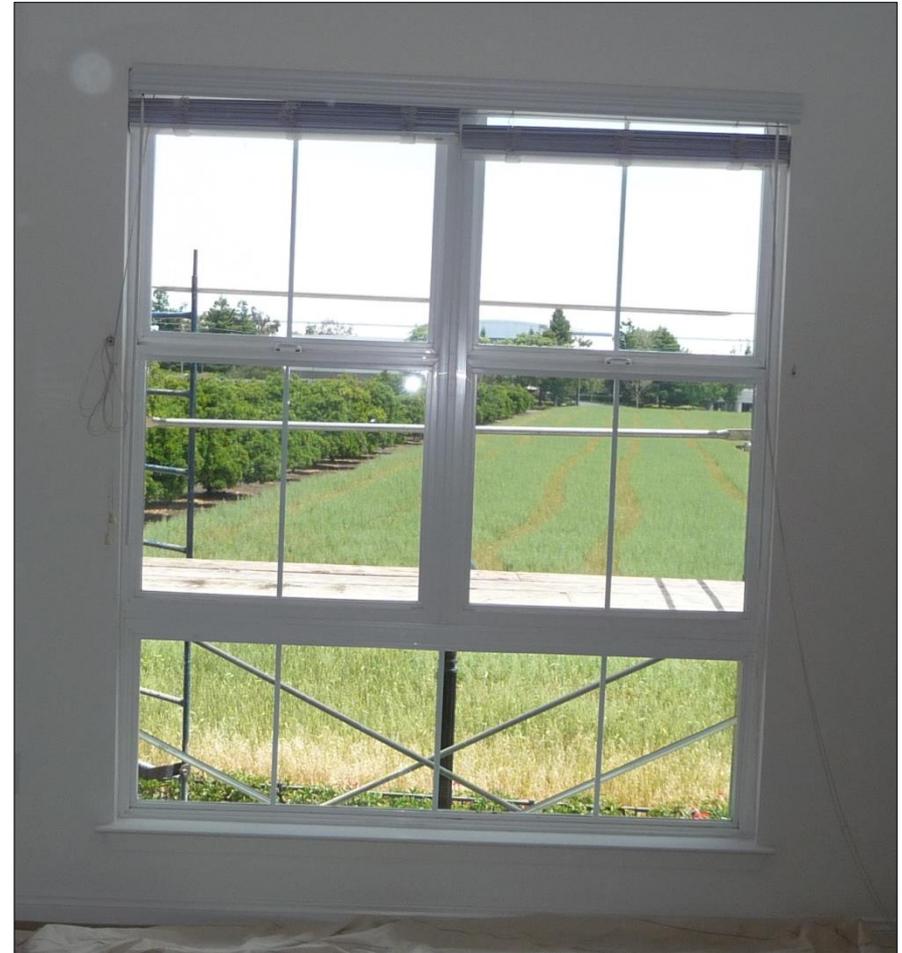
# What is a Mulled Window?

- When 2 to 3 windows are joined together

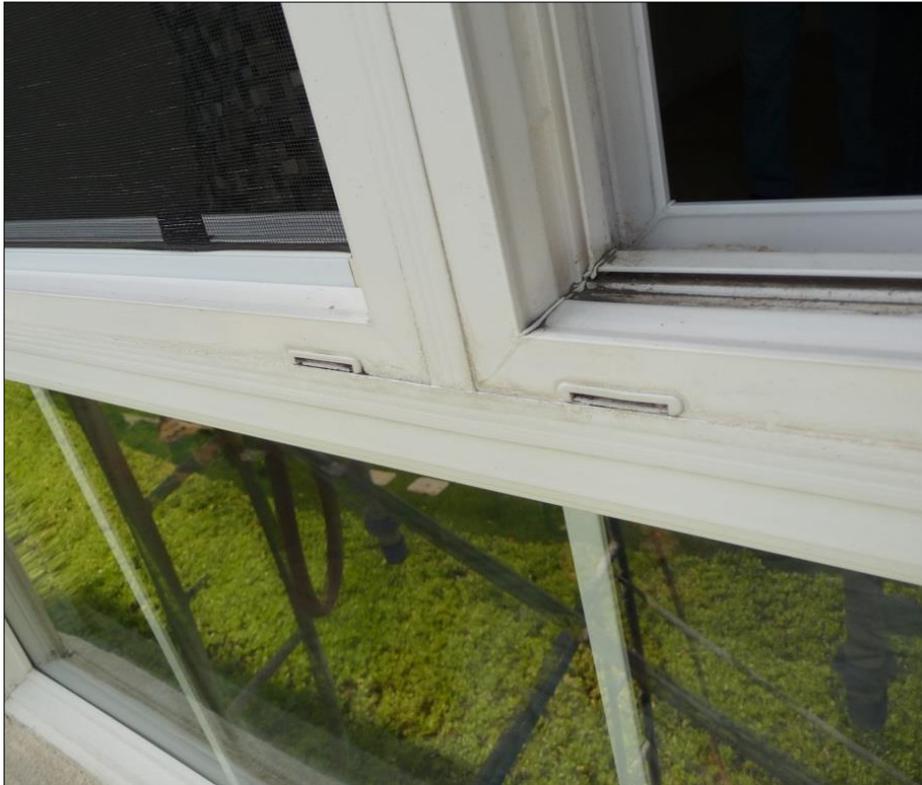
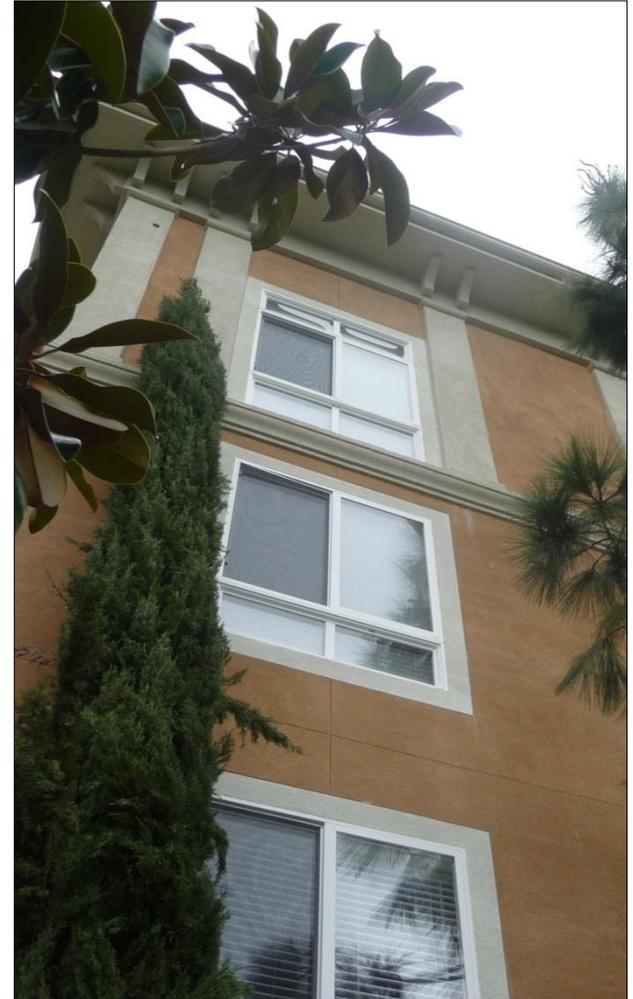
# What is a Mulled Window?

- When 2 to 3 windows are joined together

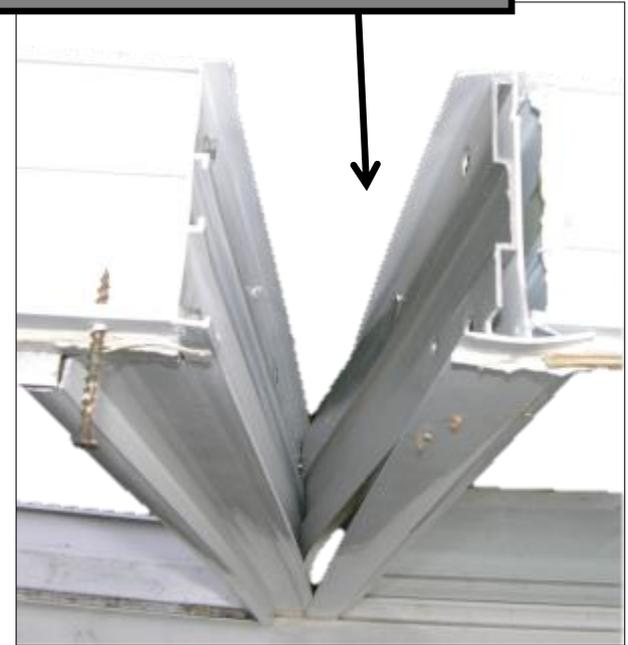
- Mullion is a stiffener used to join window frames together
- Mulled joints can inherently allow water intrusion due to a number of issues
- Often only single windows are tested under AAMA 501 protocol and not the “mulled” configuration
- If you must specify mulled windows, be sure to specify that the window must be tested in it’s “mulled” condition (AAMA 450)

Aluminum stiffener.  
Note an absence of sealant between the aluminum and the windows

Mulled windows separated

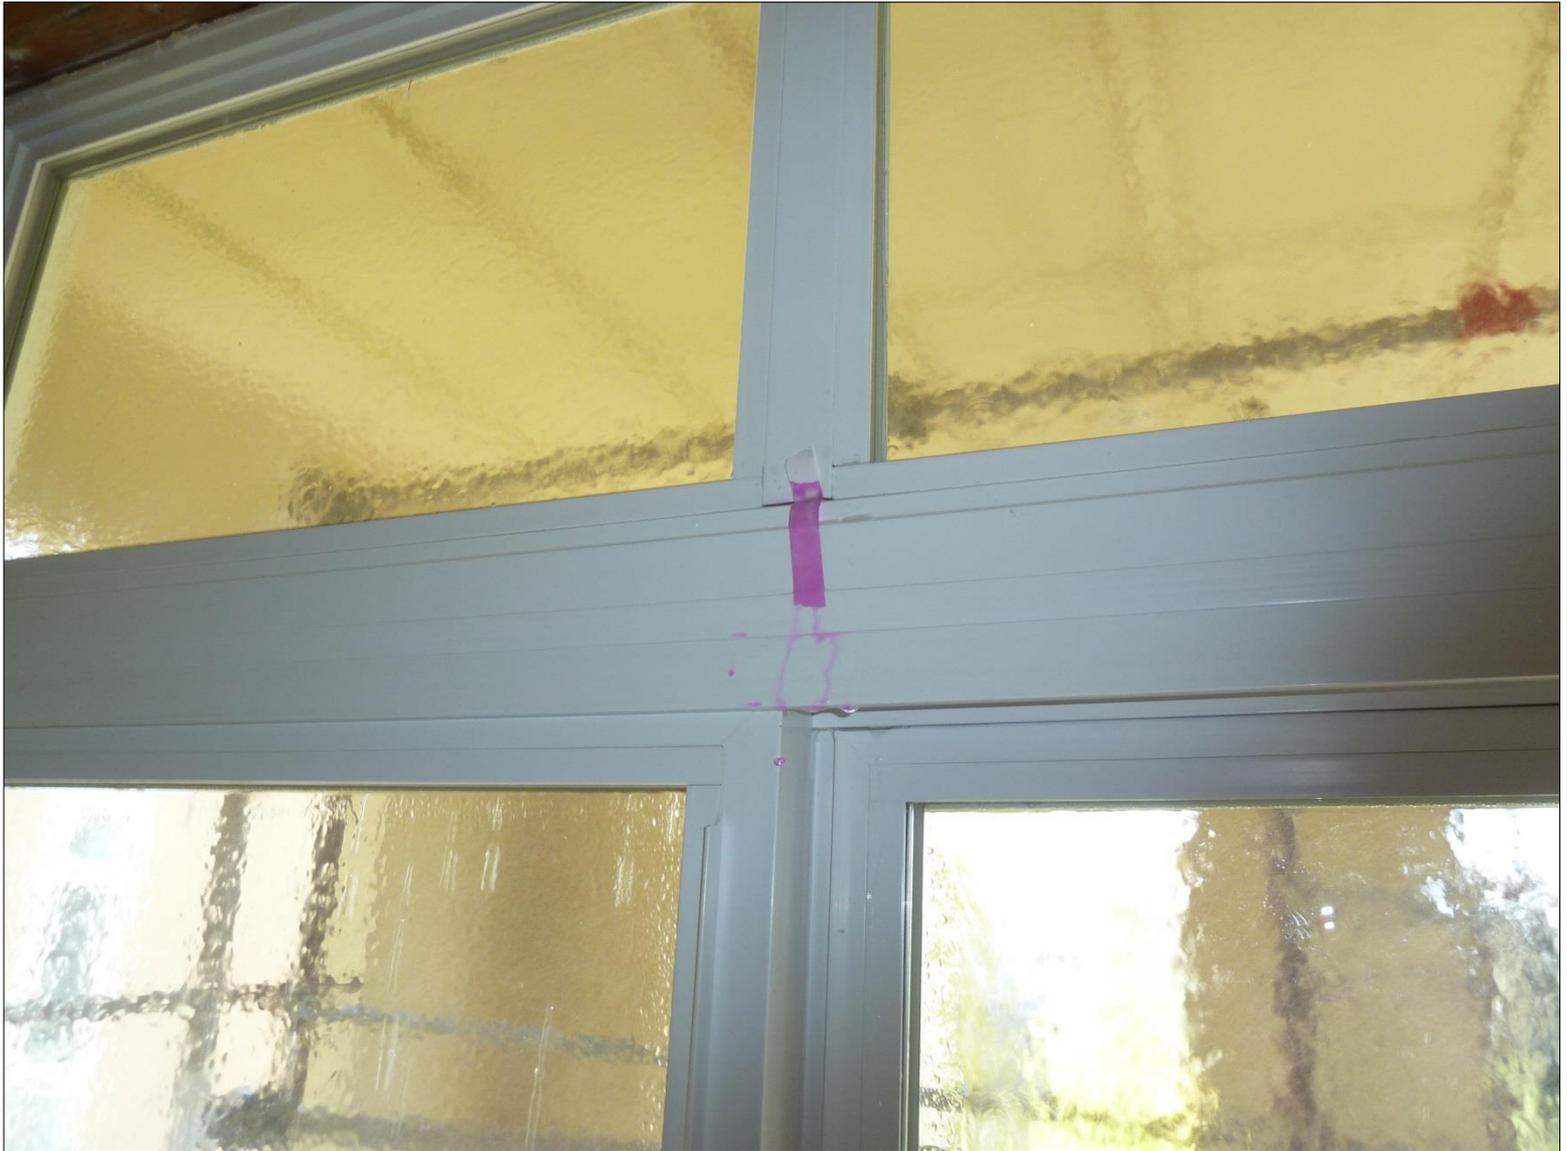
# Horizontal and Vertical Mullion Failures

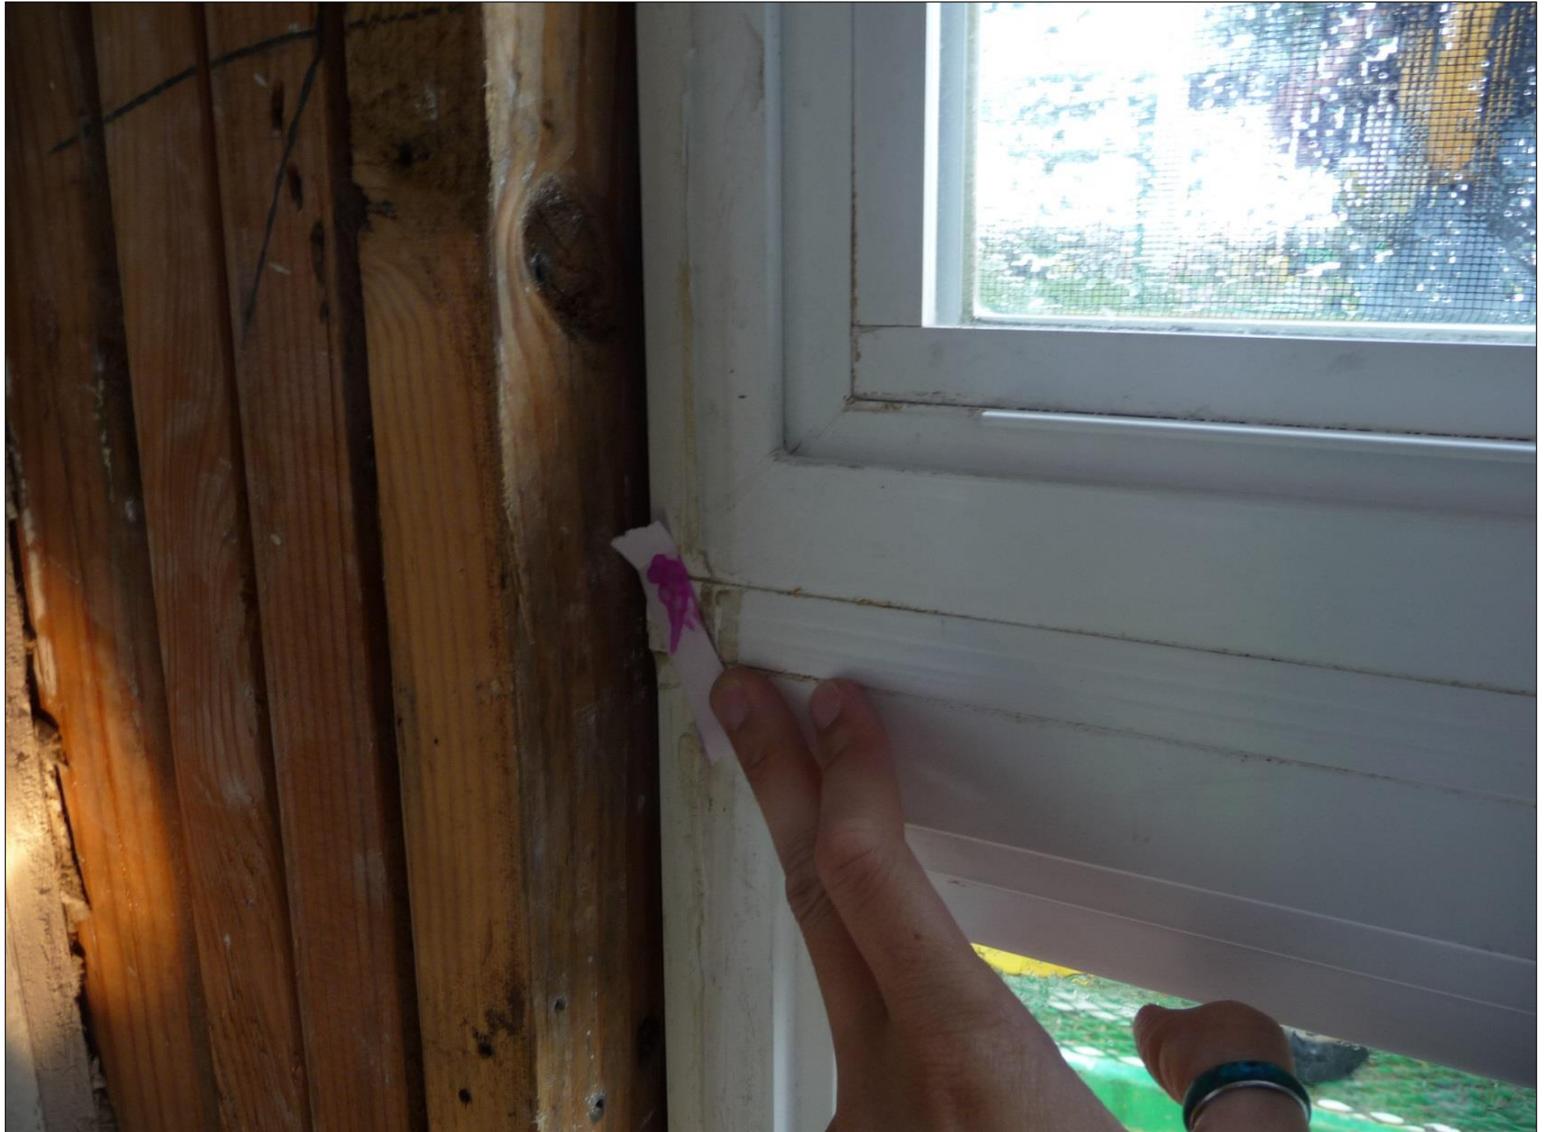
# Horizontal and Vertical Mullion Failures

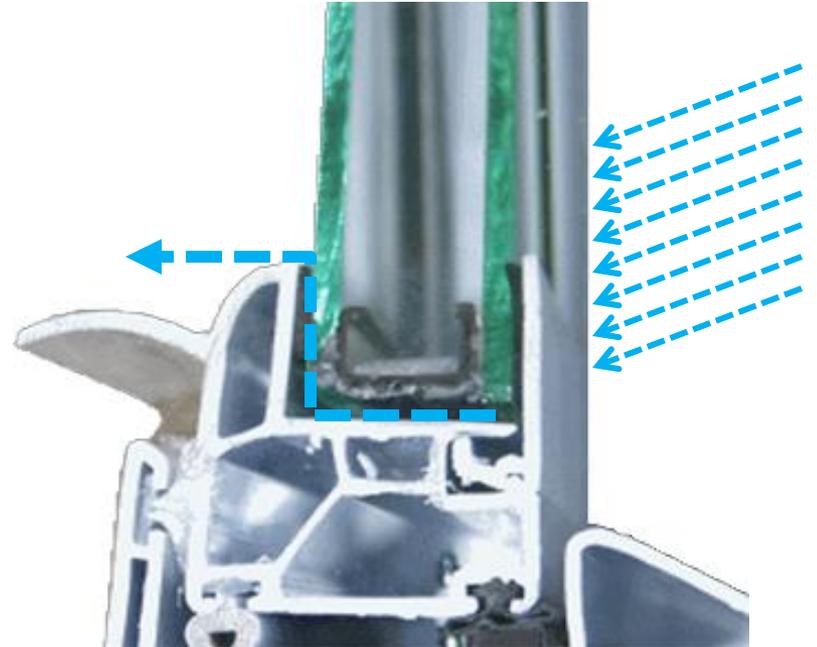
# Water Leaks Through Glazing Seals

- “Glazing seal” refers to the seal between the glass and window sash
- Commercial windows use tape with adhesive backing on two sides and silicone heel or cap beads for glazing seals
- Fin style windows often only use acrylic tape and no wet silicone
- Acrylic tape can break down from UV and water
- In some cases window sashes can overflow with just a light spray

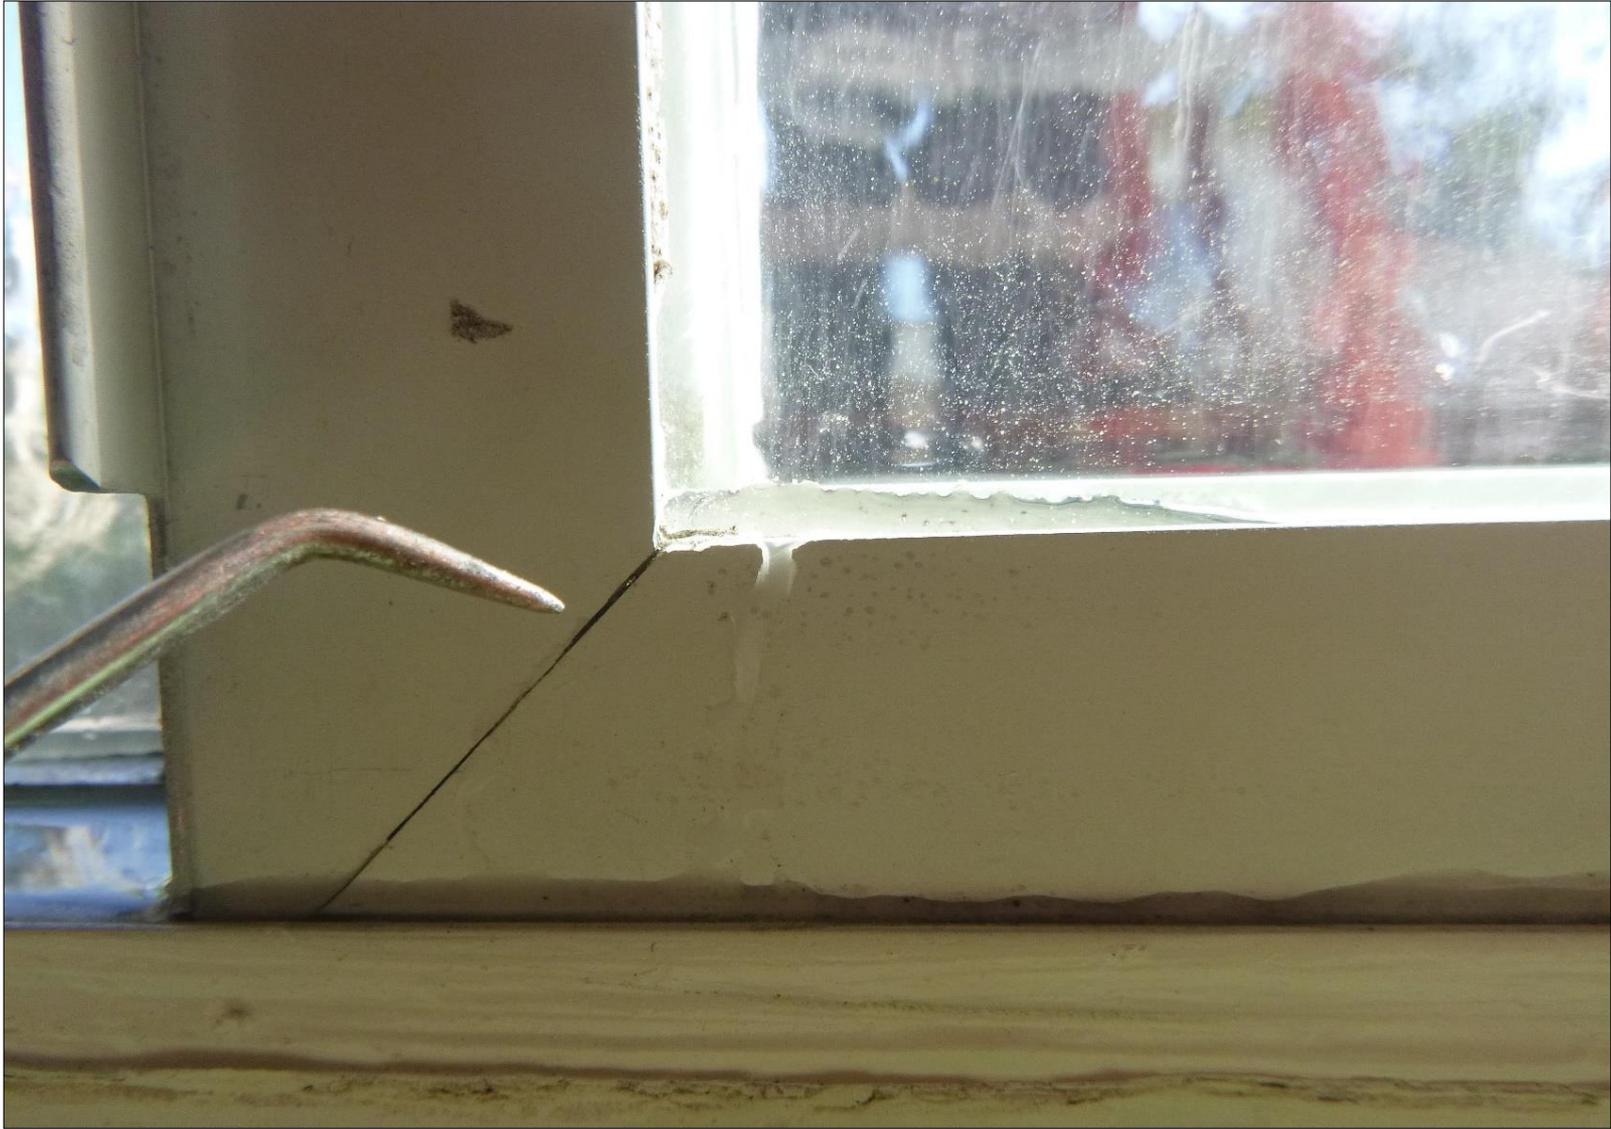
# Glazing Failures And Resultant Leak

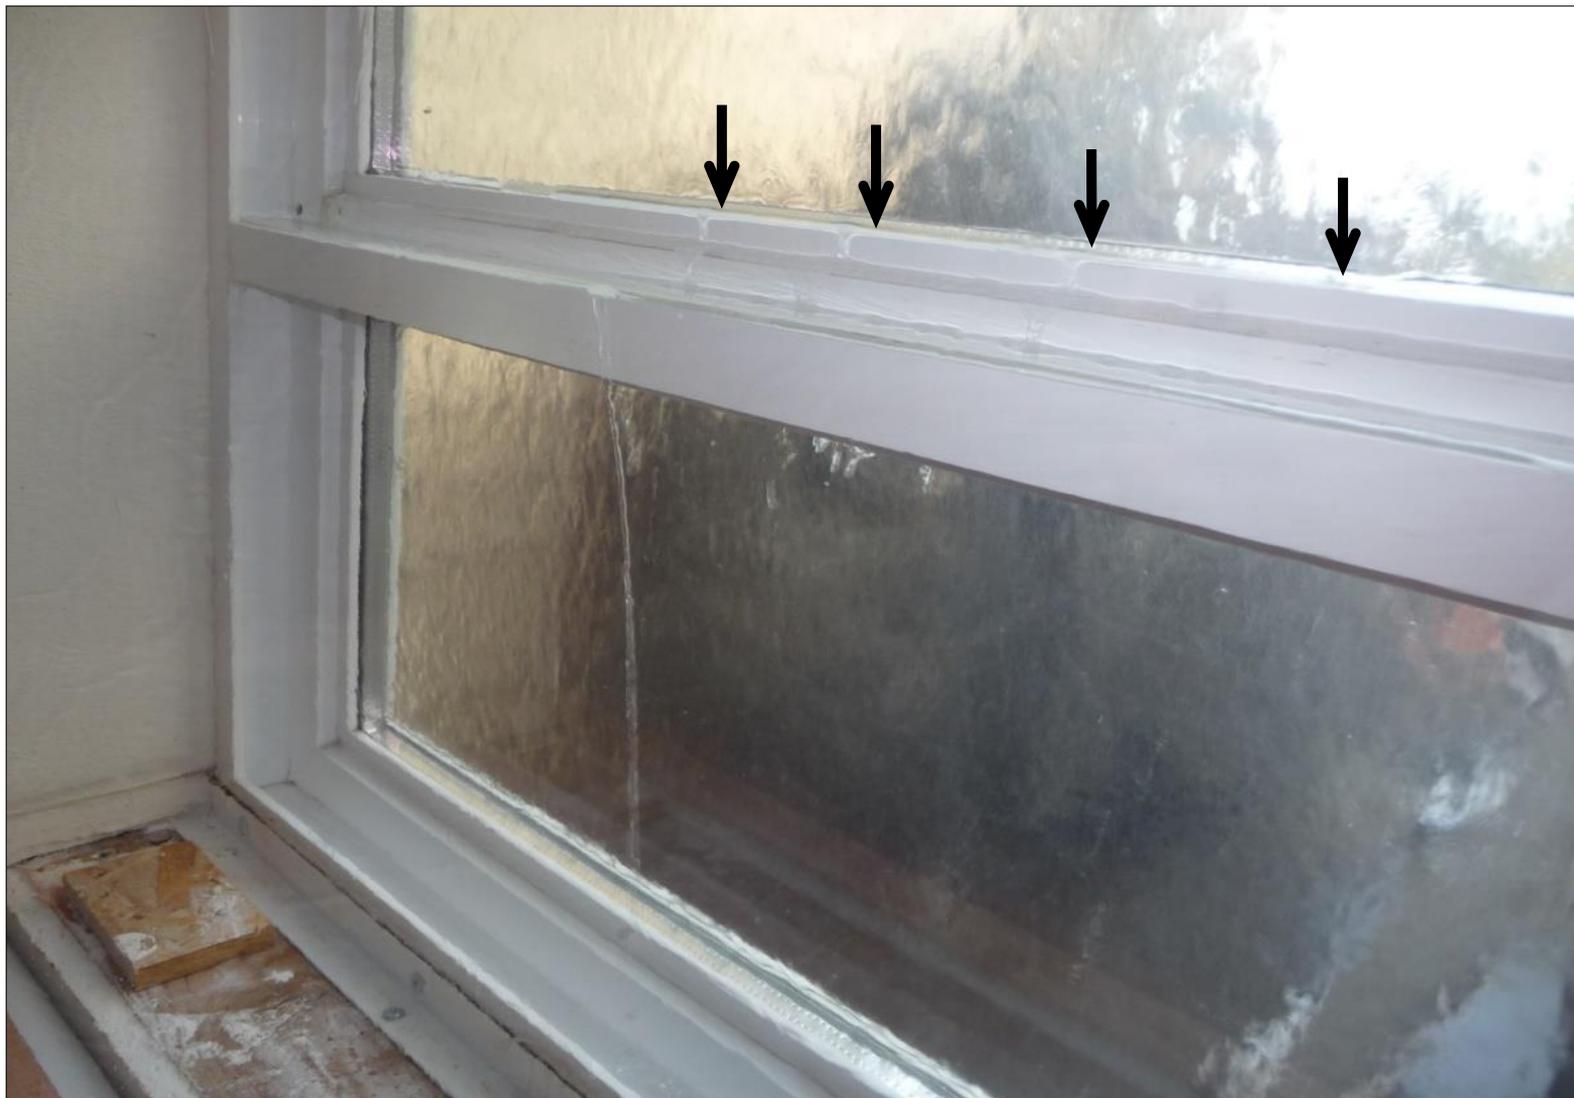
# Glazing (Glass to Frame) Failures And Leak

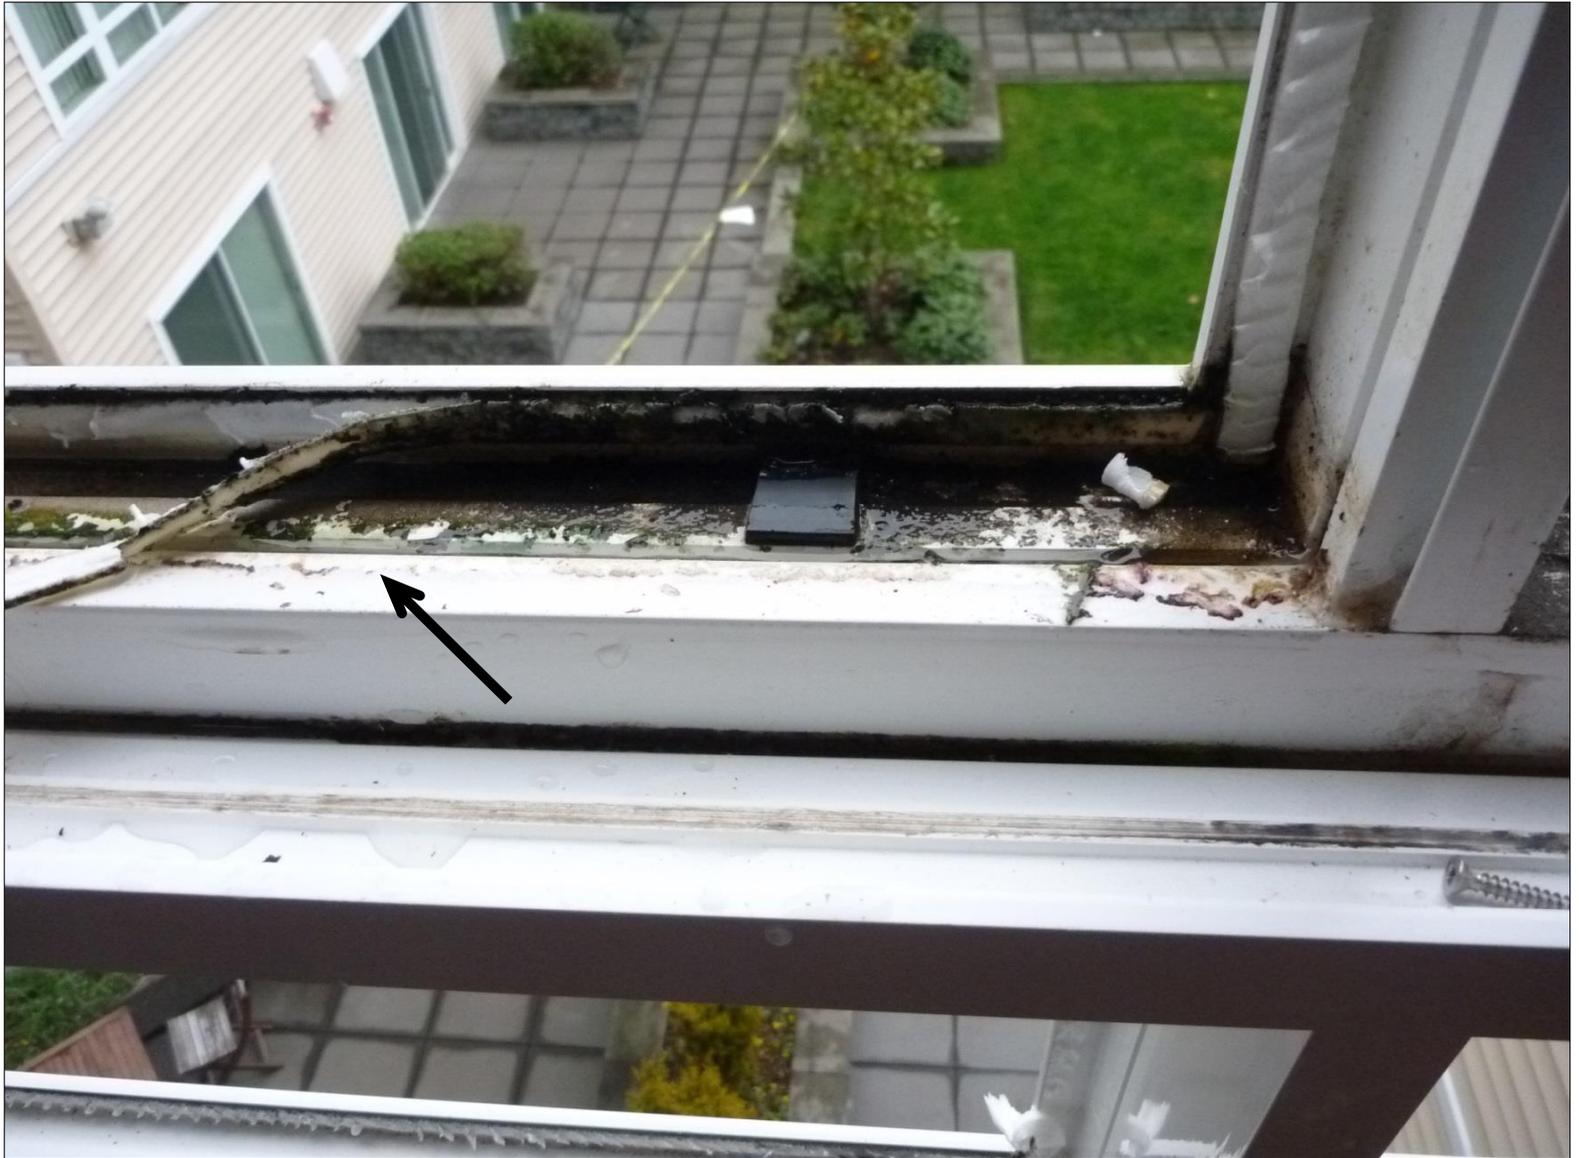
# Glass Has Been Removed, Foam Tape Exposed
