**ALLANA BUICK & BERS**

## **Life Expectancy and Longevity of Buildings and Assemblies**

Condo Council of Maui 2016 Seminar  
November 16, 2016

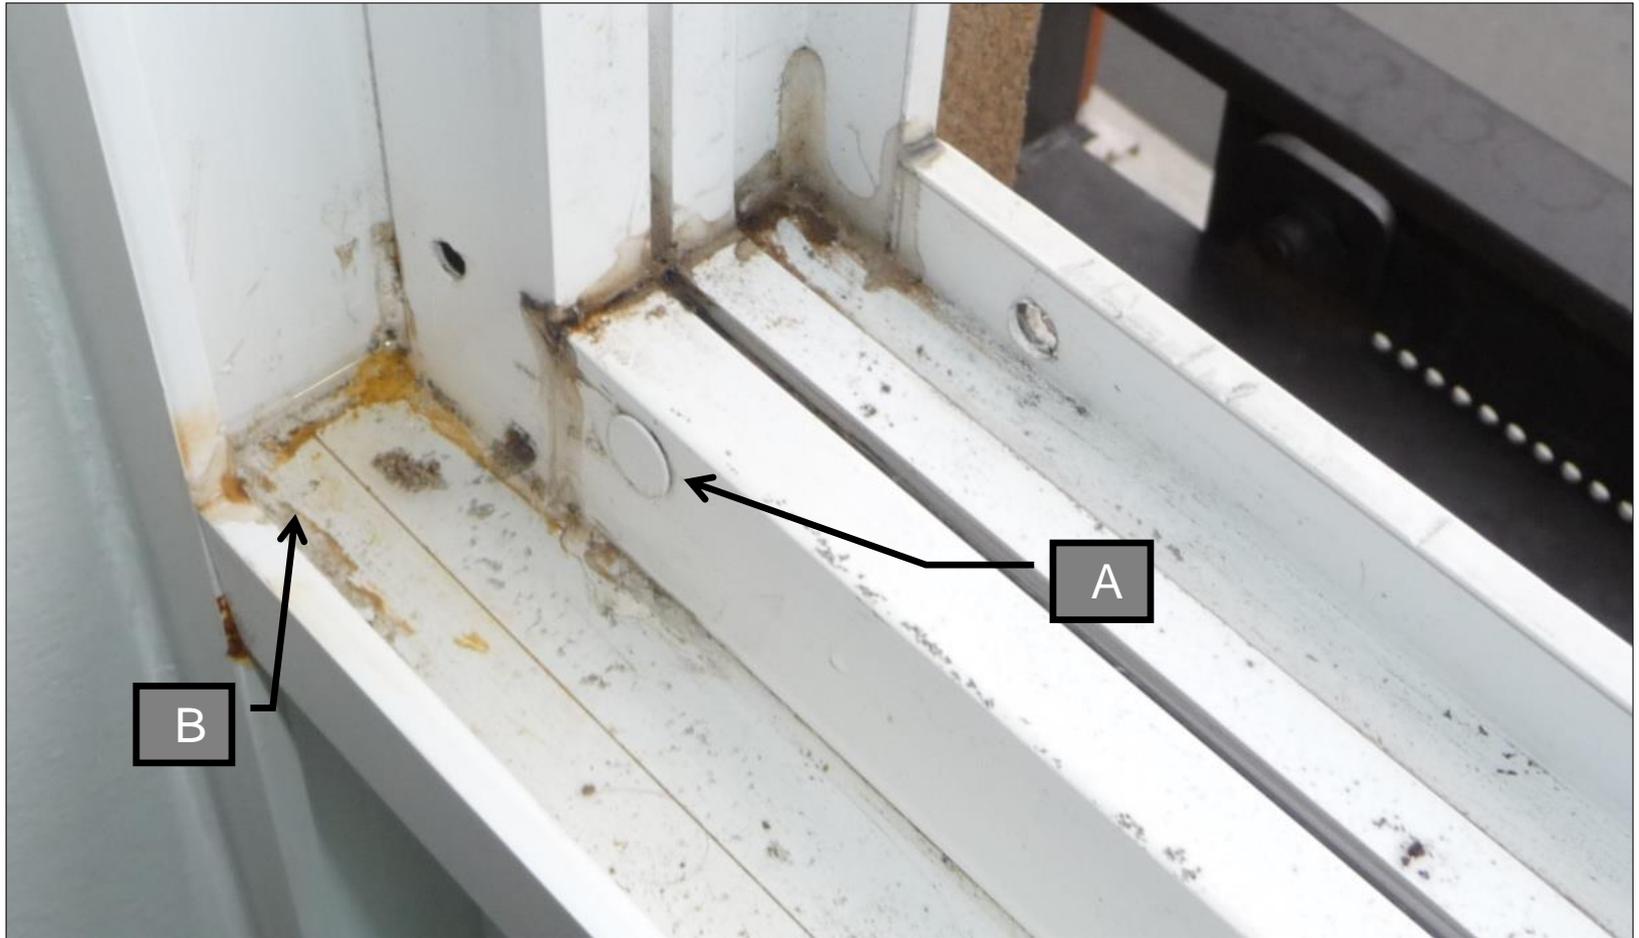
# Coped Joint (Horizontal to Vertical) Failure

A = Manufacturer attempted to seal leak by pumping foam at coped joint

B = Clear silicone sealant, failed attempt to seal coped joint

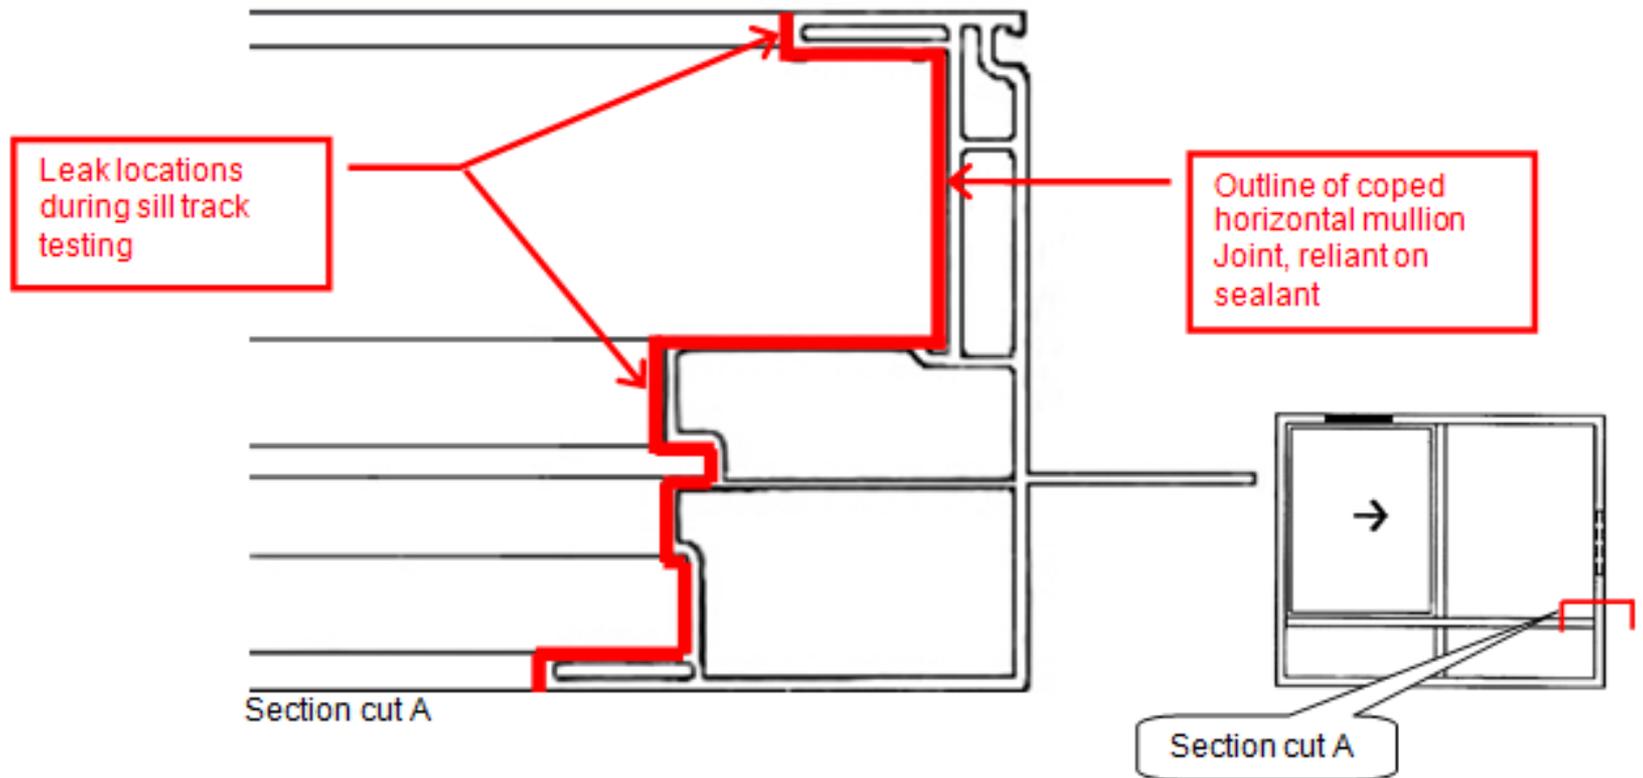
# Coped Joint At Intermediate Horizontal Mullion

- The sealant-dependent coped joint in the horizontal mullion has failed and allows water to leak through this junction and accumulate in the lower fixed “dry” sill track, which is not designed to manage water

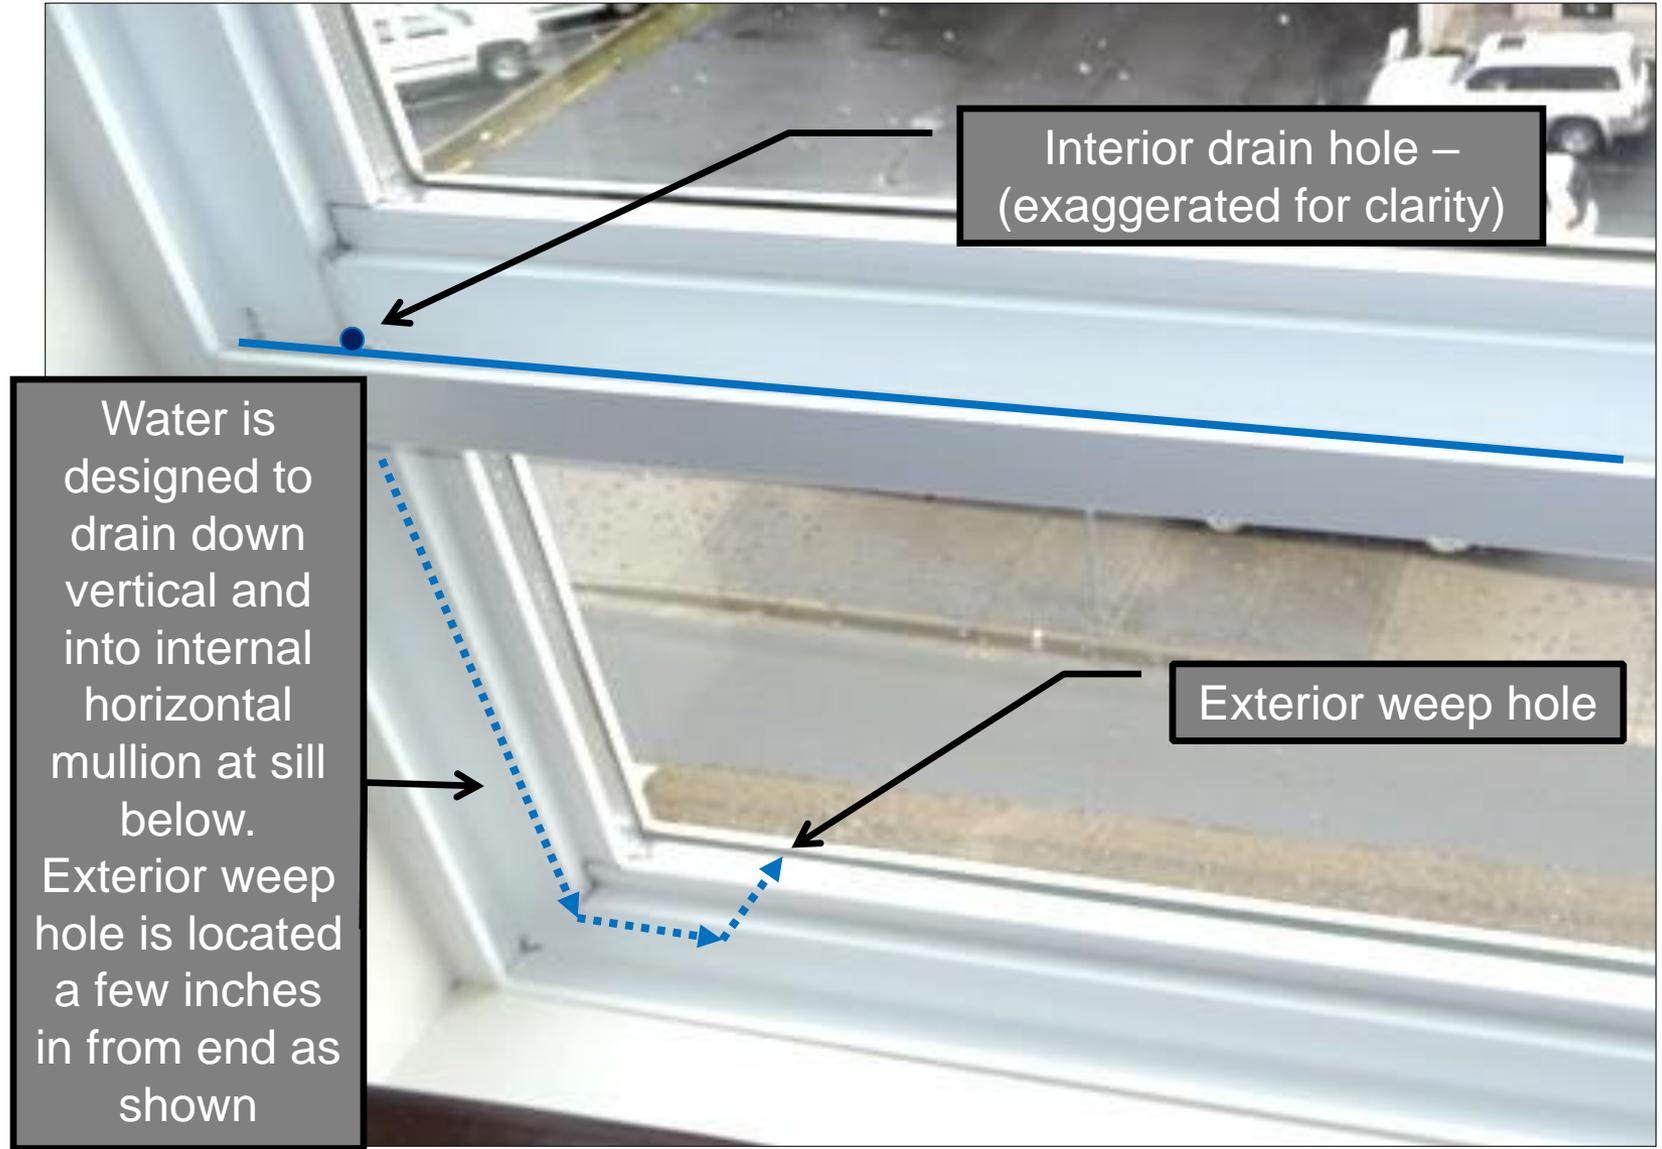
# Drainage Pathway Analyzed

Water is designed to drain down vertical and into internal horizontal mullion at sill below. Exterior weep hole is located a few inches in from end as shown

Interior drain hole –  
(exaggerated for clarity)

- **Windows were manufactured with improperly constructed weep holes and drainage pathway**
- **The weep holes were constructed with 5 mm (13/64") diameter hole which encourages surface tension and prevents proper drainage down the pathway**
- **According to the Glazing Association of North America, the minimum size of weep hole to prevent surface tension is 8 mm or 5/16"**

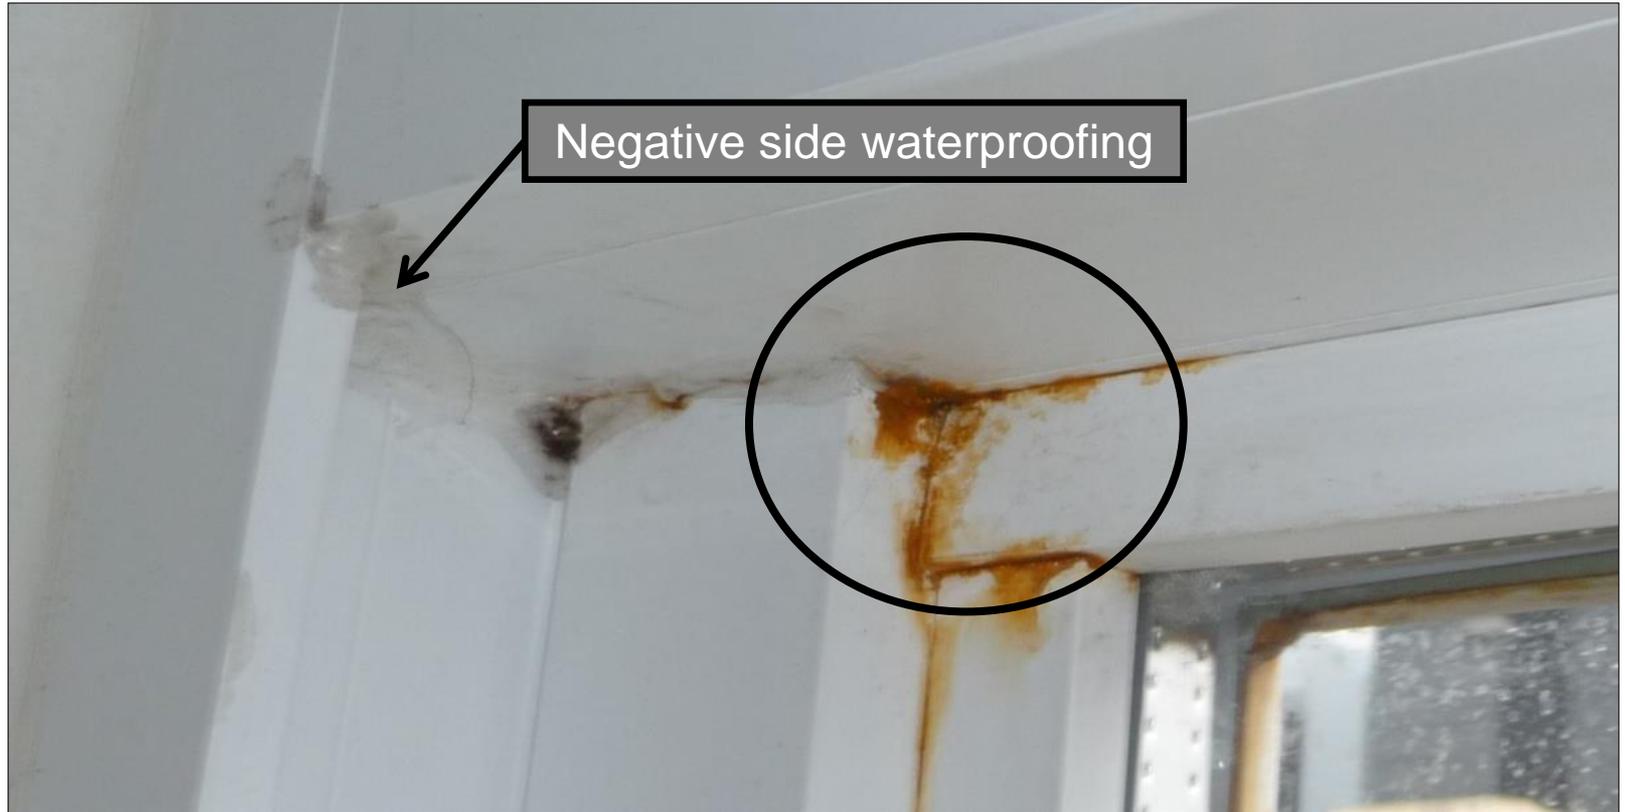
# Rust Stain at Coped Joint From Reinforcing

Sealant installed at underside of coped horizontal-to-vertical mullion joint failed to stop the leak. The leaks are rust staining from the structural steel reinforcement

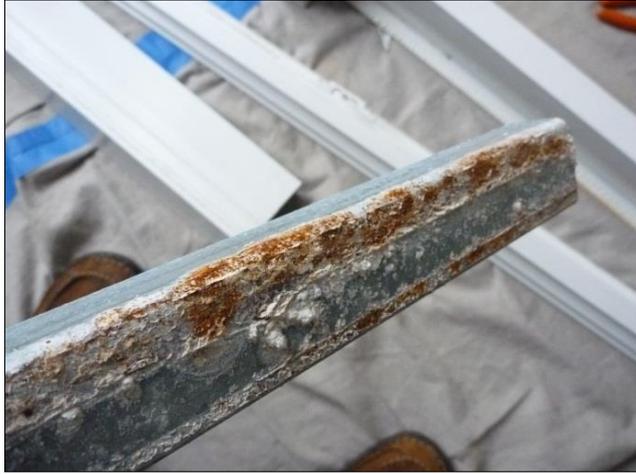
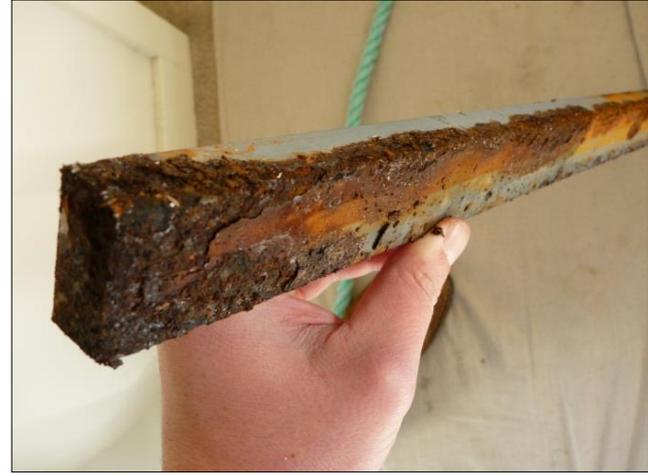
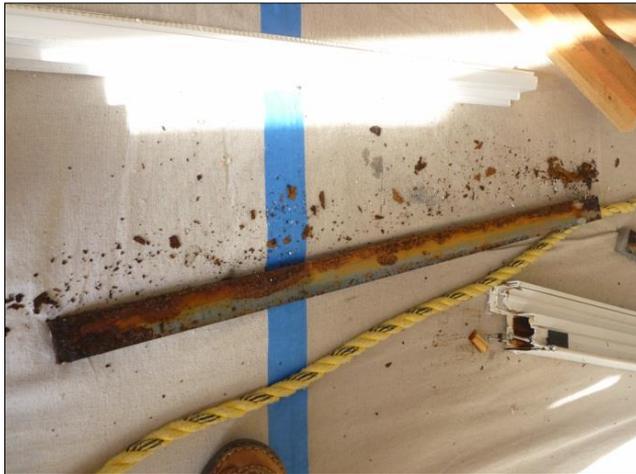
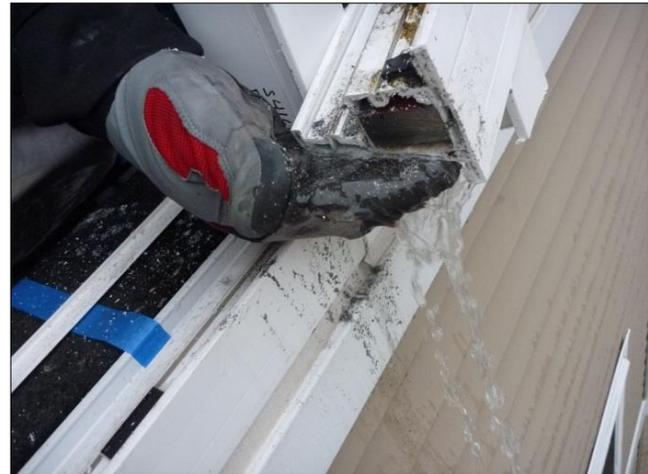
# Window Drainage and Weeping Issues

- Water traveling down weep pathway can rust the steel bar

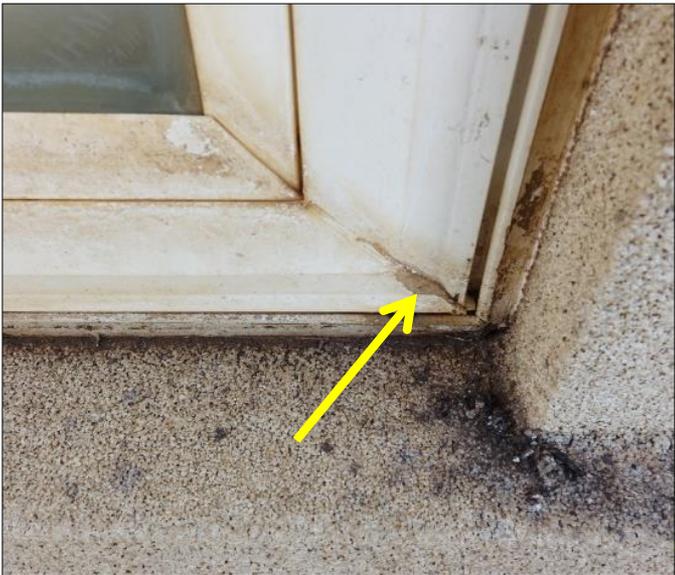
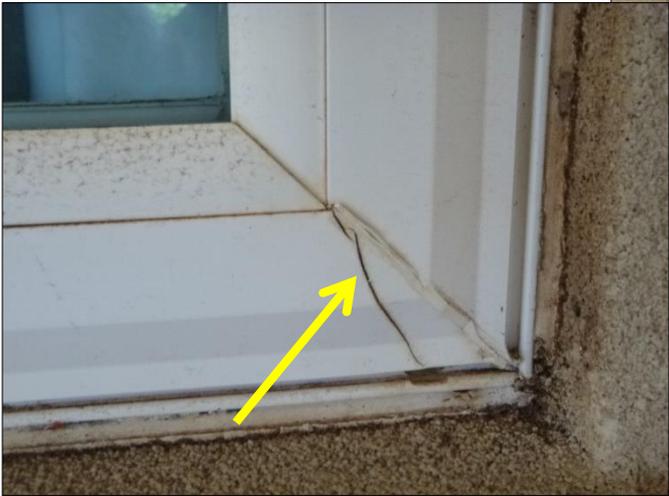
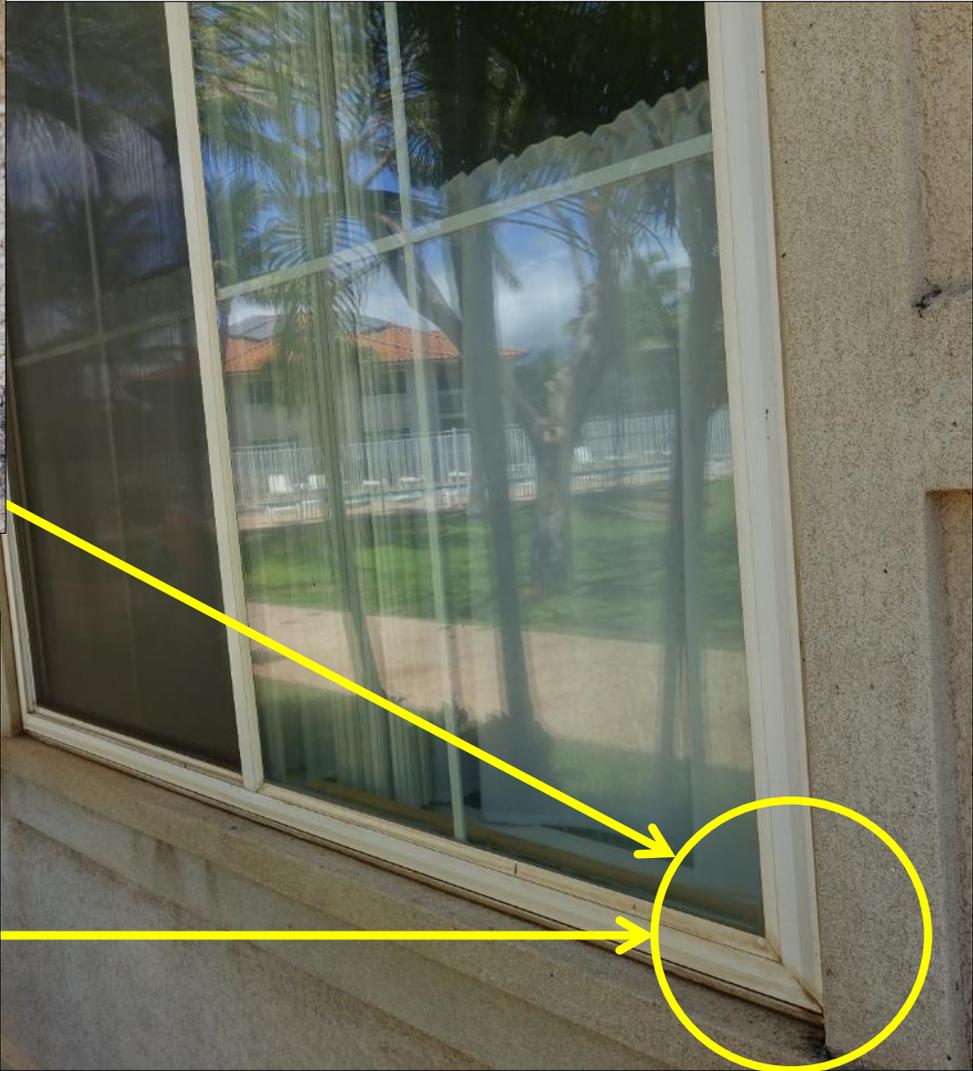
# Window Frame Corner Cracked and Leaking

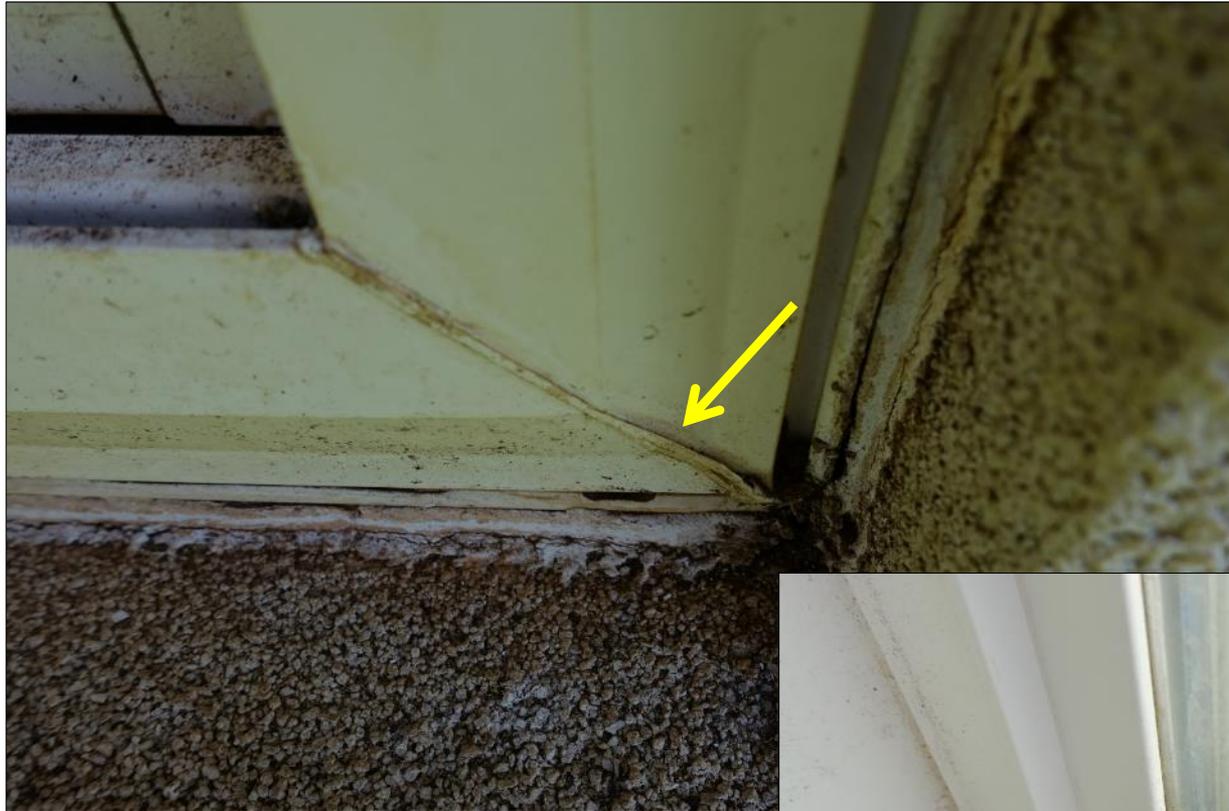
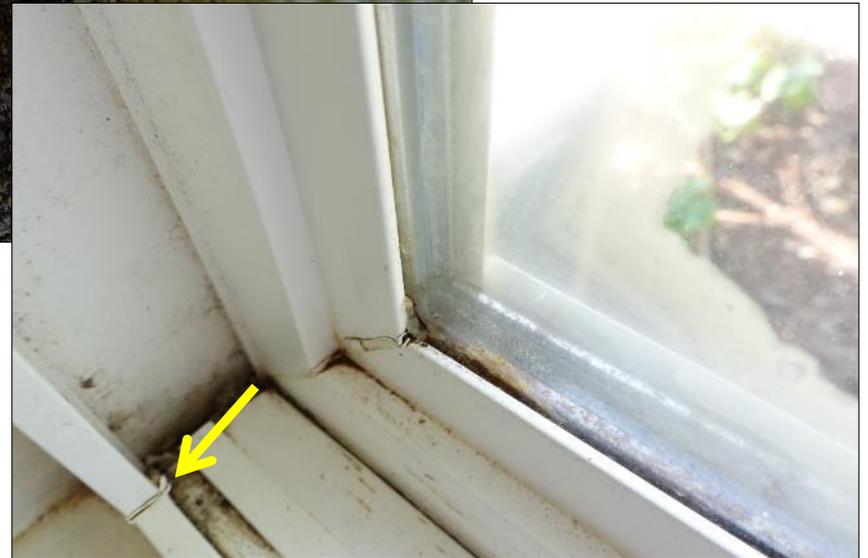
# Poor Quality PVC and Manufacturing

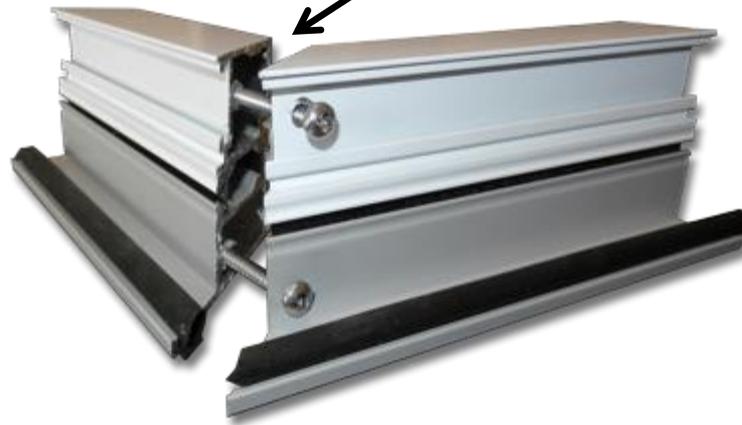
# Window Frame Corner Seals and Leaks

- **Aluminum Frame Corners are sealed in the factory before being screwed together. Applying sealant in place from the top doesn't work because of lack of proper geometry and profile**

Sealant is applied in the frame corner joint before the frames are screw splined together

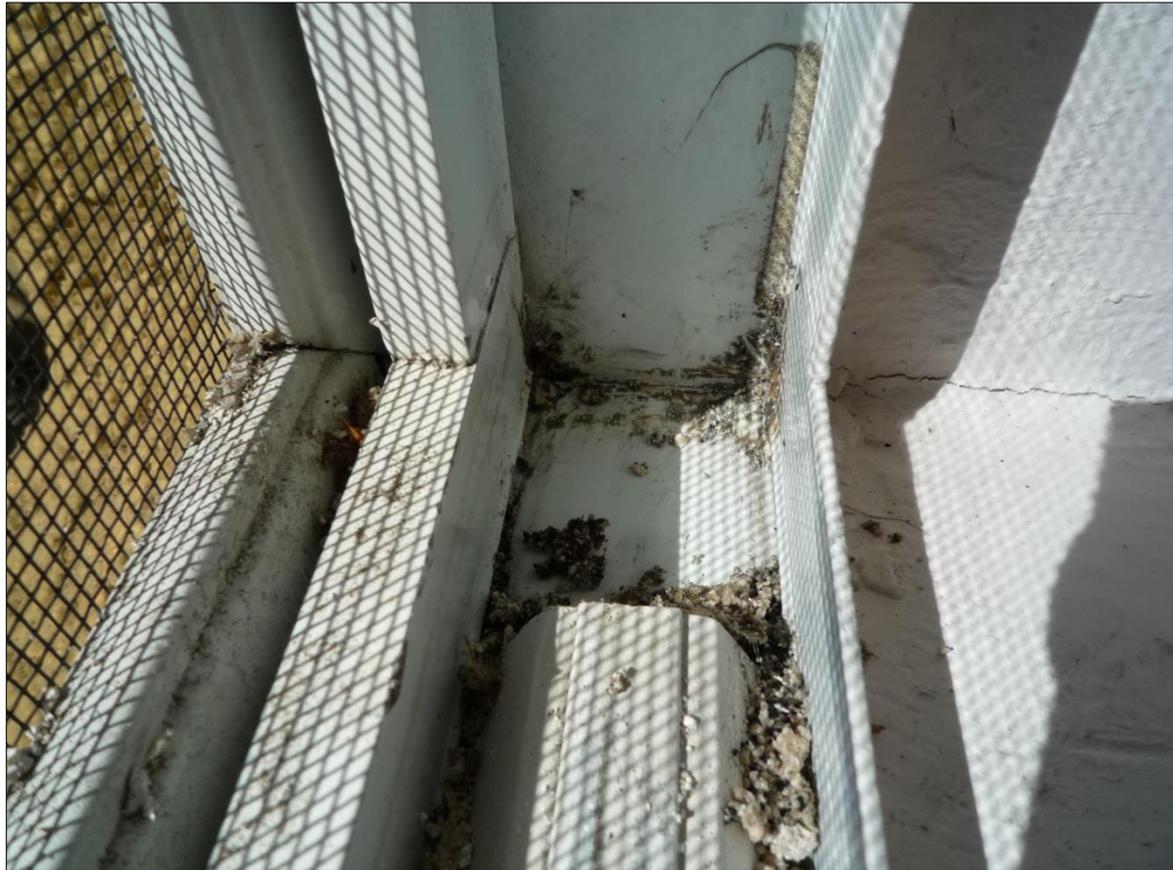
# Failed Corner Acrylic Sealants, Exposed to UV

According to recent laboratory testing, the acrylic sealants are inherently not designed for the window frames and can revert to a tacky state due to chemical degradation. These sealants are not recommended where water immersion will occur

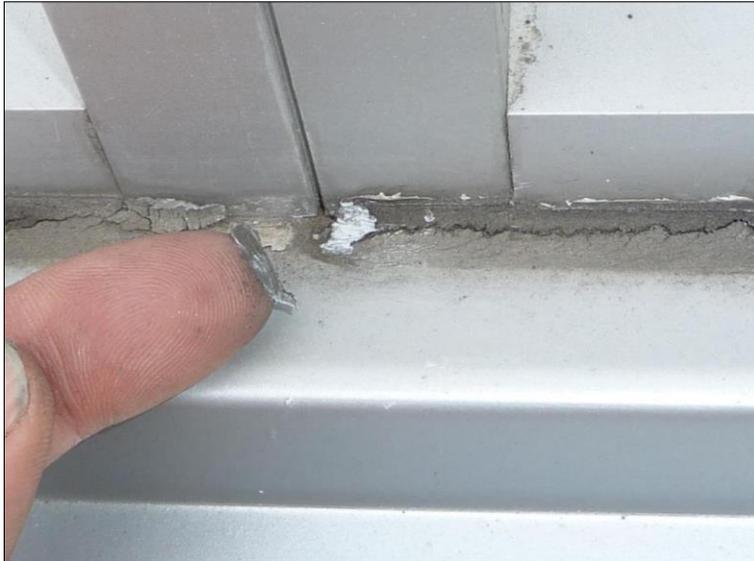
Polyurethane sealant  
prematurely failing after 7 years

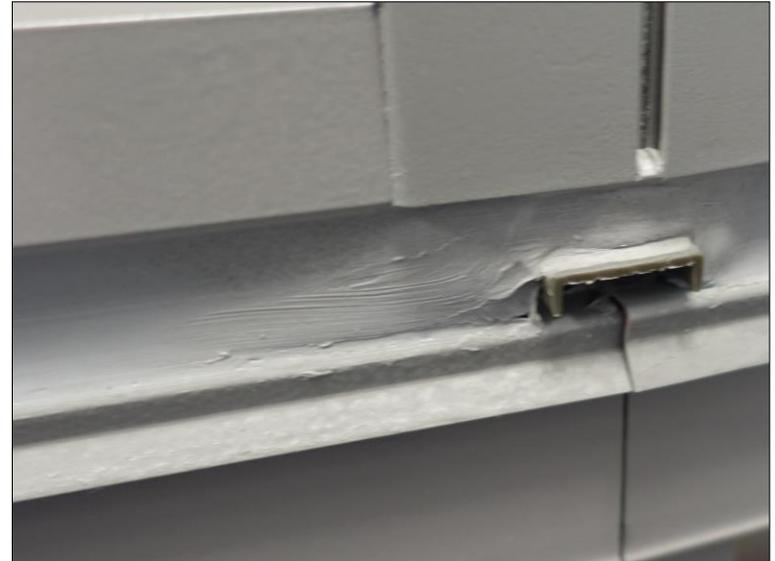
Silicone sealant can last up to 40  
years, only slightly more  
expensive

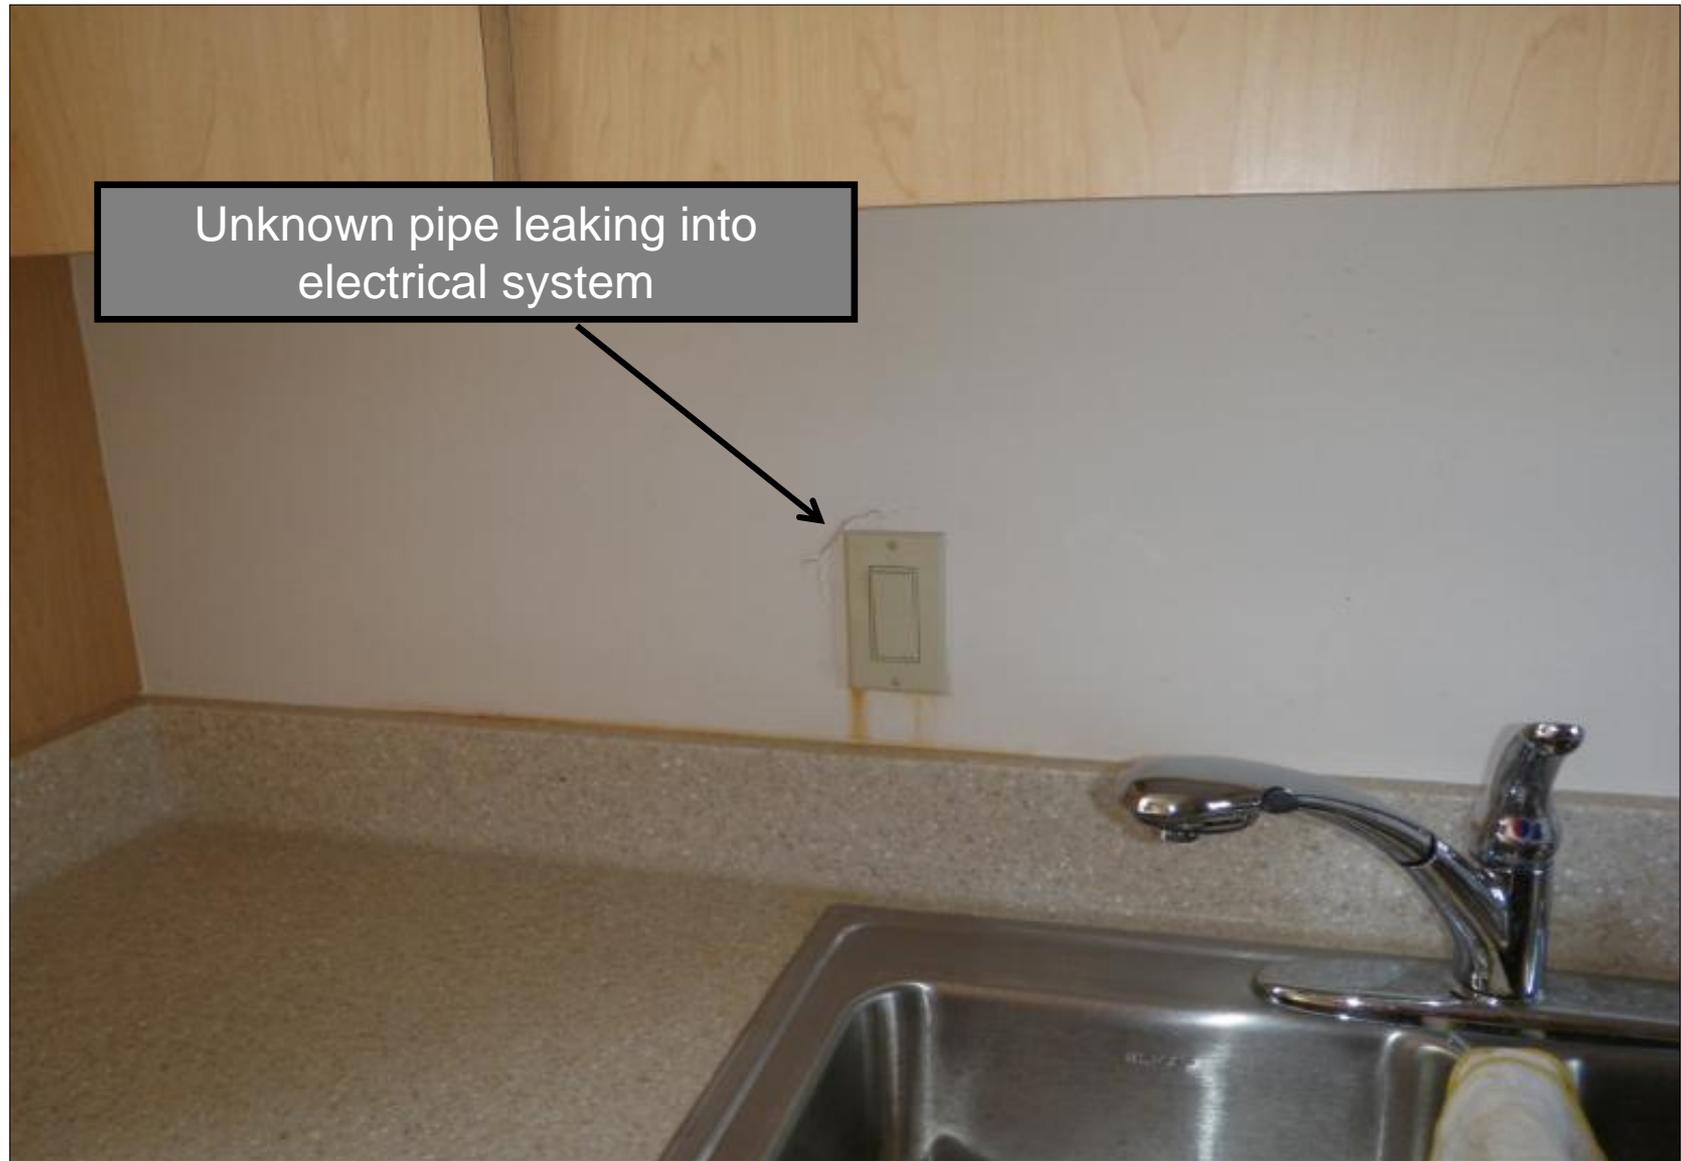
# Is this a Plumbing or Electrical Problem?

Unknown pipe leaking into electrical system

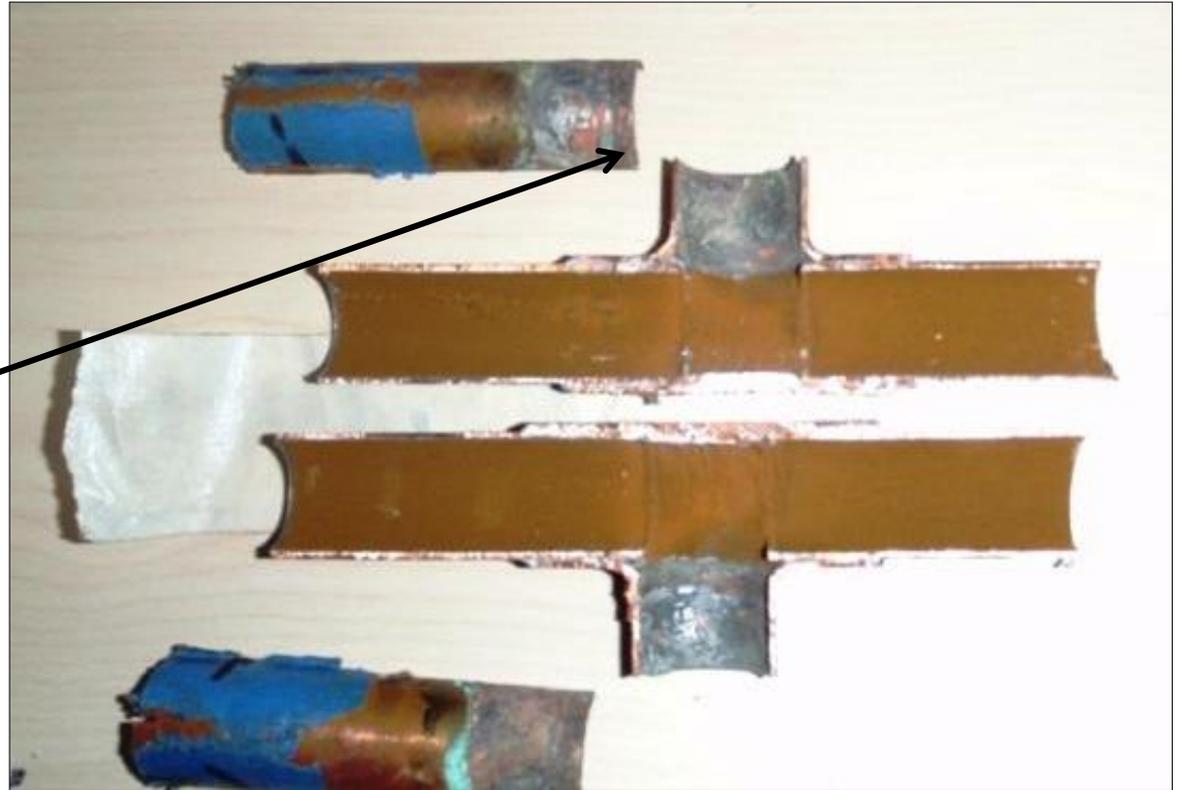
# Poor Workmanship

Solder joints in 40 year old 1/2" copper pipe – fell apart at joints due to poor soldering.

Copper Pipe at 35 Years

- **Use only contractors with solid reputation**
  - Significantly low bids can be a cause for concern.
  - Unable to furnish a performance bond can be a cause for concern.
- **Specify hydrostatic pressure test of piping systems**
- **On copper systems require chlorination and certificates of lab testing**
- **Require construction oversight by consultant**

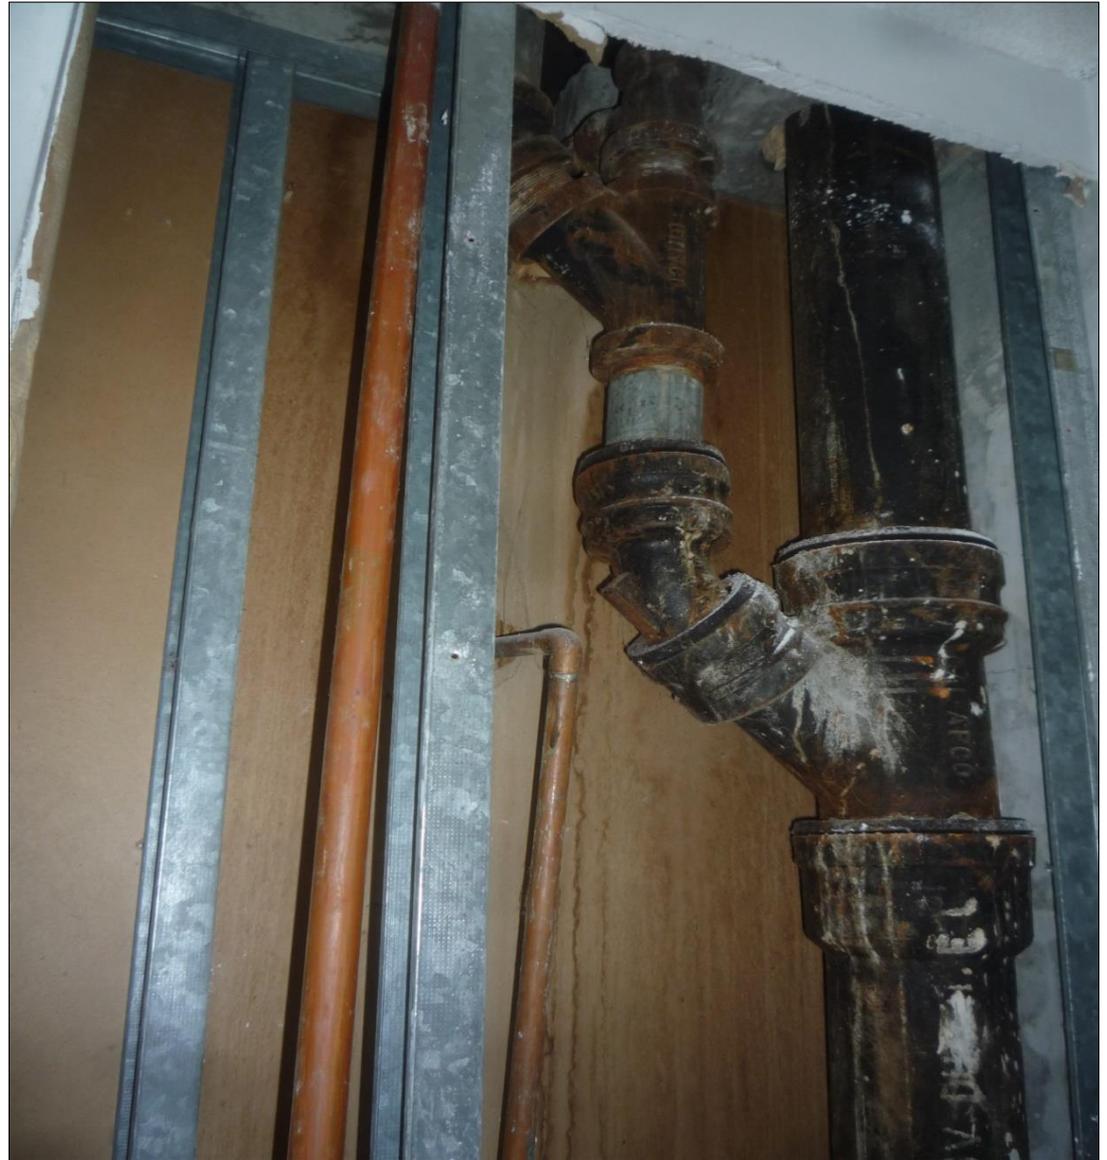
# Aged Coupling Failure

**Pipes and Gaskets  
at 35 years**

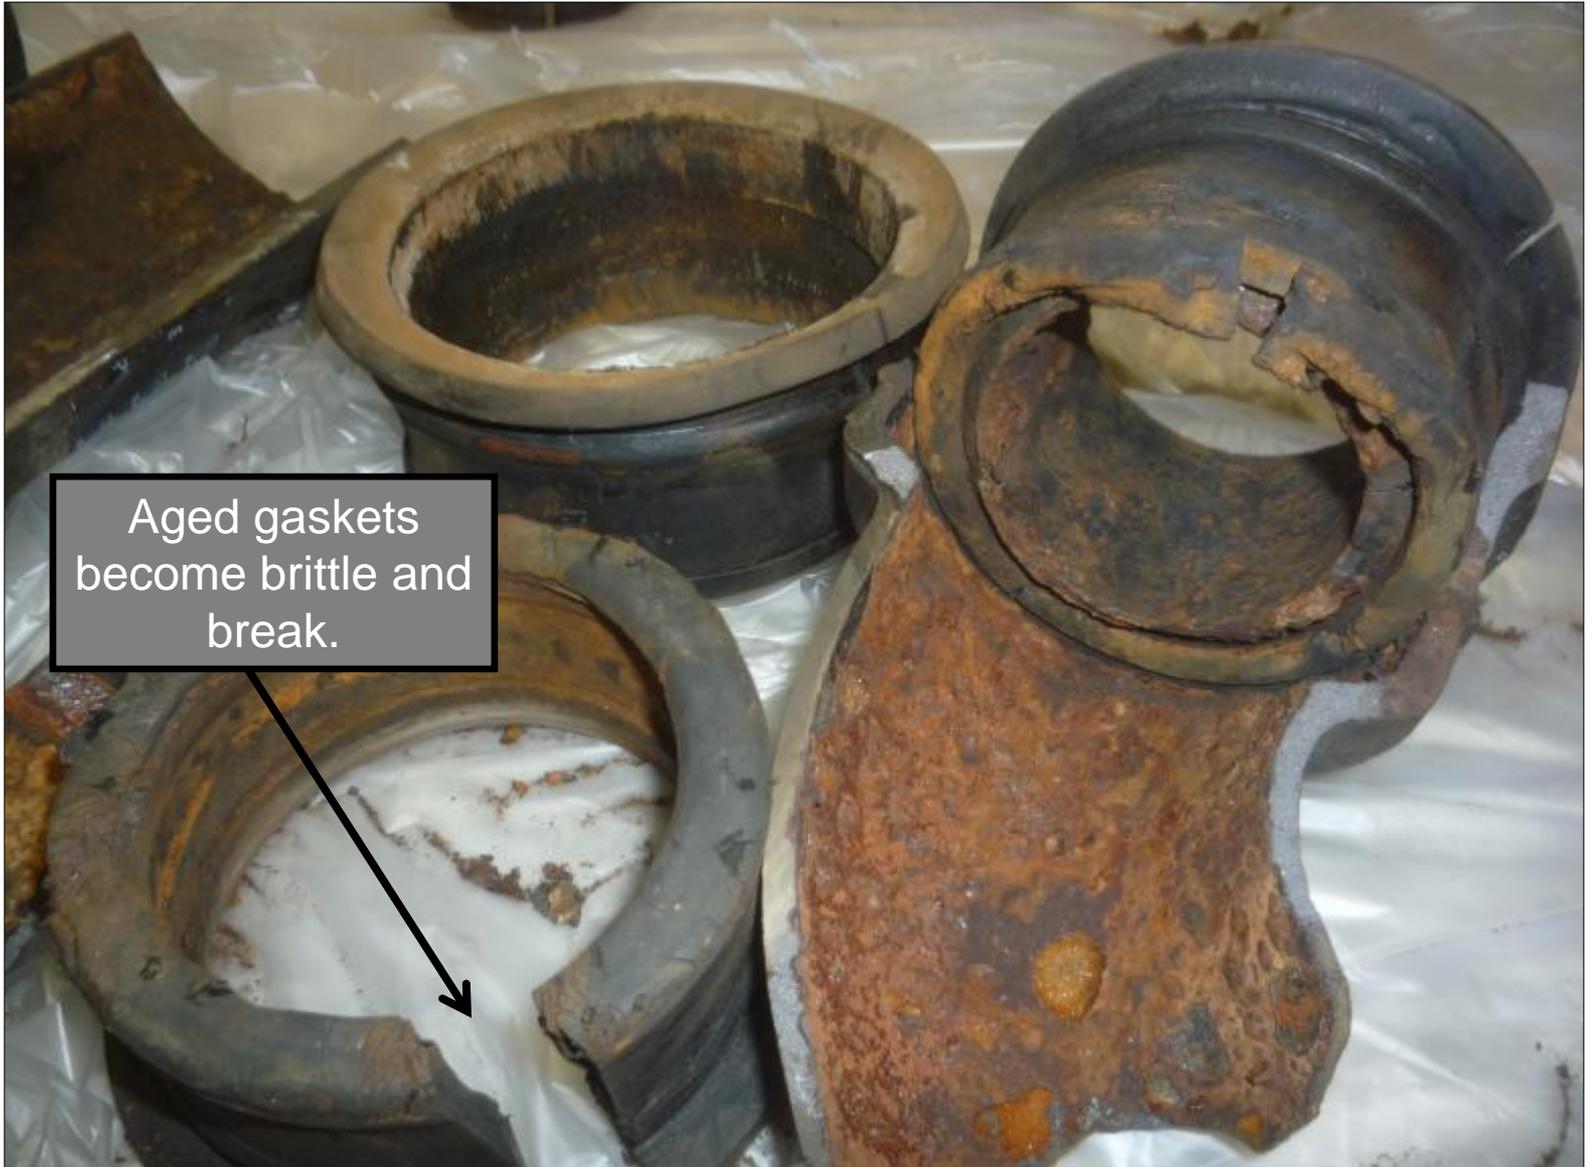
# Gasket Material Failure Due To Age

Aged gaskets  
become brittle and  
break.

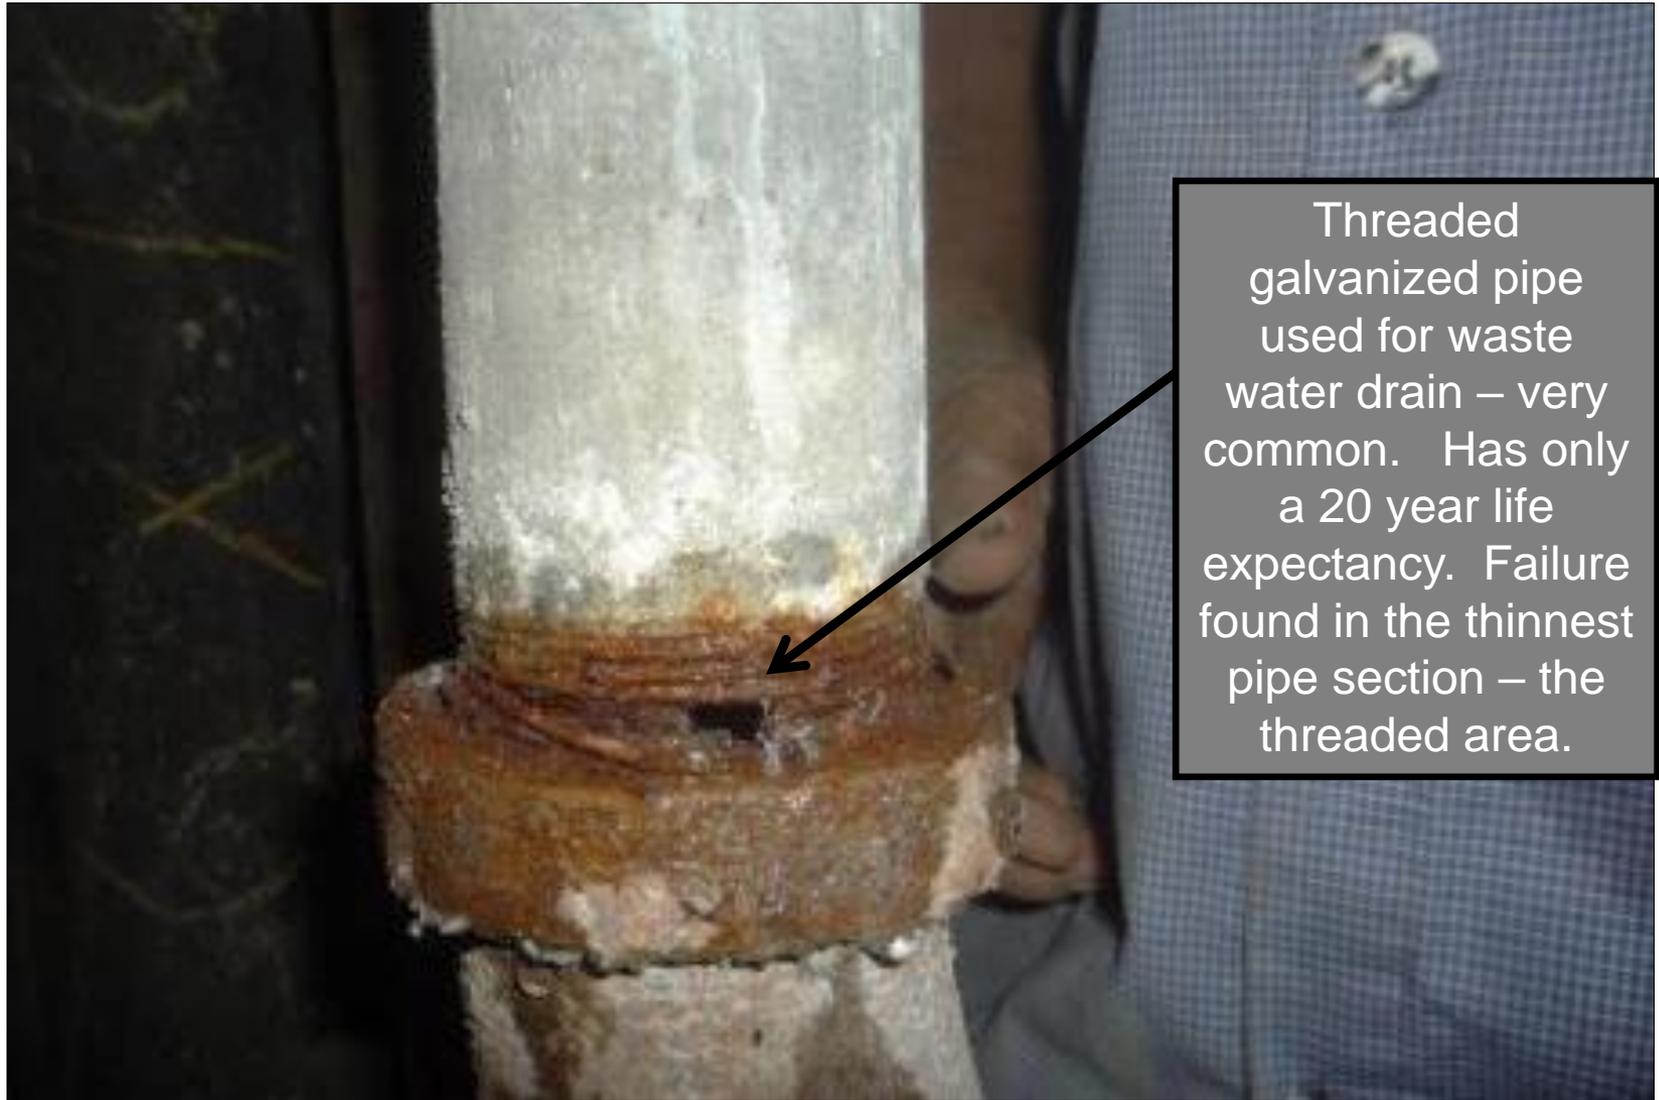
# Galvanized Pipes Last 20 Years in Hawaii

Threaded galvanized pipe used for waste water drain – very common. Has only a 20 year life expectancy. Failure found in the thinnest pipe section – the threaded area.

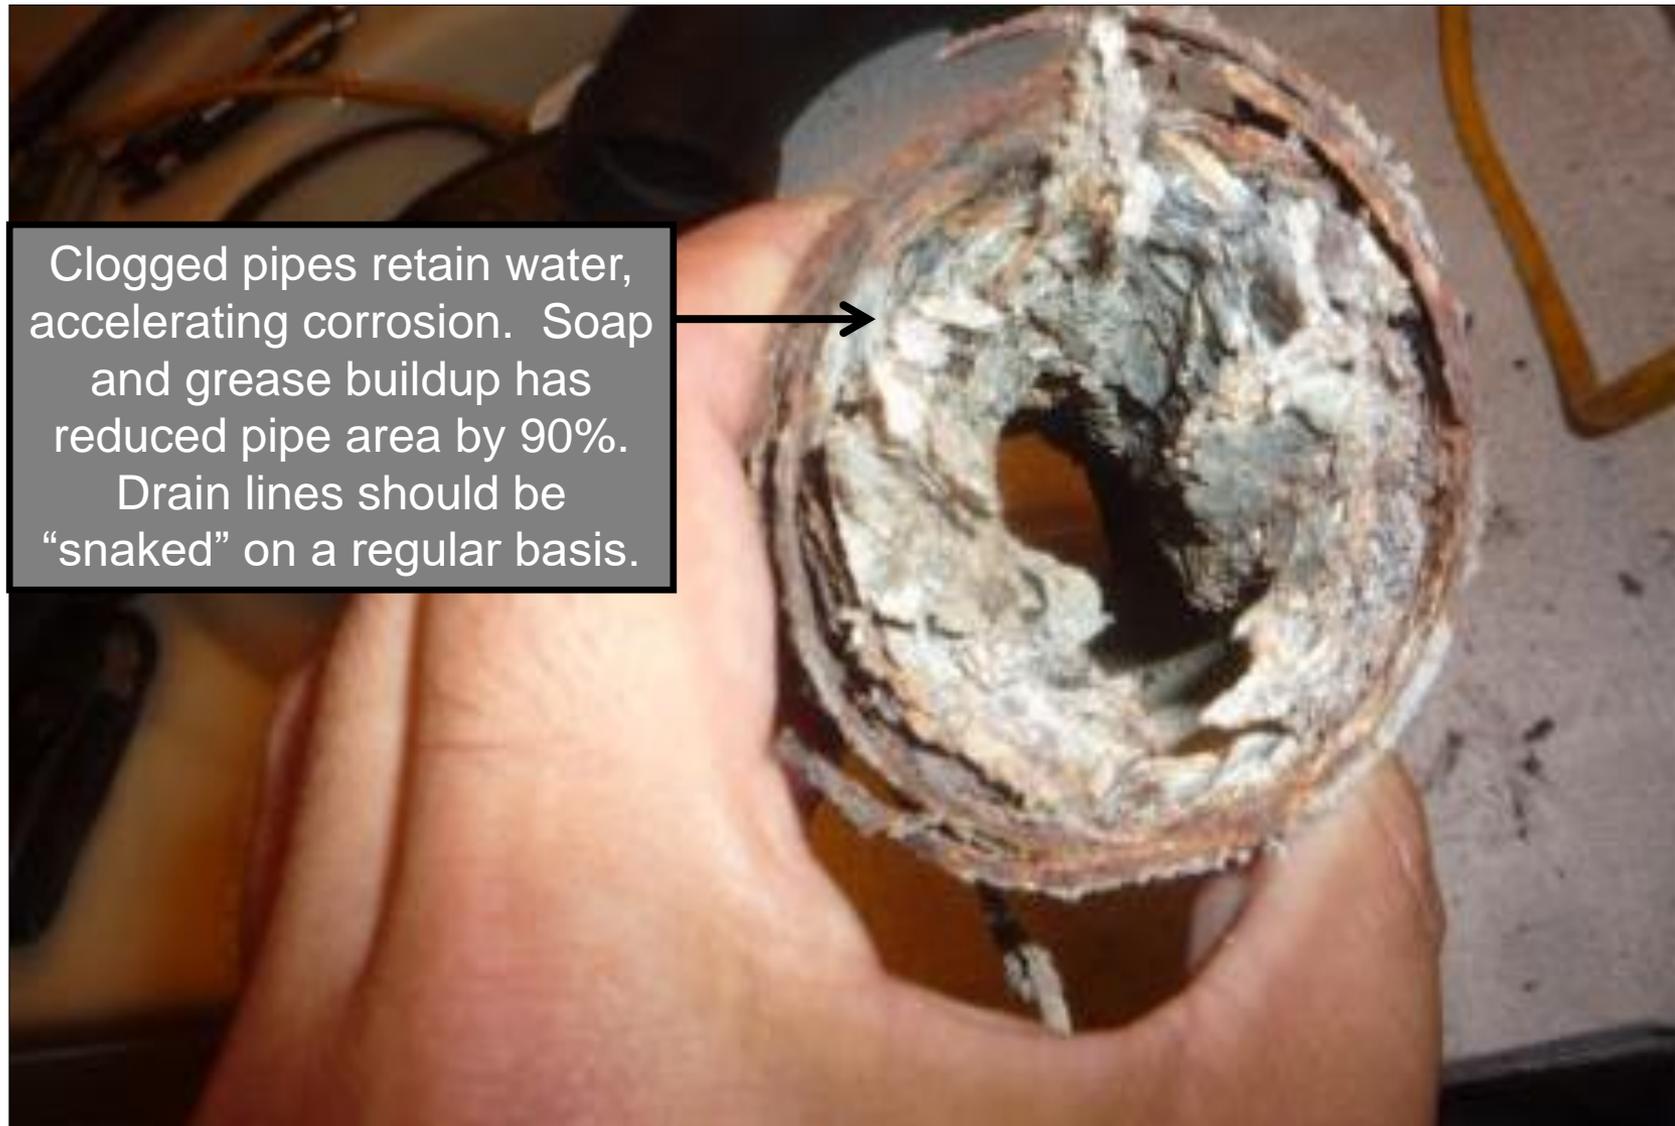
# Effects of Chemicals & Organic Compounds

Clogged pipes retain water, accelerating corrosion. Soap and grease buildup has reduced pipe area by 90%. Drain lines should be “snaked” on a regular basis.
