**ALLANA BUICK & BERS**

## **Life Expectancy and Longevity of Buildings and Assemblies**

Condo Council of Maui 2016 Seminar  
November 16, 2016

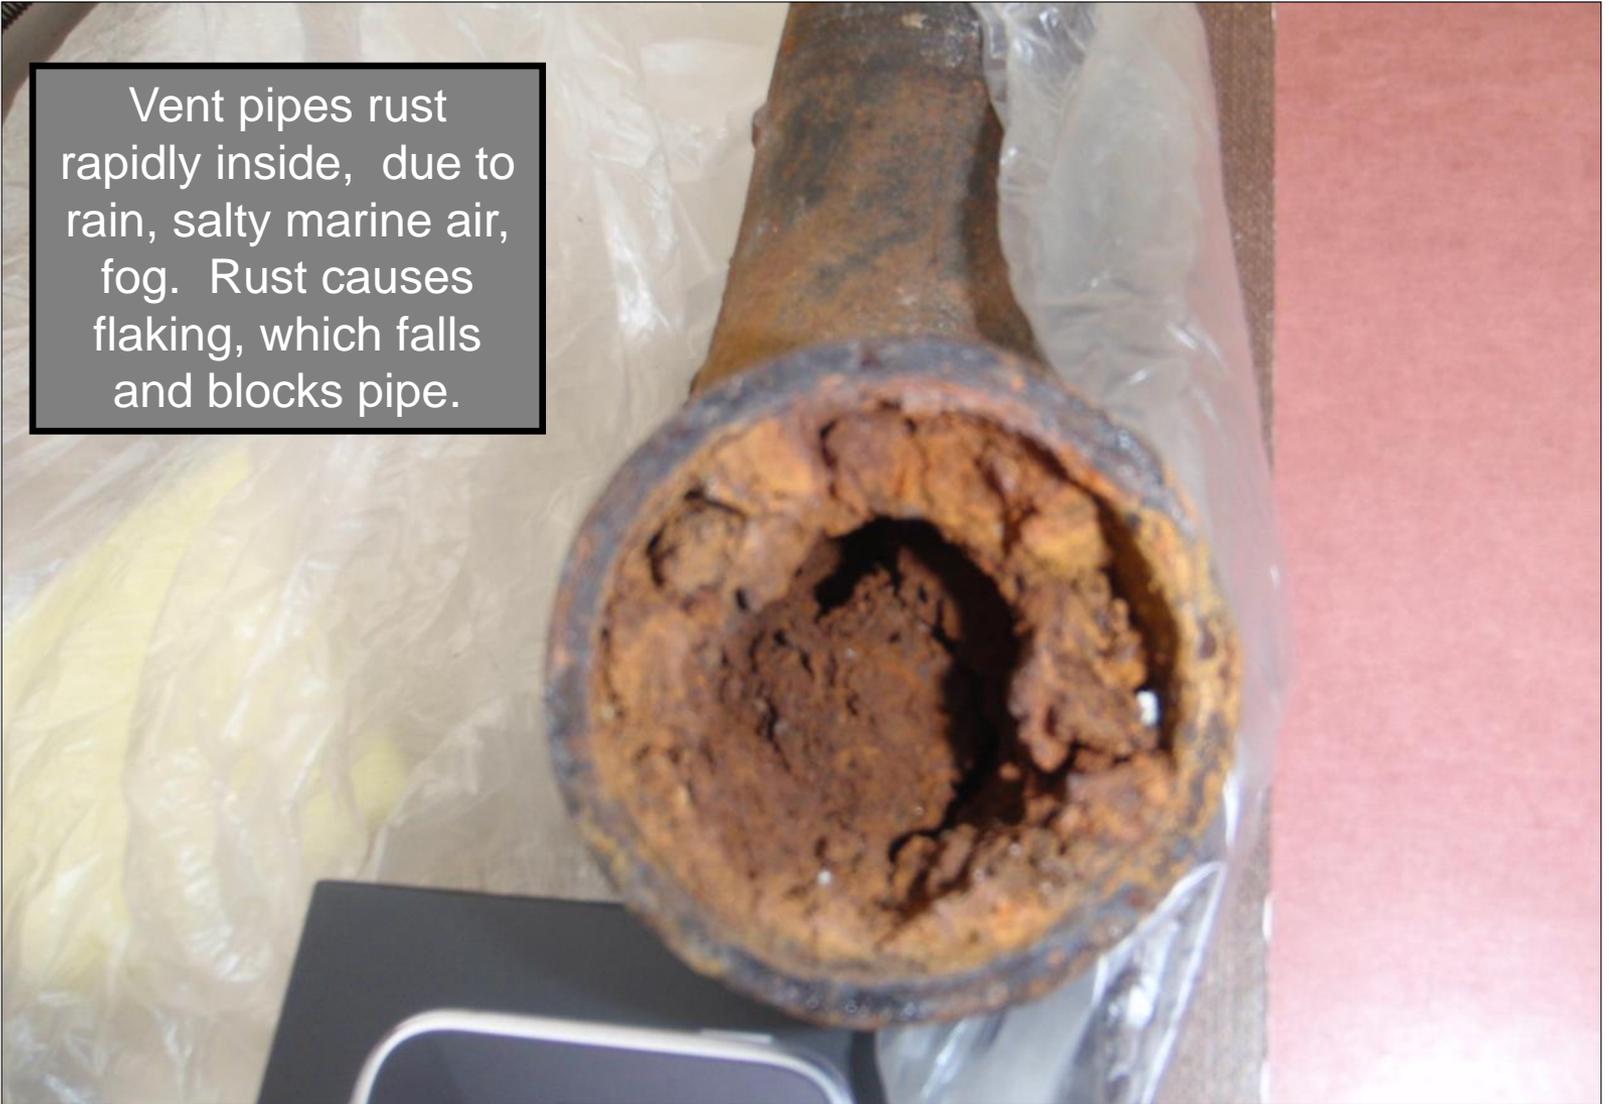
# Vent Pipe Failure Due to Rust

Vent pipes rust rapidly inside, due to rain, salty marine air, fog. Rust causes flaking, which falls and blocks pipe.

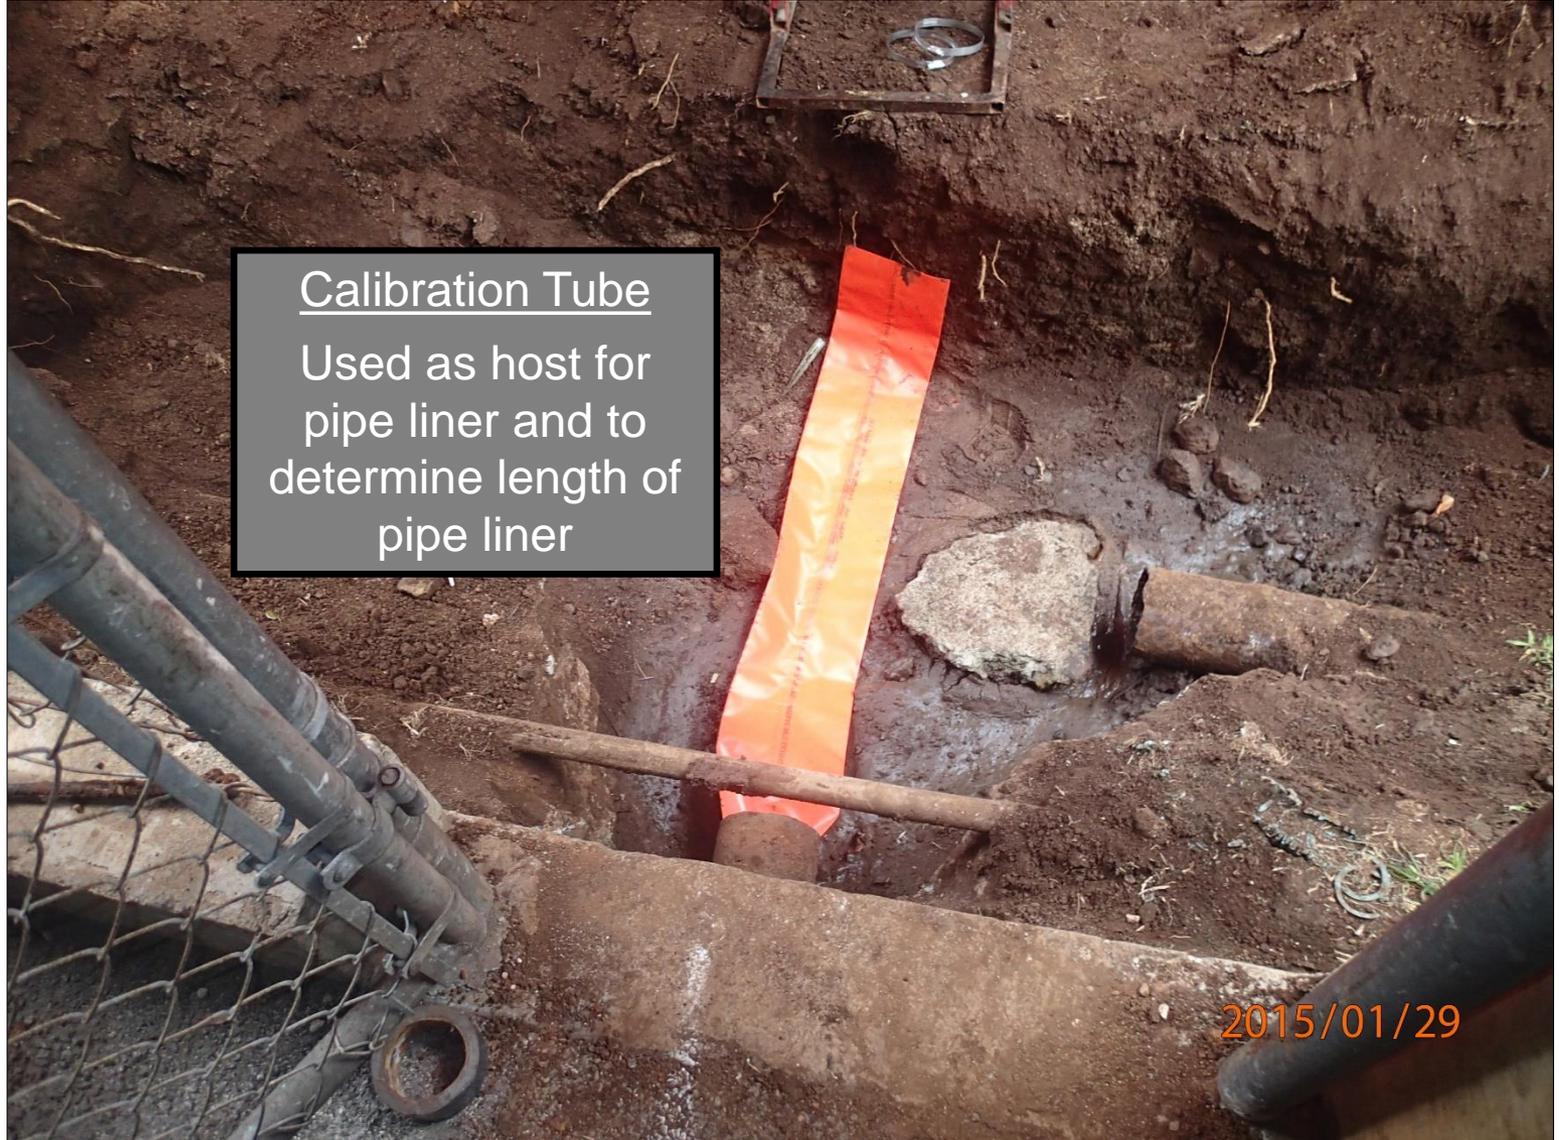
# Pipe Lining – Calibration Tube Inserted

Calibration Tube  
Used as host for  
pipe liner and to  
determine length of  
pipe liner

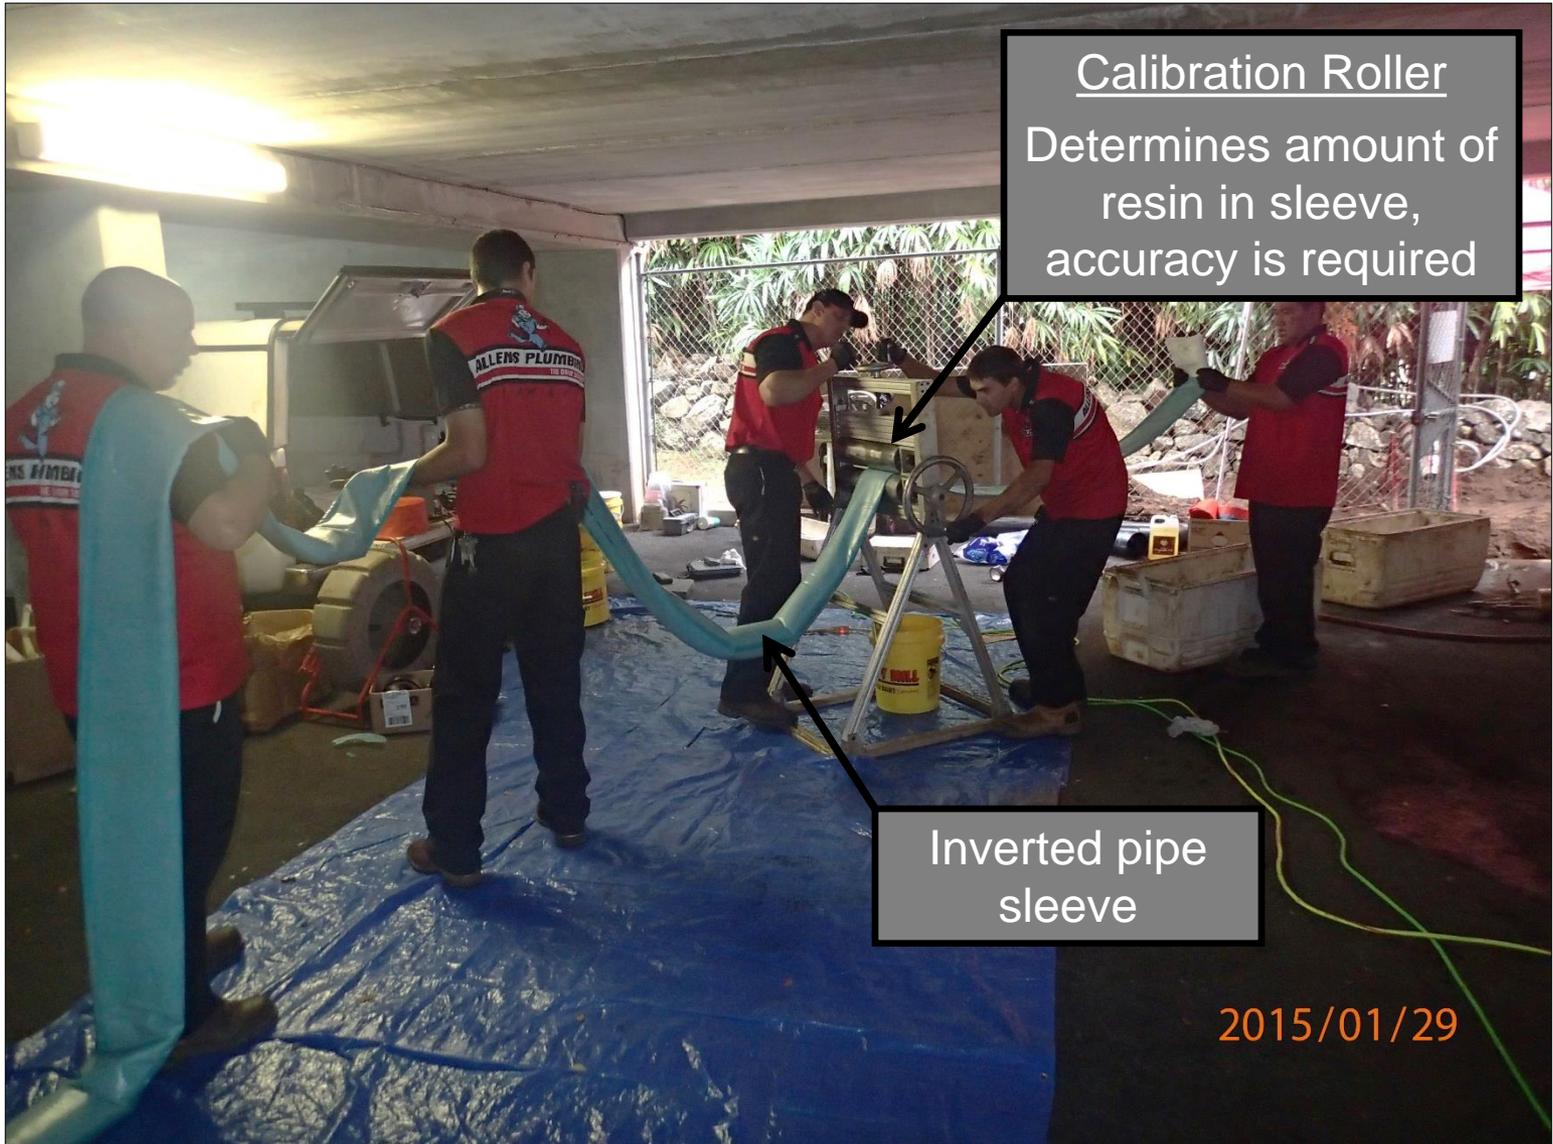
# Pipe Lining – Calibrating Resin Volume

Calibration Roller  
Determines amount of resin in sleeve, accuracy is required

Inverted pipe sleeve

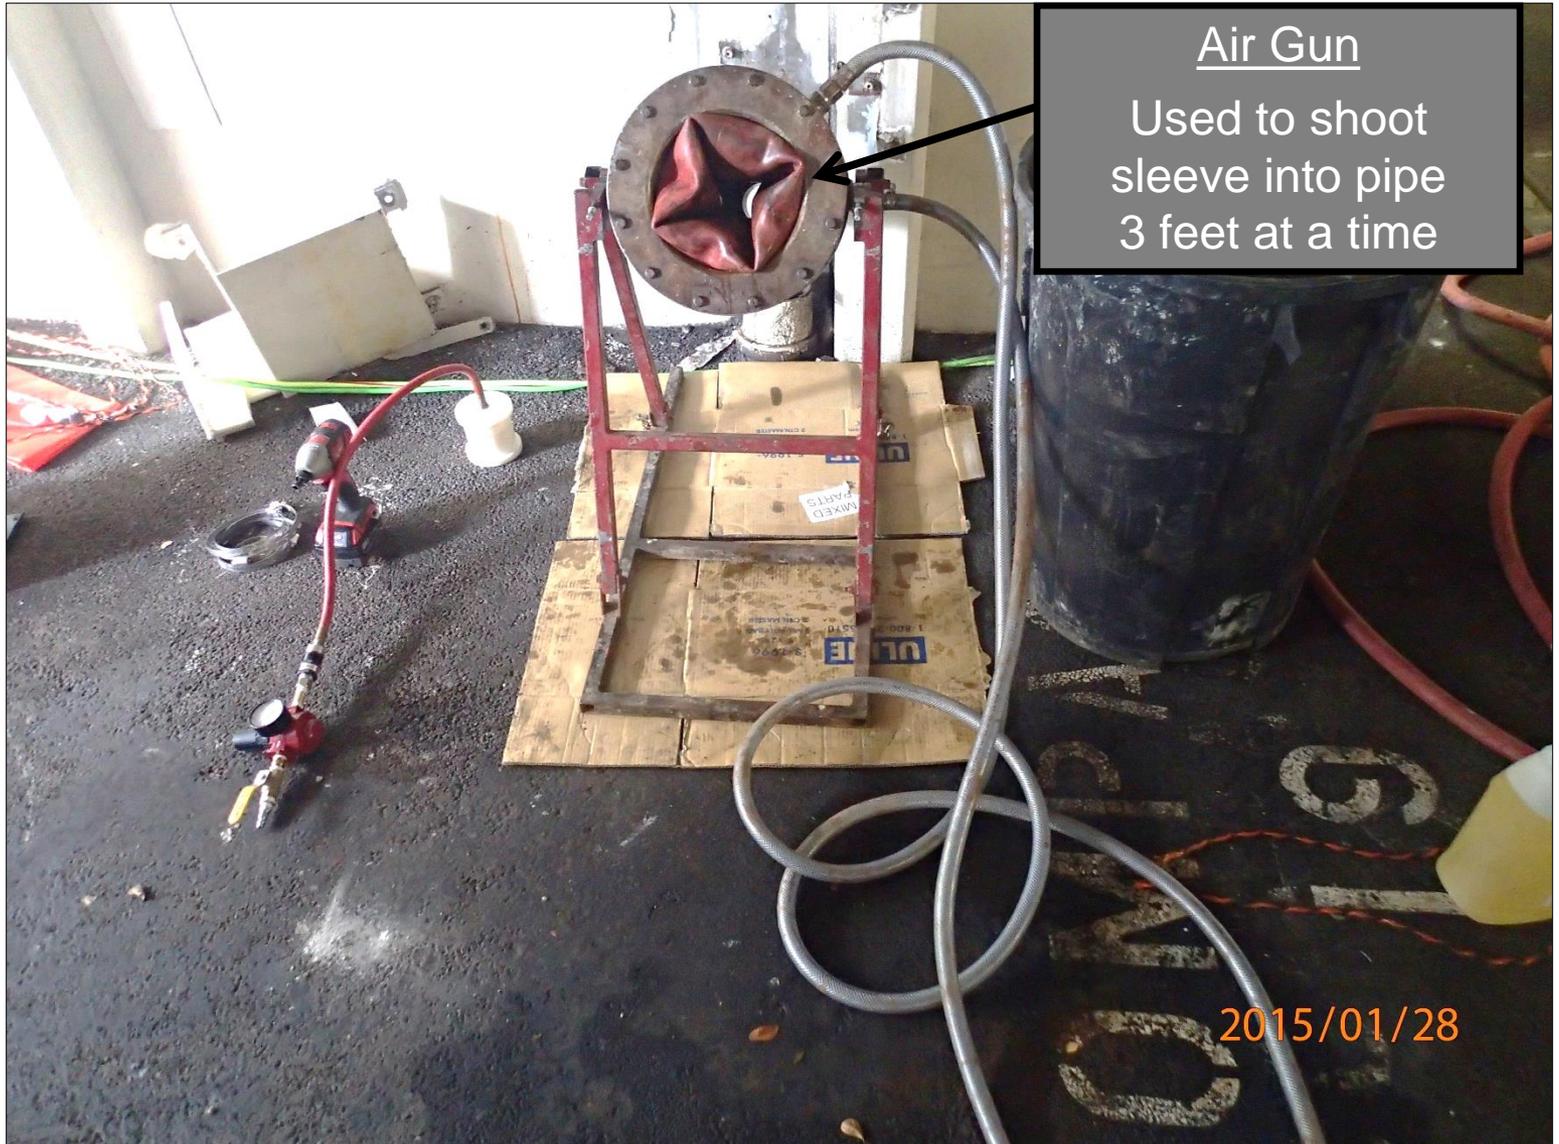
# Pipe Lining – Air Gun

Air Gun

Used to shoot sleeve into pipe  
3 feet at a time

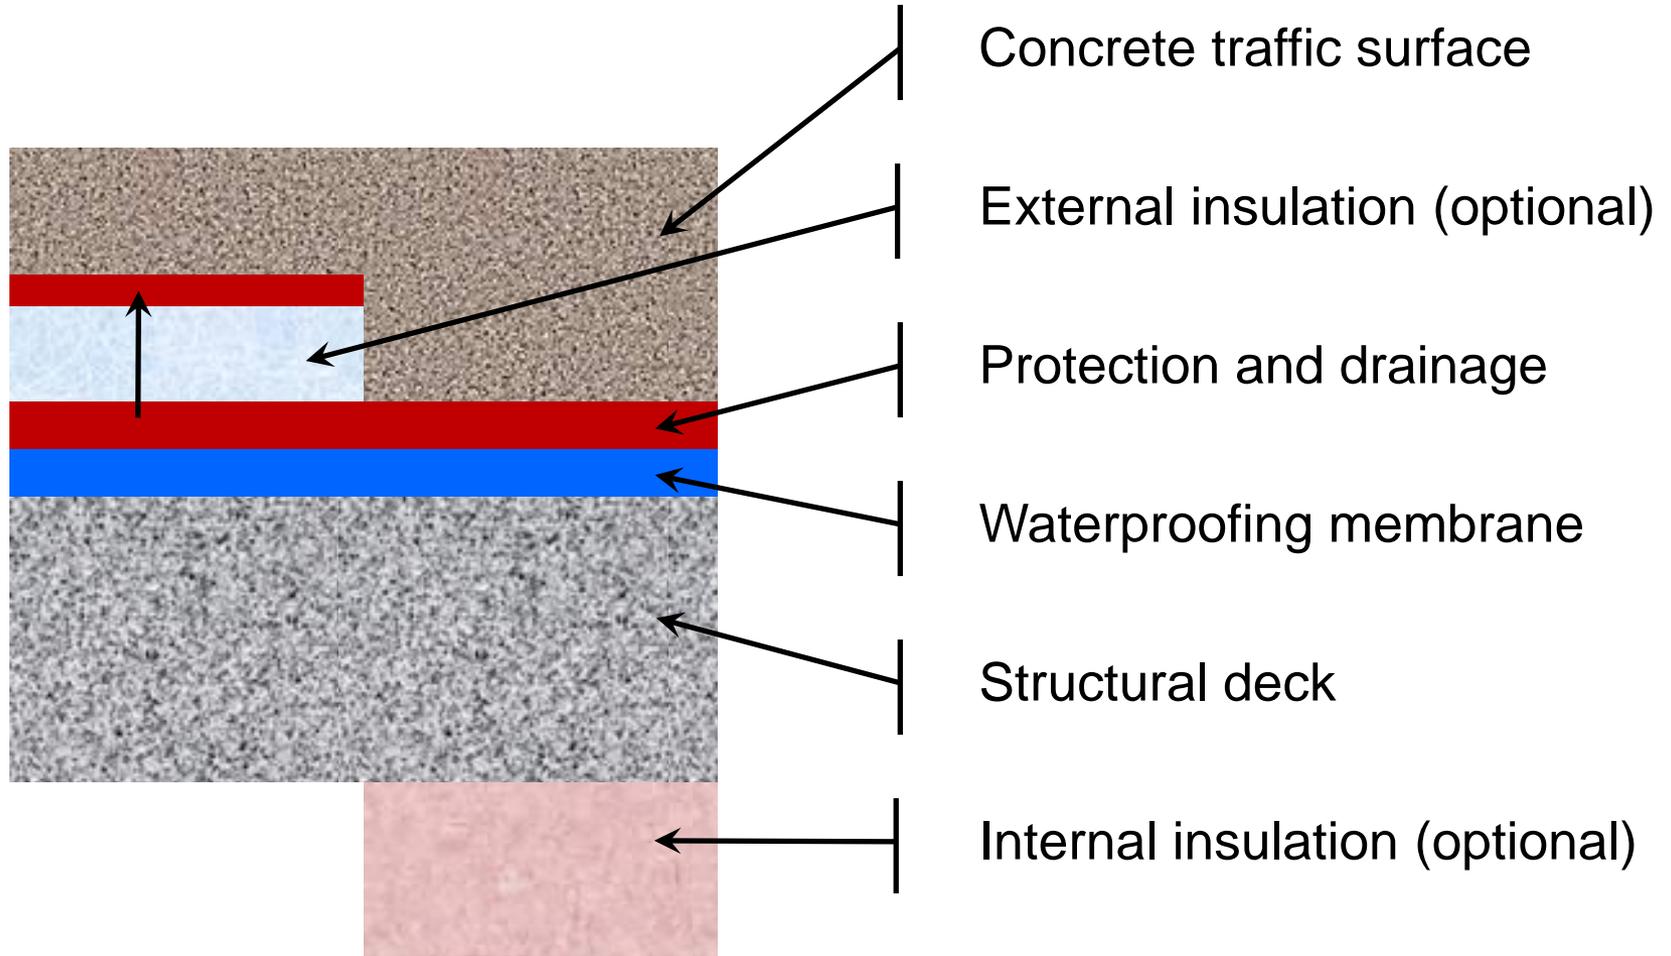
# Split Slab, Protects Waterproofing From UV & Traffic

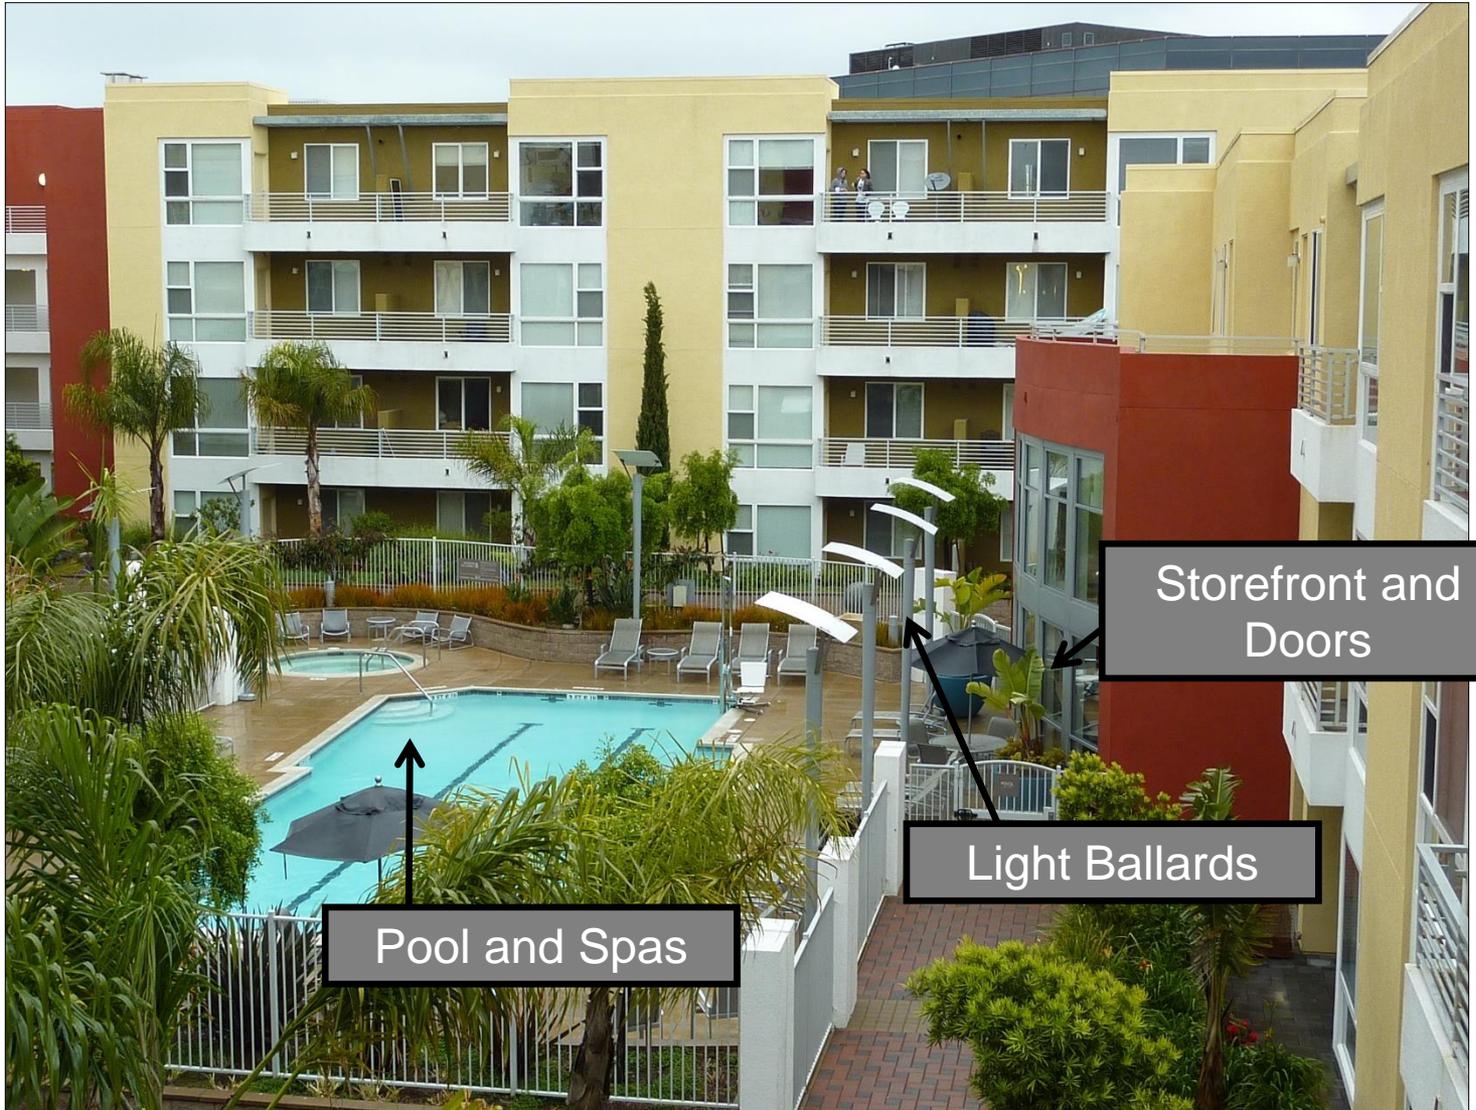
# Life Expectancies, Protected Assemblies

Life of the building – Typically 50+ years

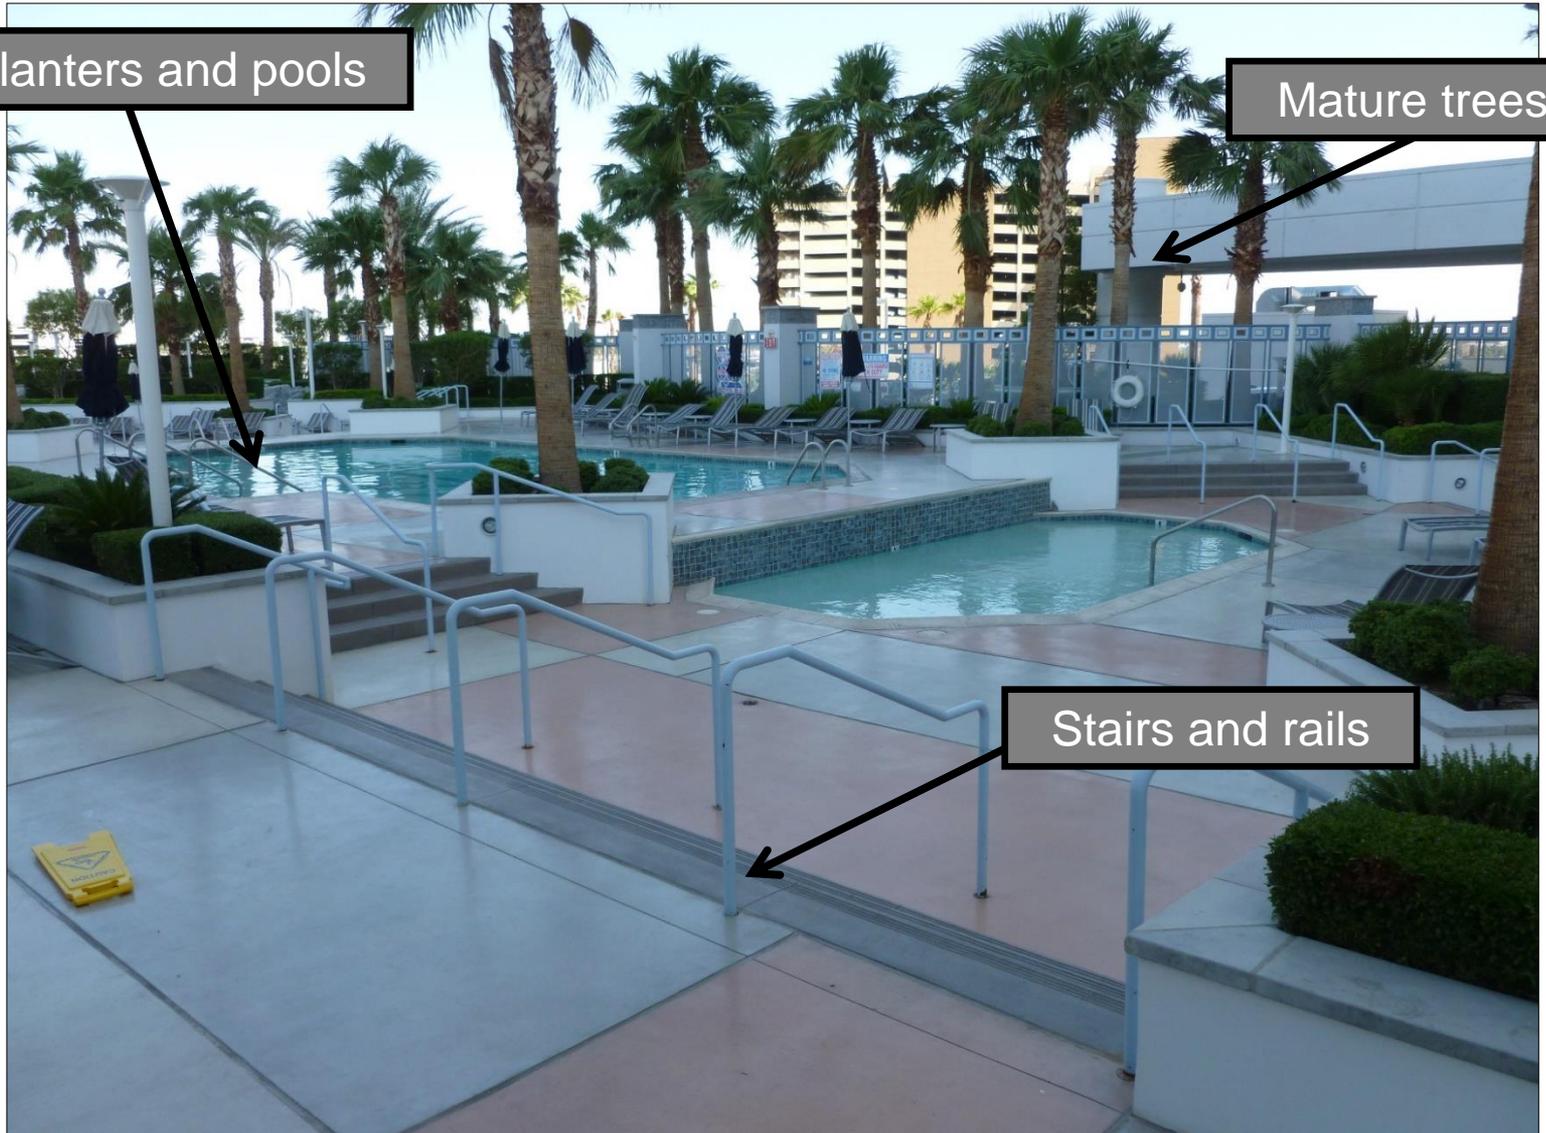
# Post Tensioned Concrete Pool Decks

Planters and pools

Mature trees

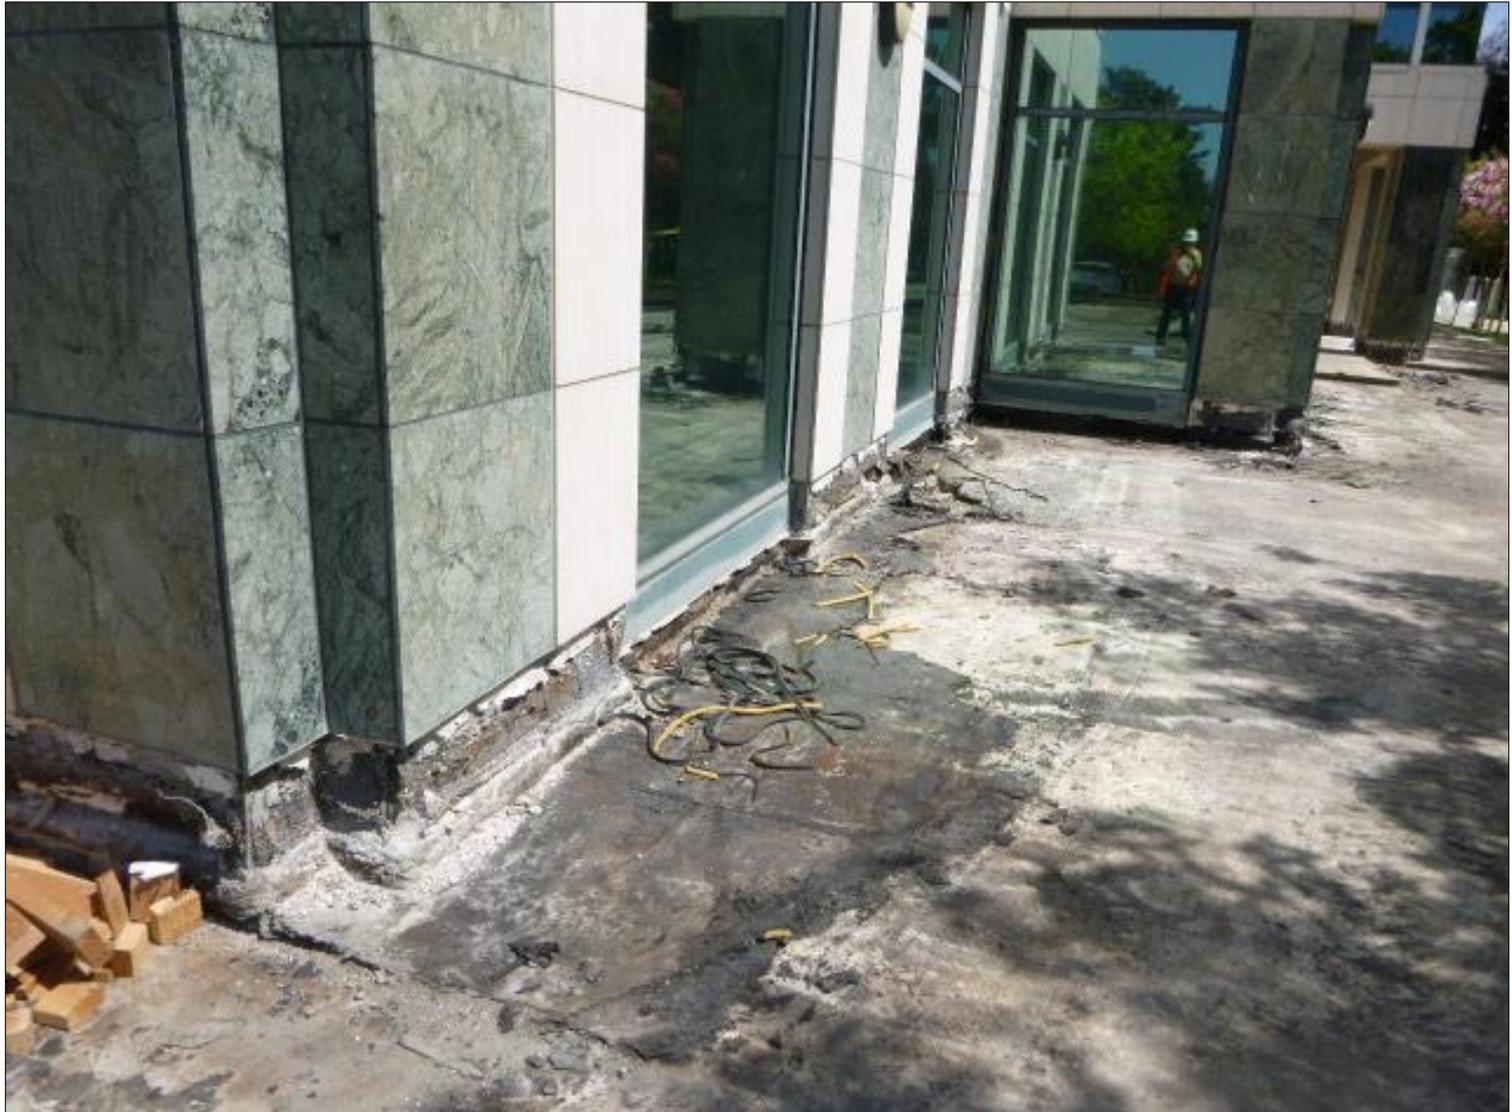
# Complexities and Repair Cost of Podiums

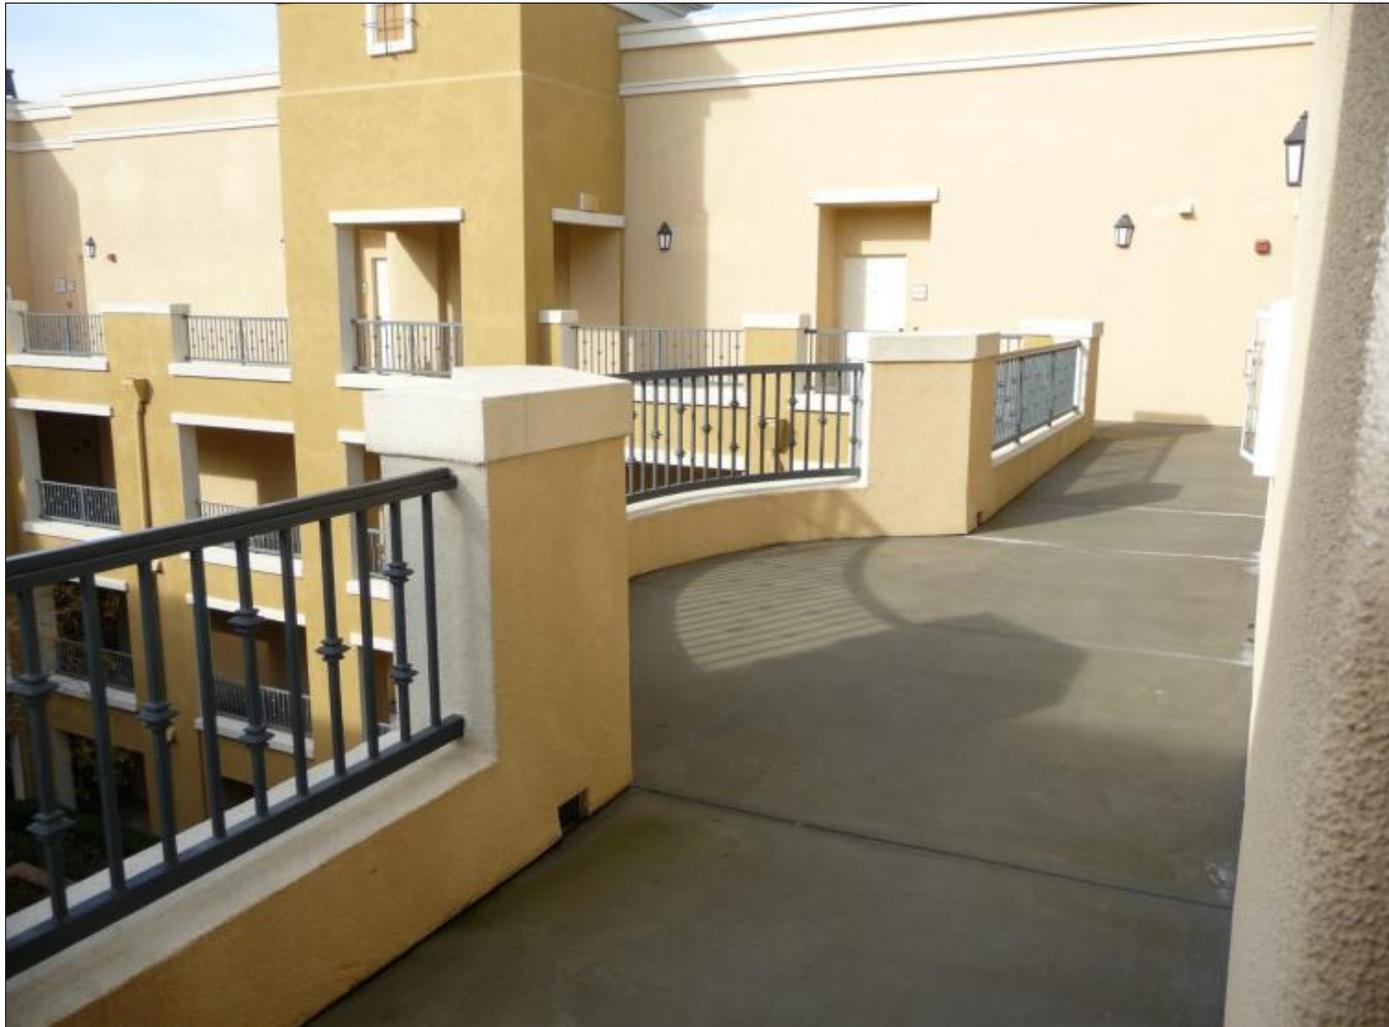
# Elevated Exterior Surfaces on Wood Framing

These assemblies require extensive integration with permanent features

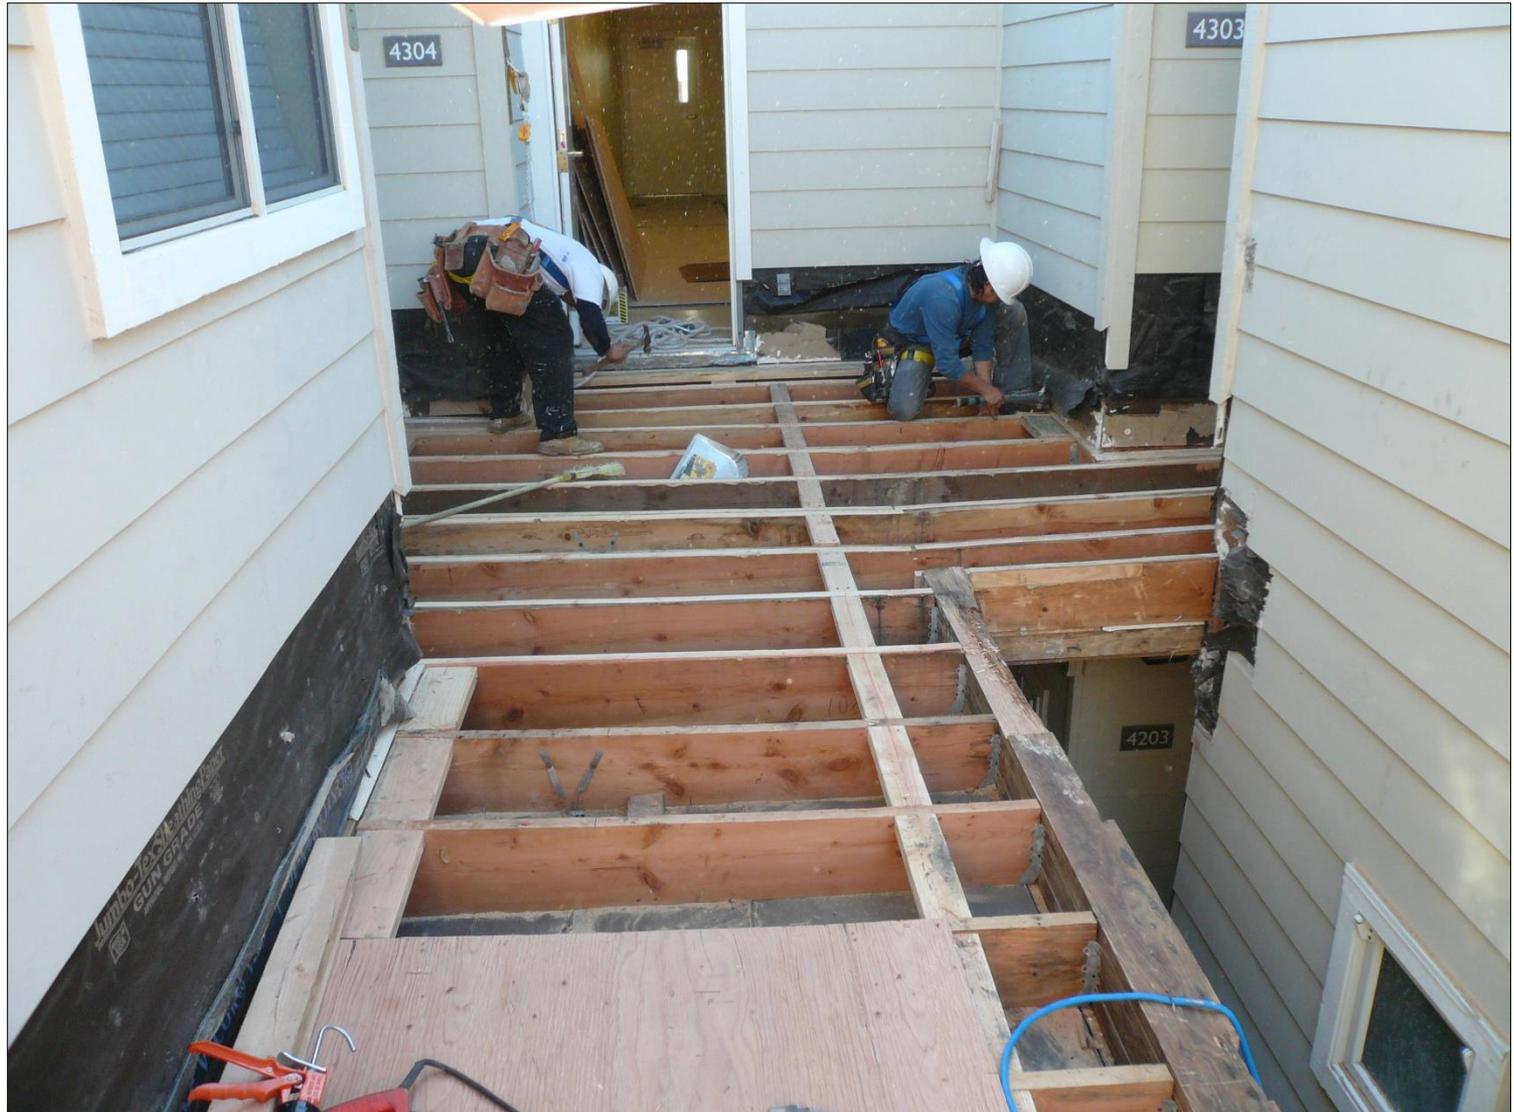
# Complexities of Repairing Wood Walkways

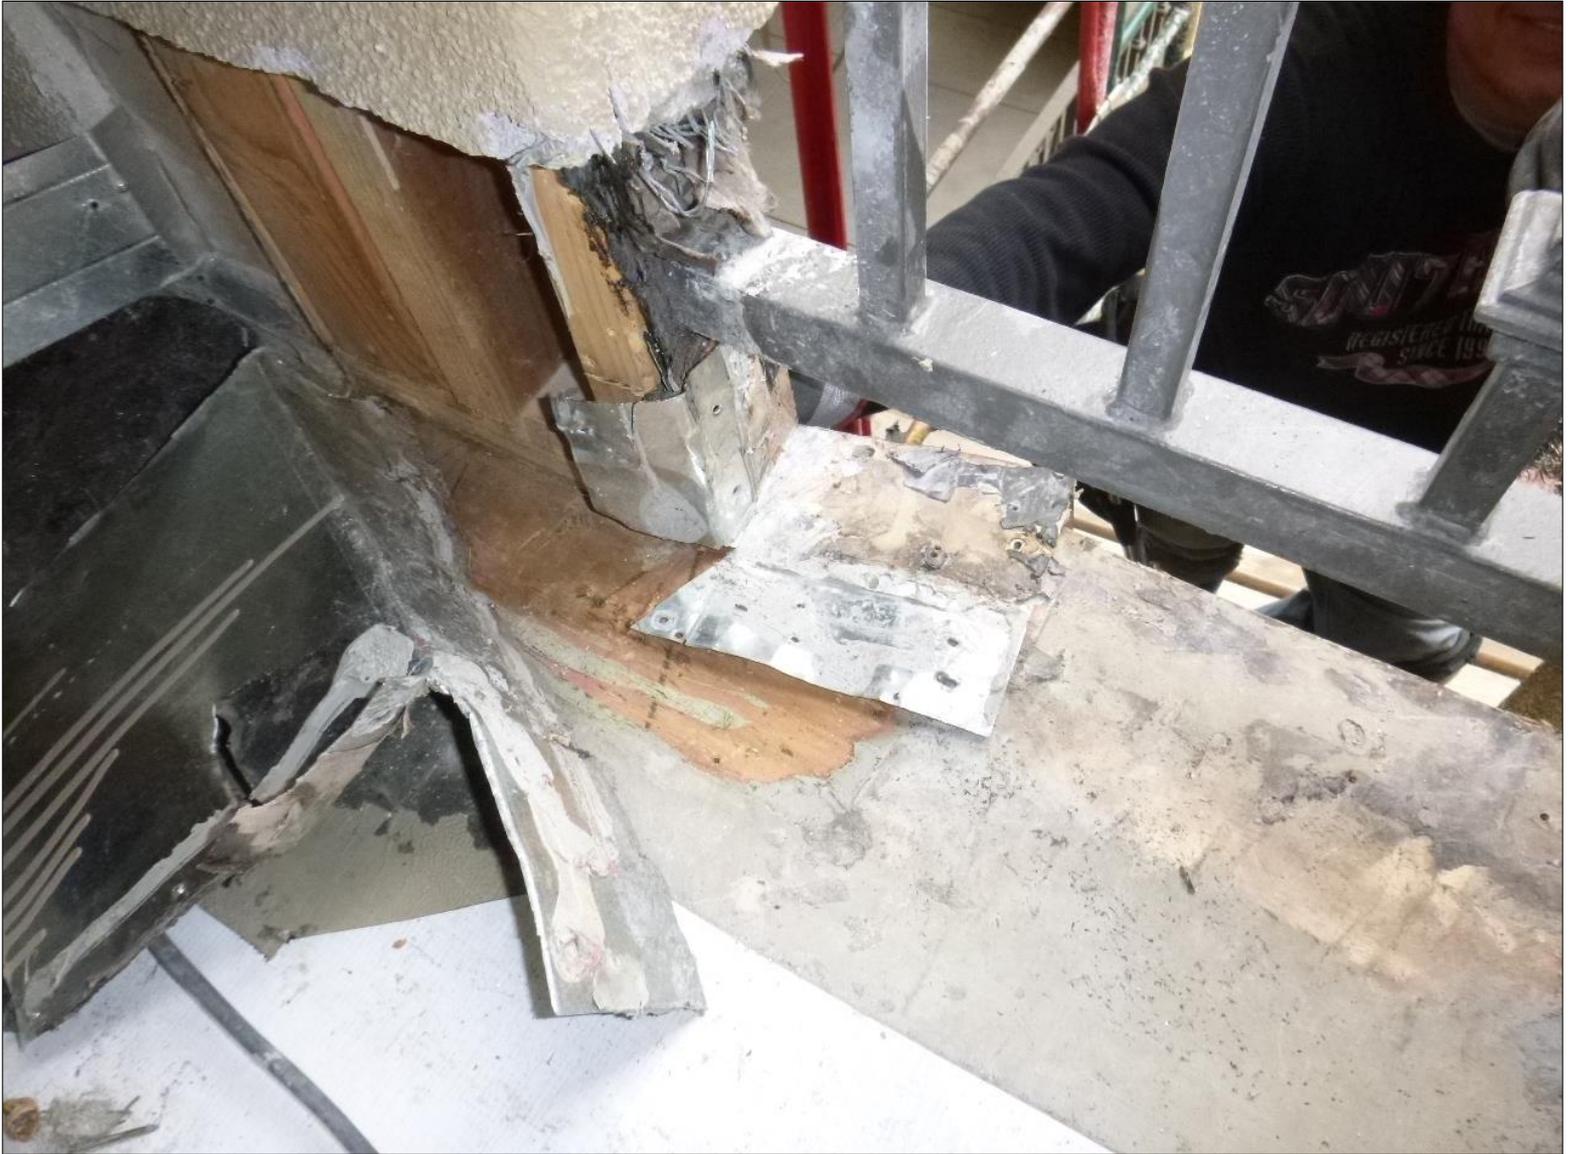
# Lack of Soldering Saddles, Corners & Scuppers

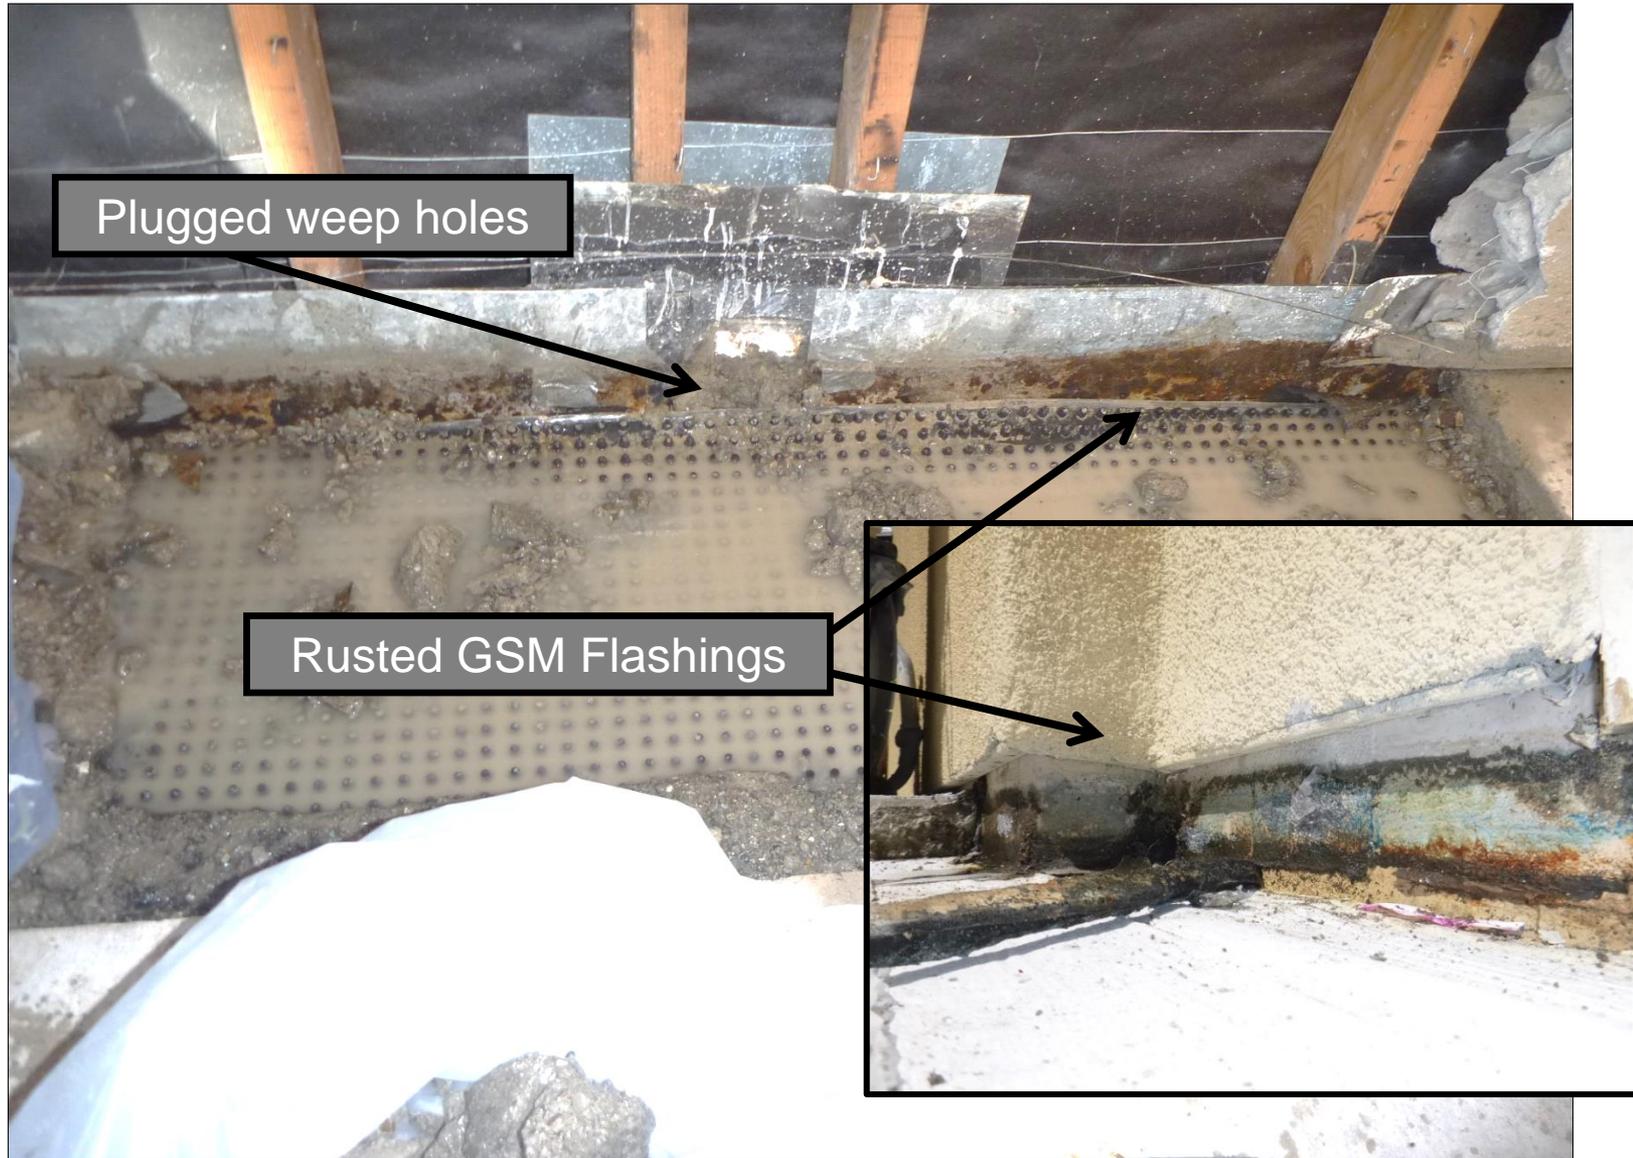
# Rusting of Submerged GSM Flashings

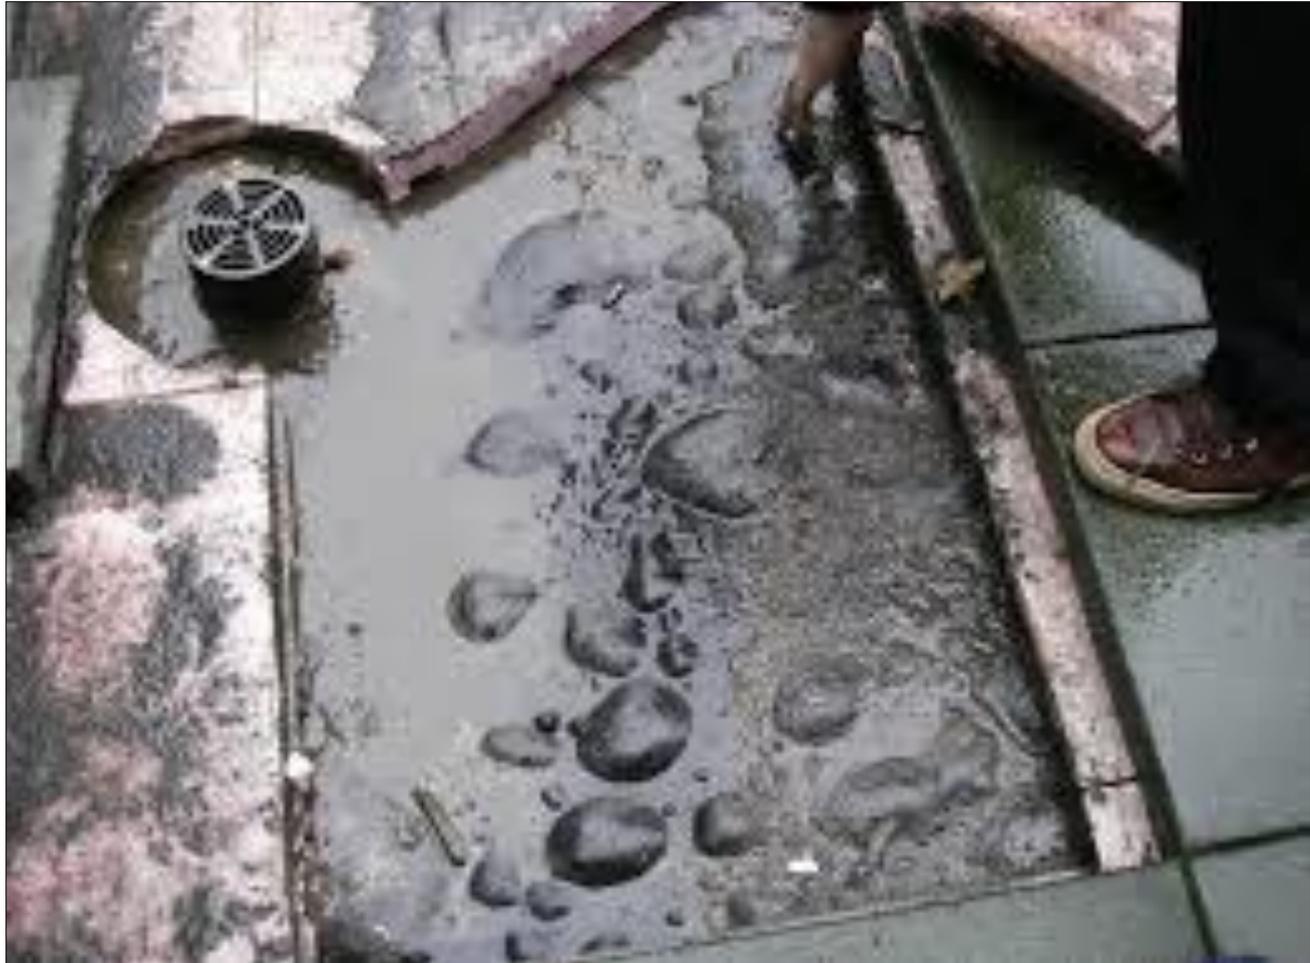
# Improper Selection of Materials

- **Cold modified polyurethane waterproofing membrane**
  - Osmosis in Permeable Membranes

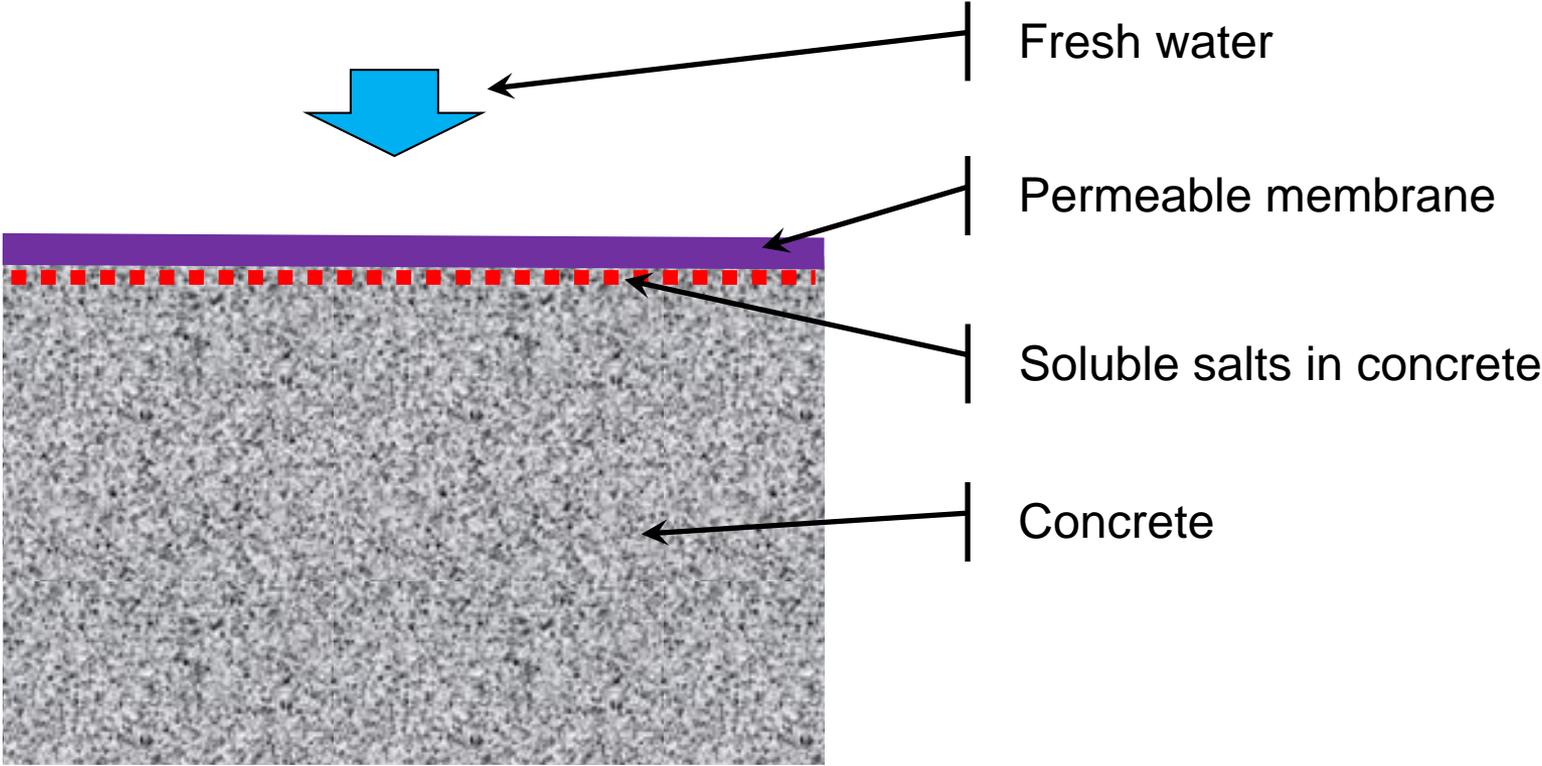
# Semi-Permeable Membranes, Osmosis

- Osmosis and Permeable Membranes
