**ALLANA BUICK & BERS**

## **Life Expectancy and Longevity of Buildings and Assemblies**

Condo Council of Maui 2016 Seminar  
November 16, 2016

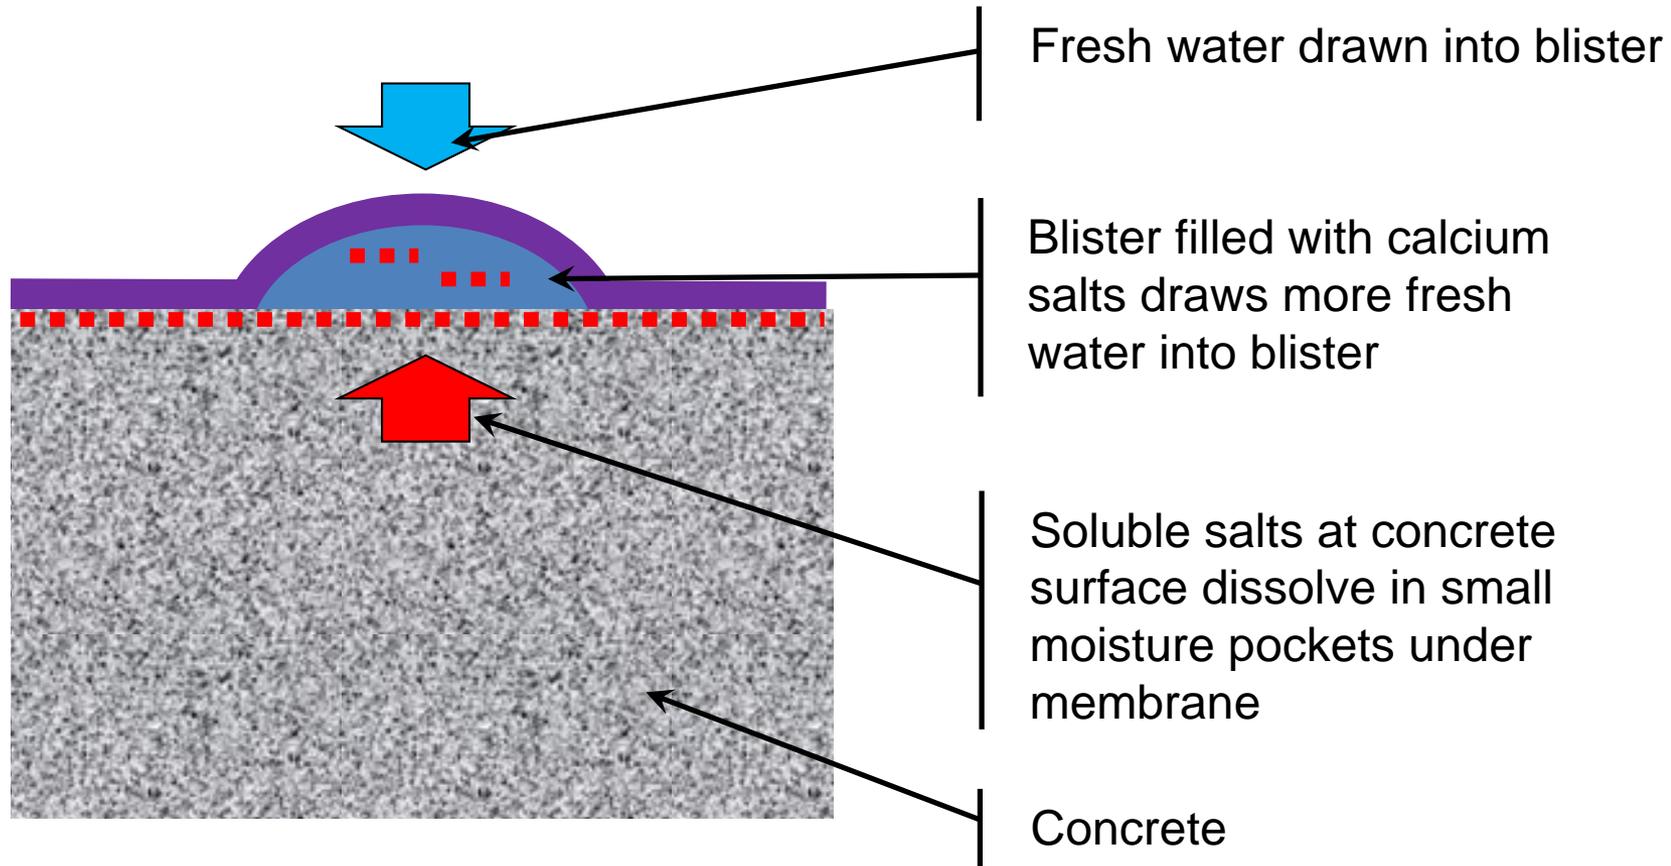
# Semi-Permeable Membranes, Osmosis

- Osmosis and Permeable Membranes

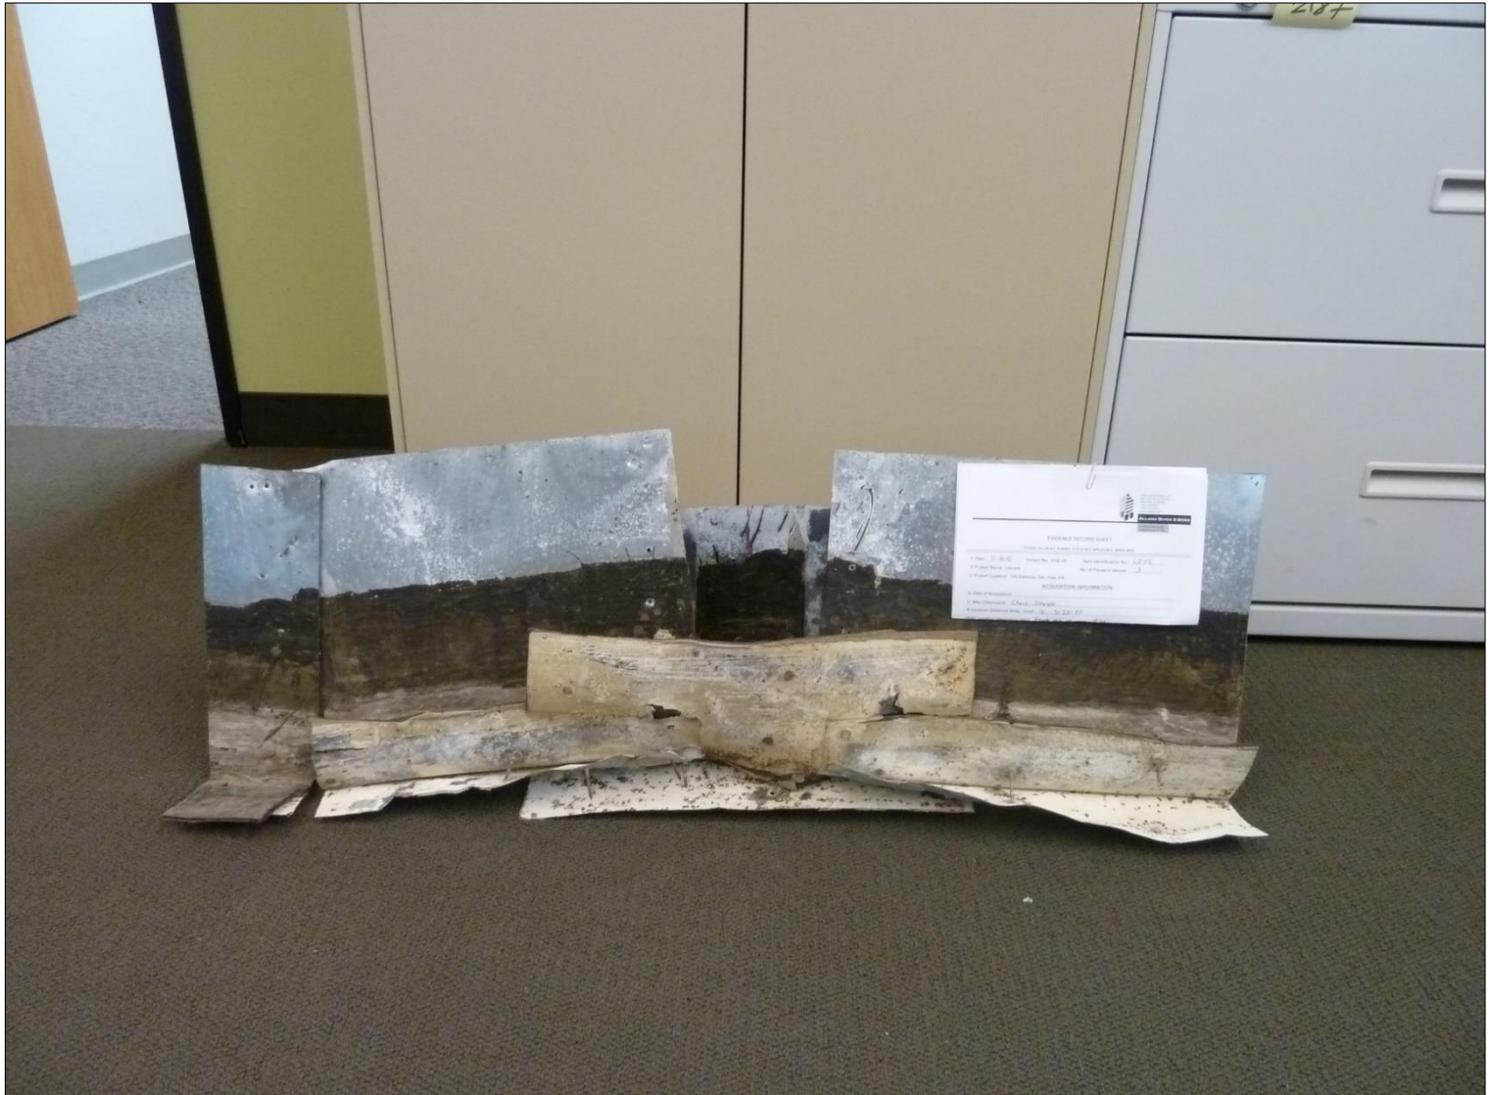
# Membrane Permeability Rusting GSM

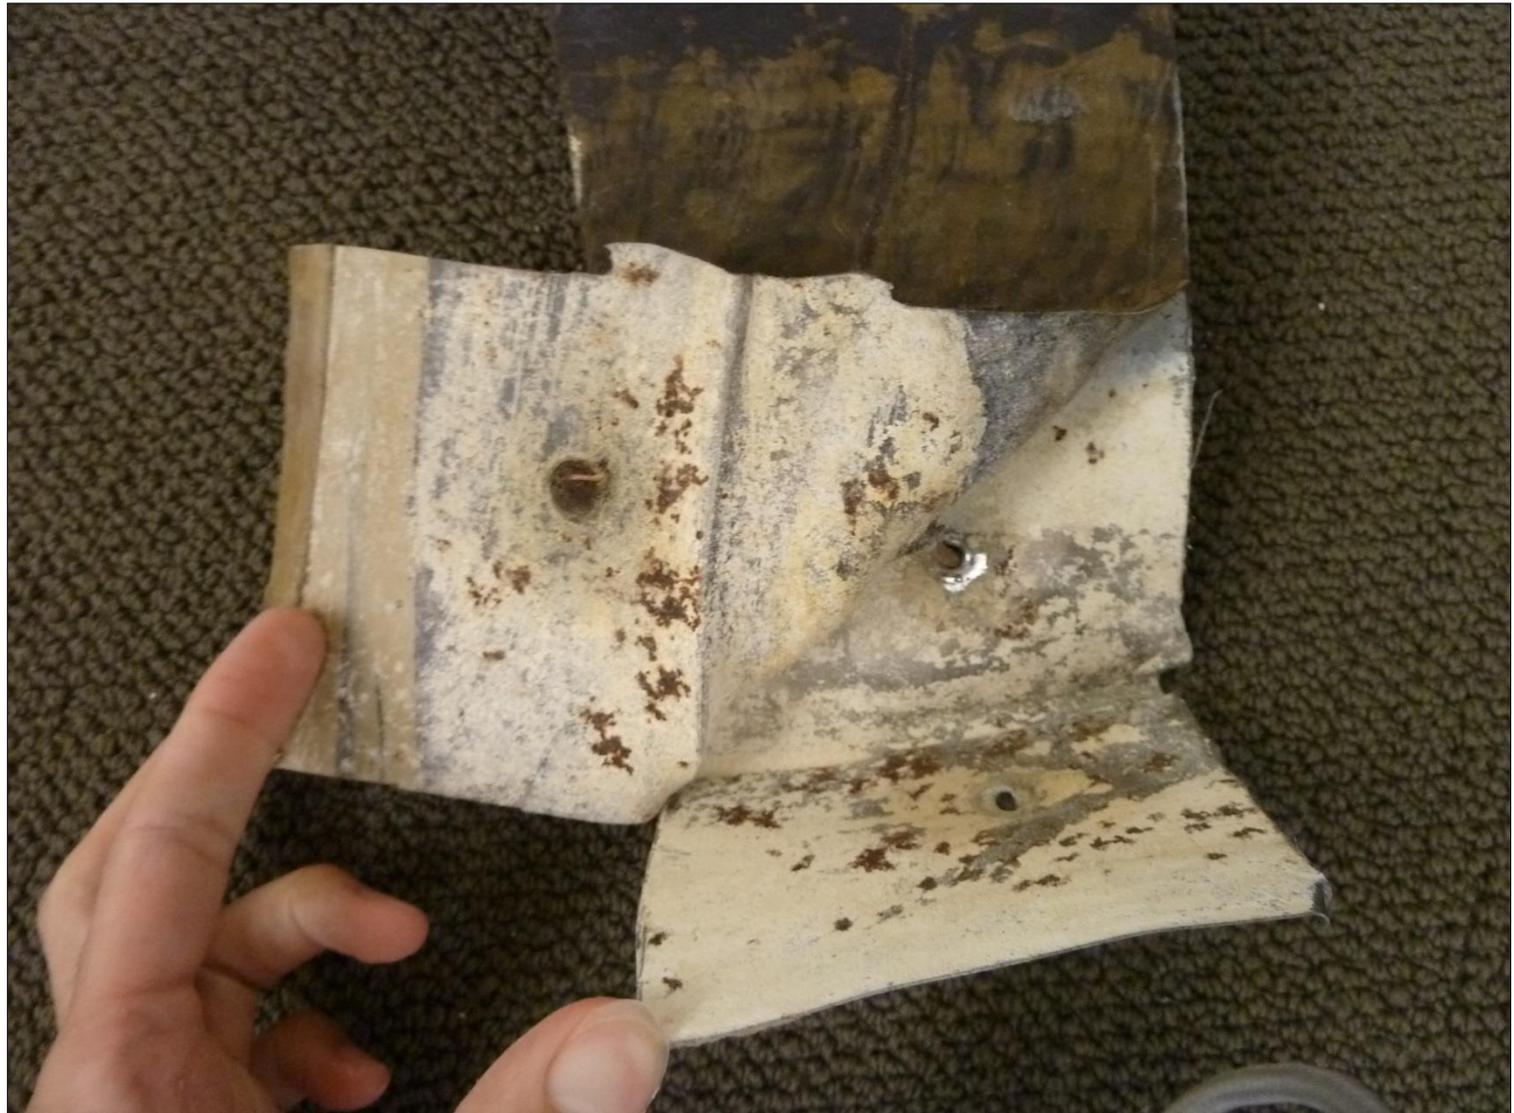
# Permeability Issue, Rusting GSM Flashings

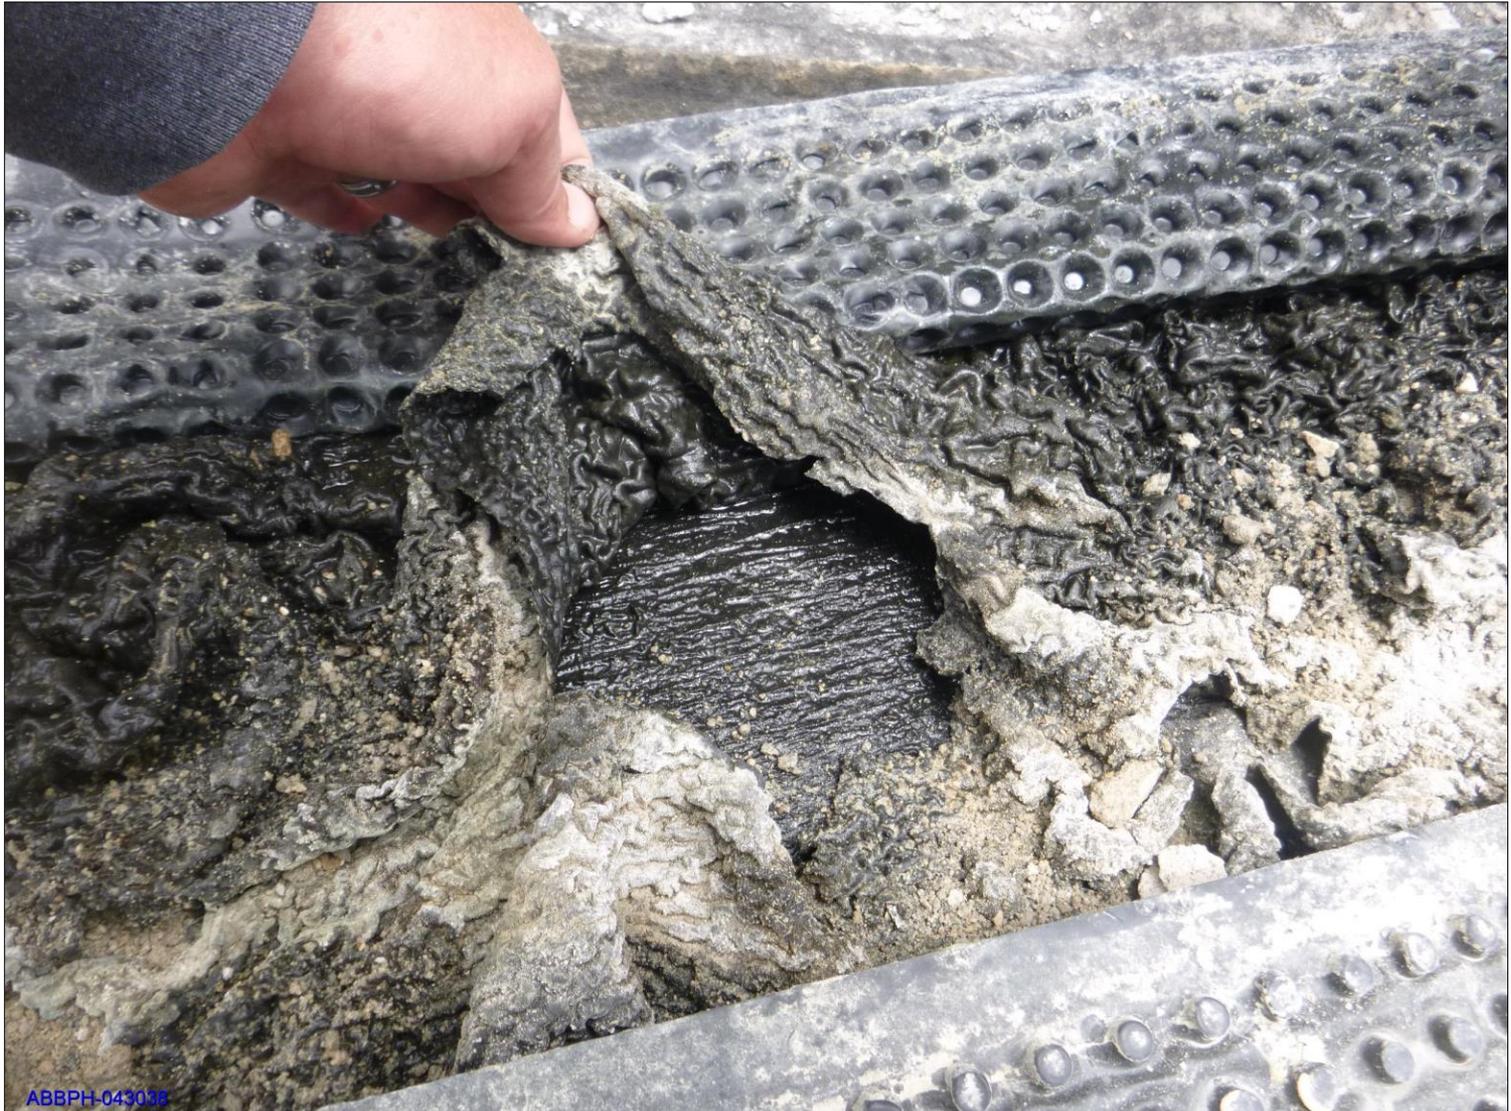
# Membrane Swelling Due To Ponding

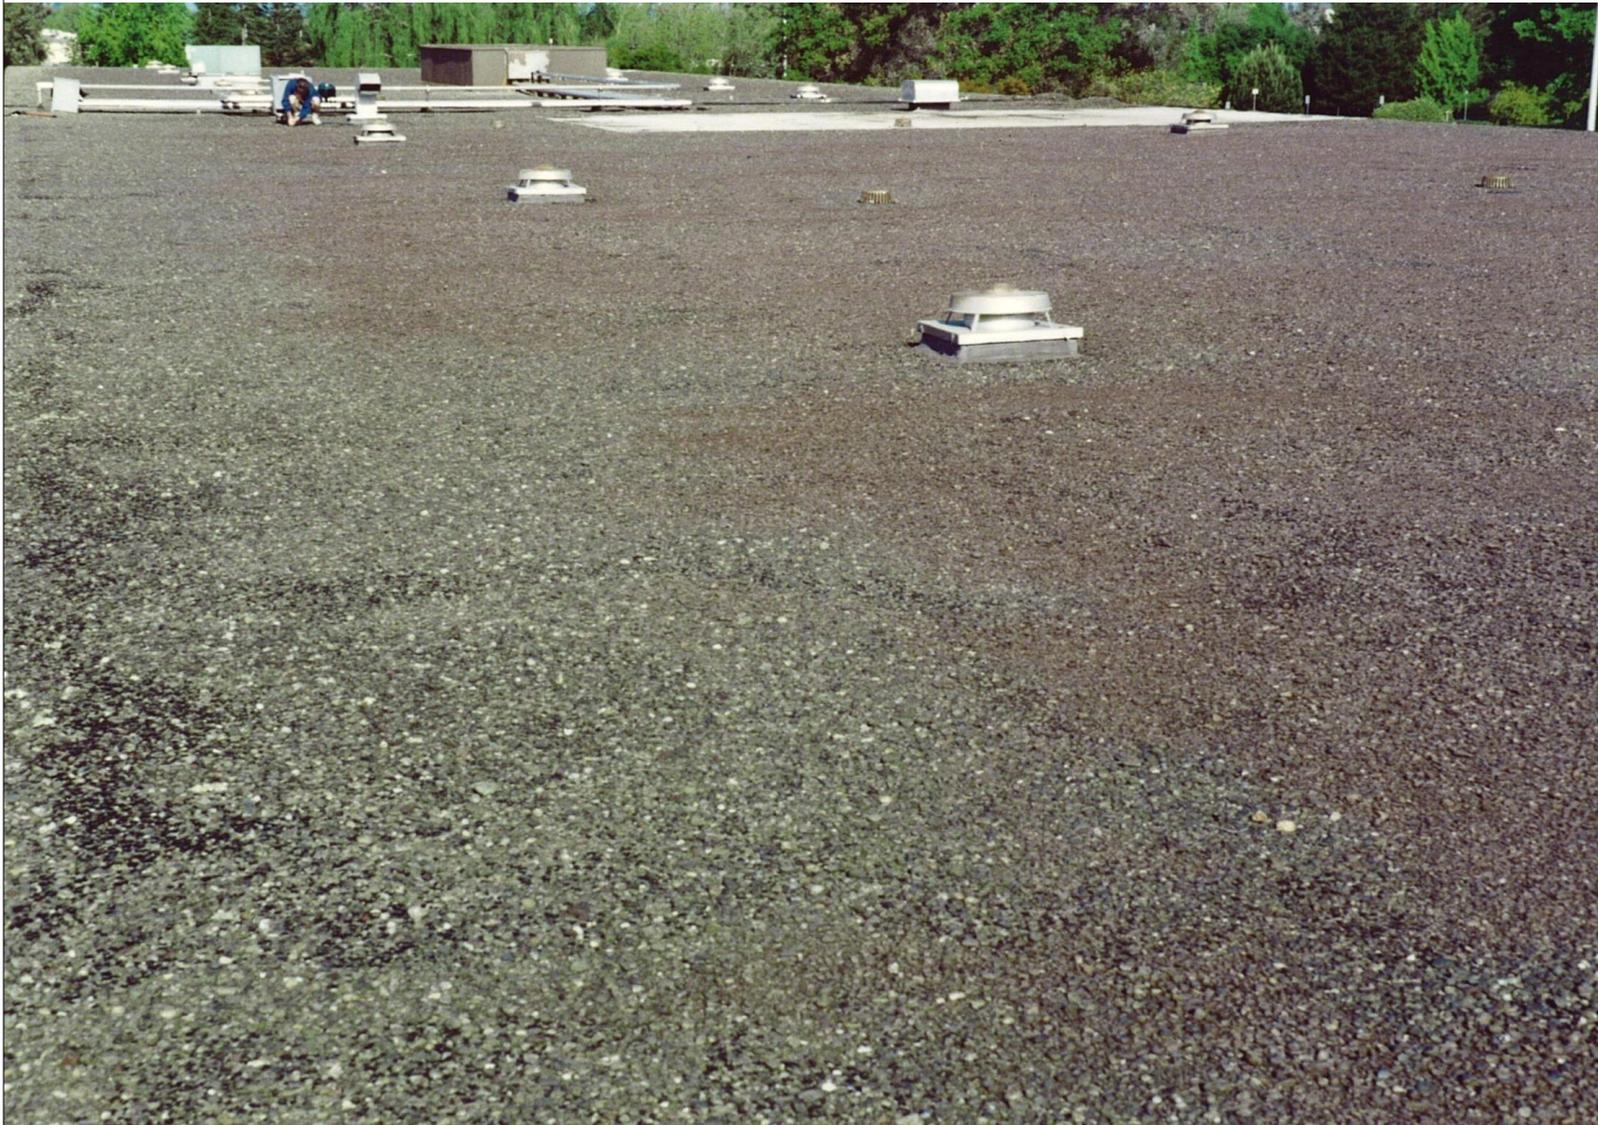
# Example Of a 34 Years Old Performing Roof

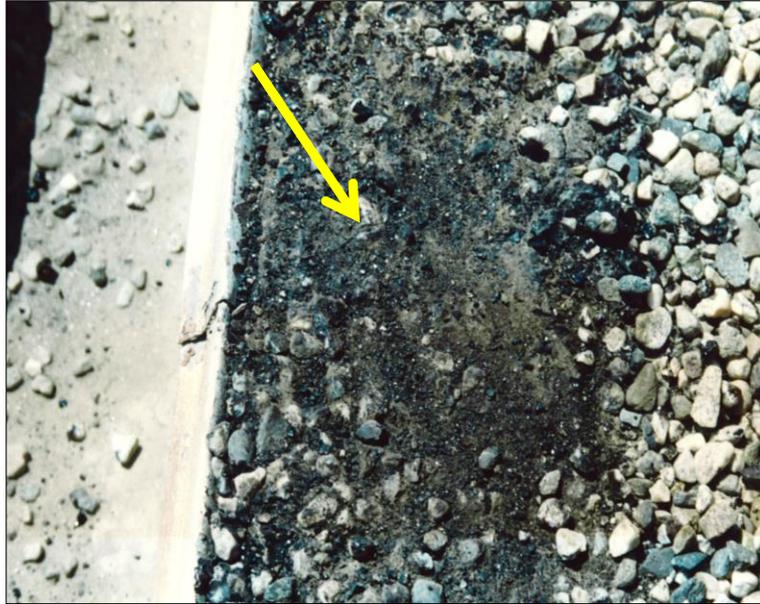
- Gravel stop joint is performing well after 34 years
- Roof could last 40-50 years
- Gravel embedment is excellent, providing great UV resistance and protection from traffic

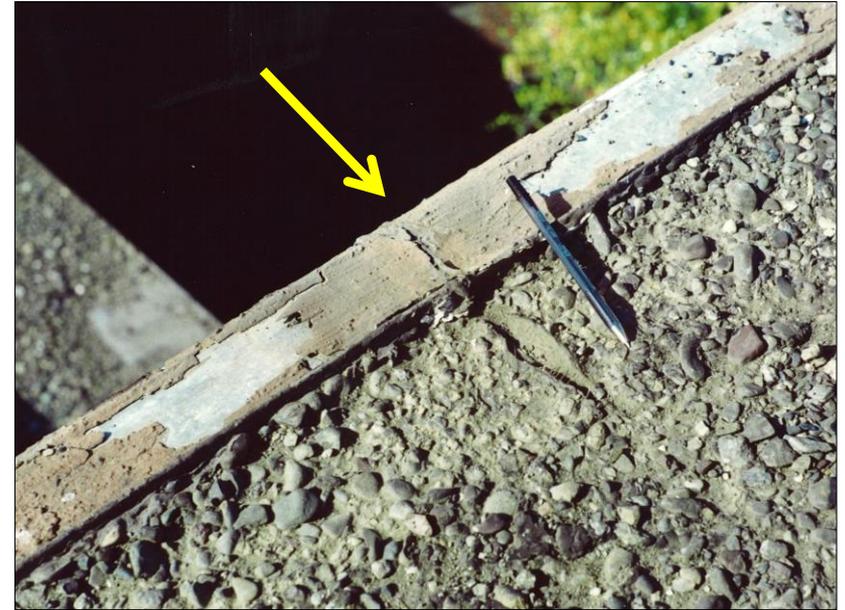
- Gravel stop joint is splitting after 20+ year old roof
- Gravel embedment is fair
- Life expectancy 25+ years with ongoing repairs and maintenance

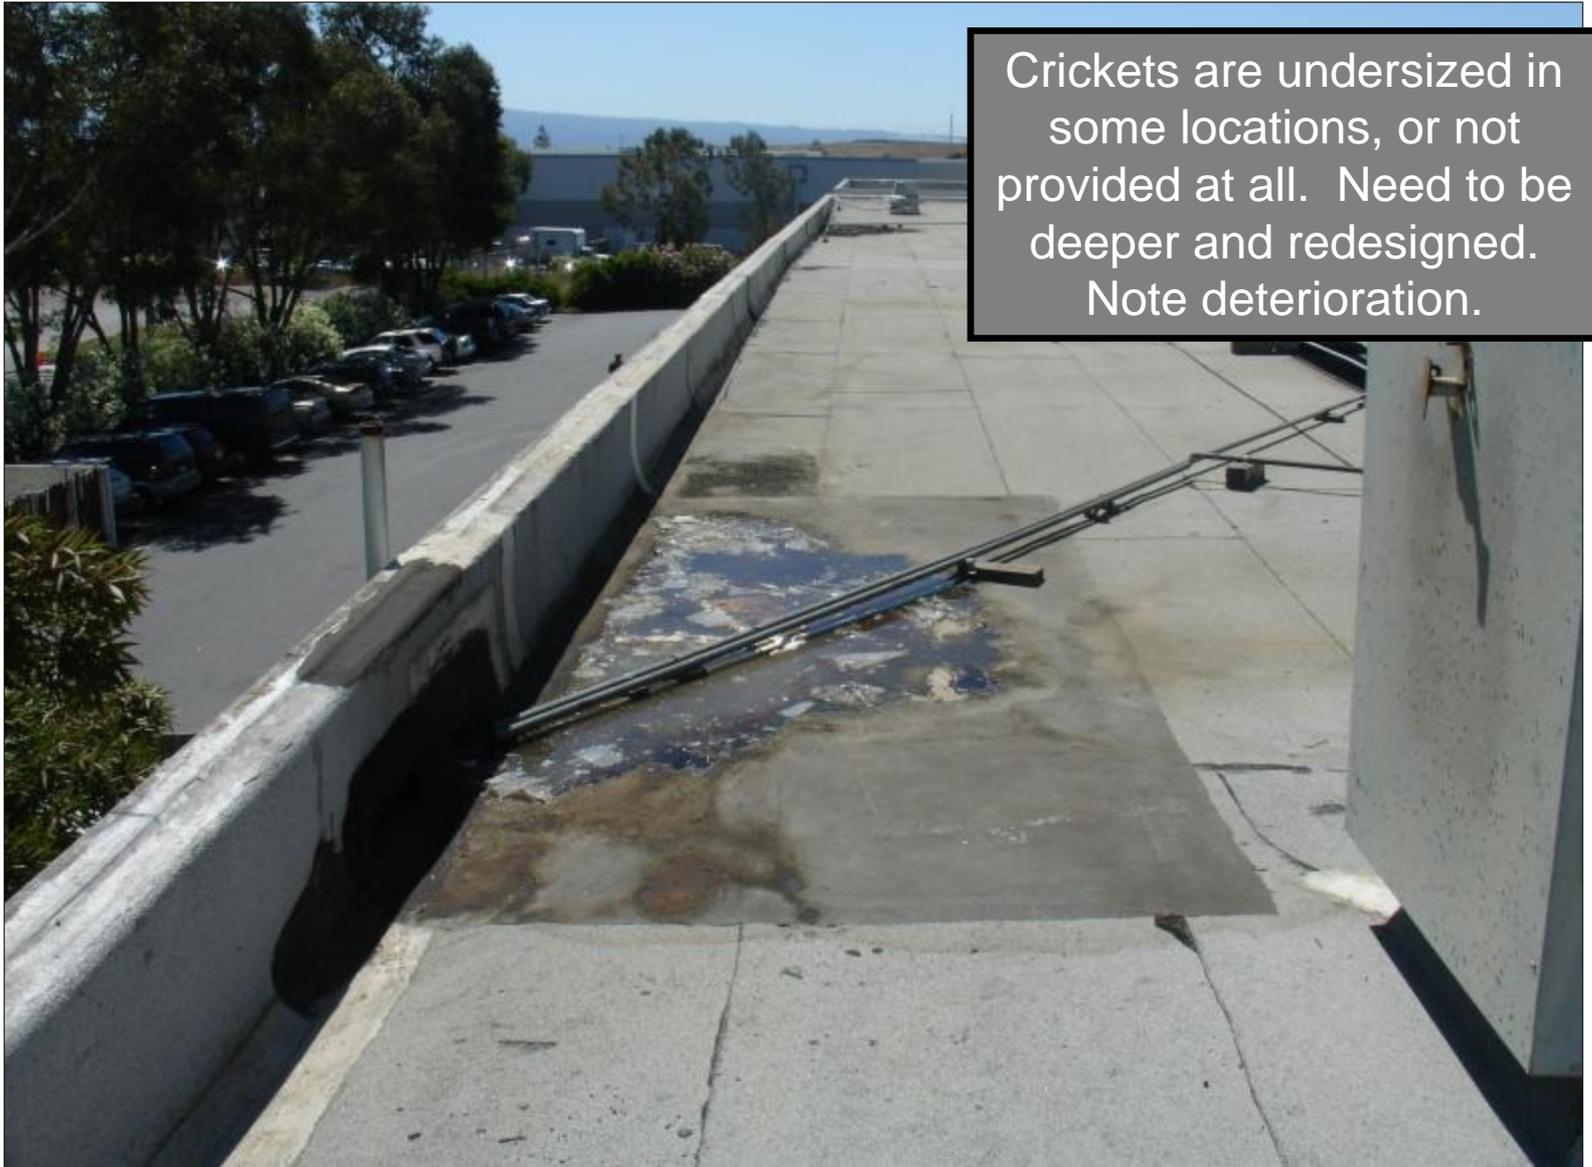
# Ponding Water Leads to Premature Deterioration

Crickets are undersized in some locations, or not provided at all. Need to be deeper and redesigned. Note deterioration.

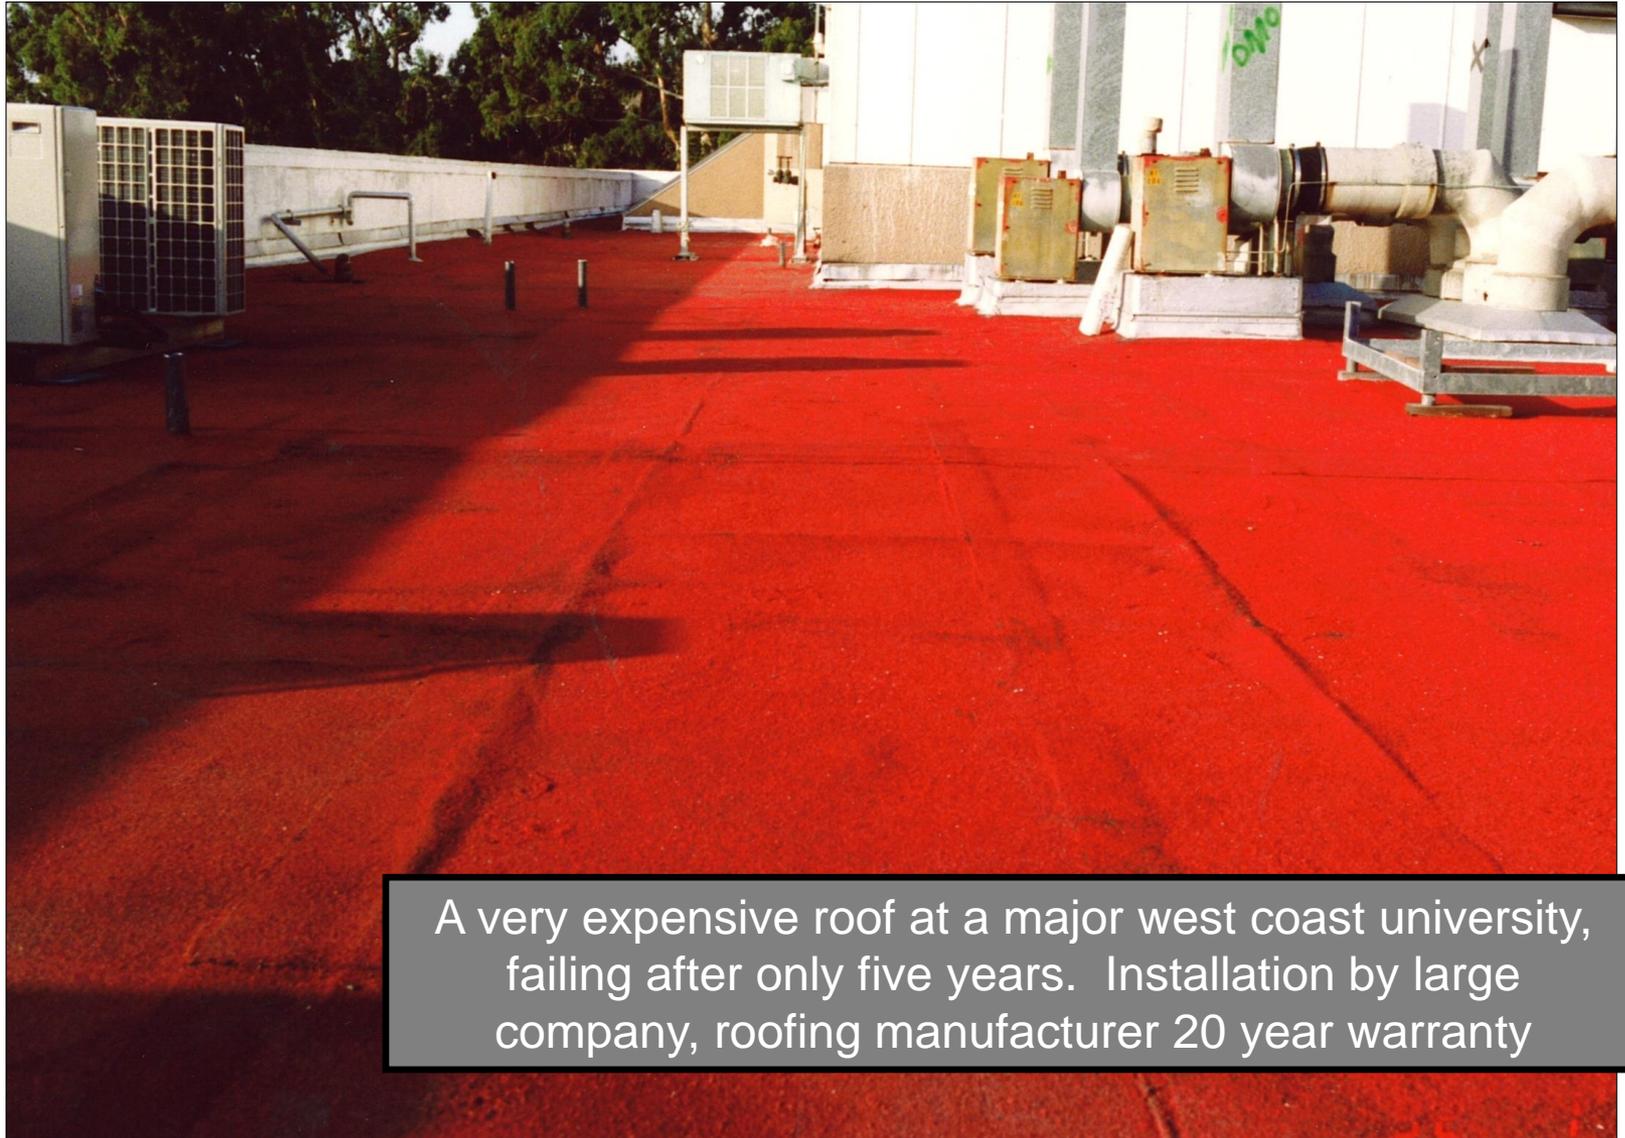
# Premature Roof Failure, Improper Attachment

A very expensive roof at a major west coast university, failing after only five years. Installation by large company, roofing manufacturer 20 year warranty

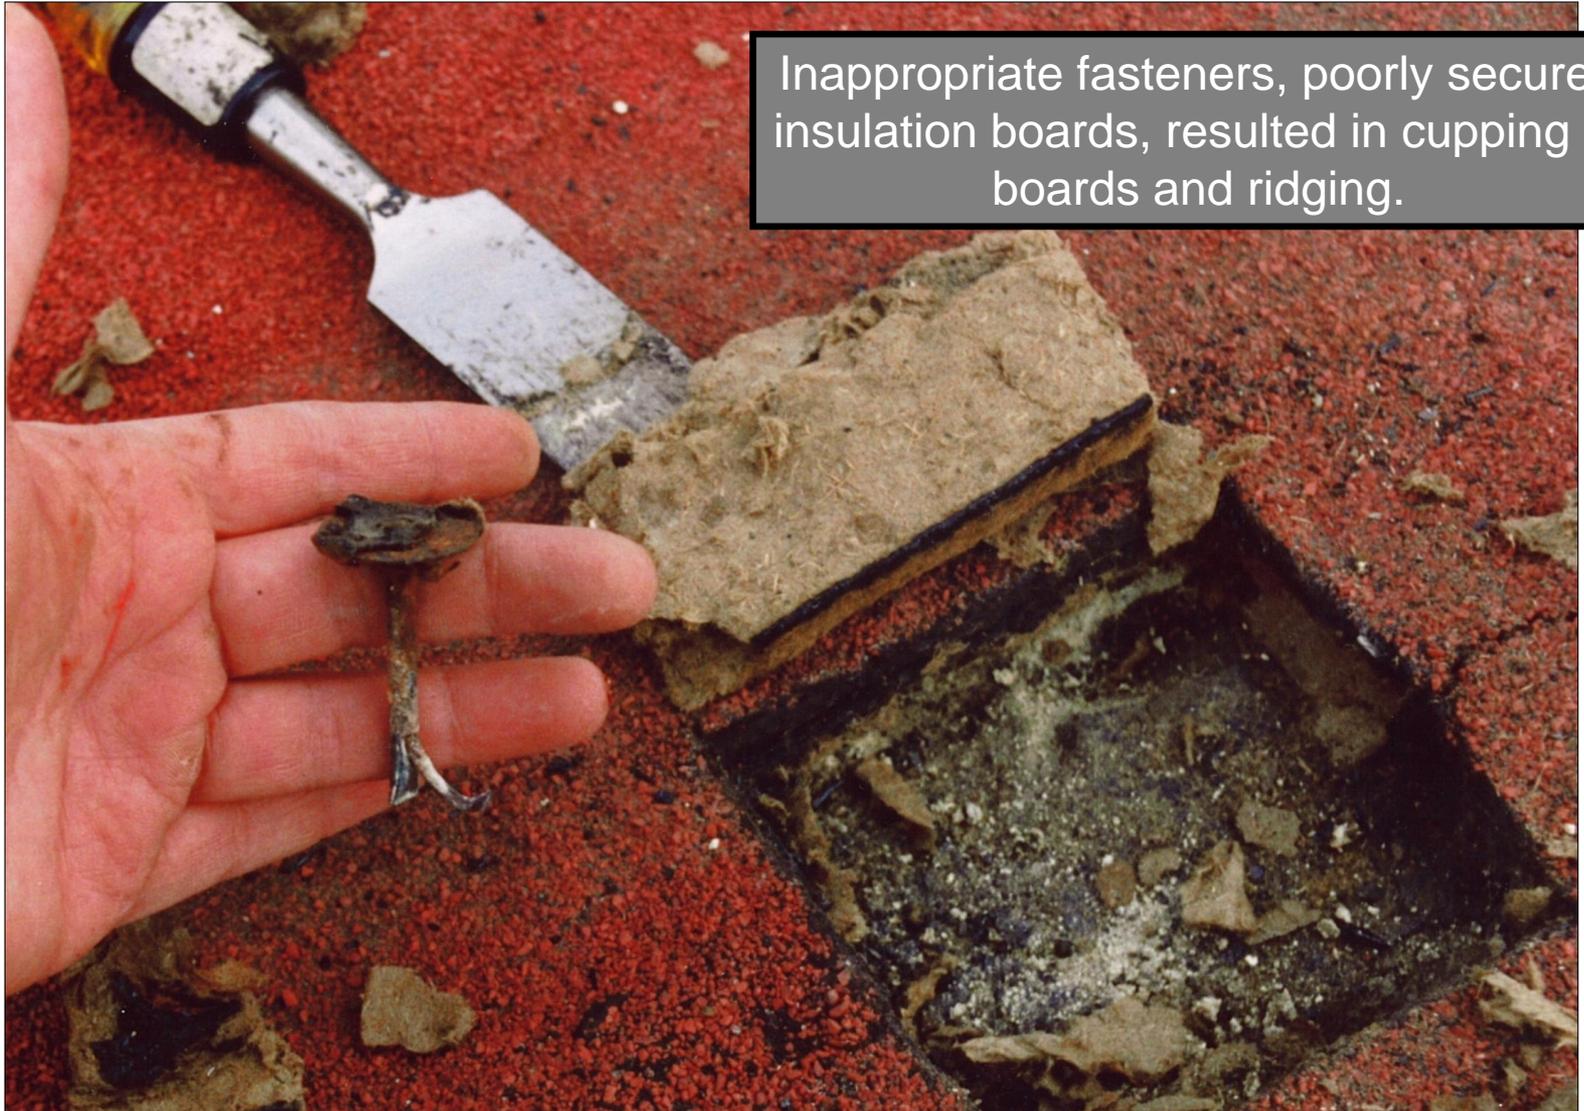
# Cause of Failure: Improper Insulation Fastening

Inappropriate fasteners, poorly secured insulation boards, resulted in cupping of boards and ridging.

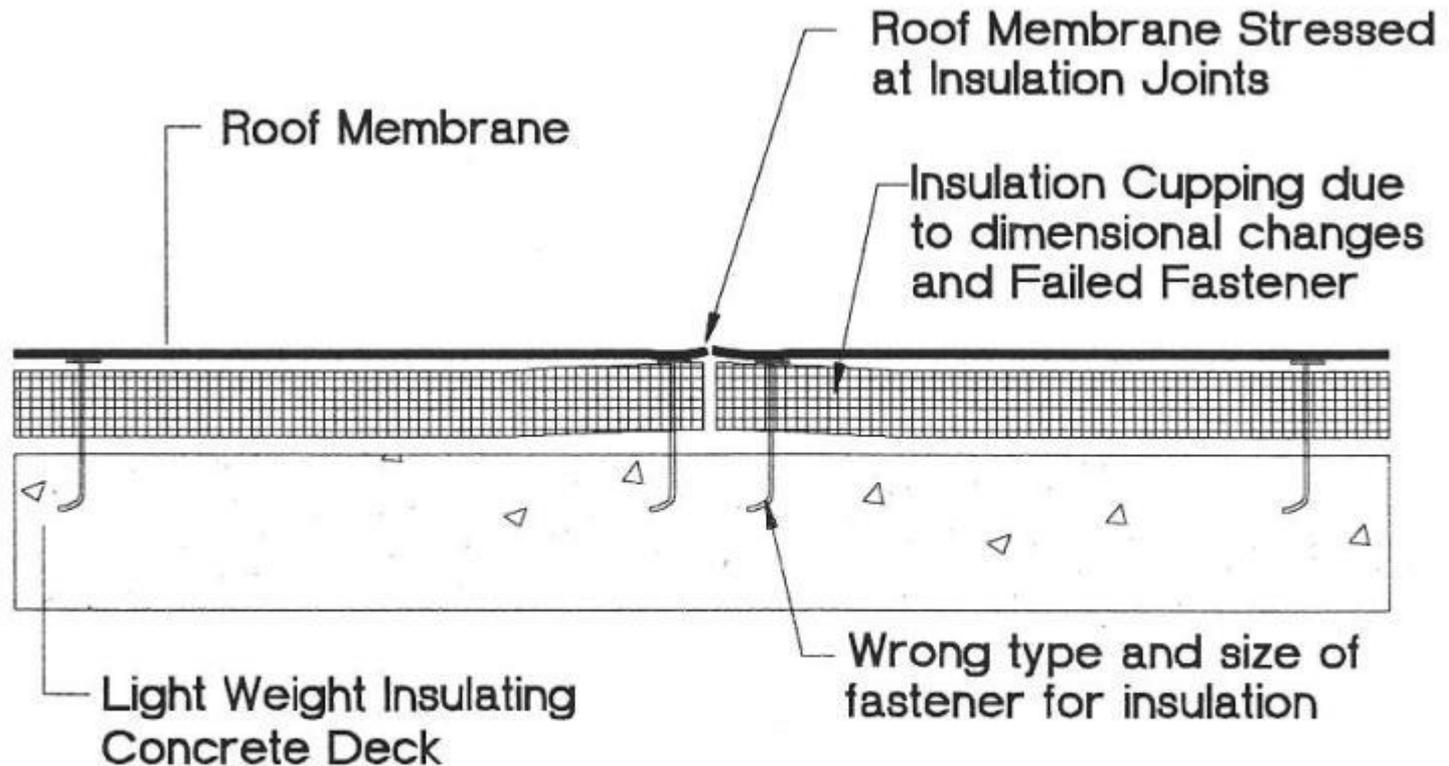
# Improper Attachment Caused The Roof Failure

PICTURE FRAMING + ROOF SPLITTING CAUSED BY  
POOR FASTENING OF INSULATION BOARD TO SUBSTRATE

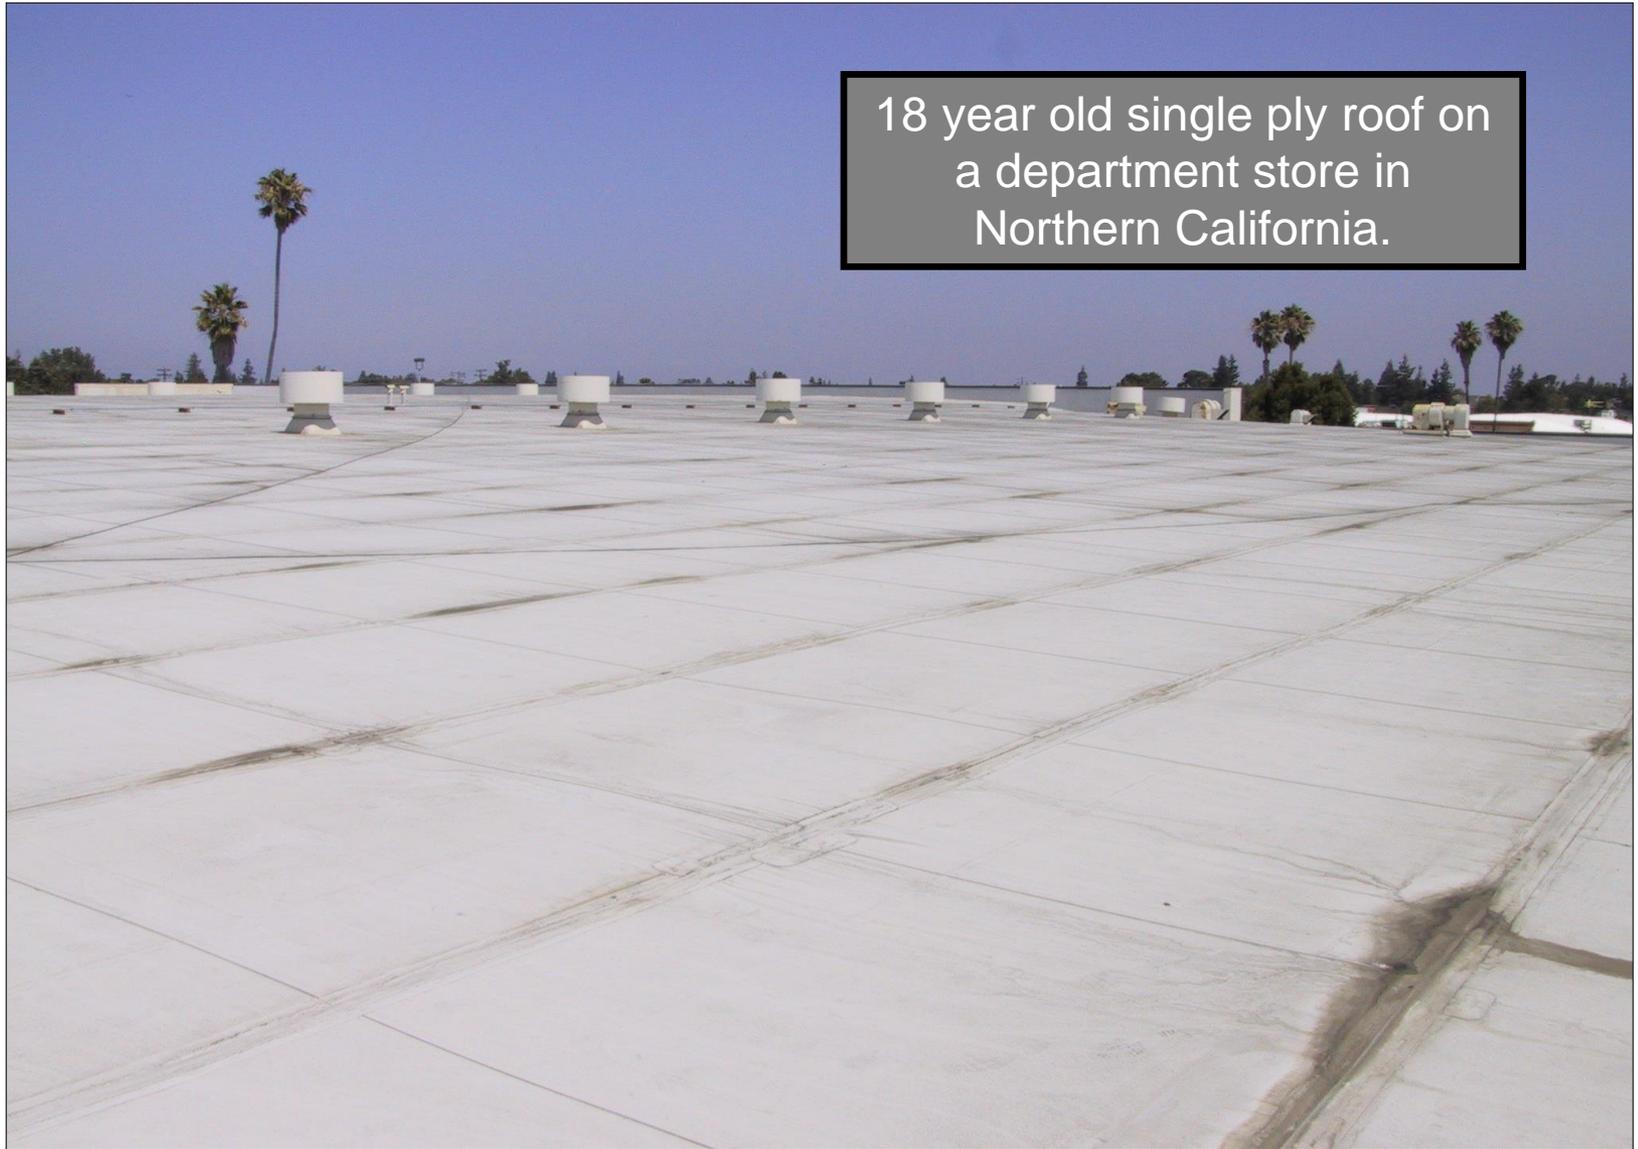
18 year old single ply roof on a department store in Northern California.

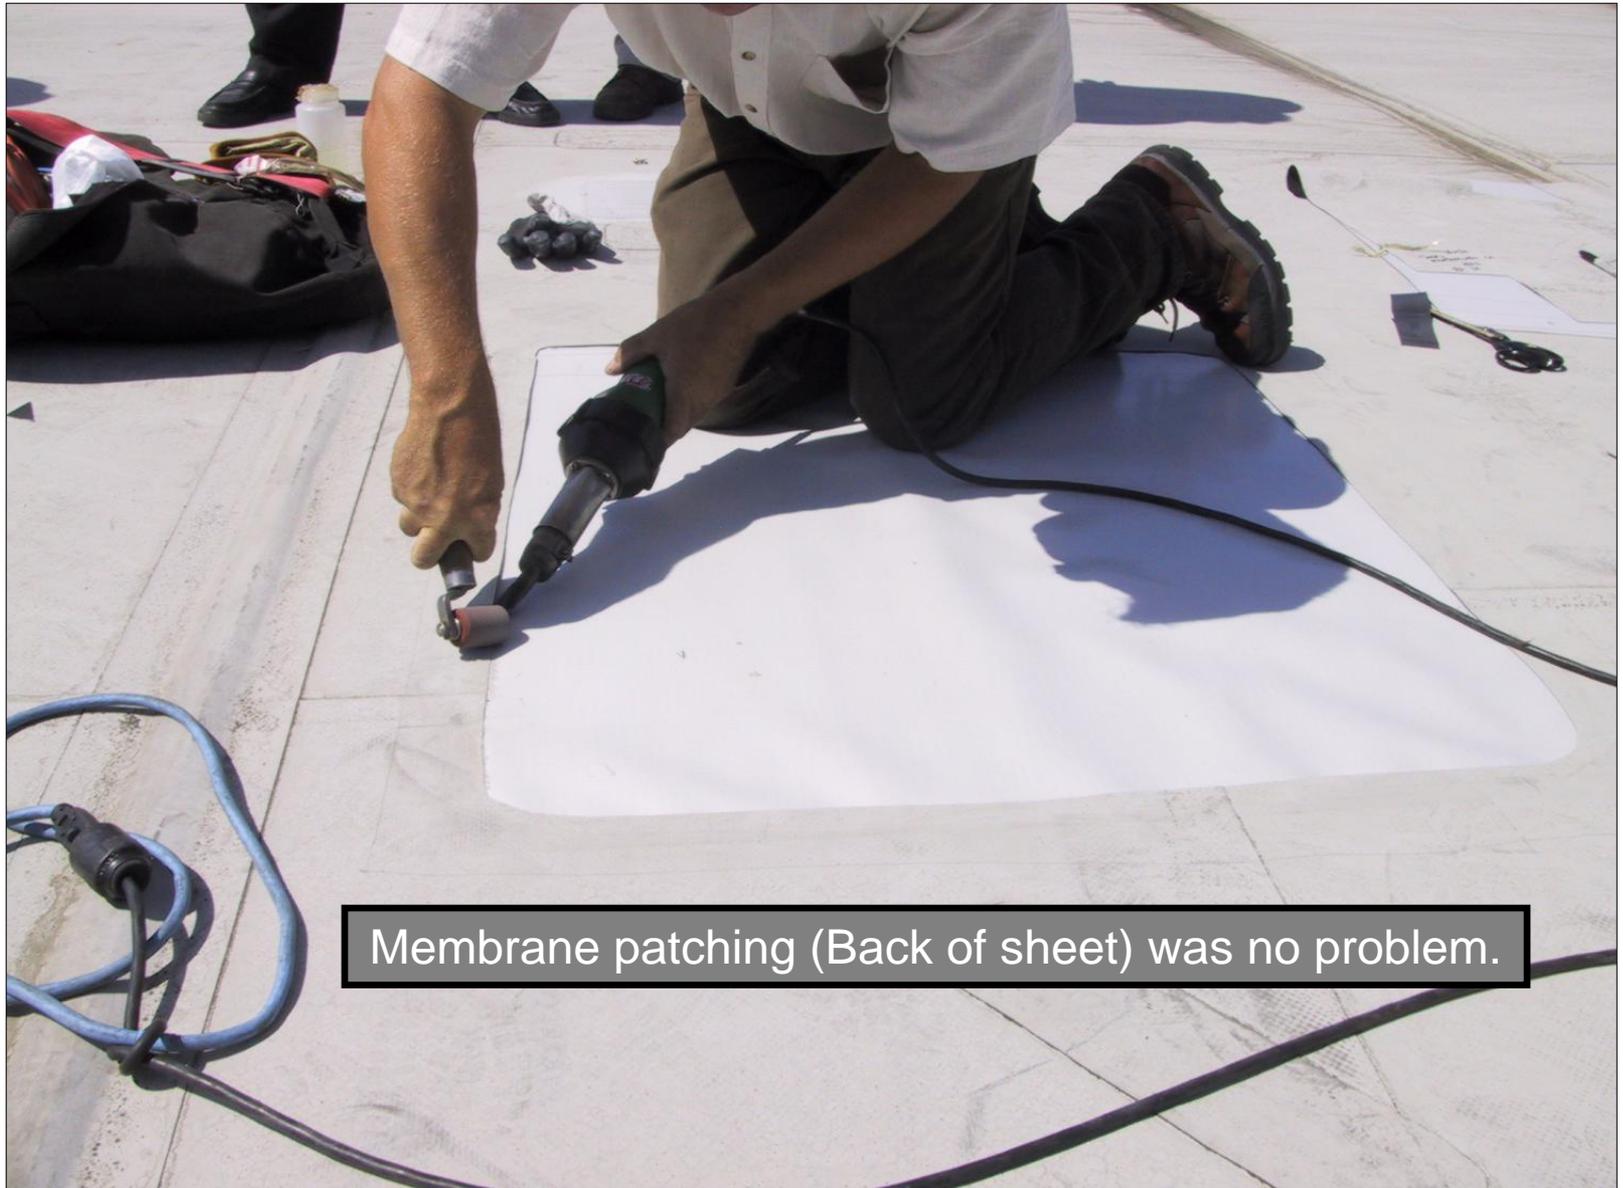
Membrane patching (Back of sheet) was no problem.

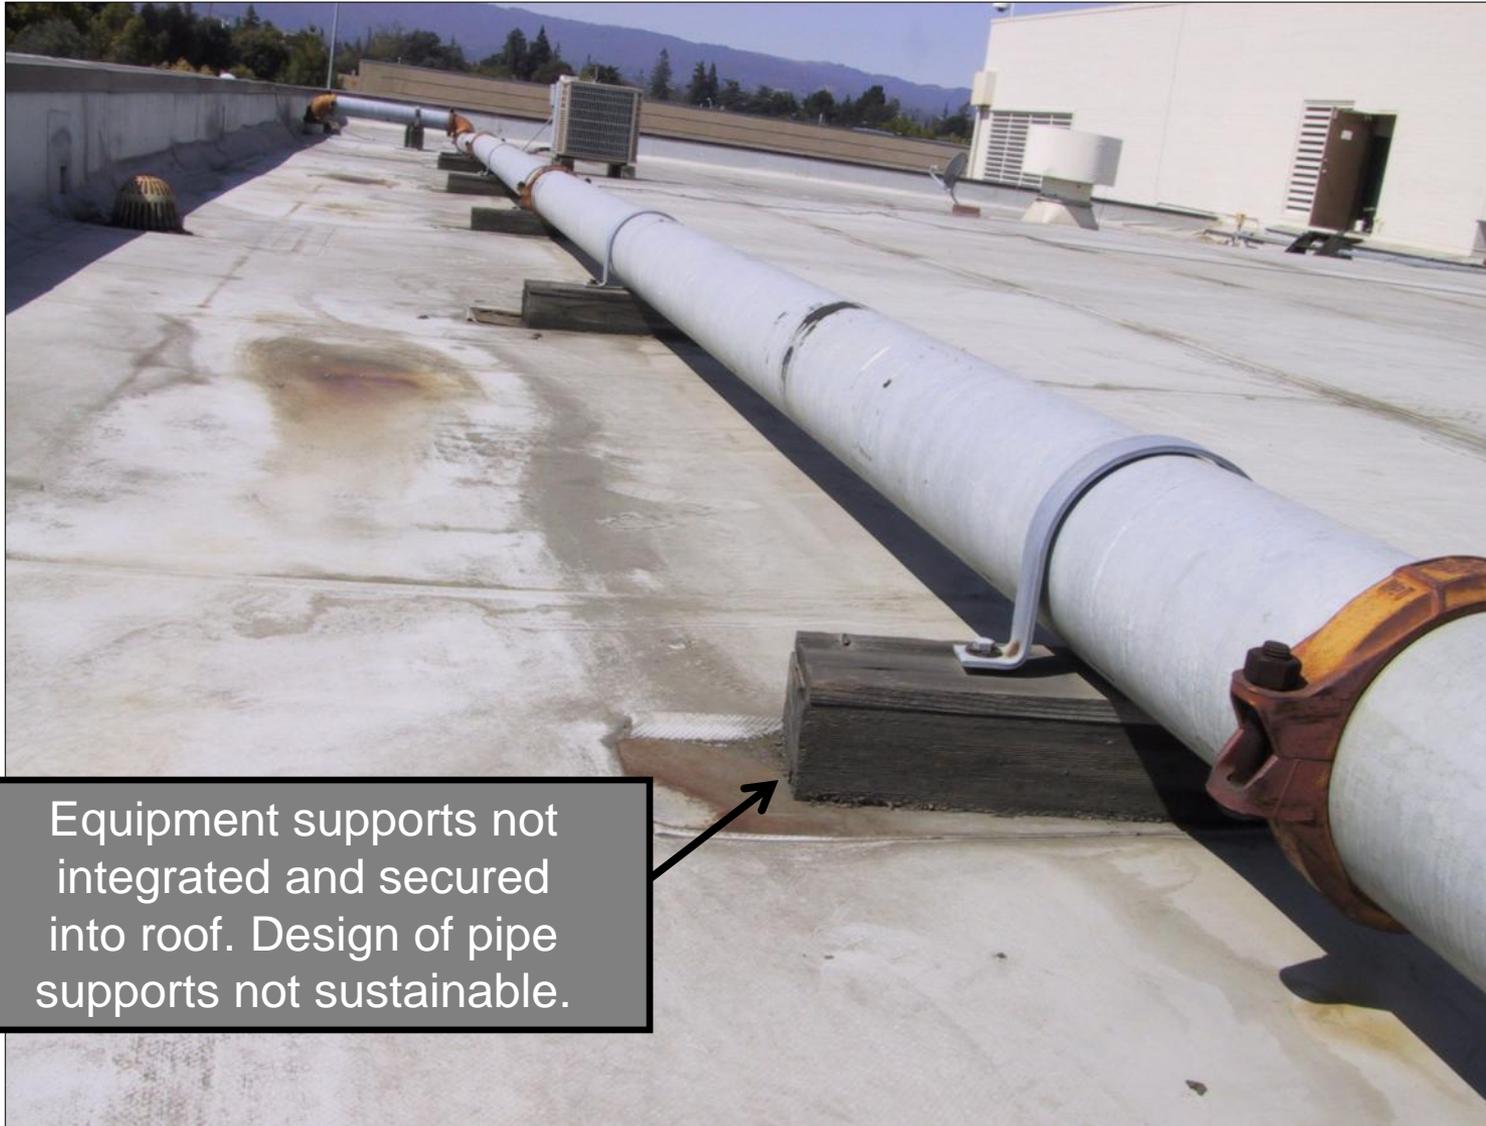
# Design Issue

Equipment supports not integrated and secured into roof. Design of pipe supports not sustainable.

- **Design**
  - Original poor design of pipe supports caused damage
  - Poor design of roof drainage caused ponding water and damage. Membrane susceptible to ponding water
  - Poor design of condensation control mechanism caused damage
