**ALLANA BUICK & BERS**

## **Life Expectancy and Longevity of Buildings and Assemblies**

Condo Council of Maui 2016 Seminar  
November 16, 2016

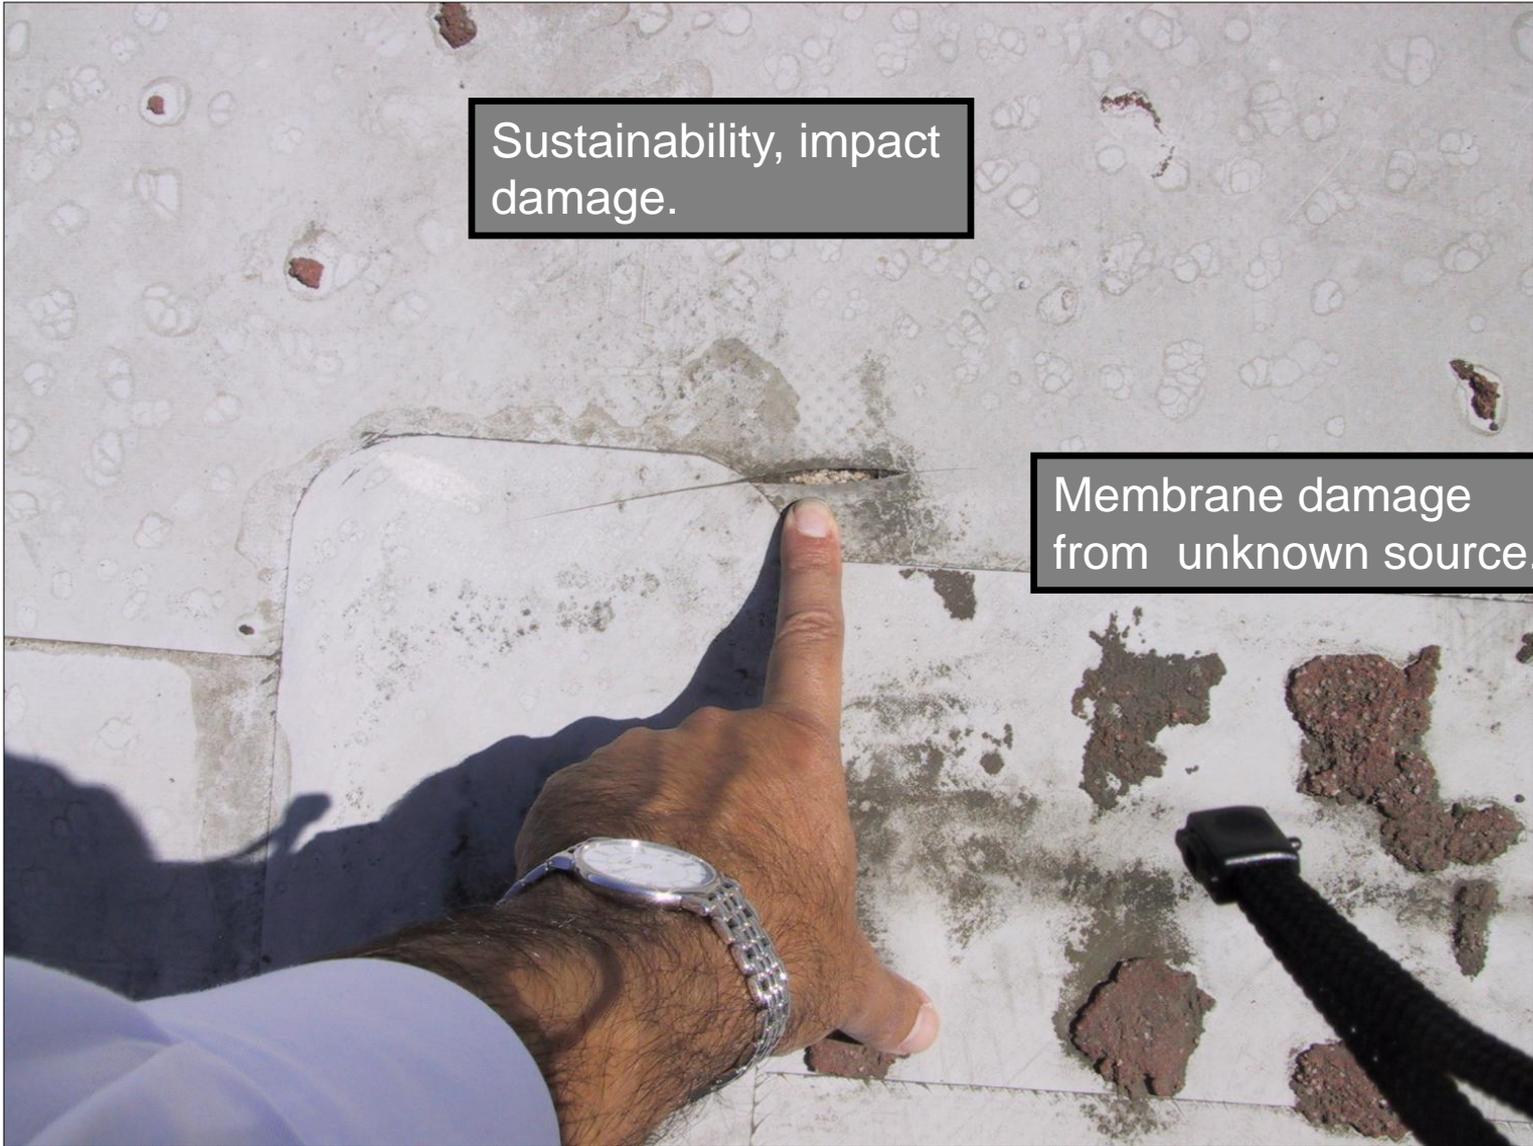
# Single Ply Membranes Very Susceptible To Damage

Sustainability, impact damage.

Membrane damage from unknown source.

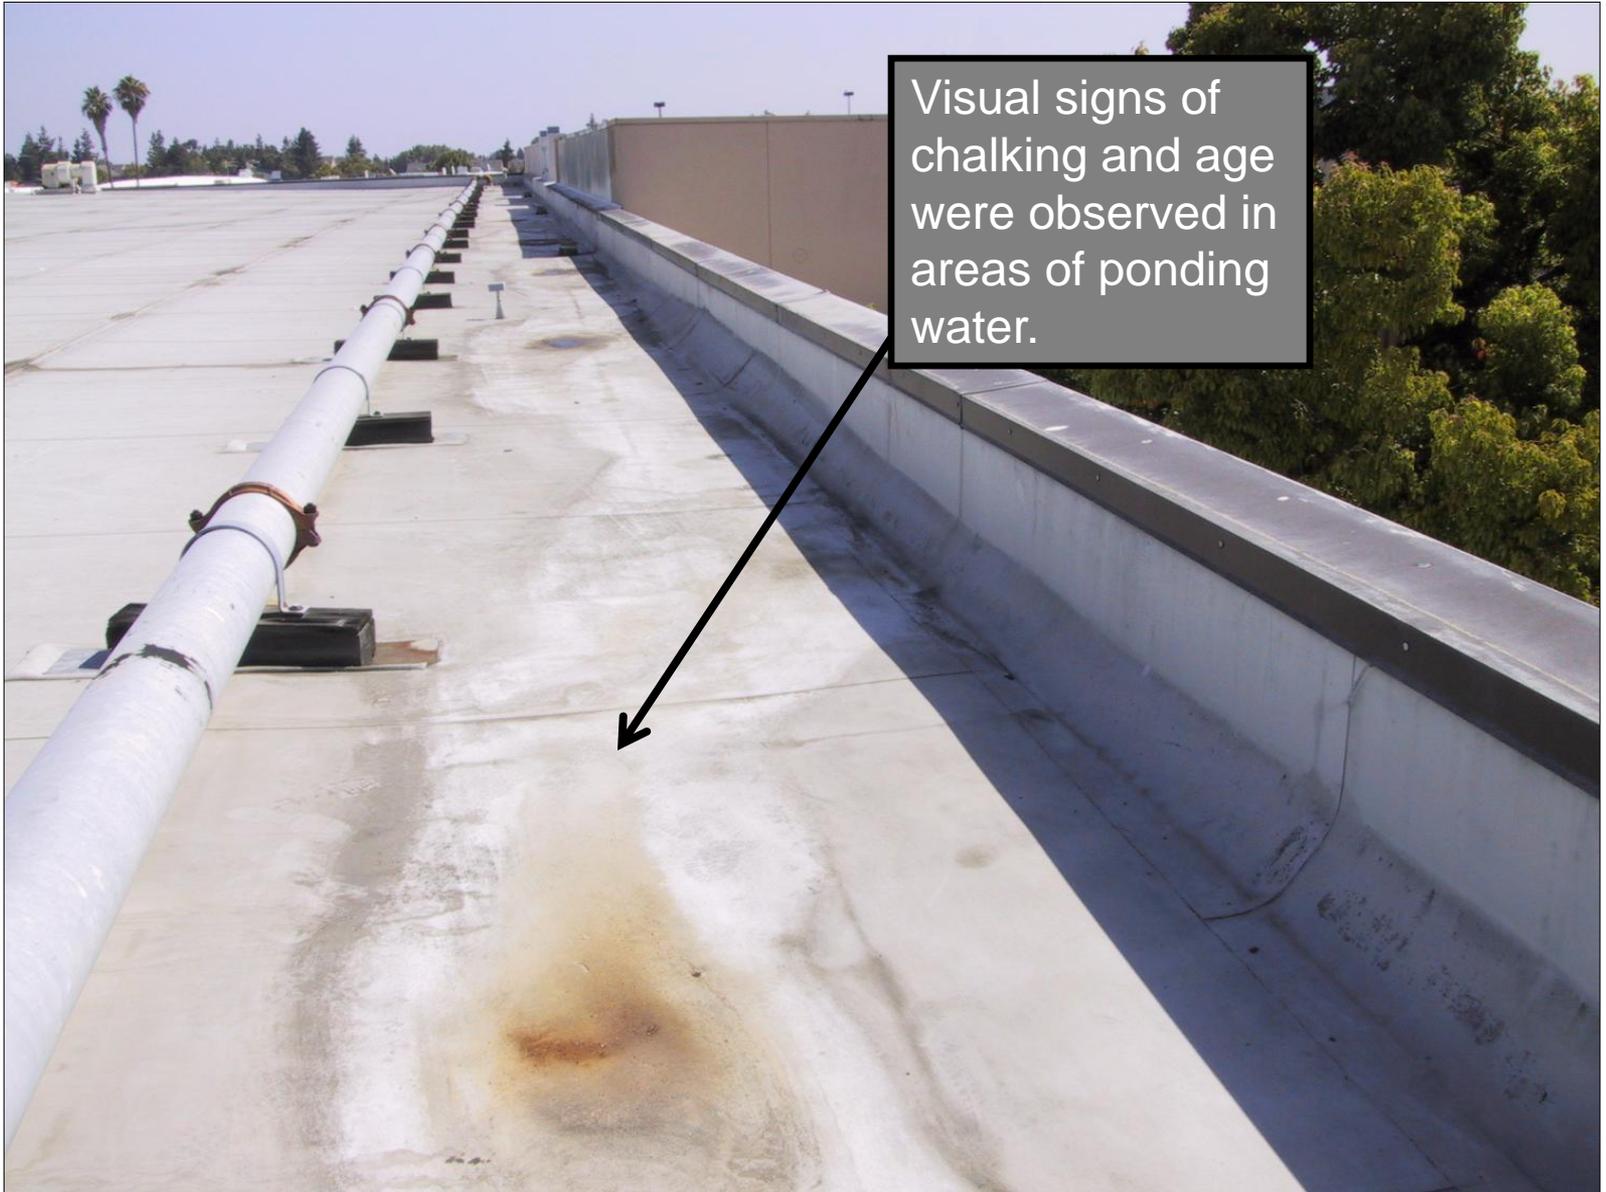
# Single Ply Susceptible To Standing Water

Visual signs of chalking and age were observed in areas of ponding water.

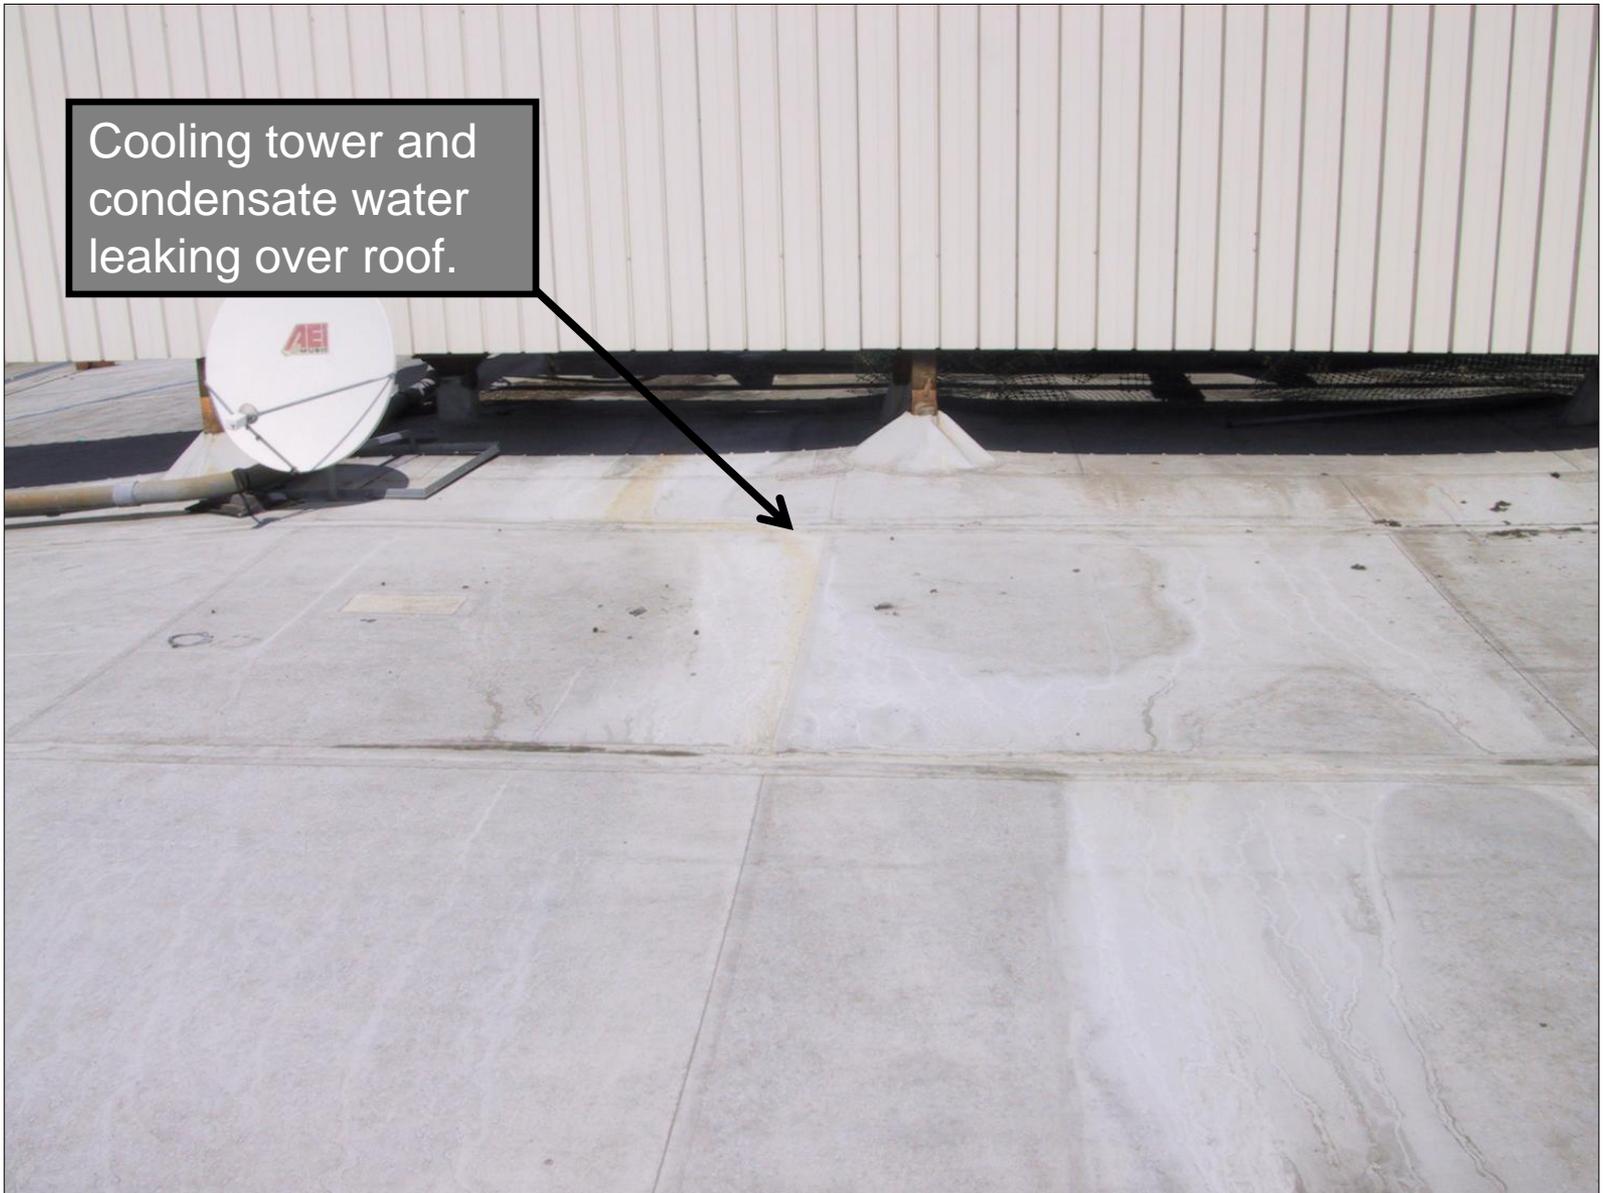
# Single Ply Susceptible To Standing Water

Cooling tower and condensate water leaking over roof.

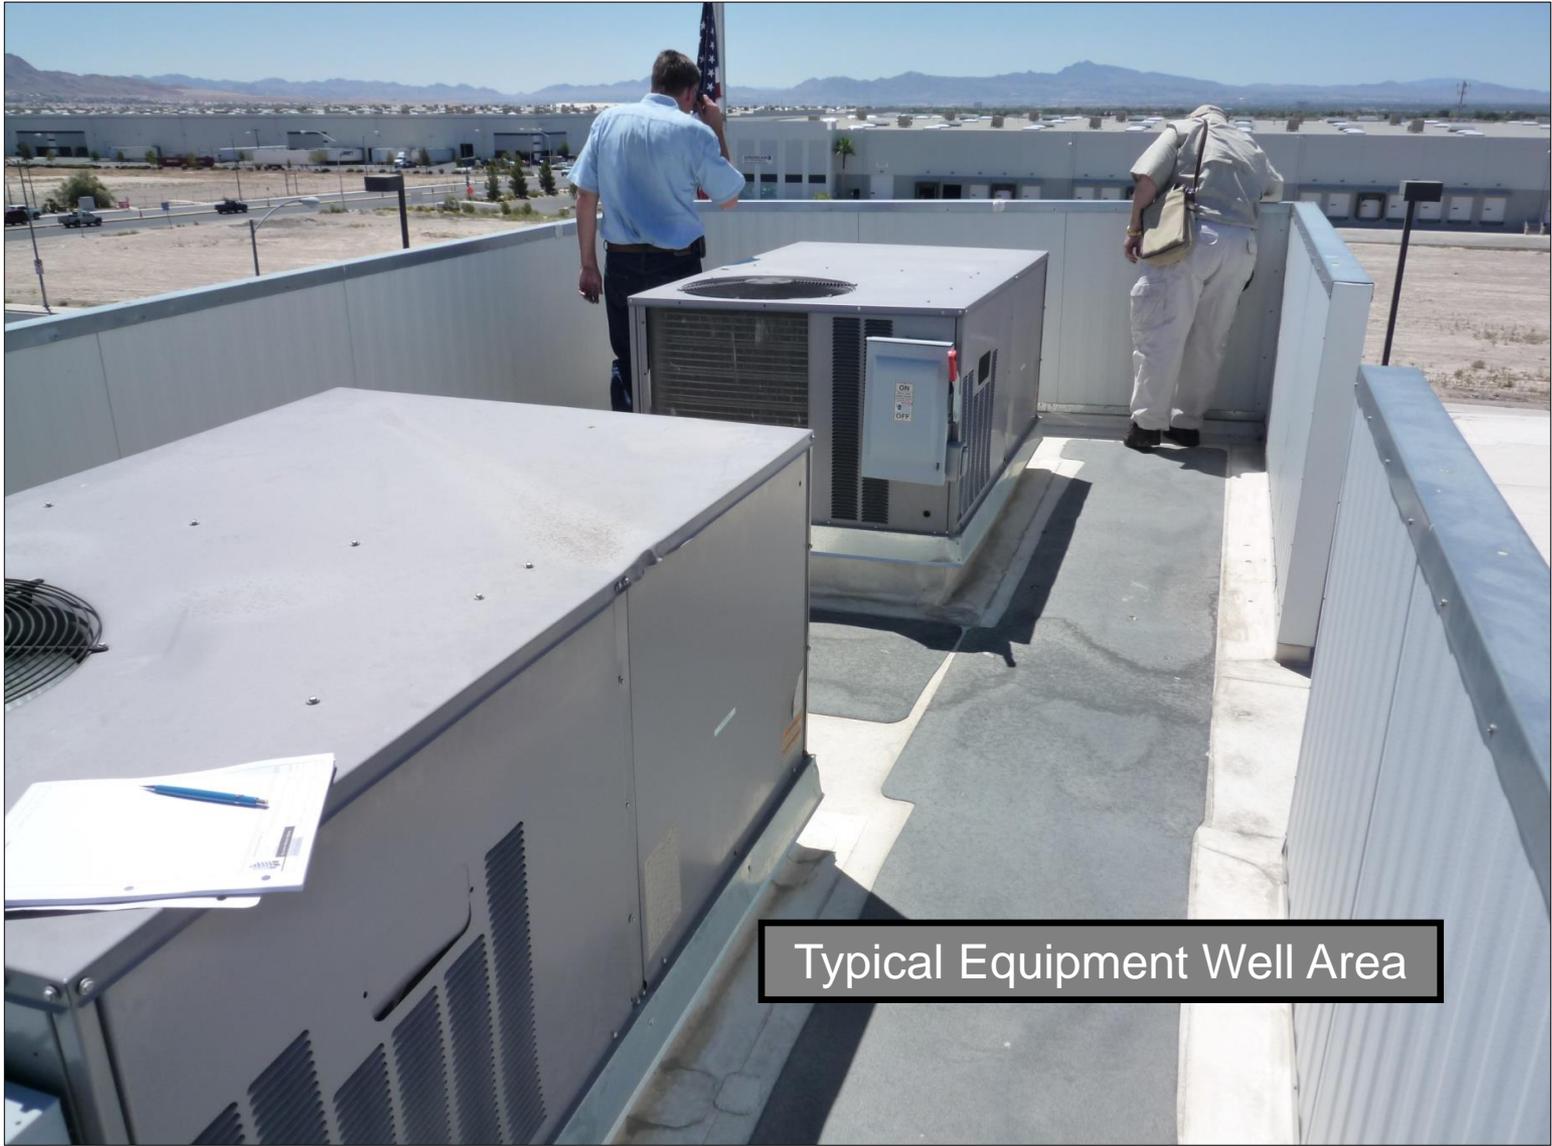
Typical Equipment Well Area

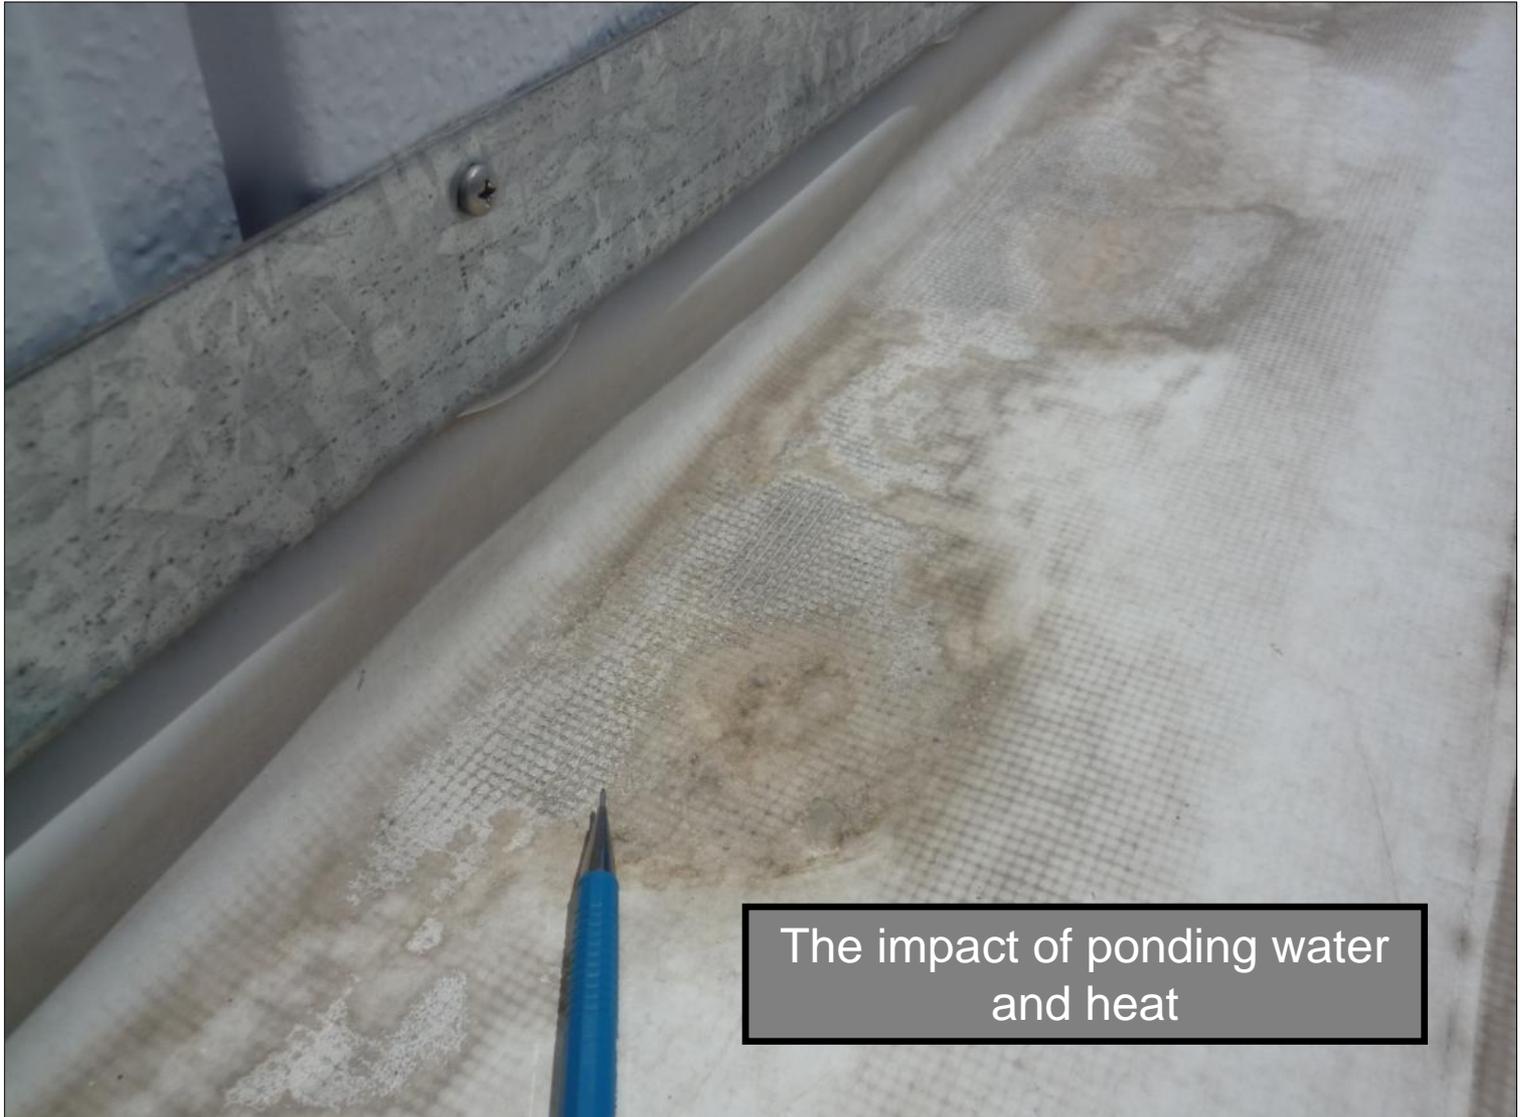
The impact of ponding water  
and heat

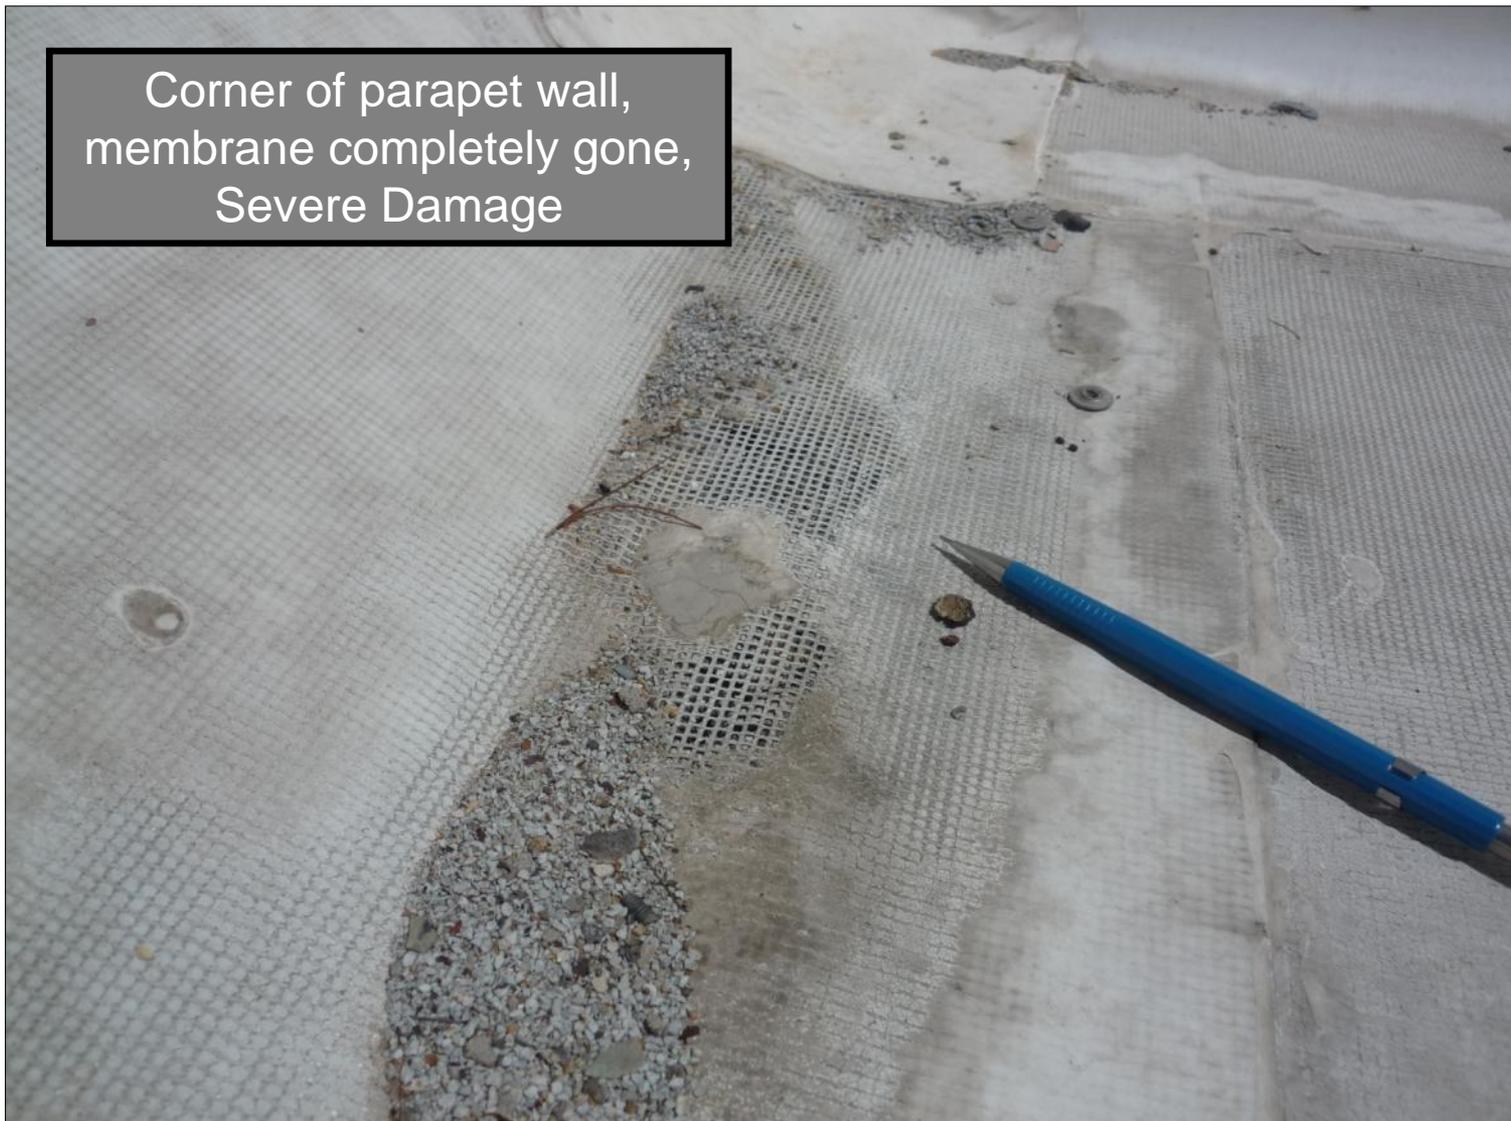
Corner of parapet wall,  
membrane completely gone,  
Severe Damage

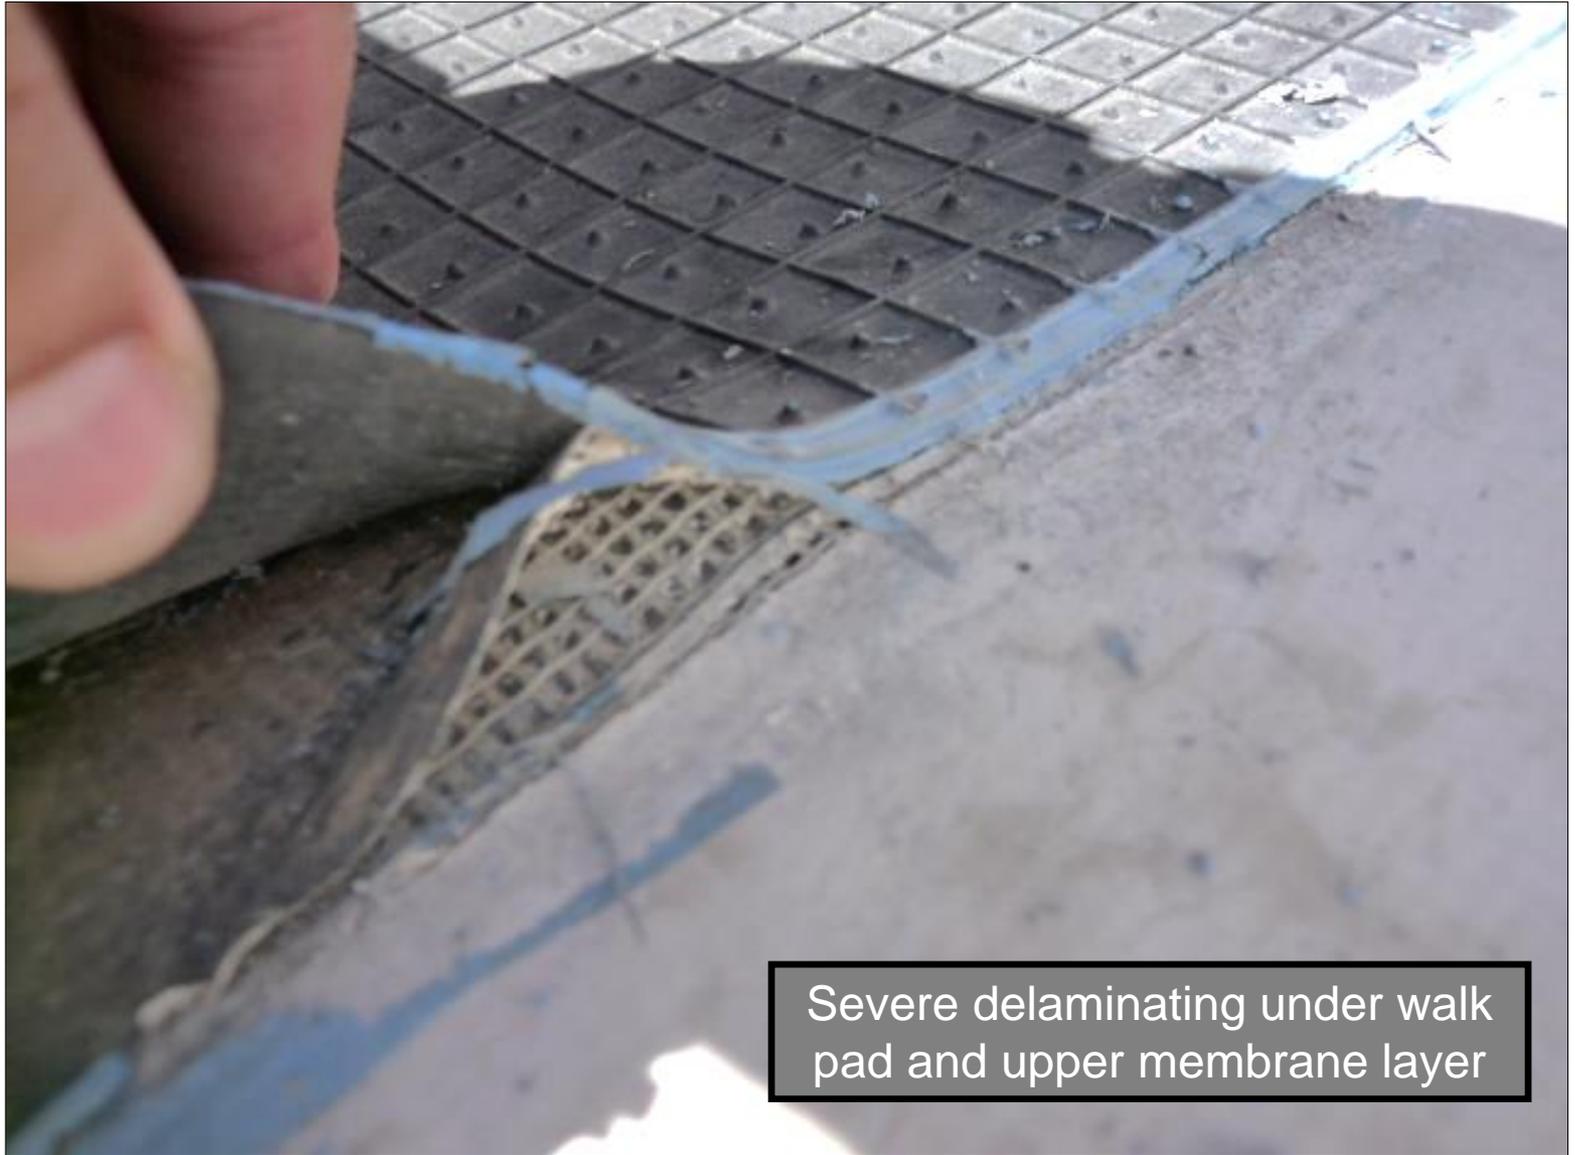
# 7 Years Old Carlisle, Hospital Building, Vegas

Severe delaminating under walk pad and upper membrane layer

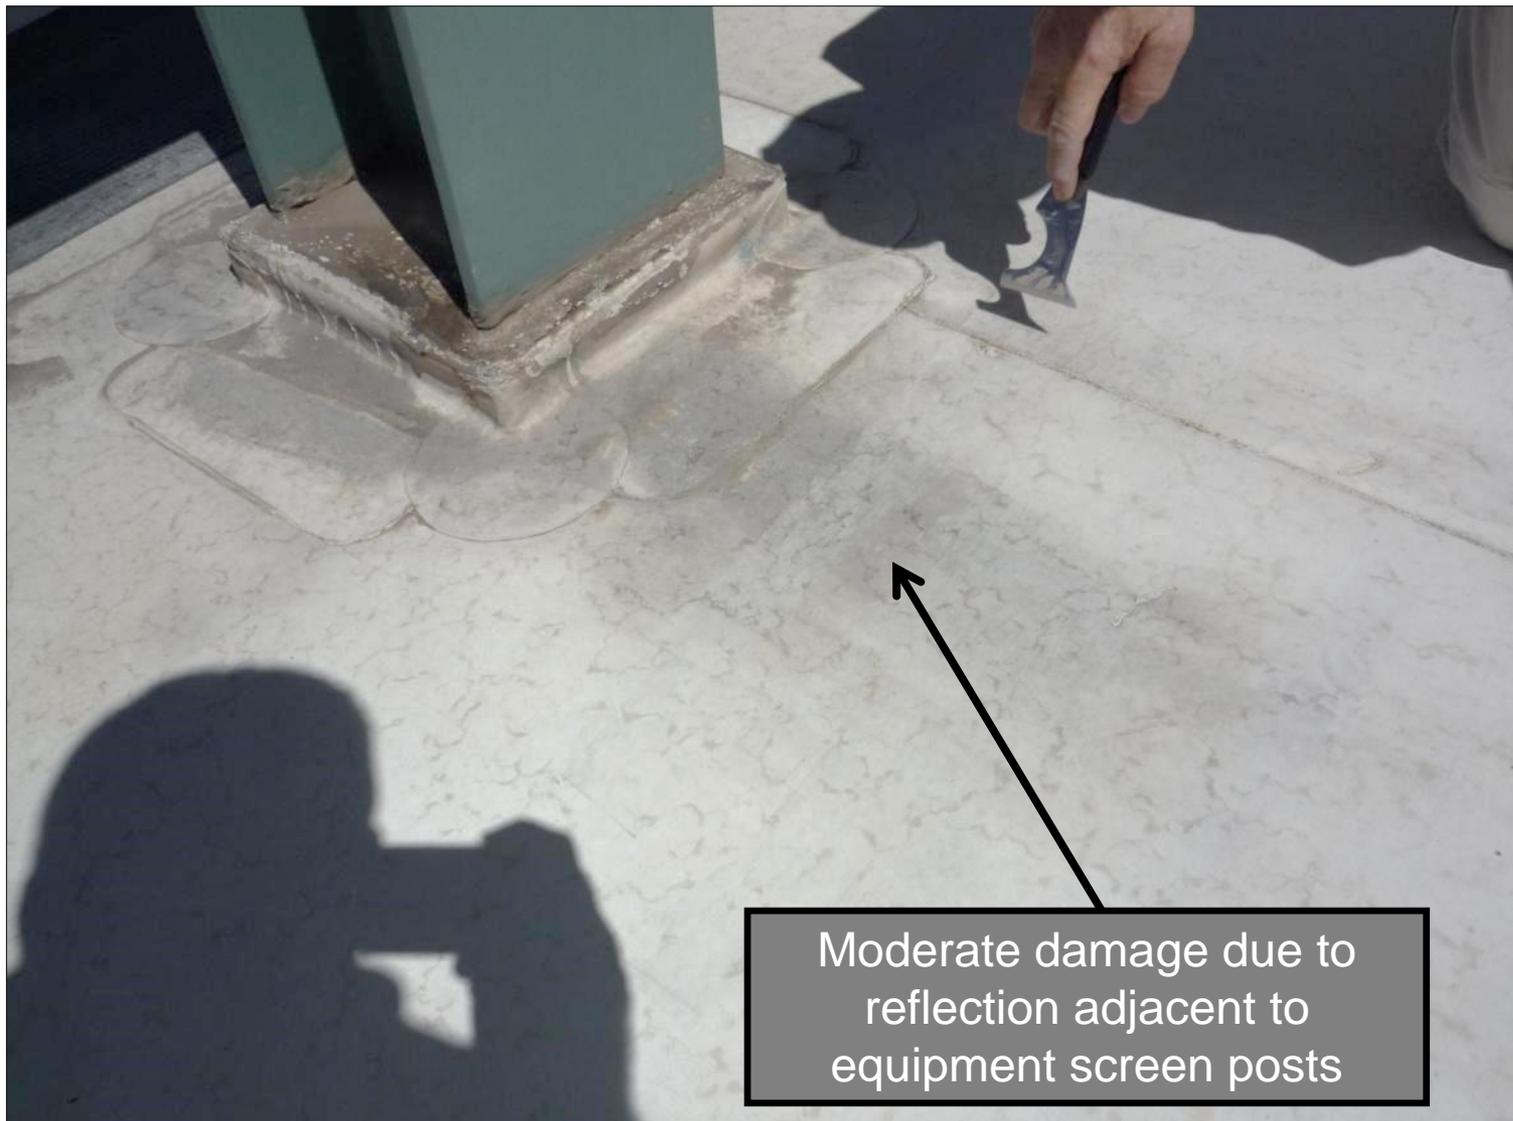
# 7 Years Old Carlisle, Hospital Building, Vegas

Moderate damage due to reflection adjacent to equipment screen posts

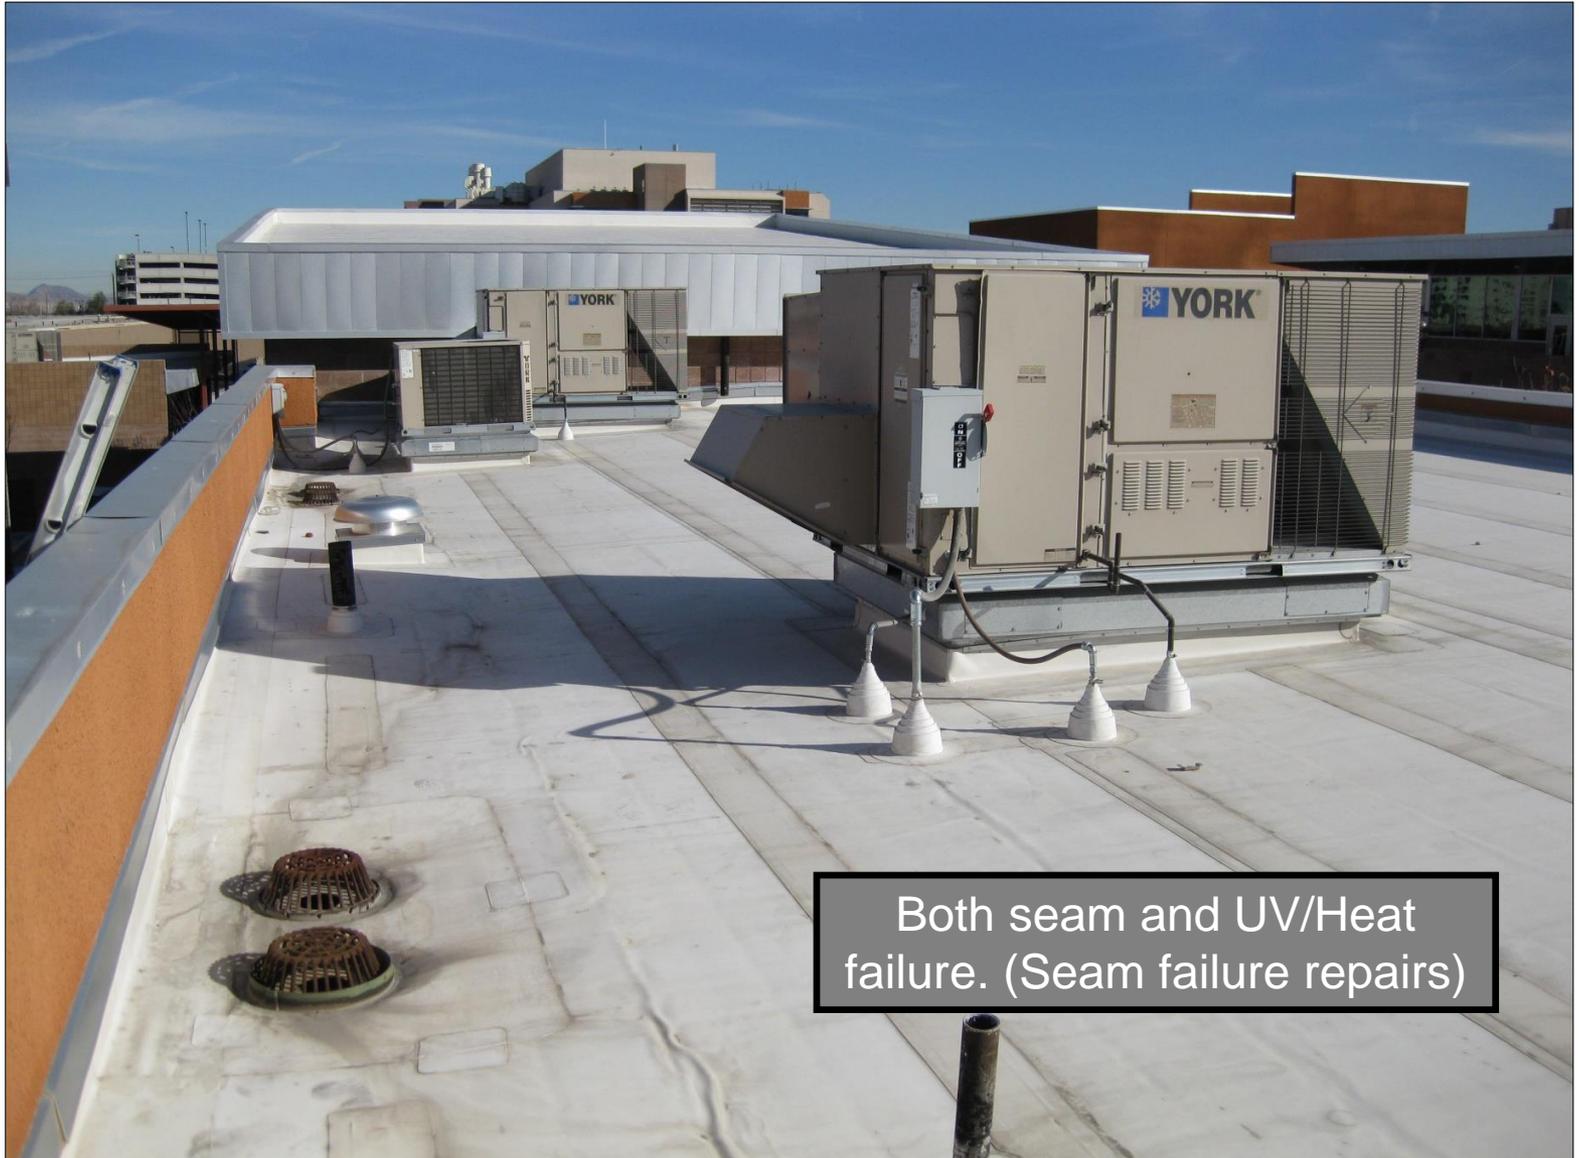
# UNLV, LBC Building, GAF 7 Years Old

Both seam and UV/Heat failure. (Seam failure repairs)

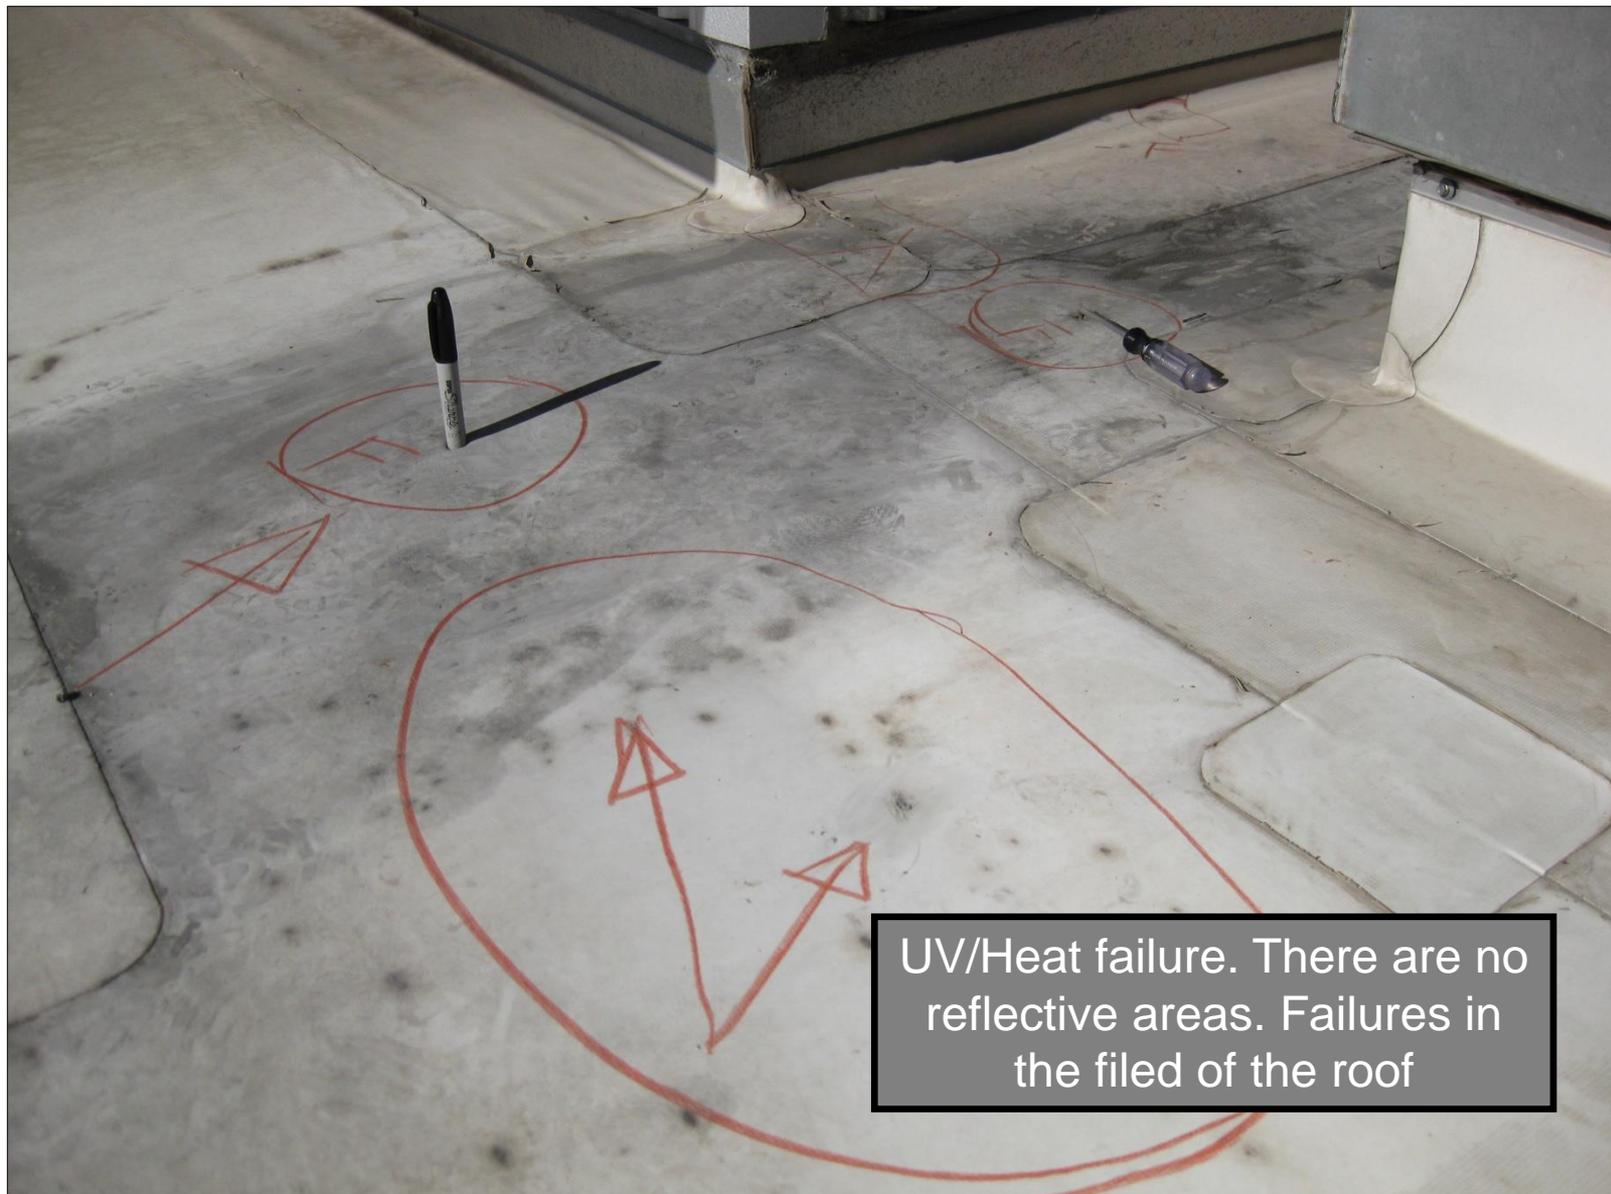
# UNLV, LBC Building, GAF 7 Years Old

UV/Heat failure. There are no reflective areas. Failures in the filed of the roof

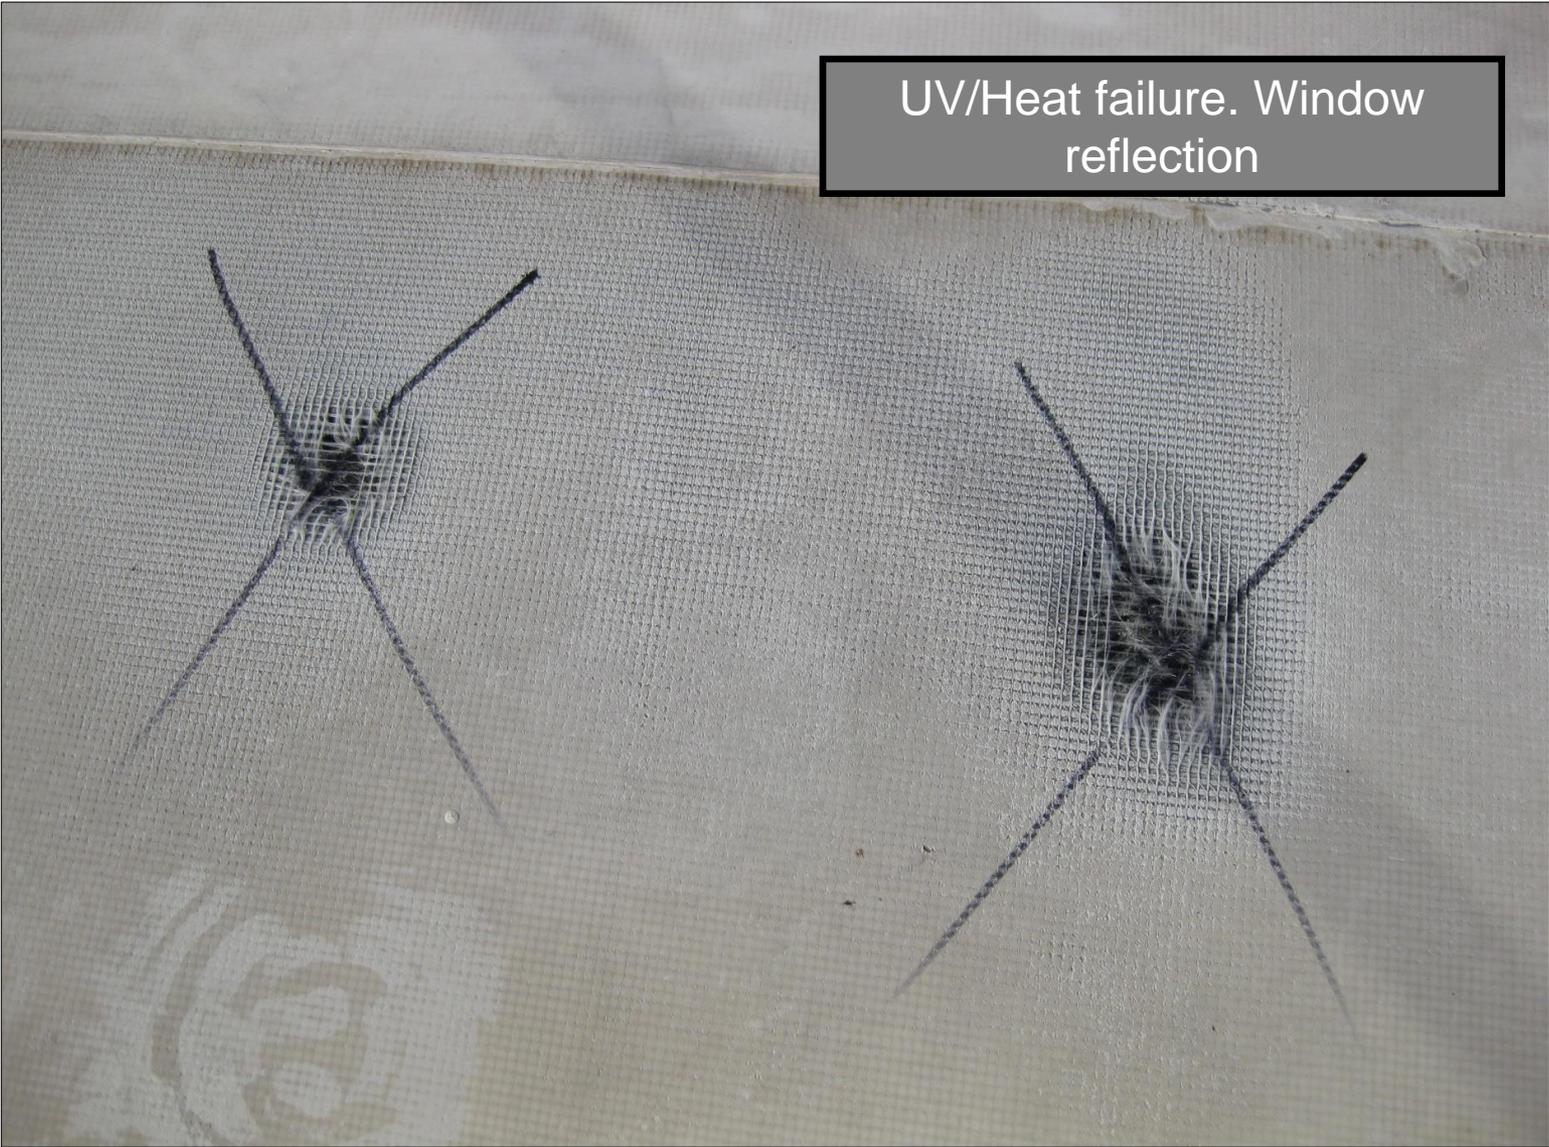
# UNLV, BSL Bridge Way, Carlisle, 10 Years Old

UV/Heat failure. Window reflection

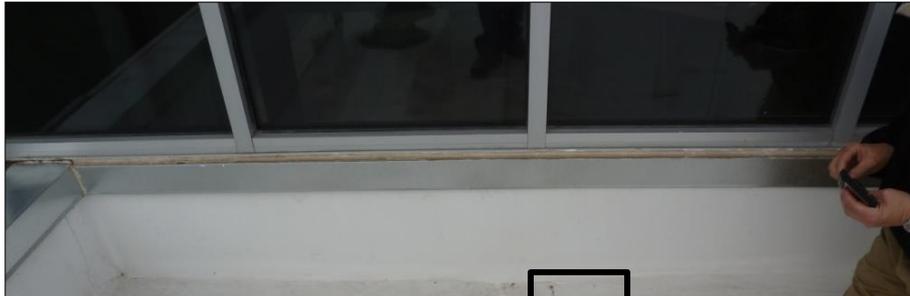
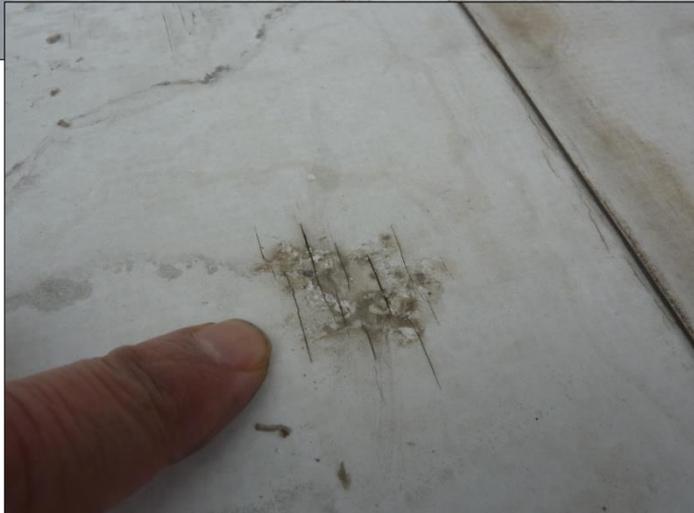
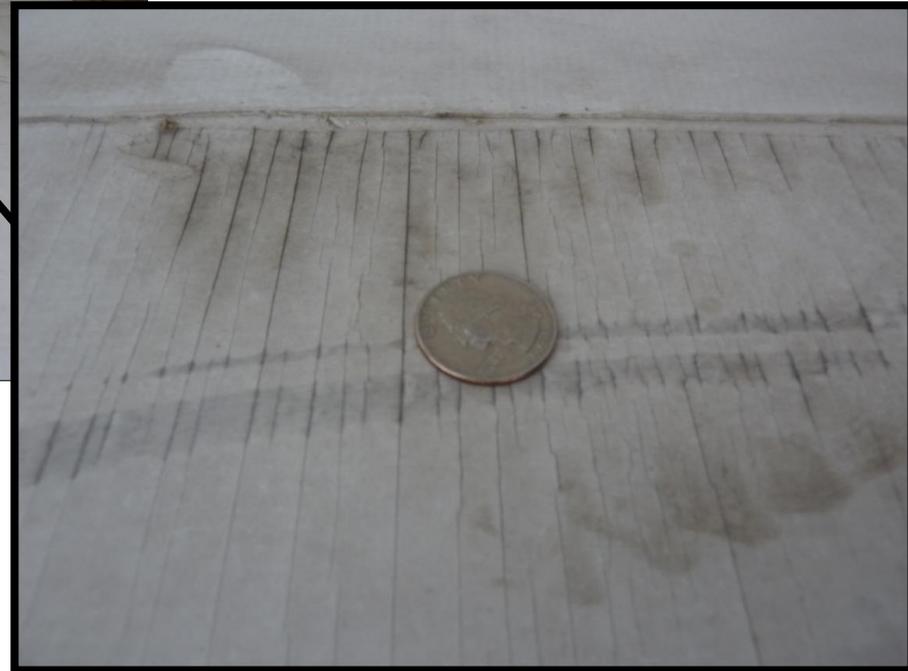
# GAF TPO 2.5 Years Old, Sun Reflection

This replacement GAF roof is less than 3 years old!

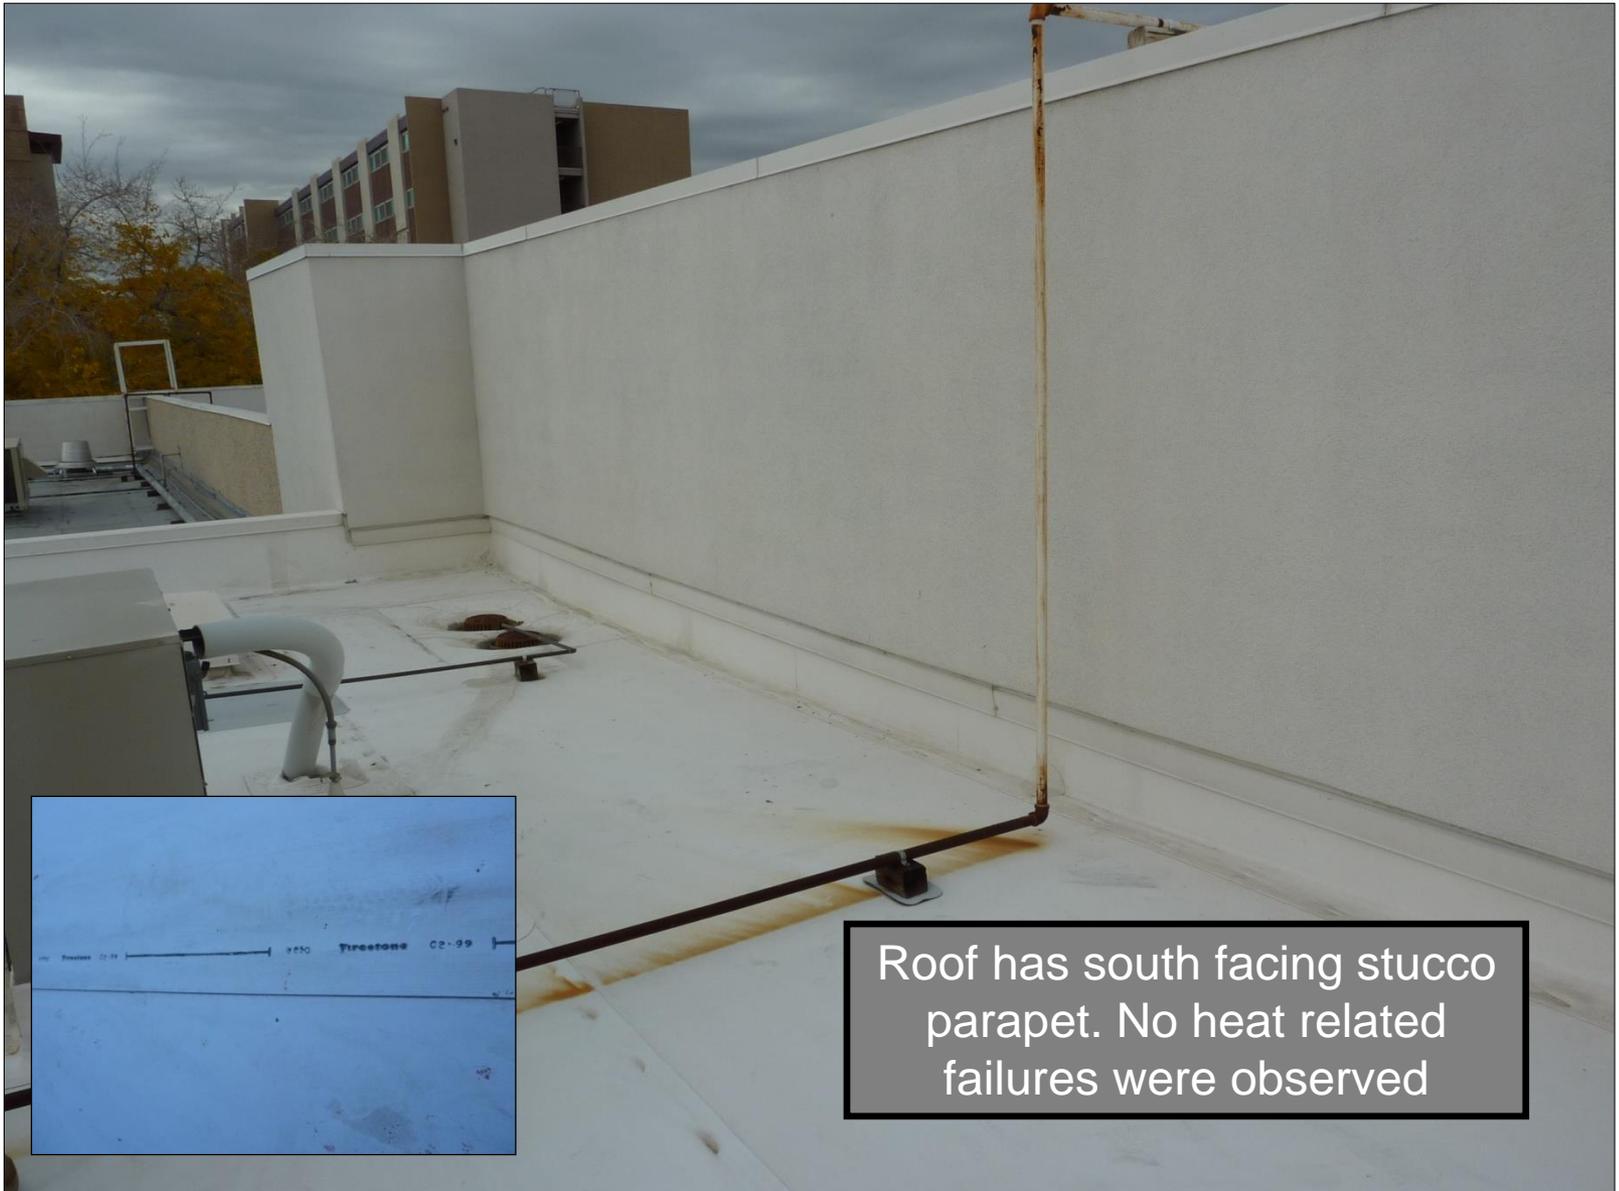
# UNLV Bookstore, Firestone 11 Years Old

Roof has south facing stucco parapet. No heat related failures were observed
