**ALLANA BUICK & BERS**

## **Life Expectancy and Longevity of Buildings and Assemblies**

Condo Council of Maui 2016 Seminar  
November 16, 2016

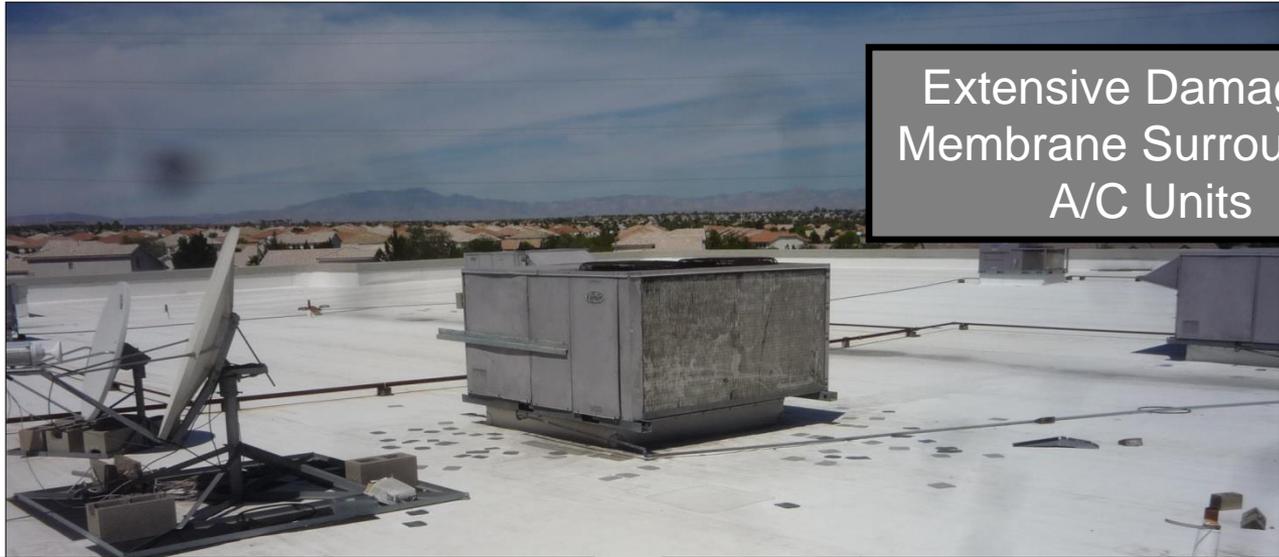
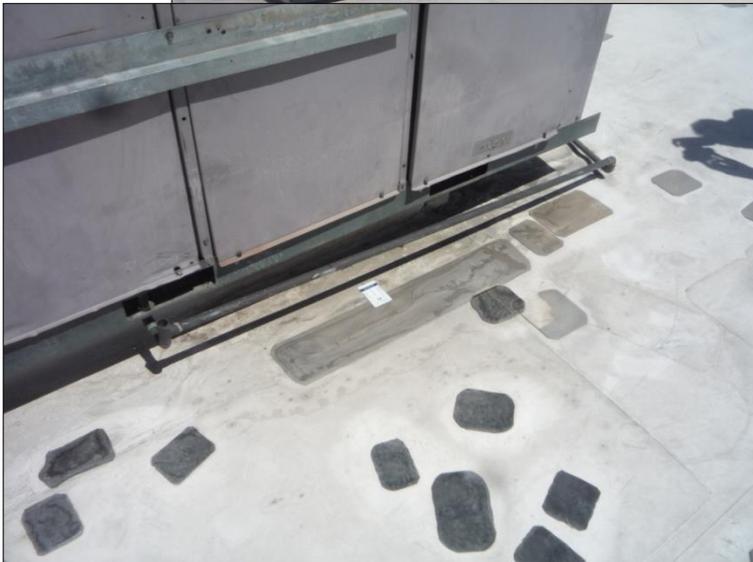
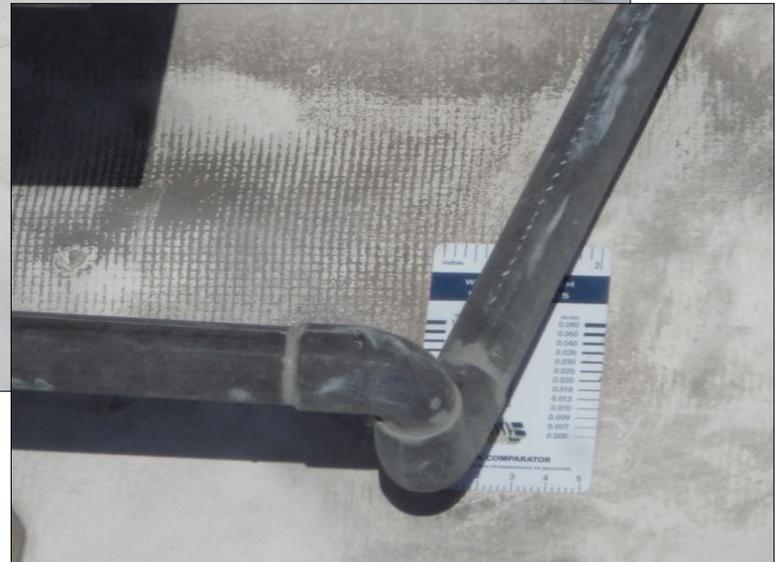
# Carlisle Roof

Extensive Damage to Membrane Surrounding A/C Units

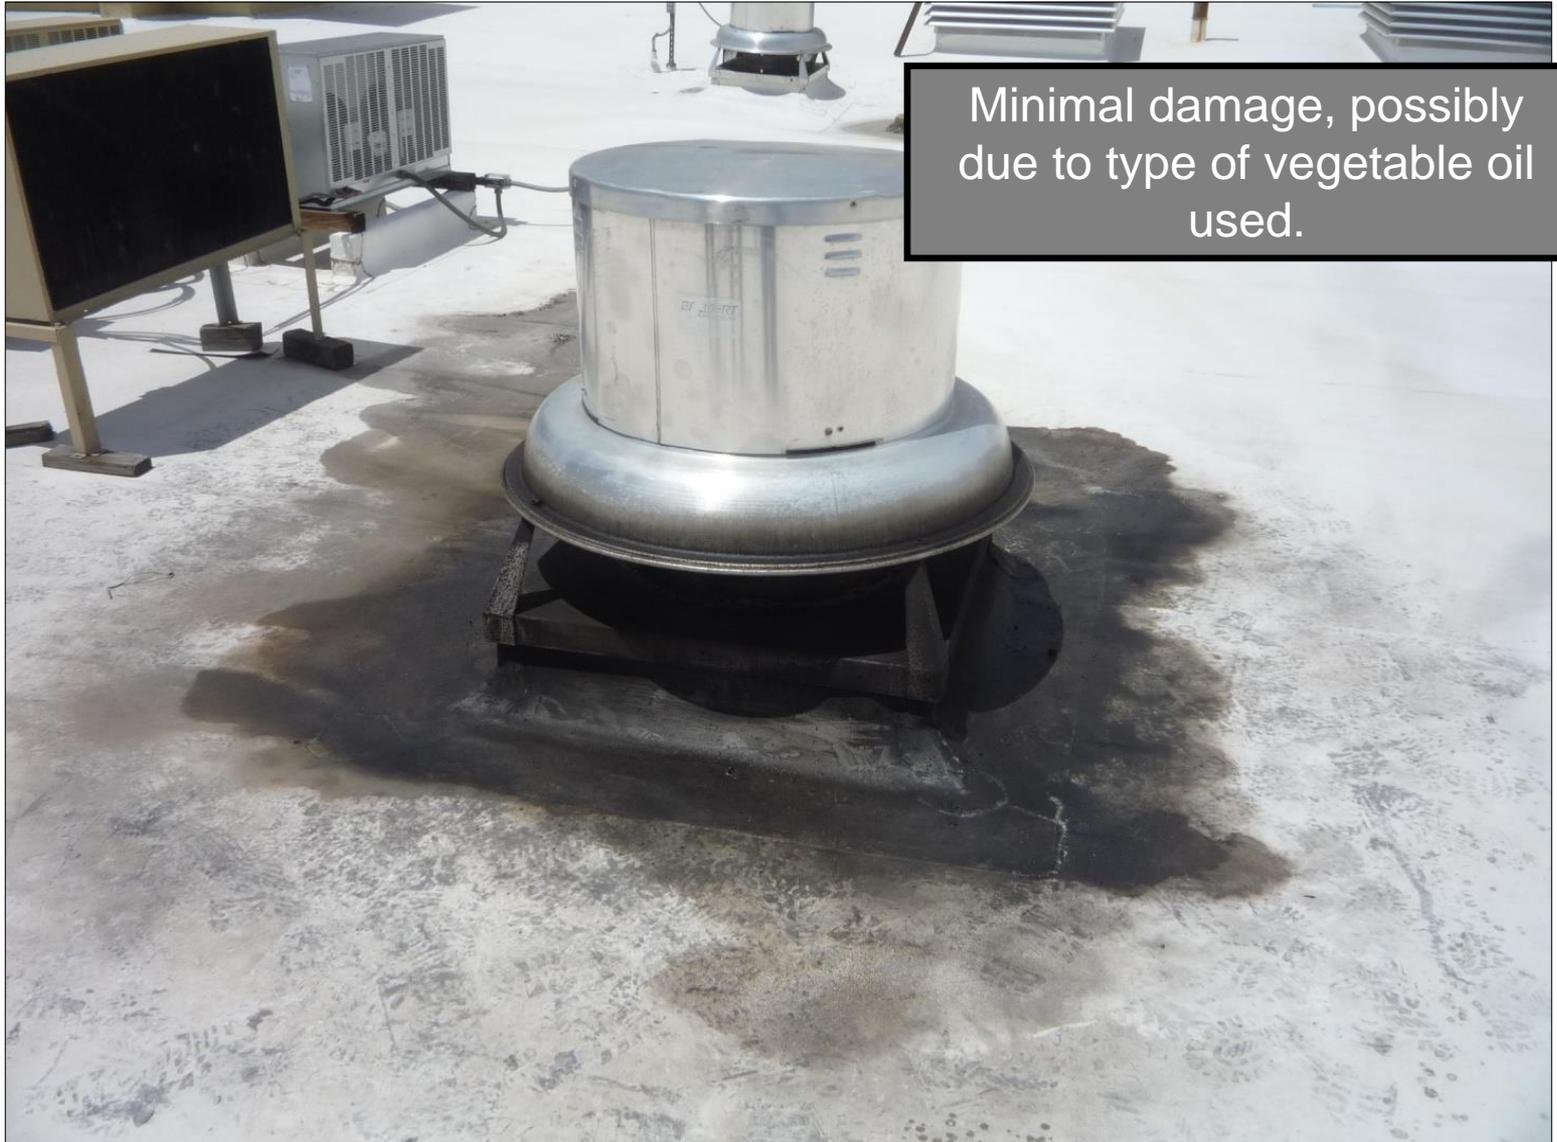
# Grease Fan

Minimal damage, possibly due to type of vegetable oil used.

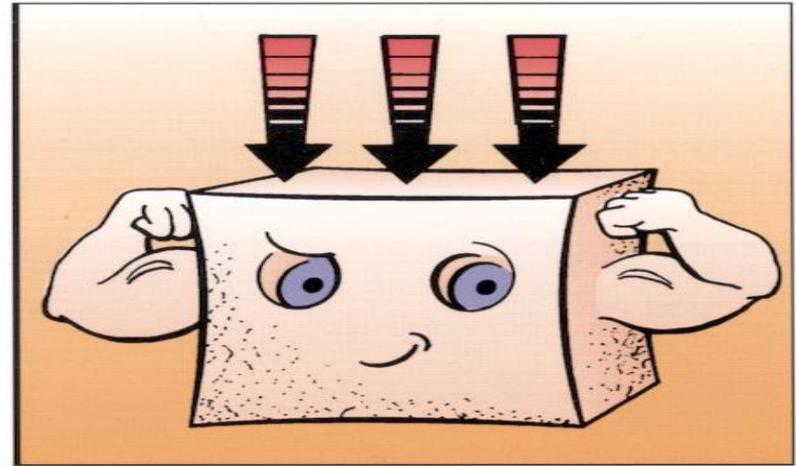
Concrete is strong in compression but weak in tension. Steel reinforcing bars provide tensile strength to concrete

*Concrete is Good in Compression*

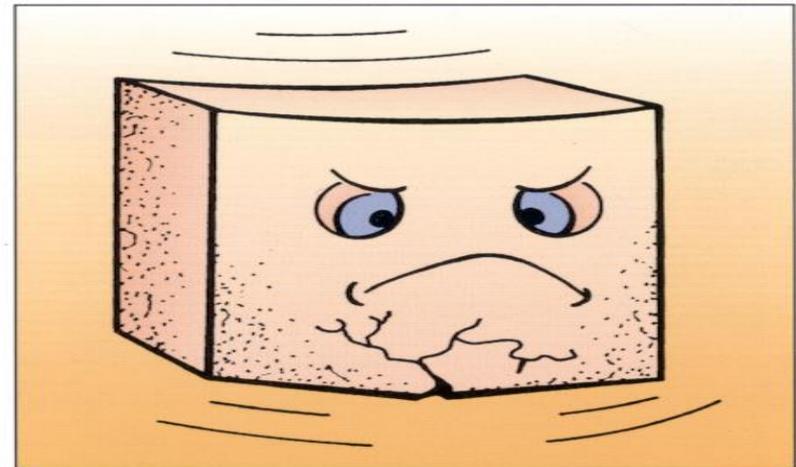
*Concrete is Poor in Tension*

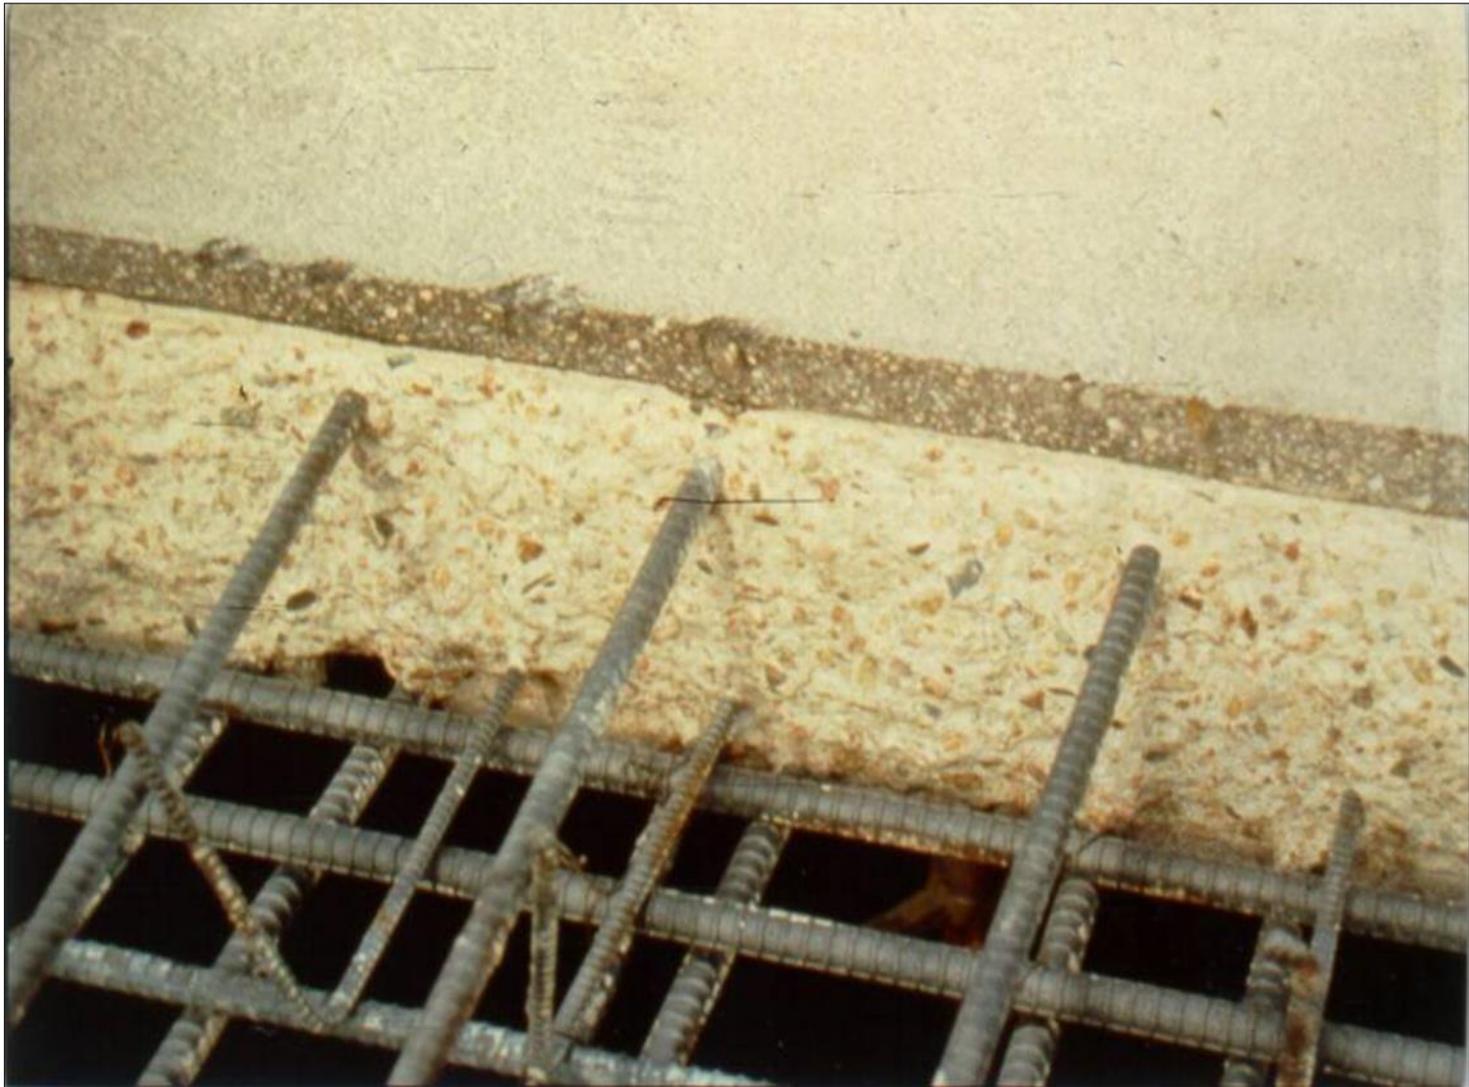
# Reinforcing Steel Provides “Tensile” Strength

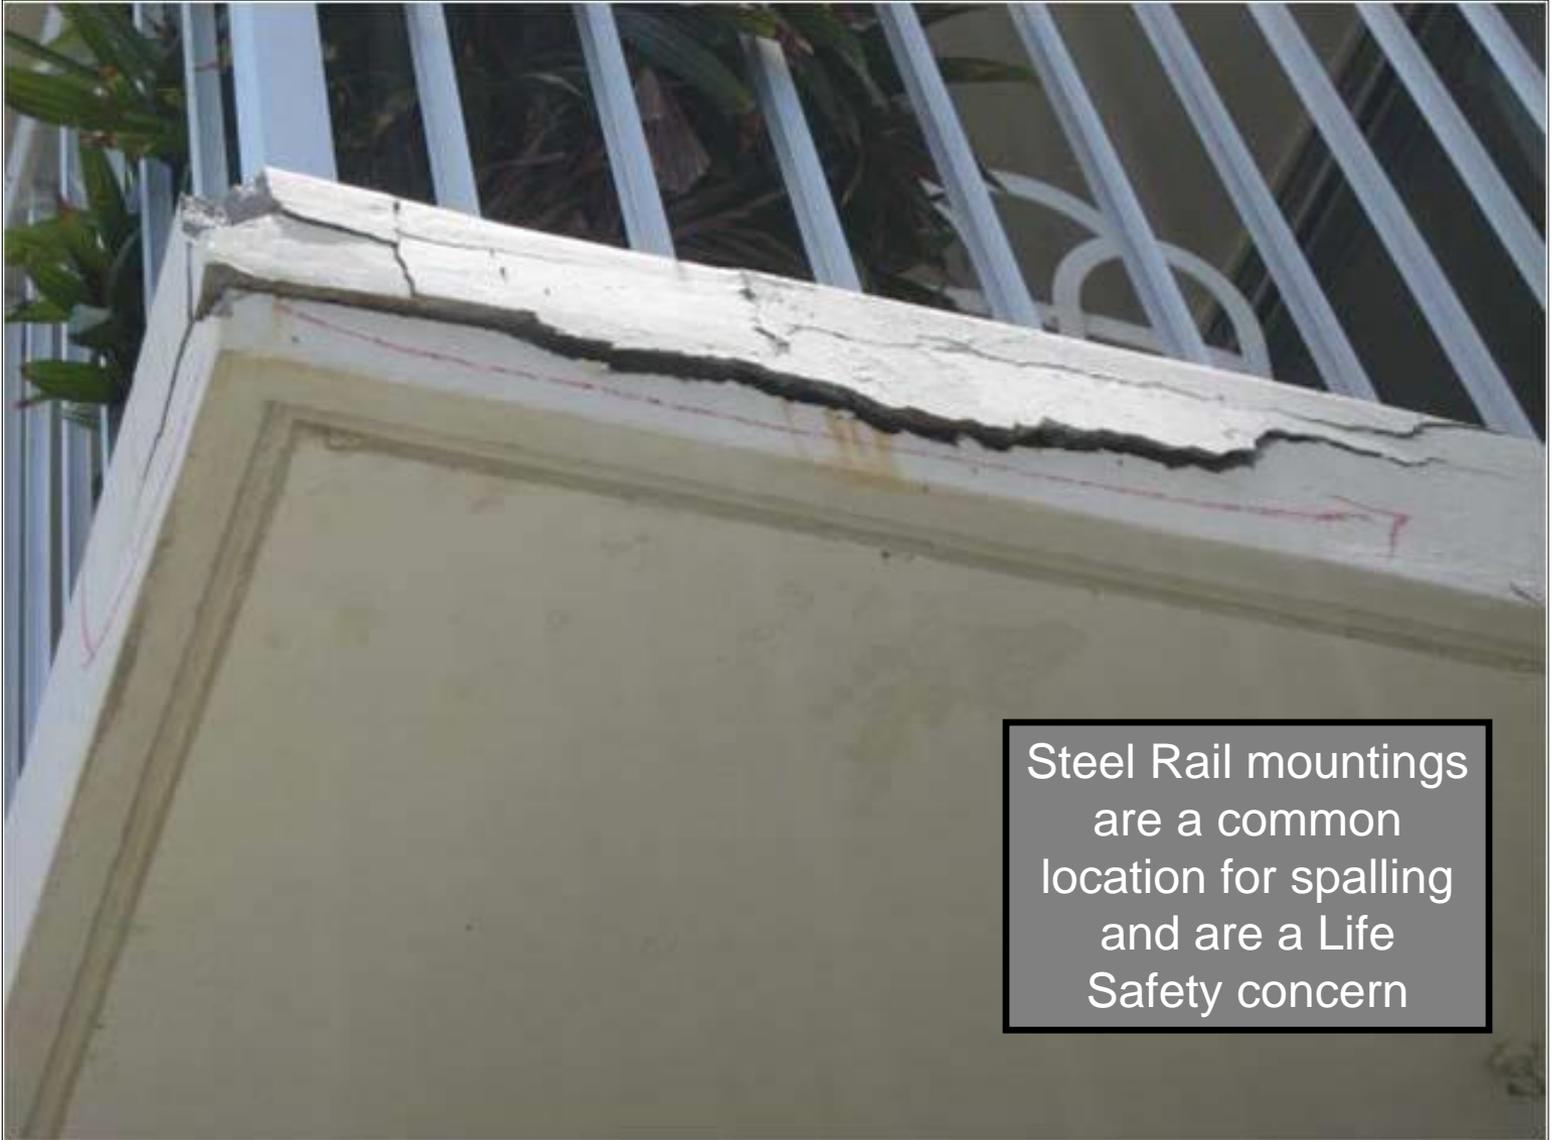
Steel Rail mountings  
are a common  
location for spalling  
and are a Life  
Safety concern

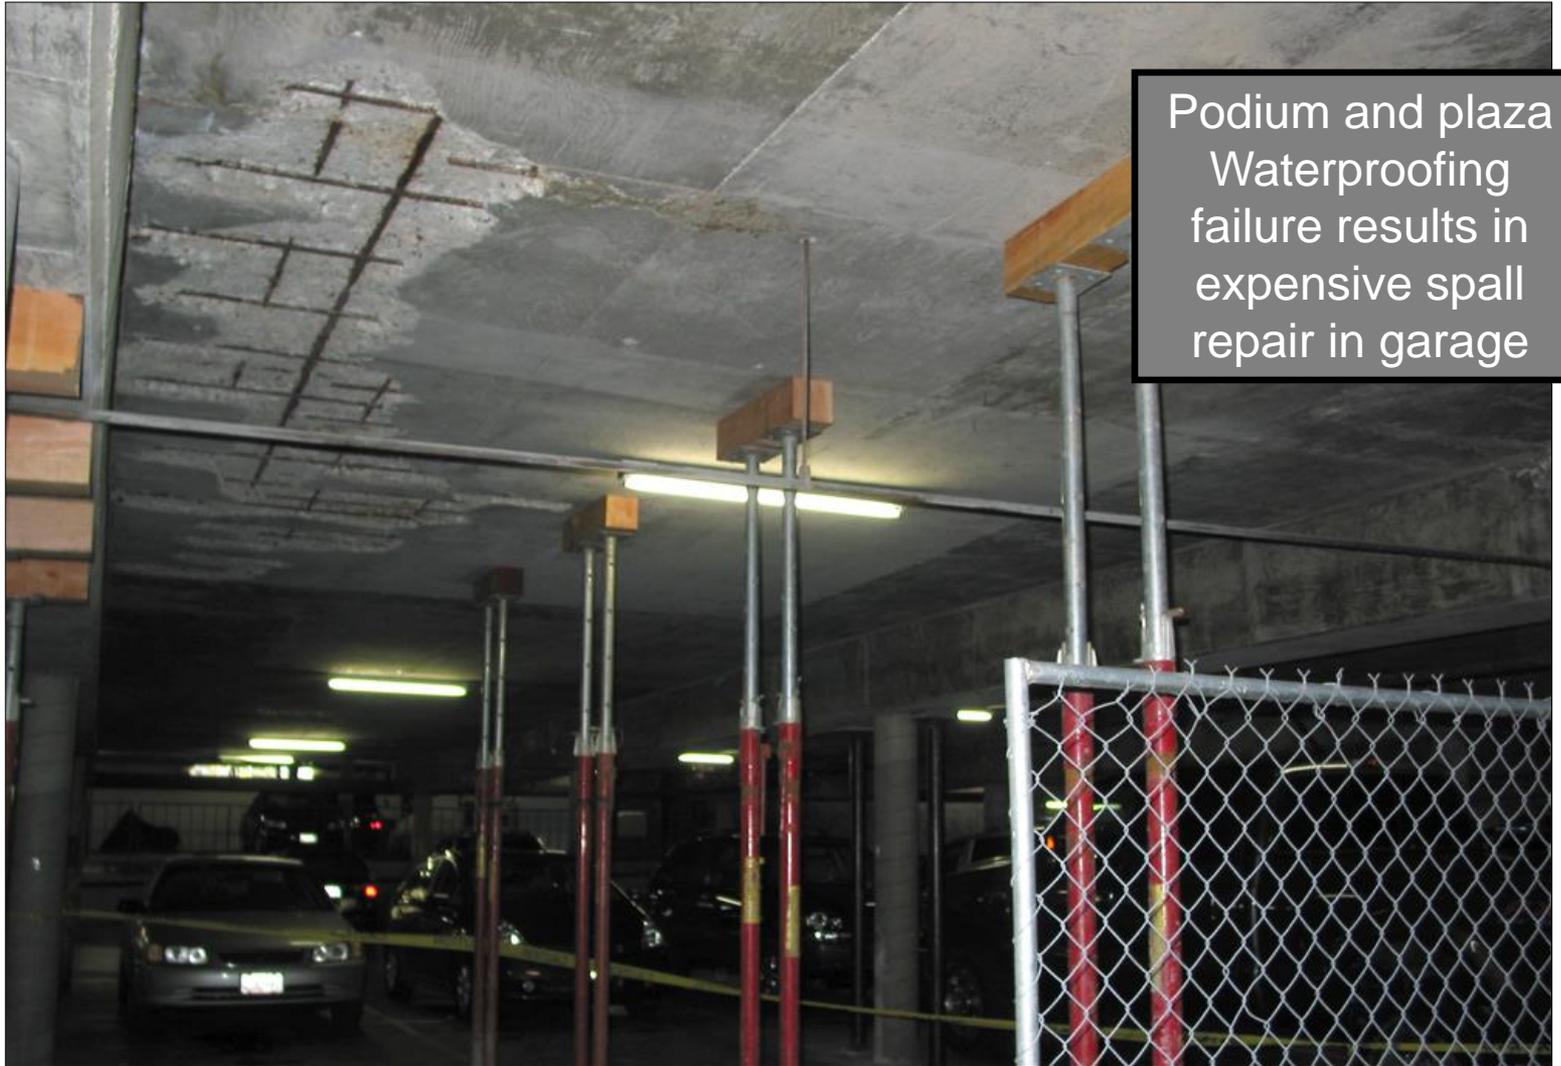
Podium and plaza  
Waterproofing  
failure results in  
expensive spall  
repair in garage

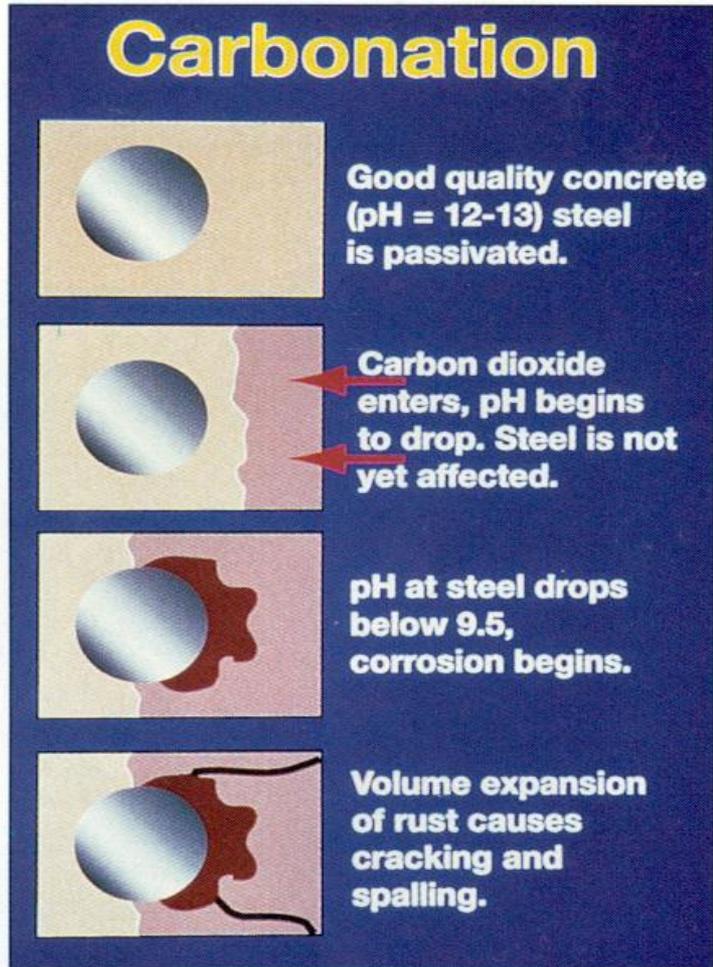
# Phenolphthalein Test For Carbonation

Figure 2. When the carbonation front reaches the level of the reinforcement, the passivating oxide layer of the rebar is no longer stable, and corrosion begins.

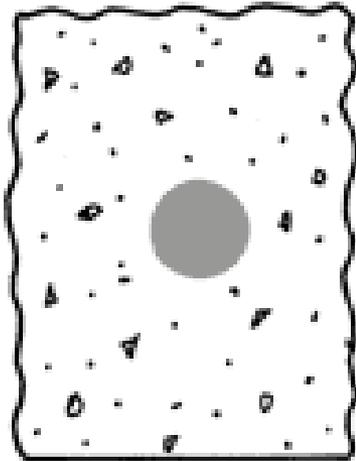
**Before  
Corrosion**

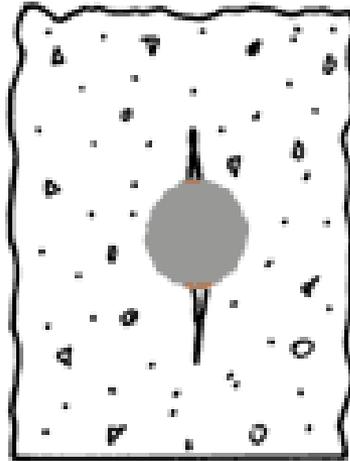
**Build-up of  
Corrosion Products**

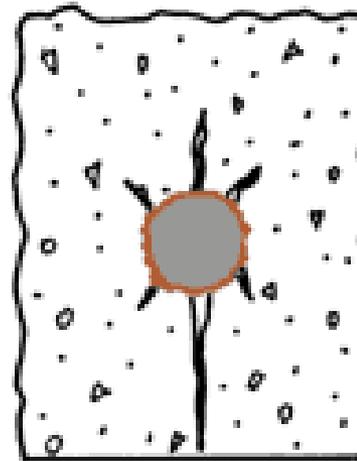
**Further Corrosion:  
Surface Cracks,  
Stains**

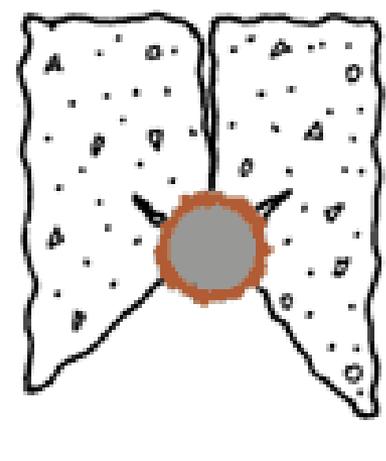
**Eventual Spalling,  
Corroded Bar  
Exposed**

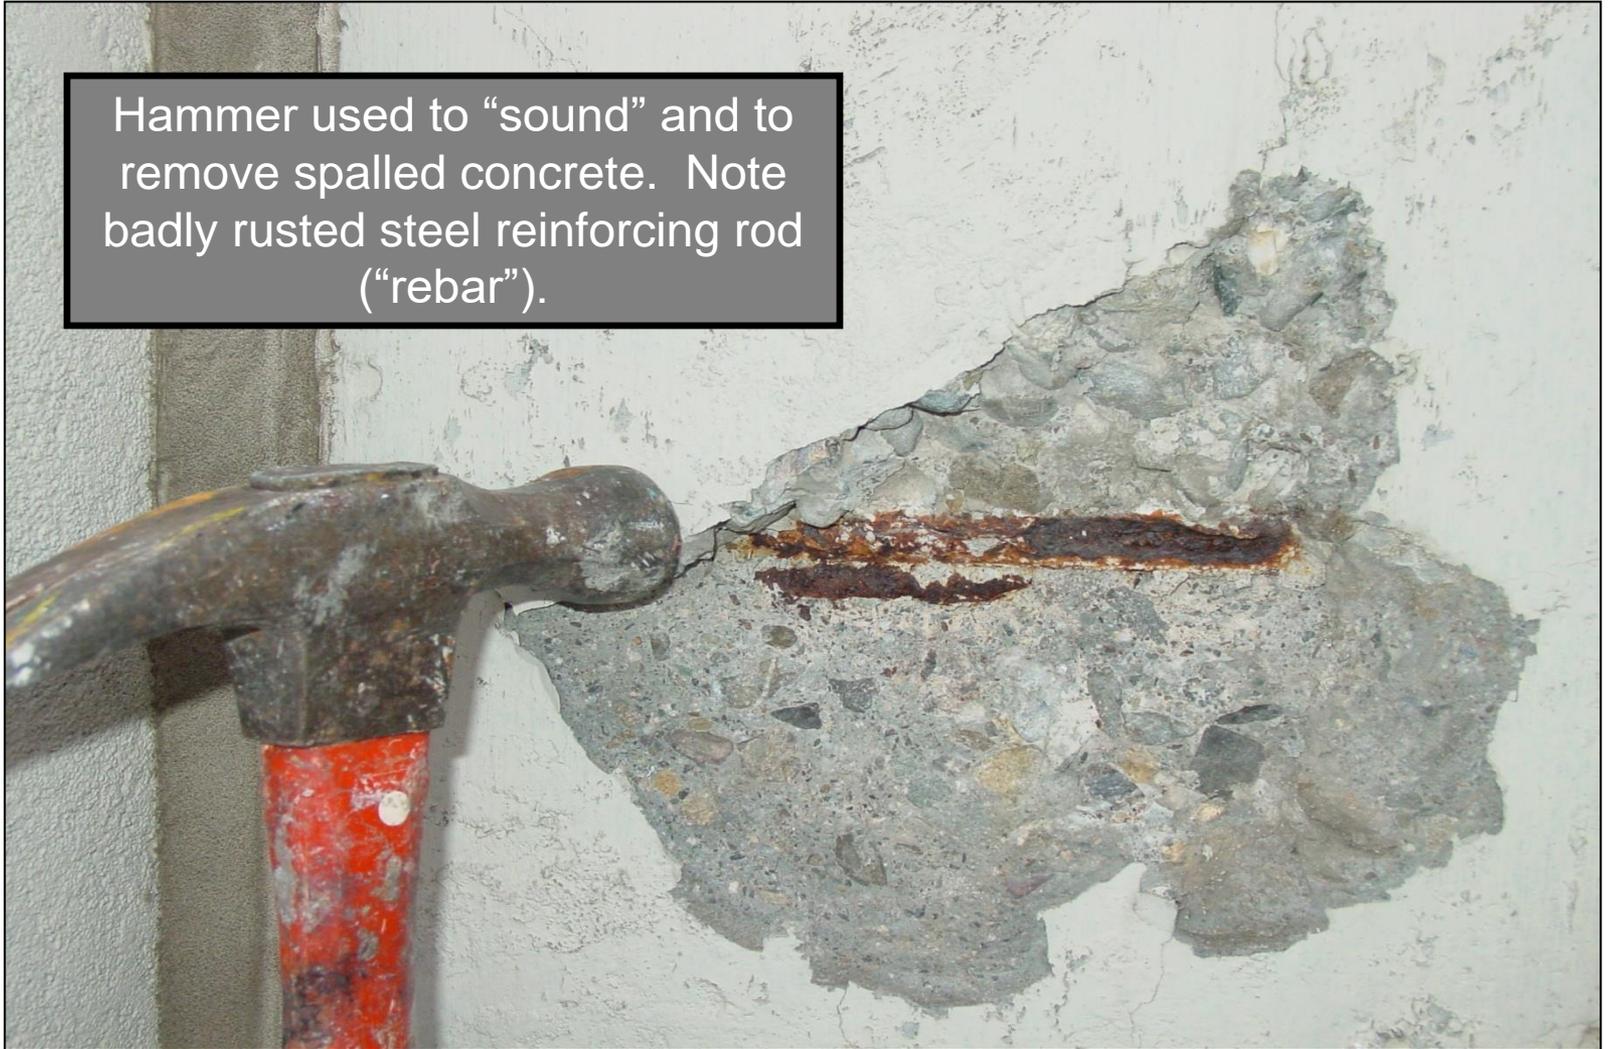
# Finding Concrete Spalls

Hammer used to “sound” and to remove spalled concrete. Note badly rusted steel reinforcing rod (“rebar”).

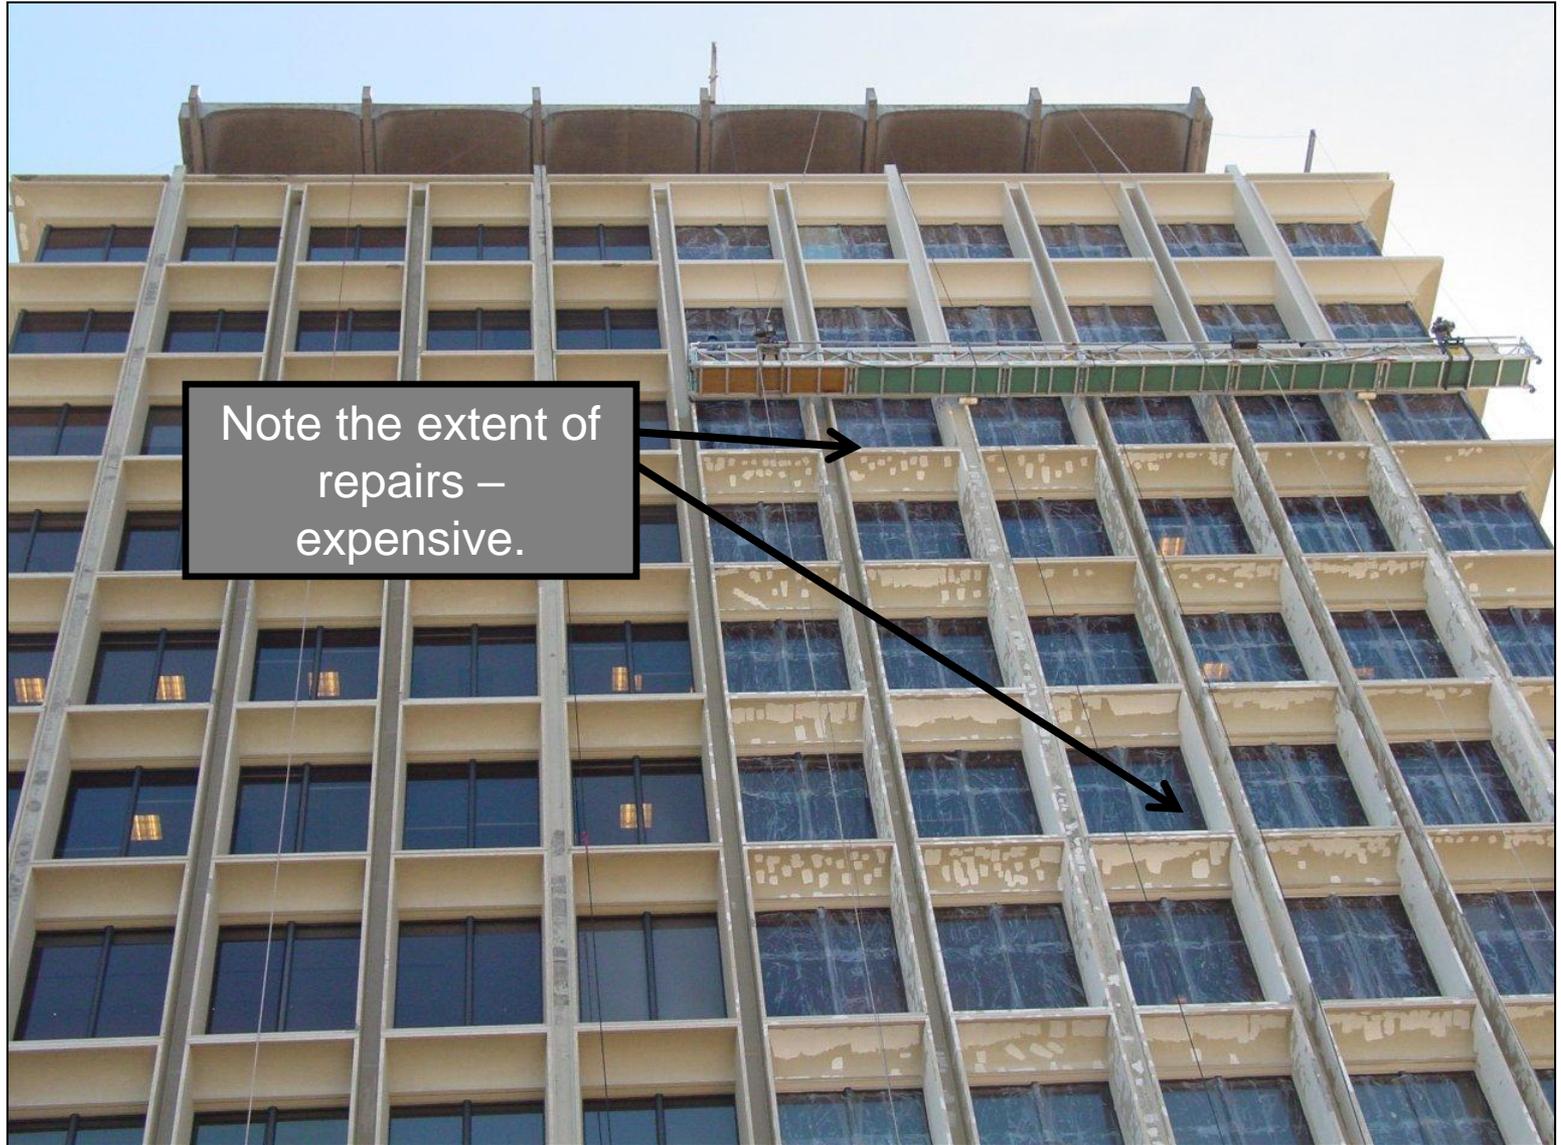
# Define Extent of Concrete Spall Repair

Note the extent of repairs – expensive.

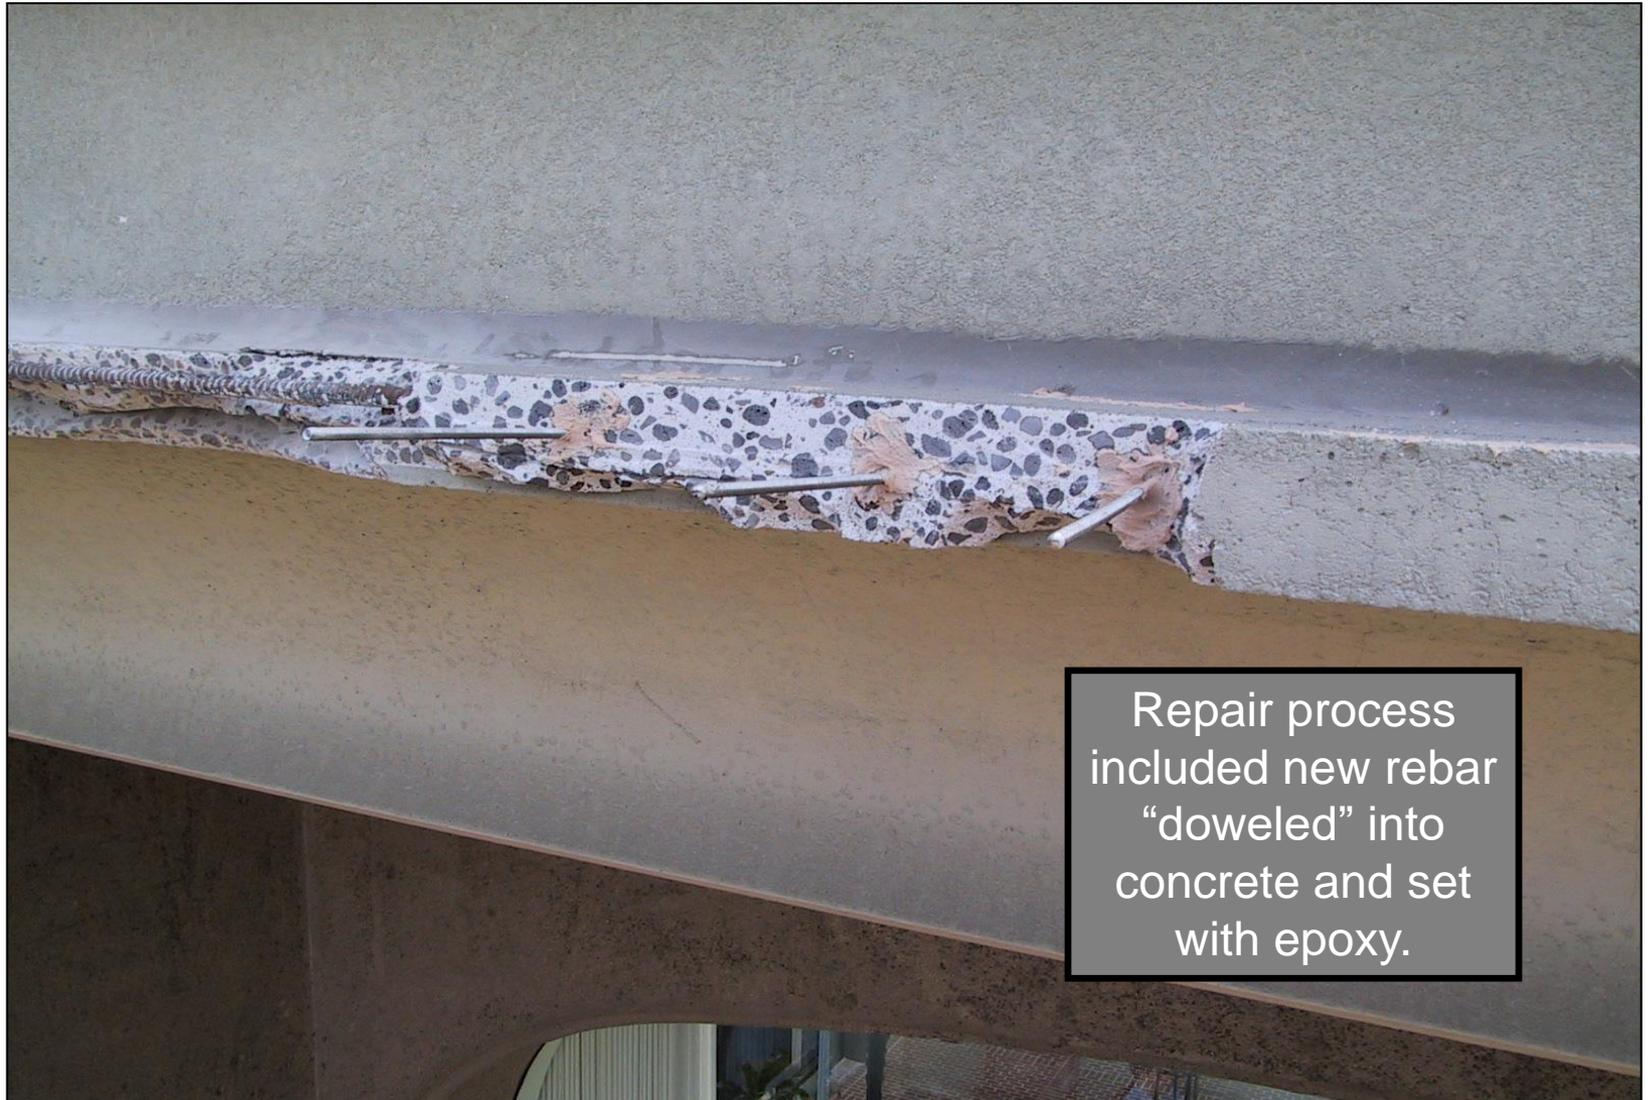
# Repairs to Concrete

Repair process included new rebar "doweled" into concrete and set with epoxy.

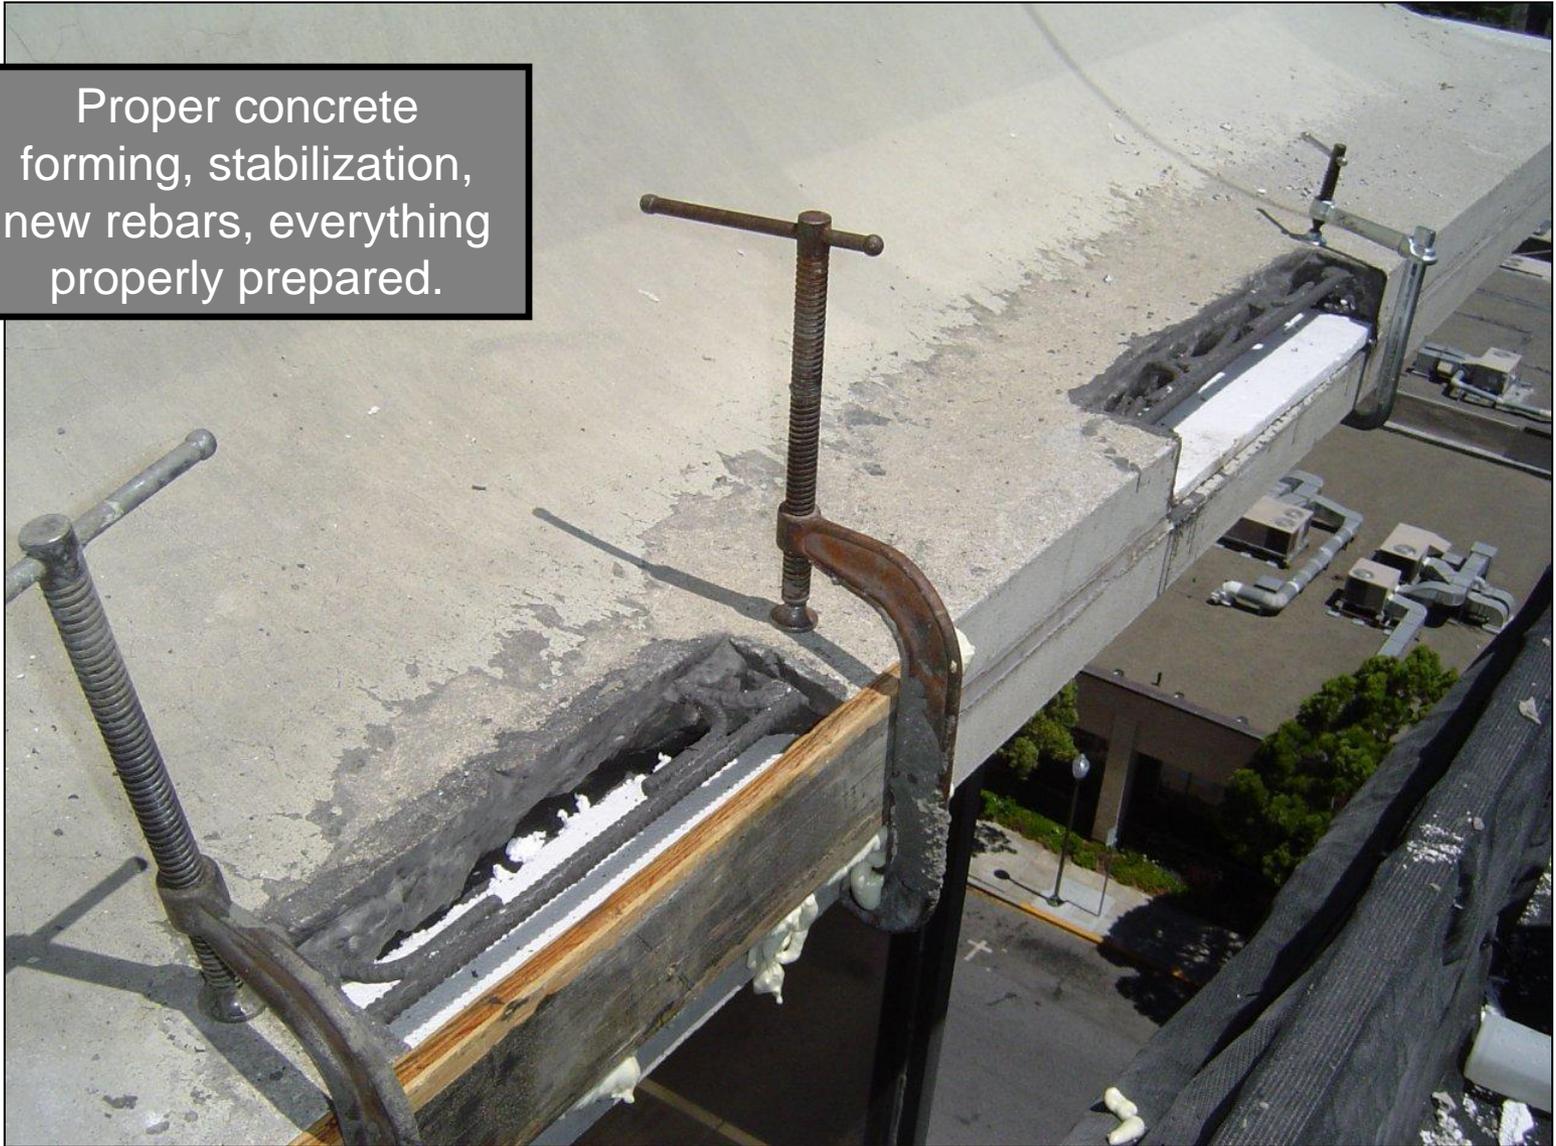
# During Repairs

Proper concrete forming, stabilization, new rebar, everything properly prepared.

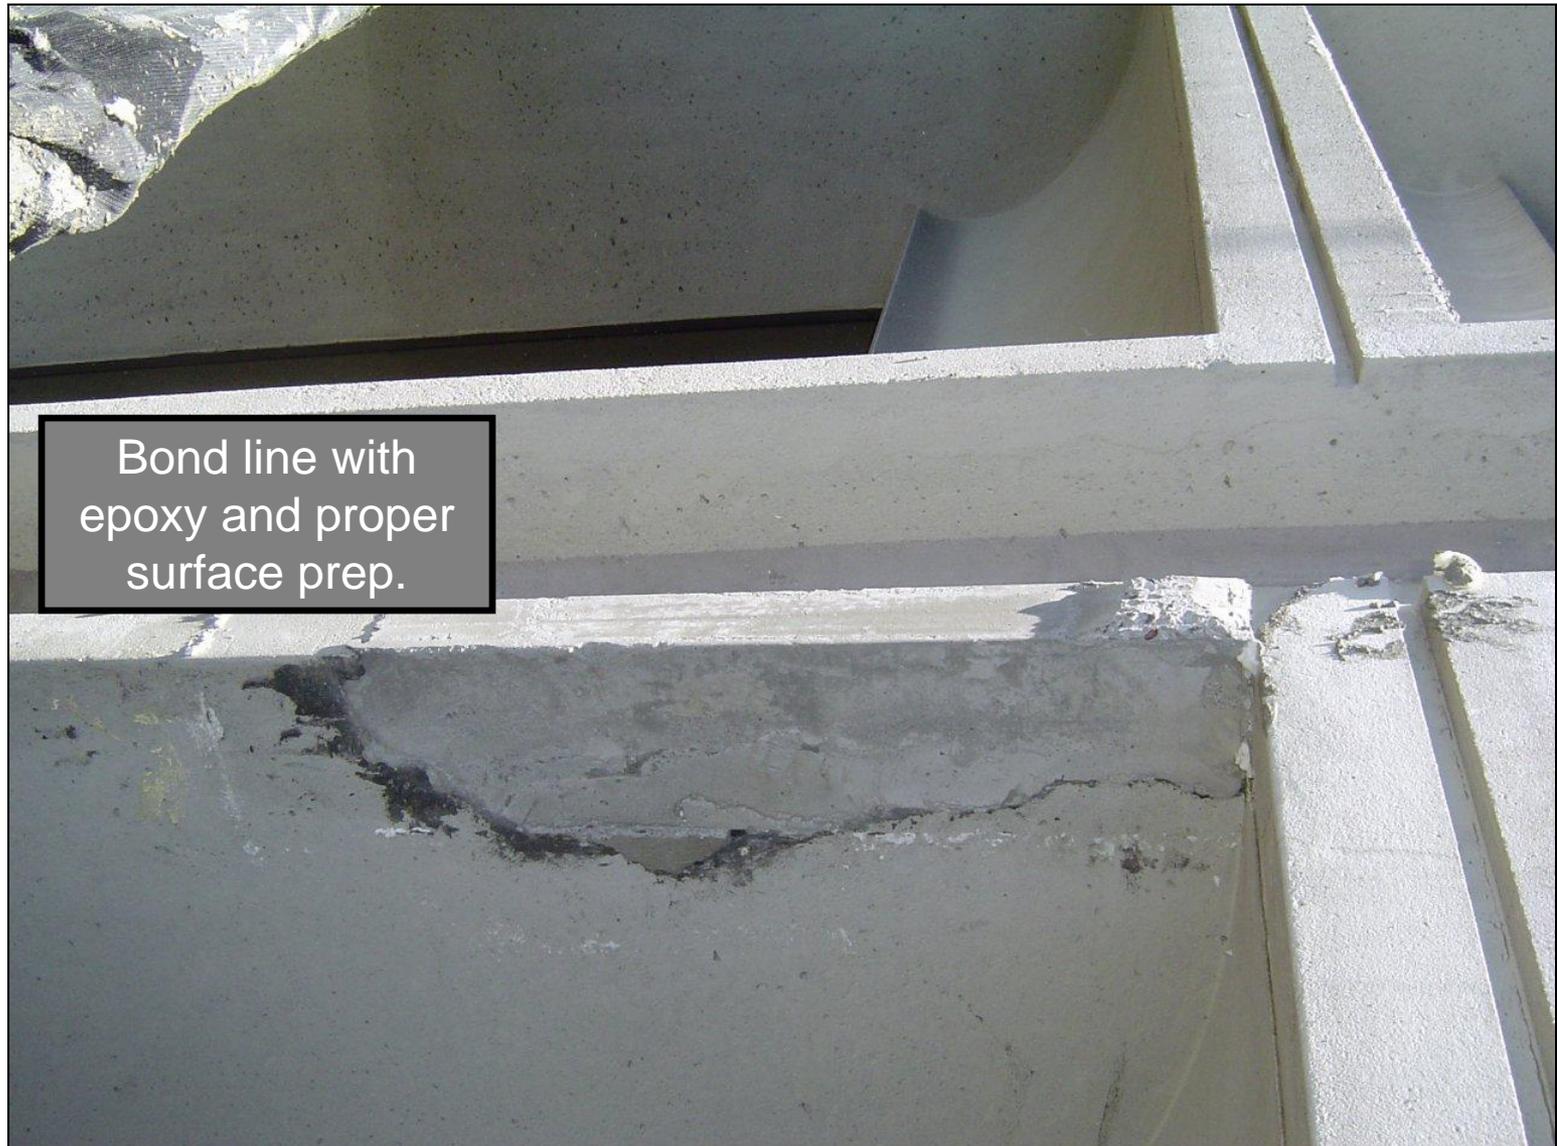
# Attention to Detail - Failed Spall Repair

Bond line with epoxy and proper surface prep.

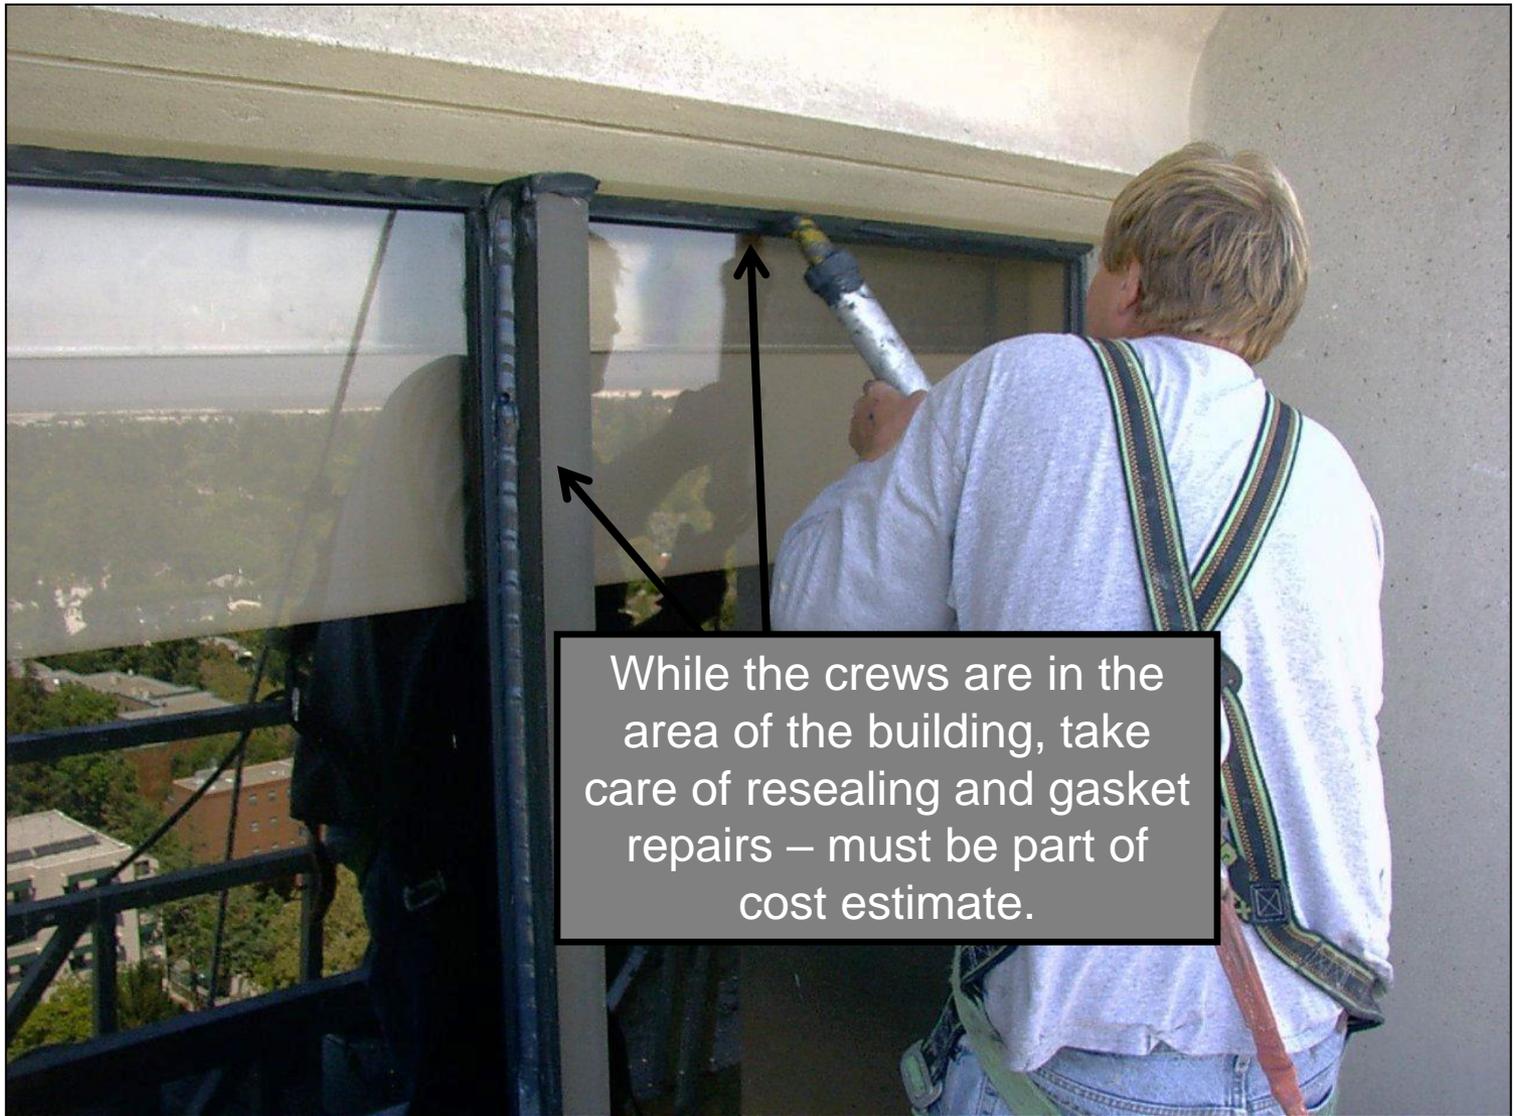
# Not Just Spall Repairs – Seal and Coat

While the crews are in the area of the building, take care of resealing and gasket repairs – must be part of cost estimate.

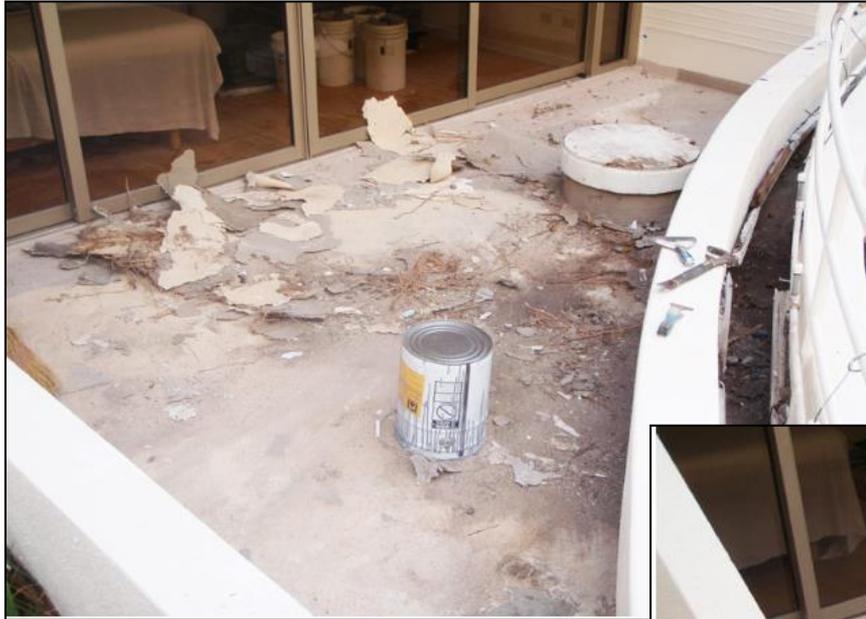
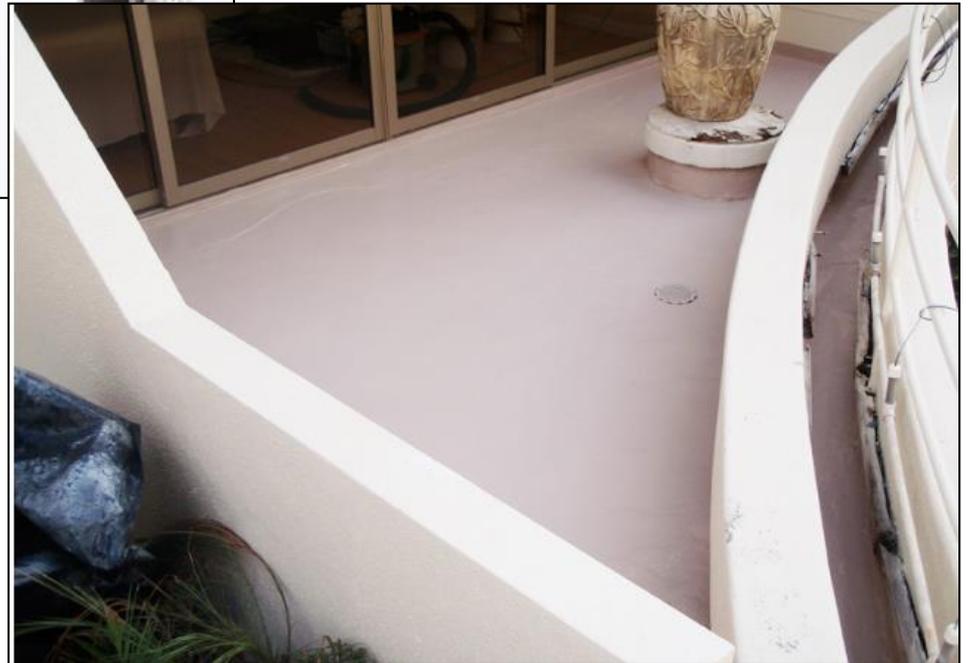
Polyurethane Elastomeric Coatings are tough, high tensile strength (500 to 1500 psi) and can stretch 200% to 500%
