**ALLANA BUICK & BERS**

## **Life Expectancy and Longevity of Buildings and Assemblies**

Condo Council of Maui 2016 Seminar  
November 16, 2016

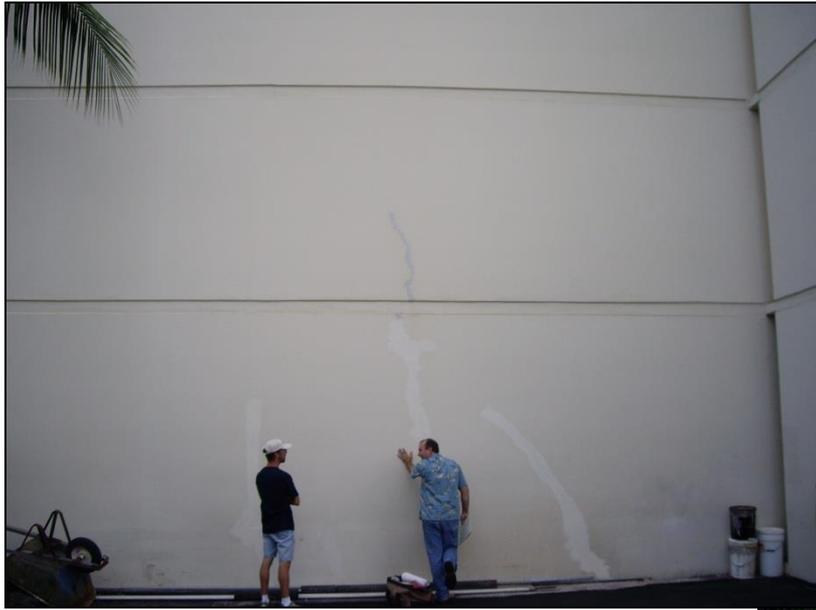
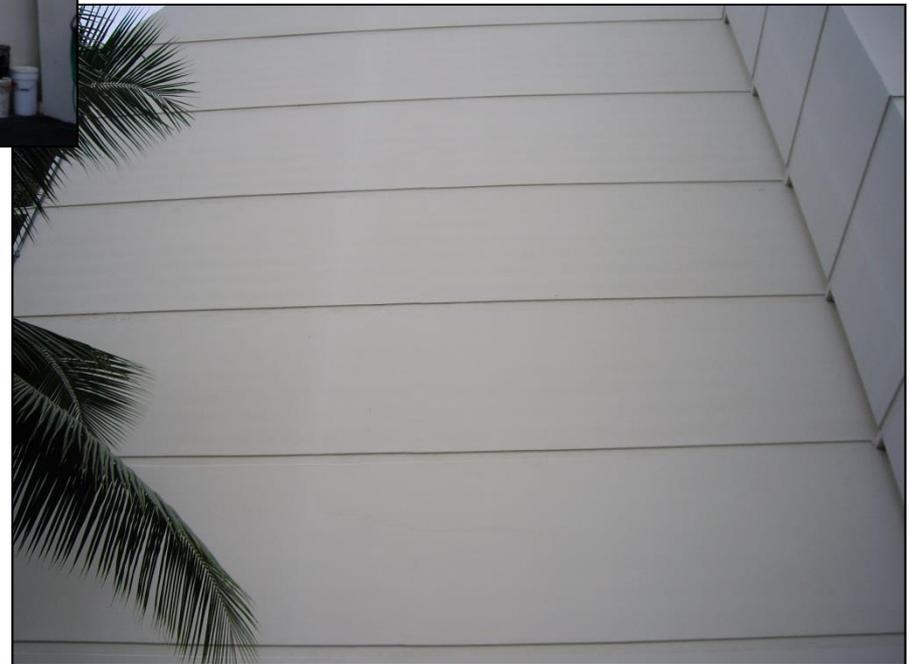
Acrylic and Silicone Elastomeric Coatings are used for wall, lower tensile strength, breathable but blocks carbon dioxide
