Forensic Analysis of Roofing Systems Examples of Roof Performance Learn from Failures to Make Roofs More Sustainable!

Bay Area Facility Management Show – Forensic Analysis of
Roofing Systems

Case 1: Forensic Investigation of Metal Roof Failure

Case 2: PVC Single Ply Sustainability

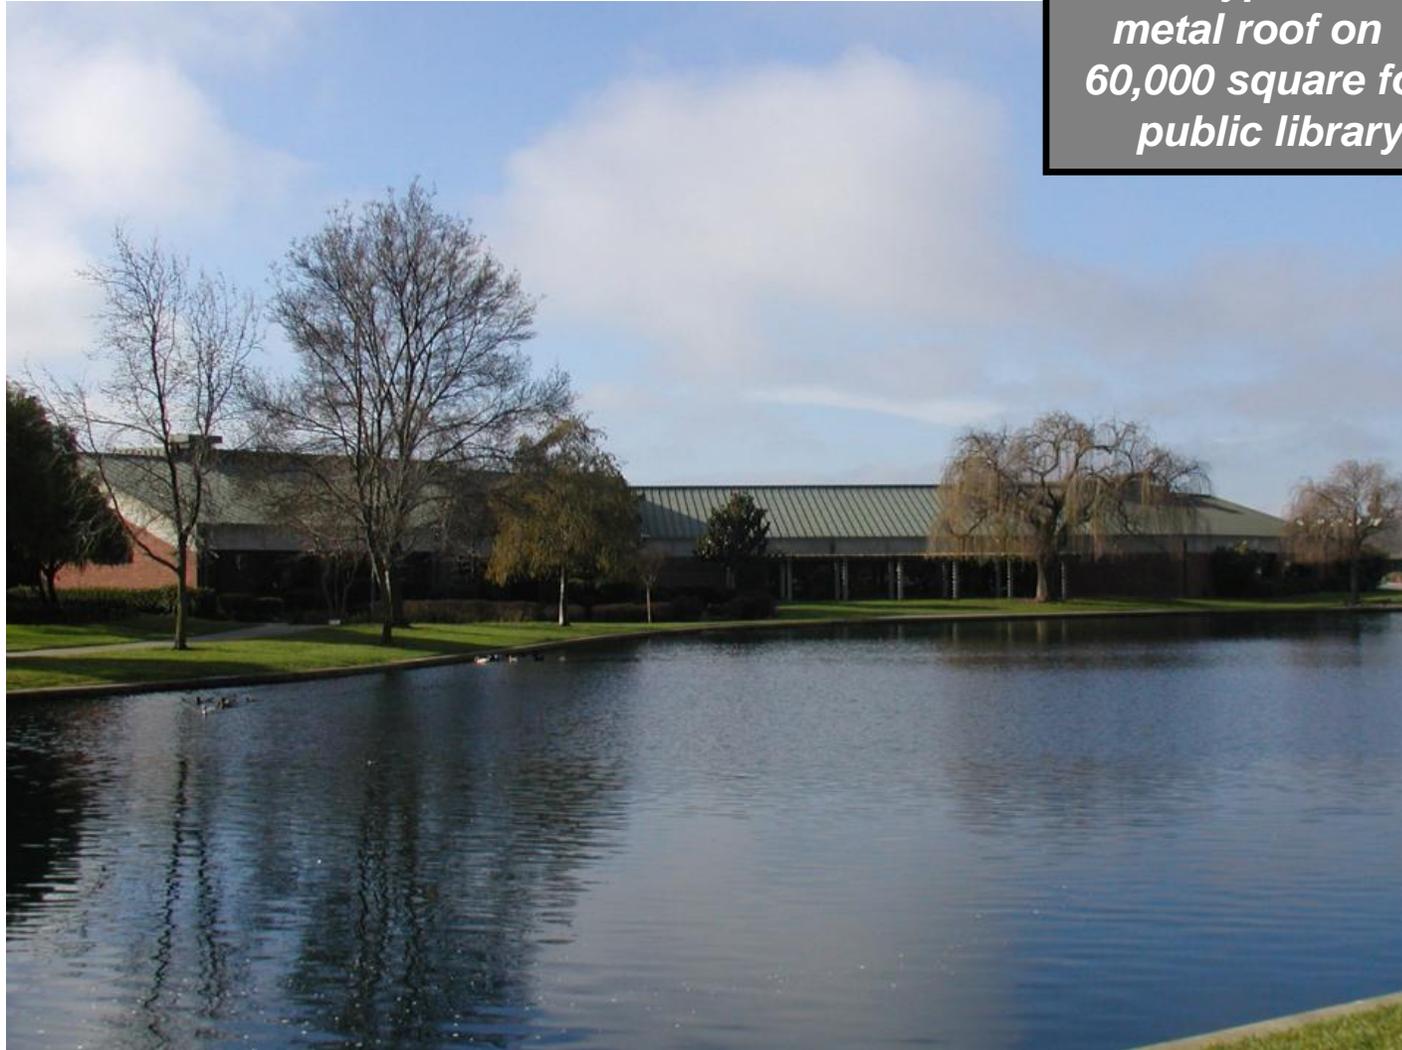
*Roof Type: Batten
metal roof on a
60,000 square foot
public library*

Single ply roof area is new, was replaced because owners believed it was the primary cause of leaks

Equipment well area was also leaking, and was covered up with a new metal roof

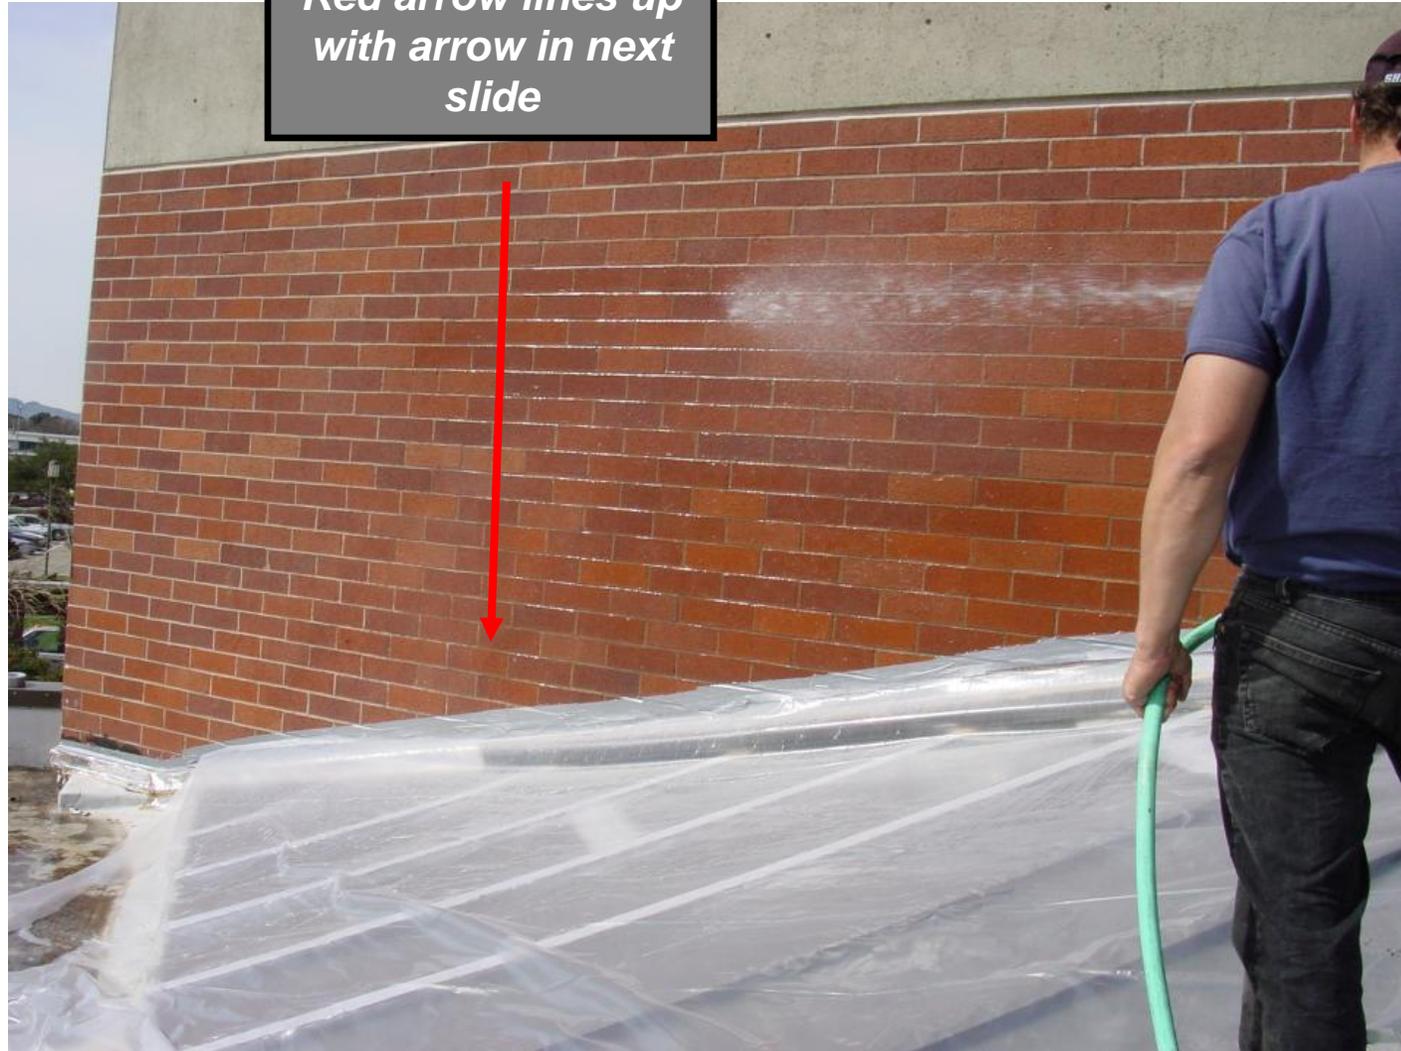
Leaks from testing are circled. Red arrow aligns with red arrow in previous photo. Leaked right away!

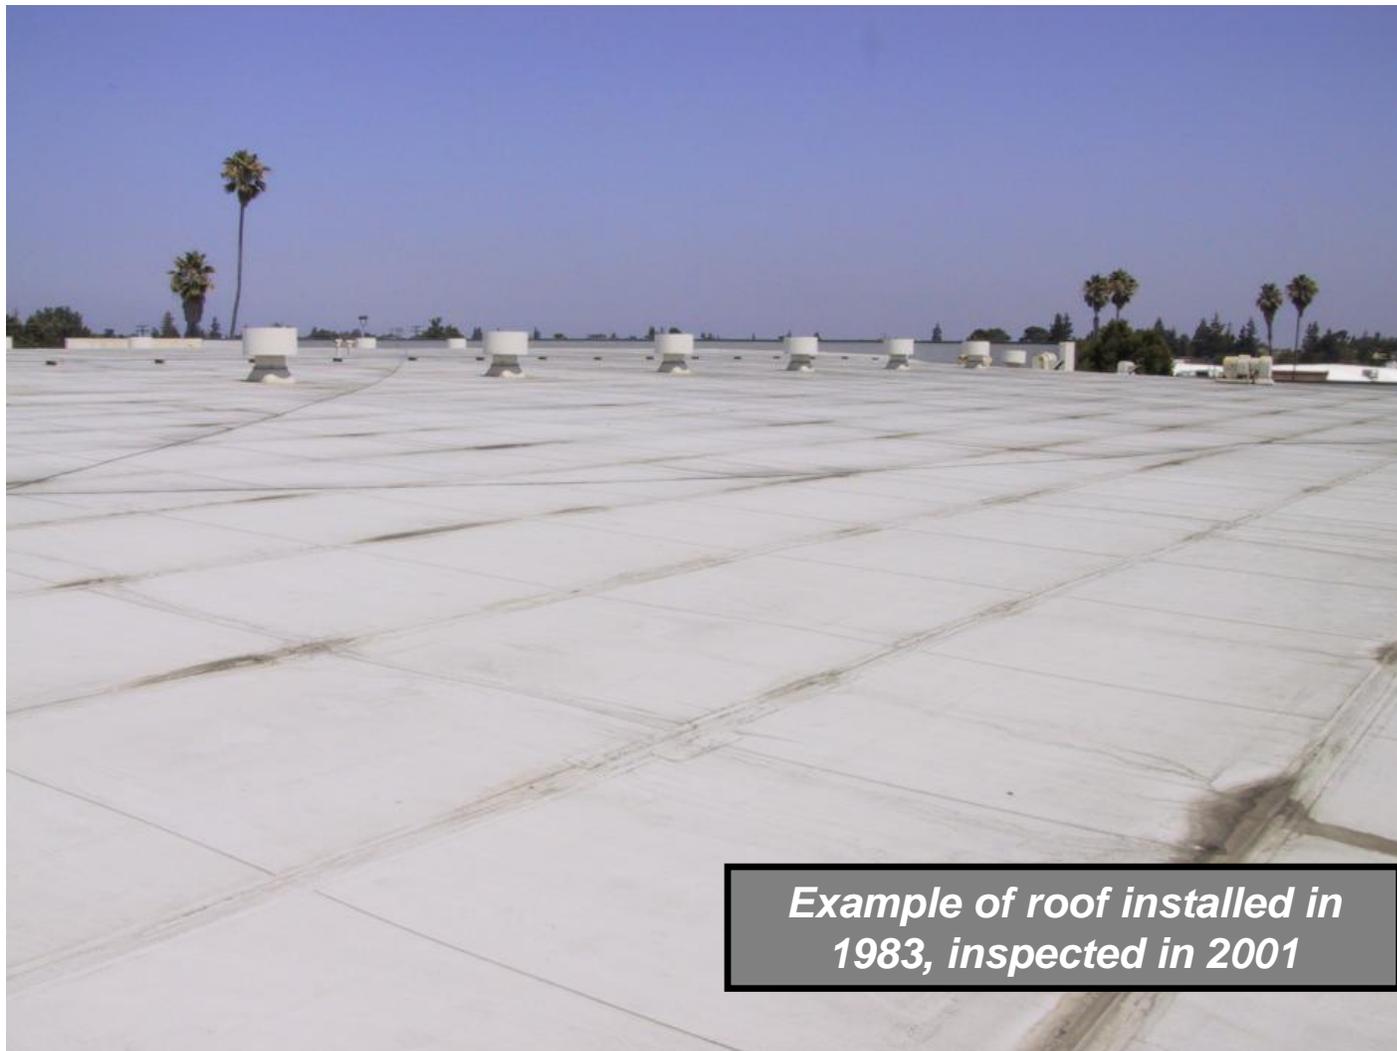
- Large department store in Northern California
- Eighteen years old
- No repairs, no leaks, no problem?
- Purpose of the investigation: Determine longevity of single ply
- We were with a team of other skeptical consultants

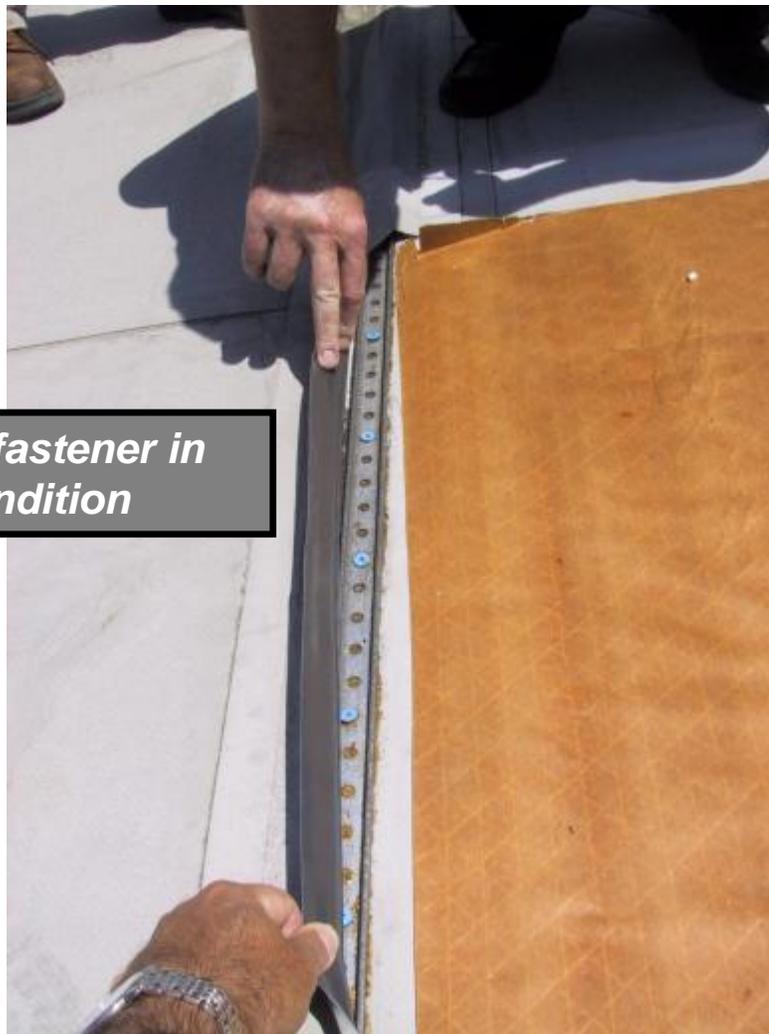
*Mechanical bar fastener in
excellent condition*

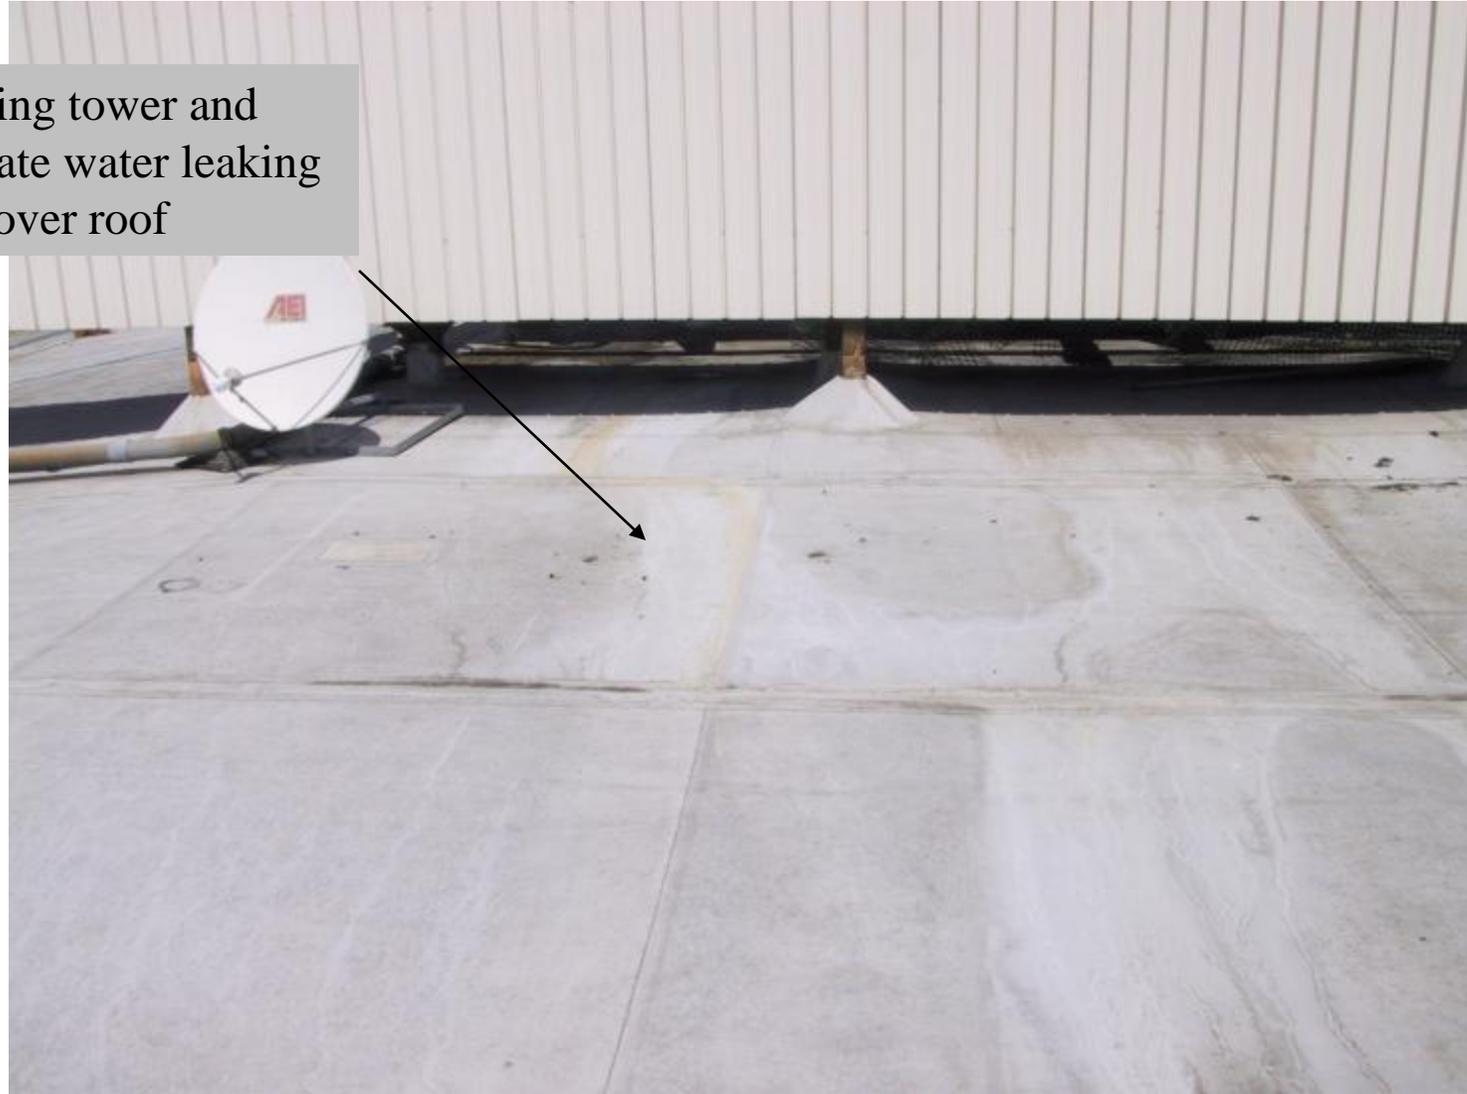
Cooling tower and
condensate water leaking
over roof

Sustainability, ponding
water and chemicals

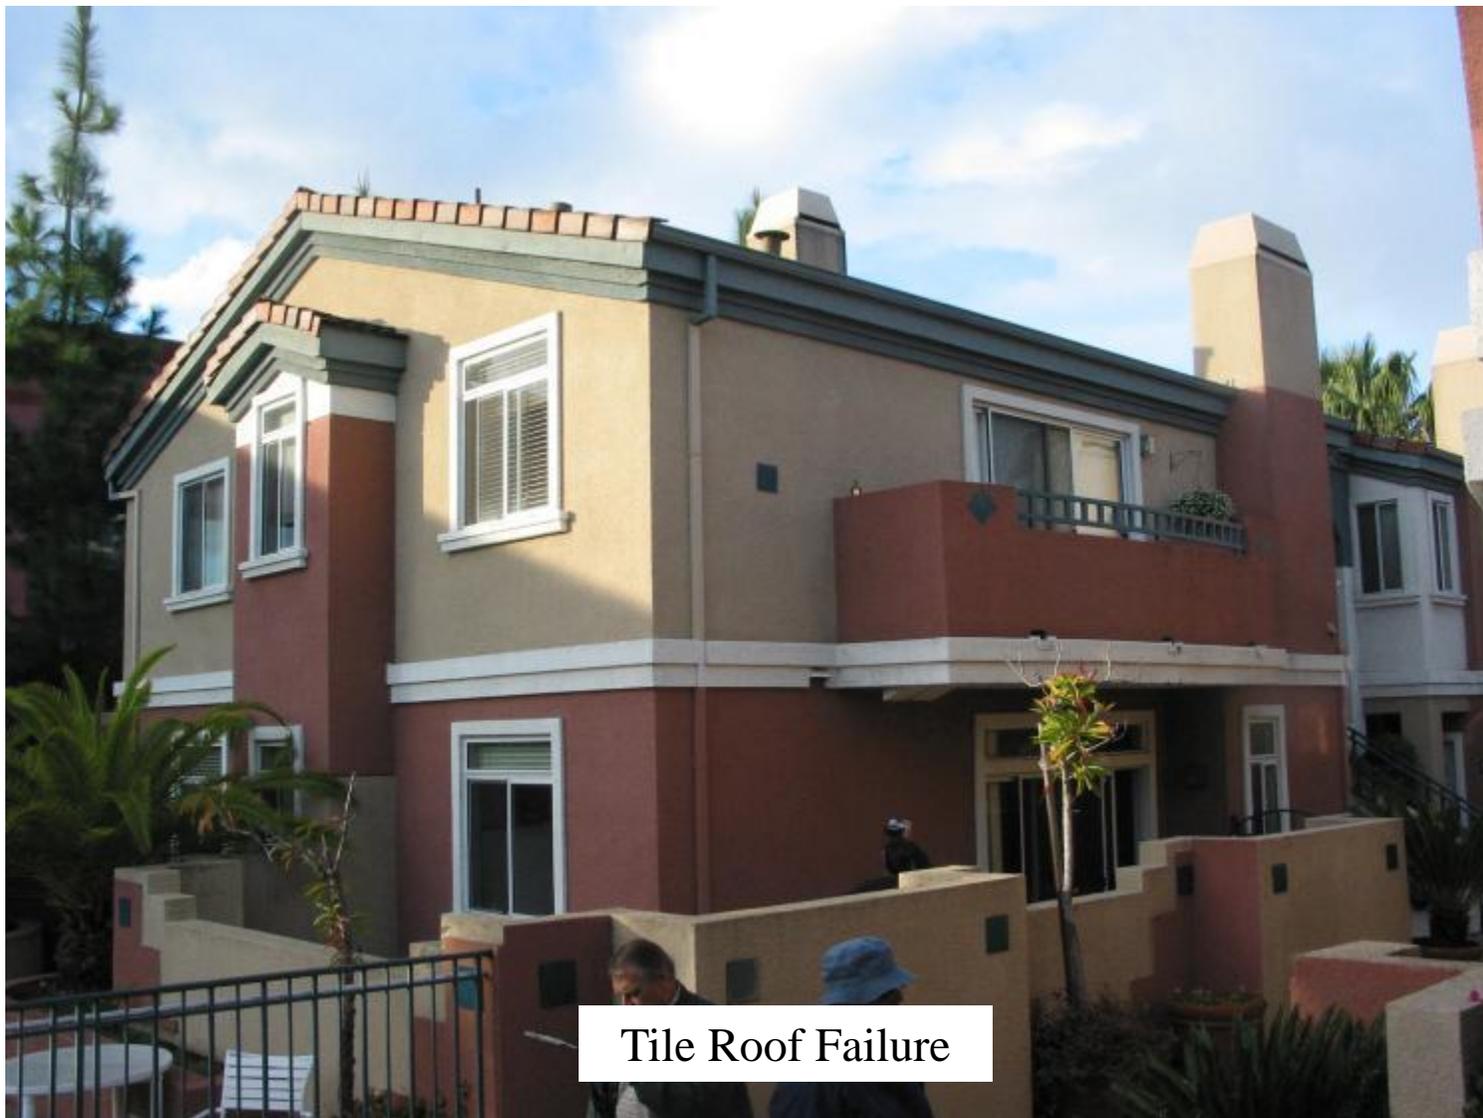
- Construction defect litigation case in Northern California
- 7 year old concrete tile roof
- Many leaks visible below, in living areas
- Visible cracks in tile
- There were some conditions of concern
 - Tile layout
 - Roof to wall conditions
 - Valley Flashing
- We were asked to investigate the source of leaks

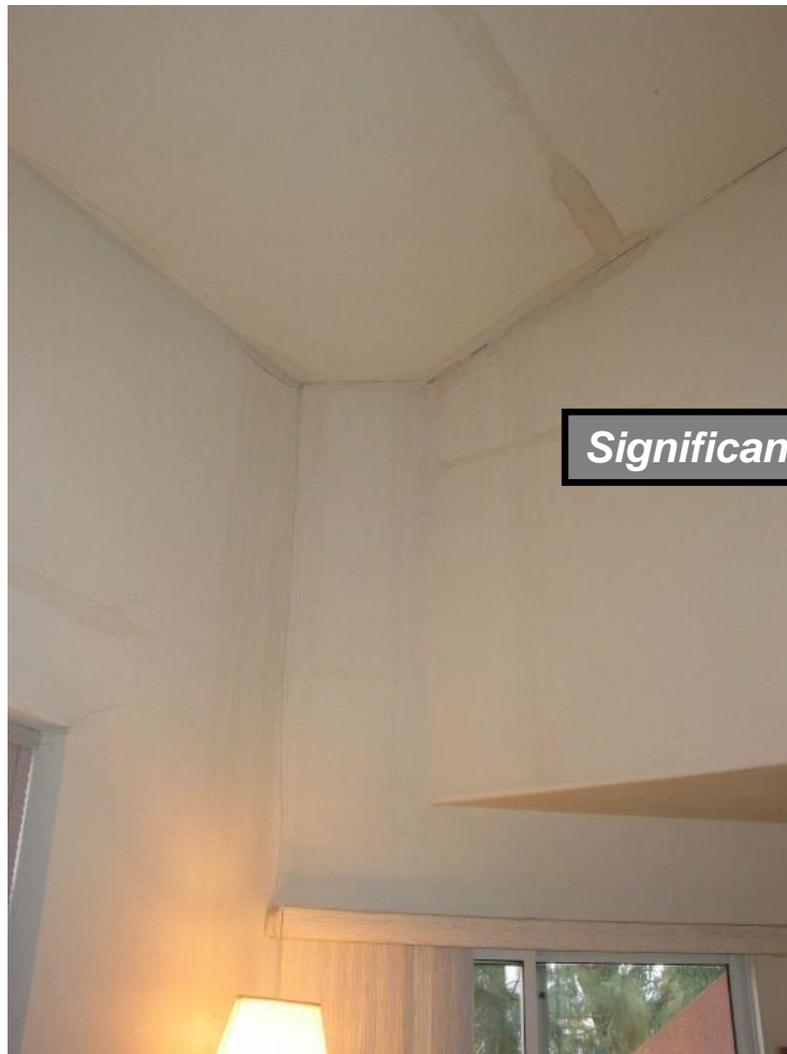
Significant leaks in ceilings

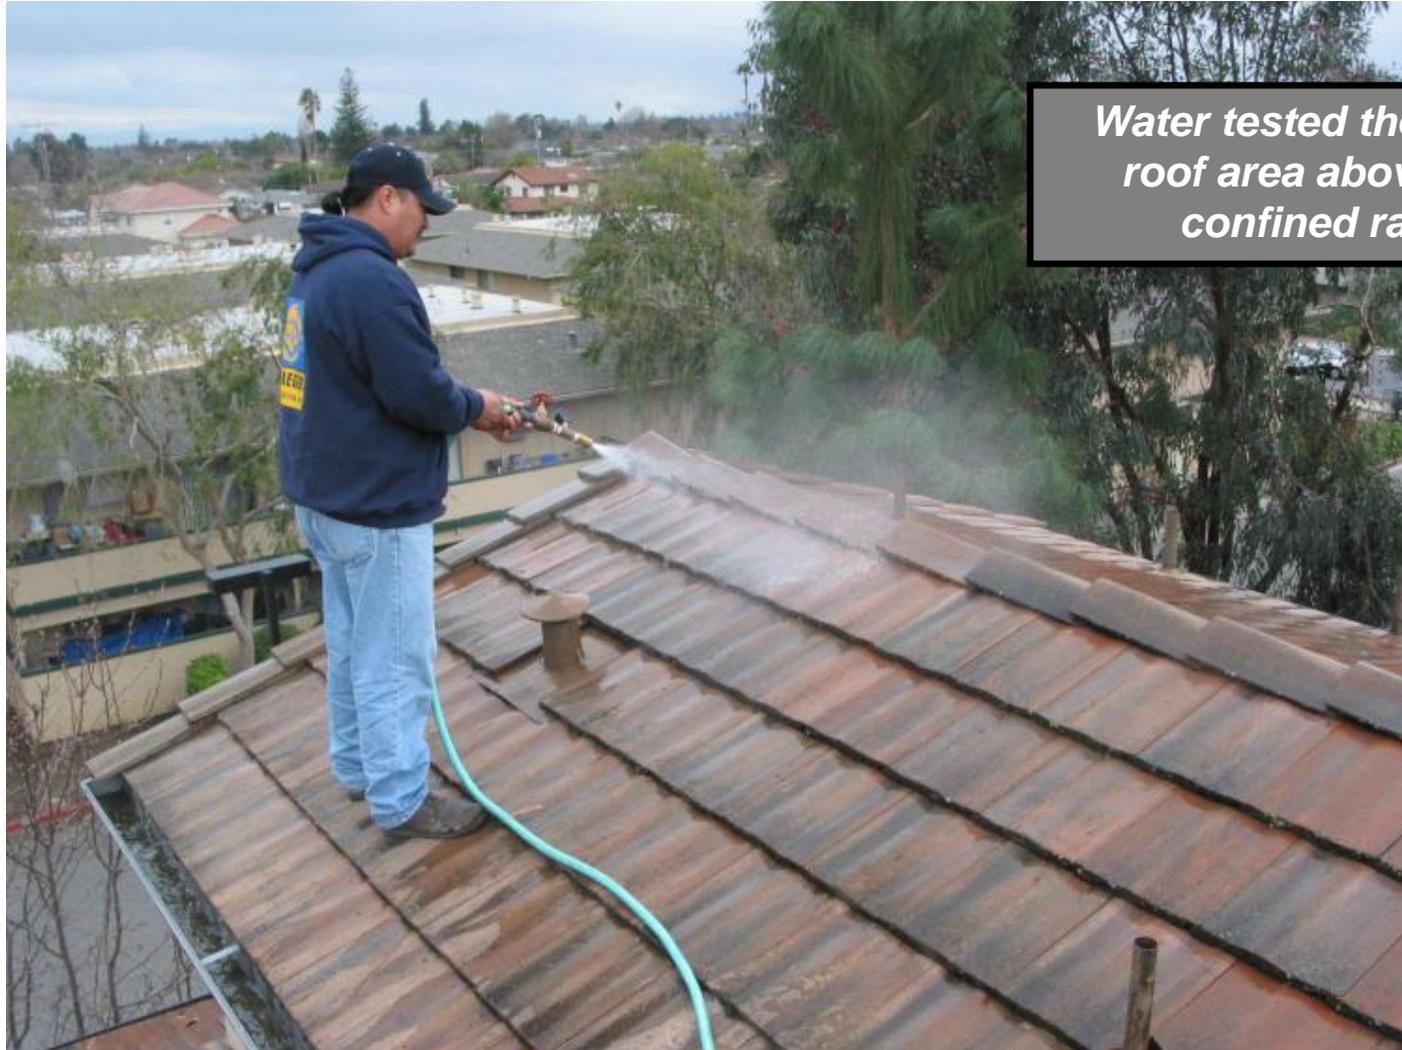
Water tested the gable roof area above the confined rake

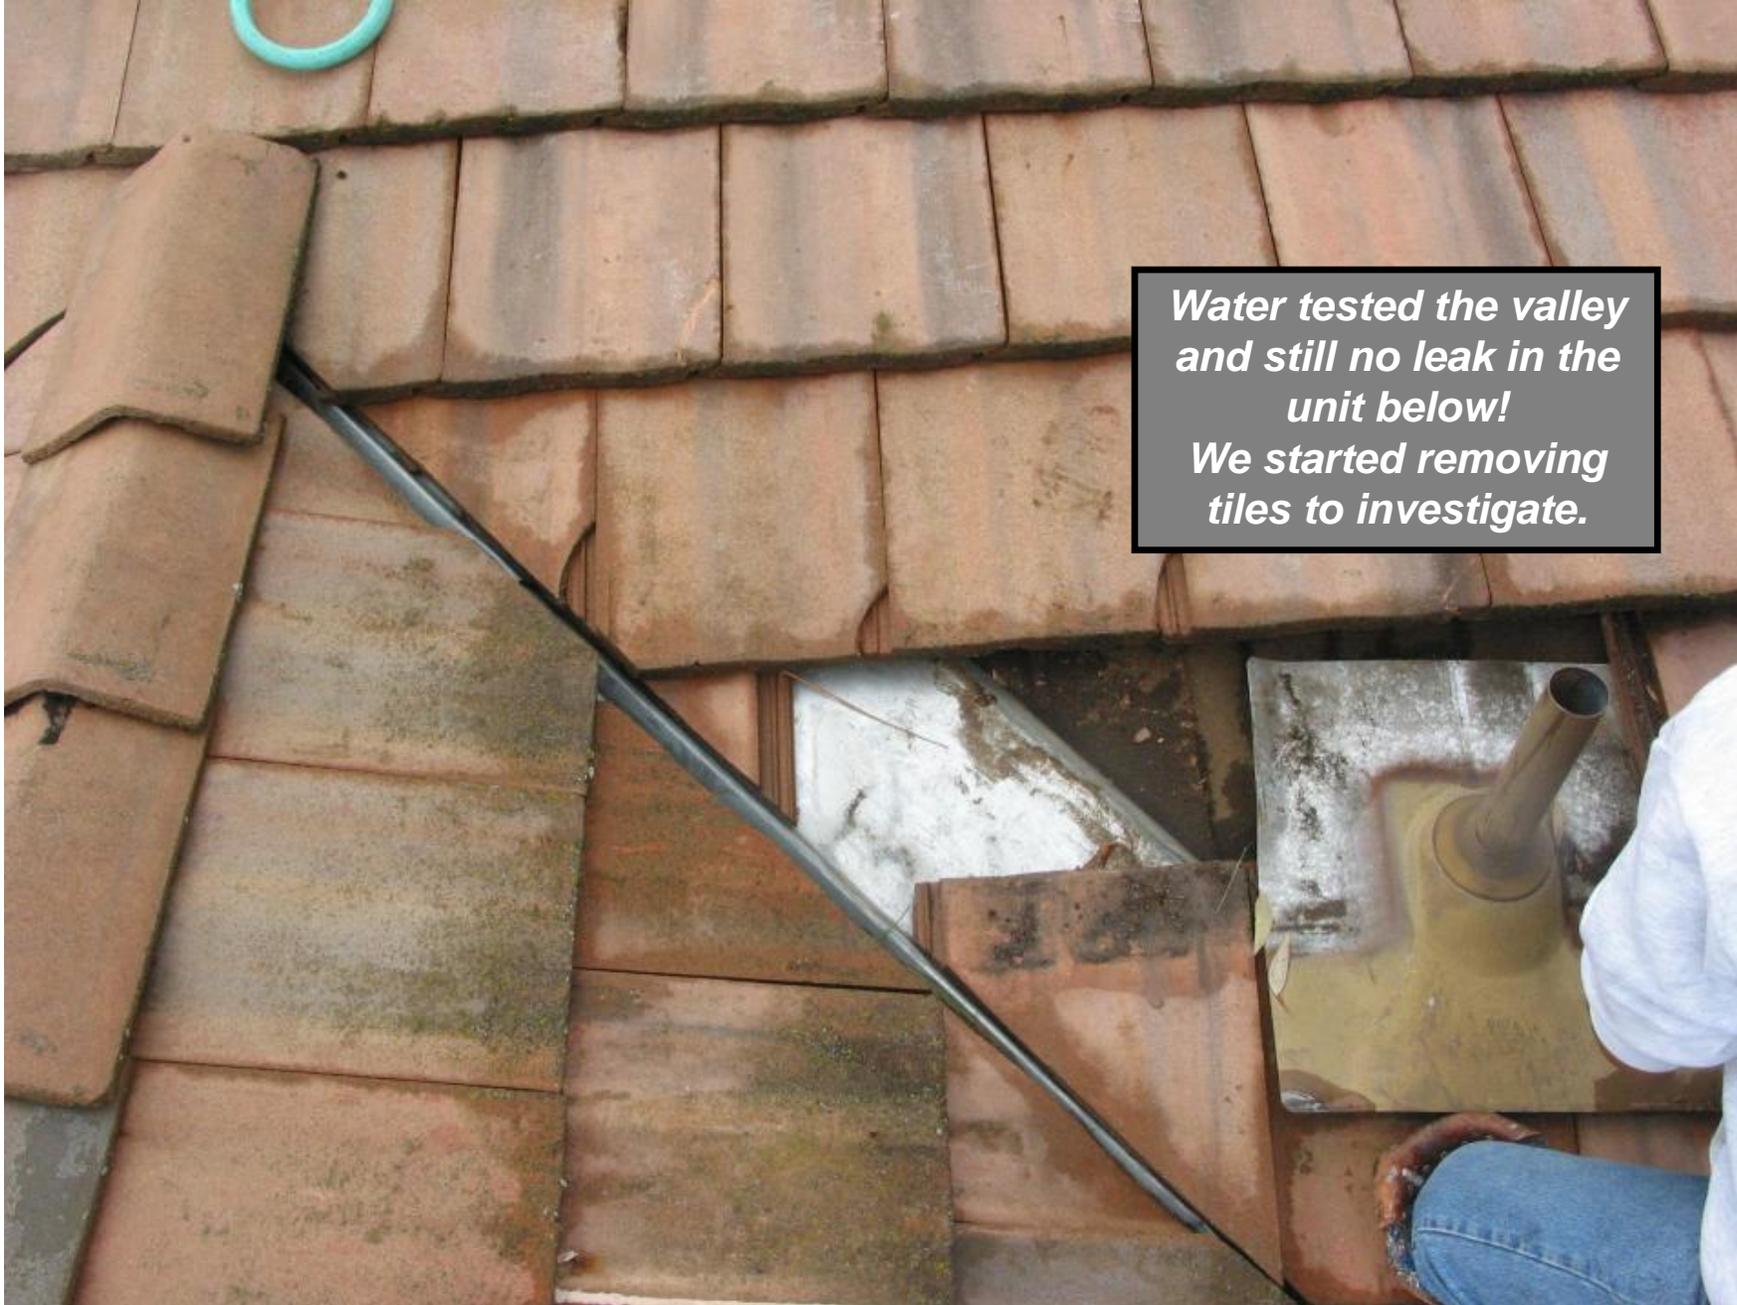
Exposed fastener. Ridge tile is not lapped properly.

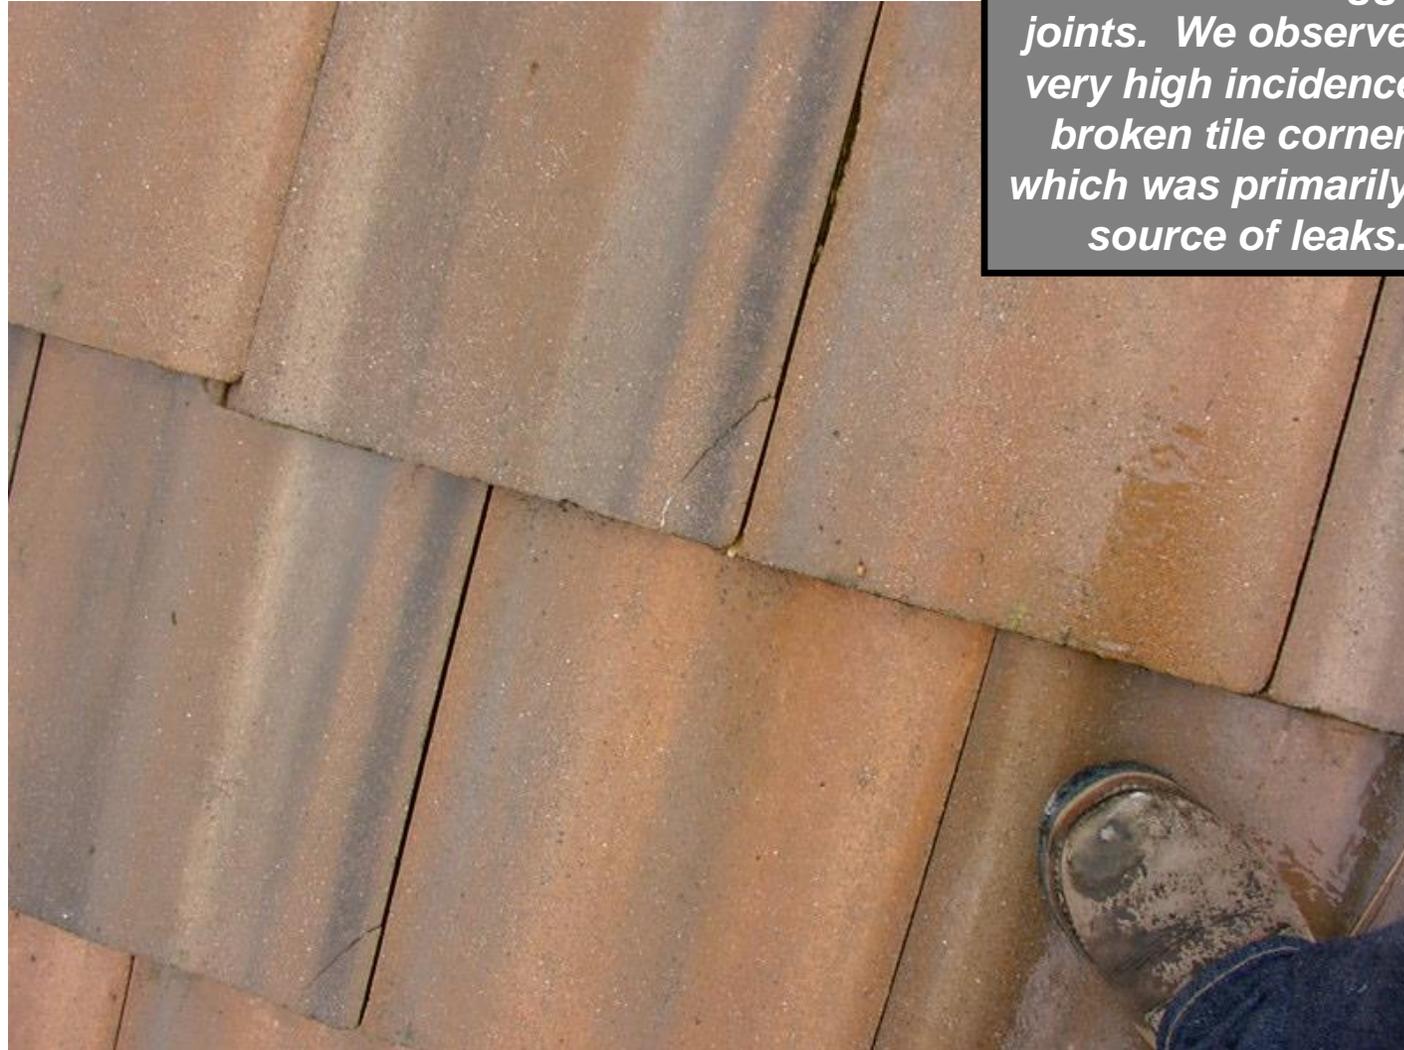
Much of the tile was installed with staggered joints. We observed a very high incidence of broken tile corners, which was primarily the source of leaks.

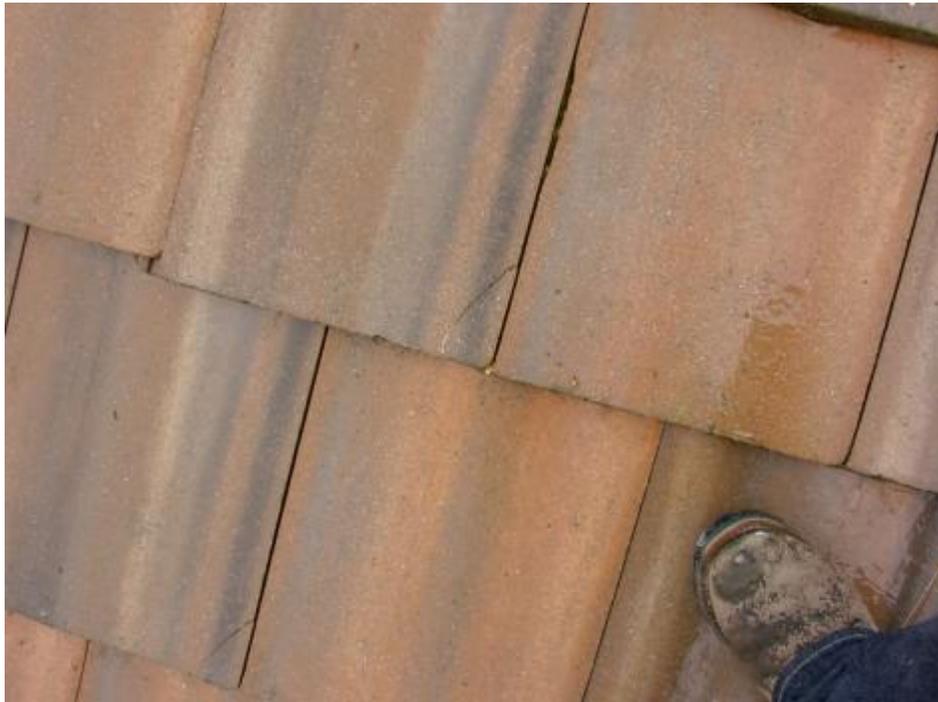
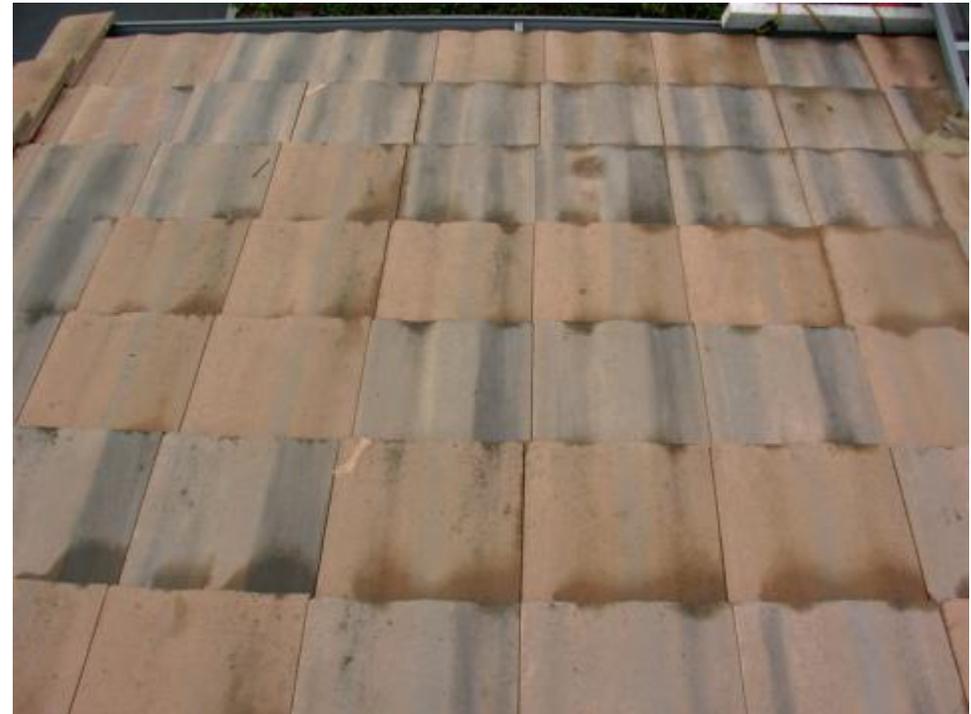
What is the correct way to install this tile, broken bond or straight bond?

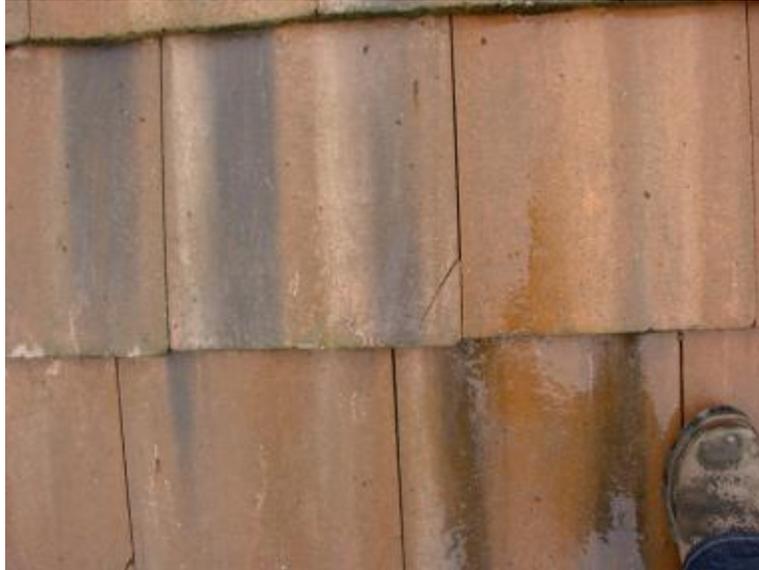
ANSWER: The manufacturer of this time recommends the straight bond method.

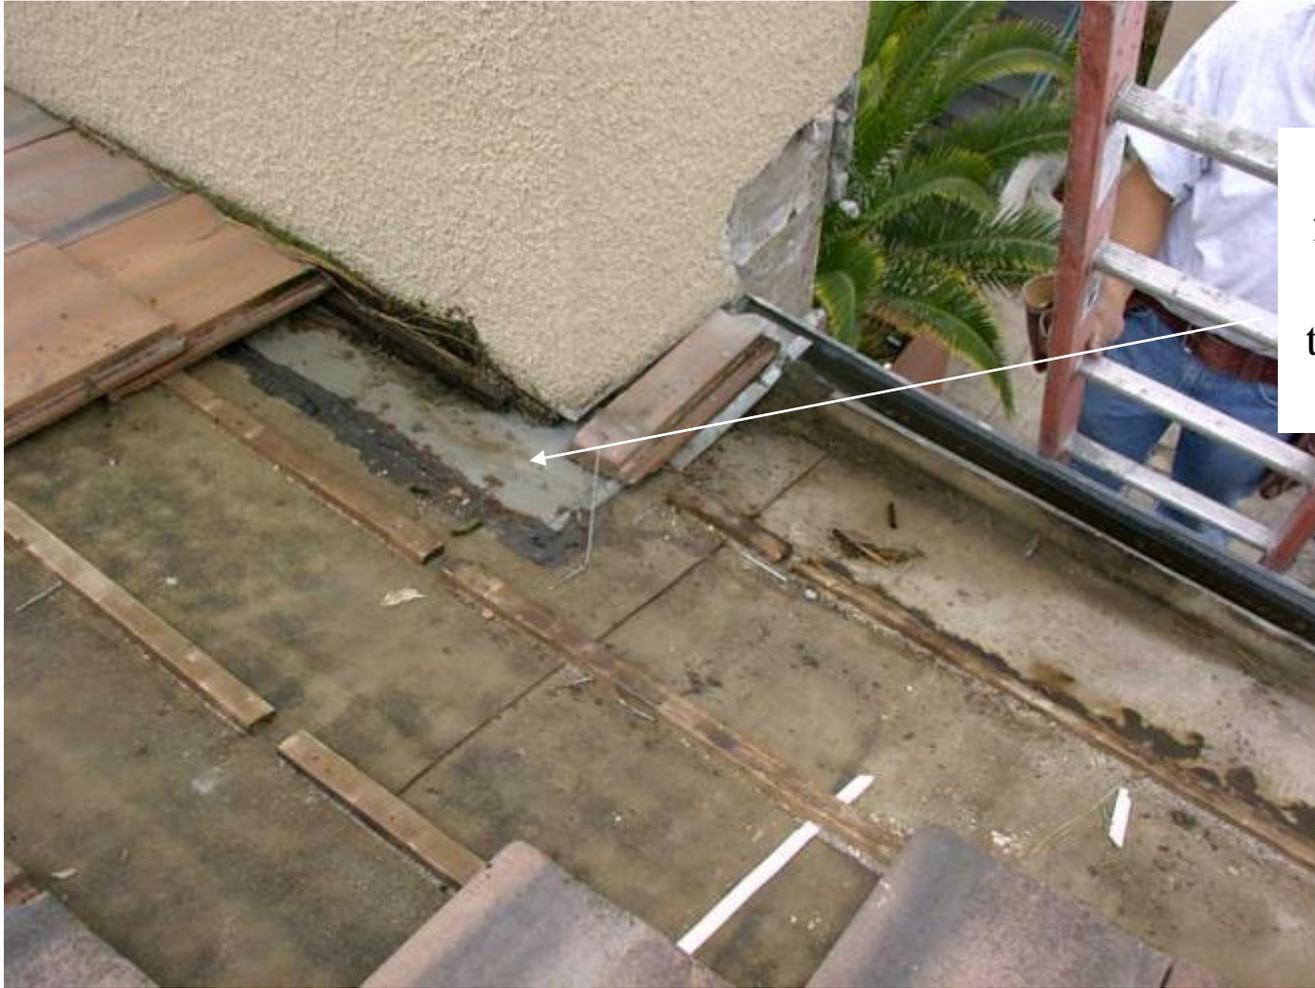
Roof to wall
flashing installed
as an after
thought, on top of
felts

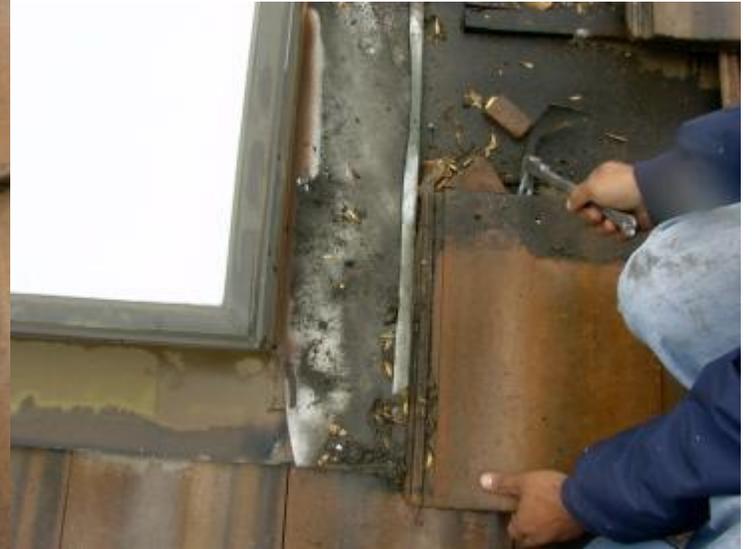
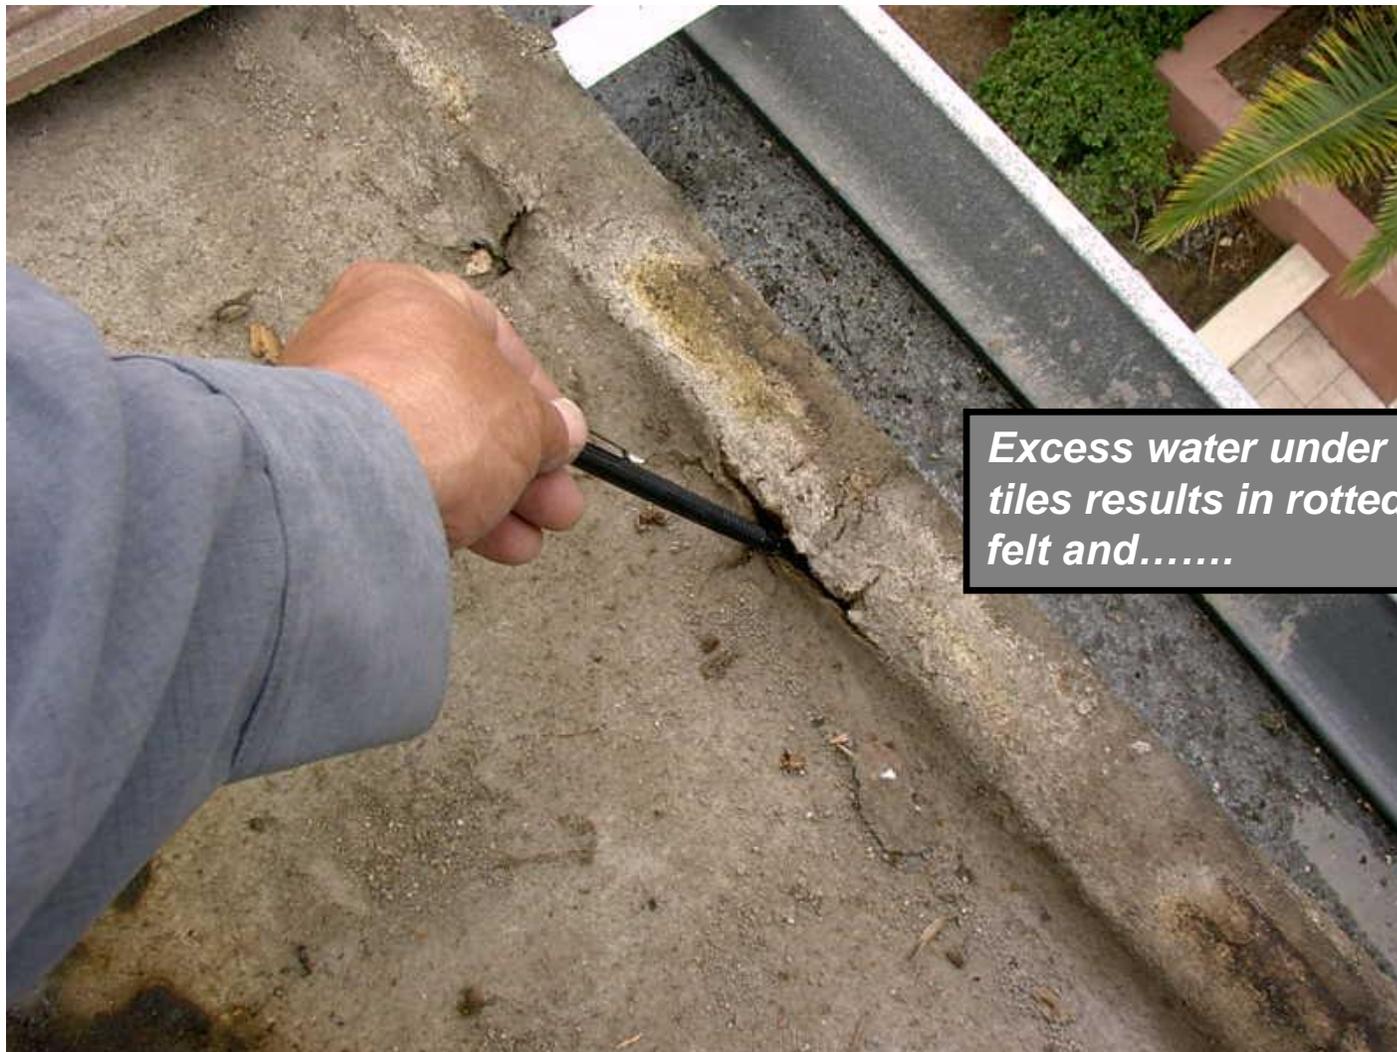
Excess water under the tiles results in rotted felt and.....
