# **Forensic Analysis of Roofing Systems Examples of Roof Performance Learn from Failures to Make Roofs More Sustainable!**

International Roofing Expos

February 16, 2005

# Case 1: Forensic Investigation of Metal Roof Failure

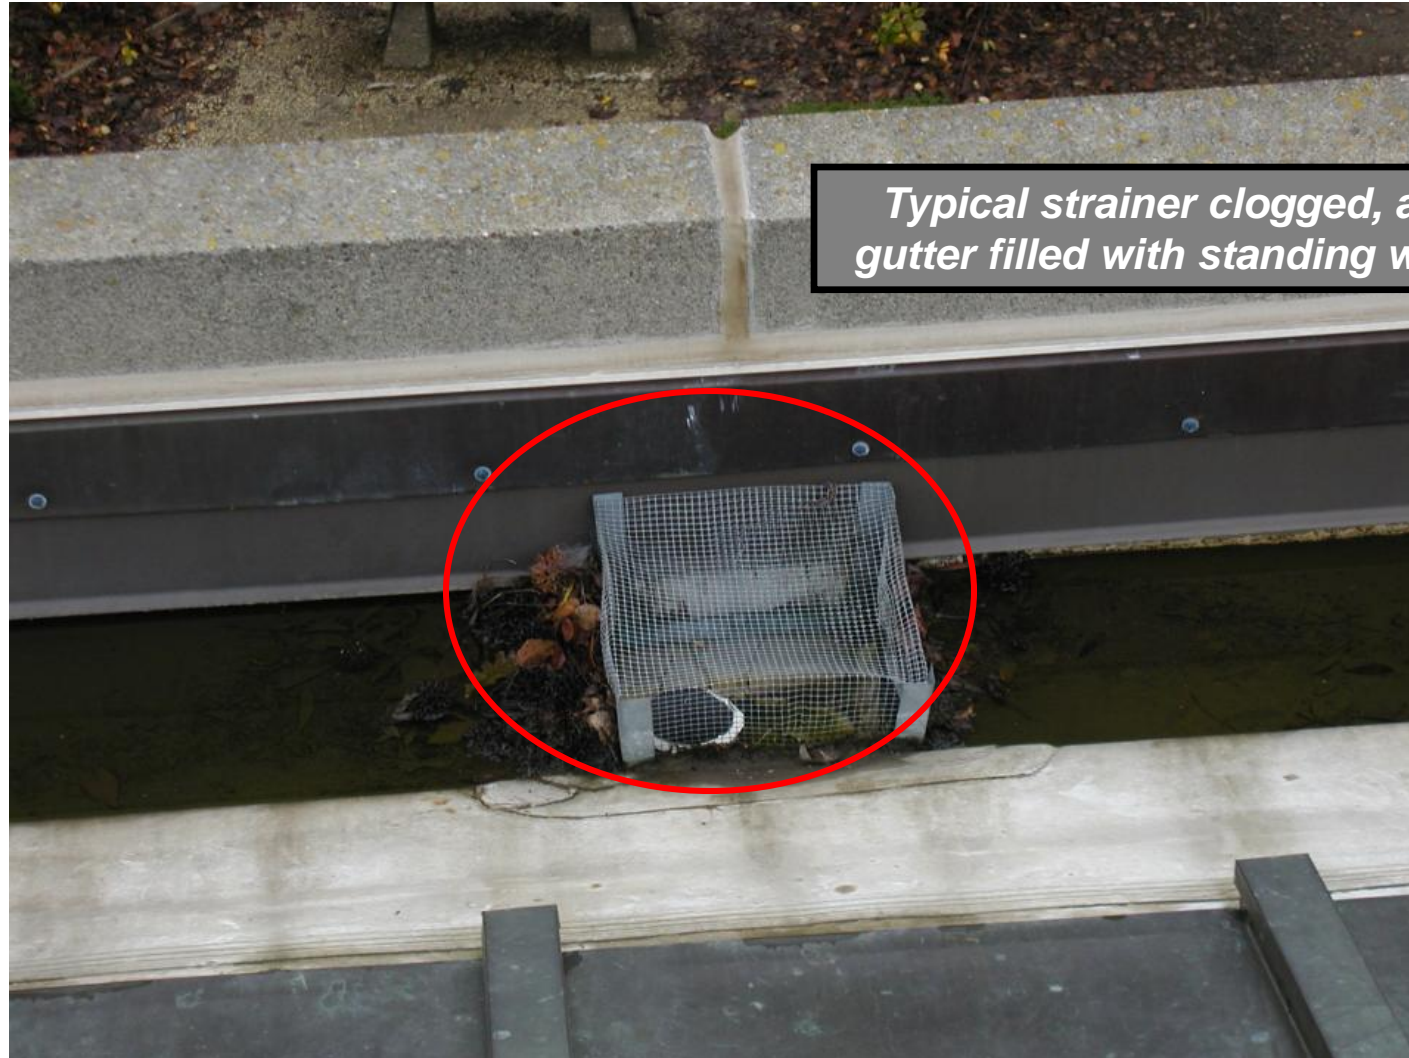
*Extensive ponding, interior gutters restricted debris filled strainers, ongoing leaks were observed under the gutter despite the 1997 repair*

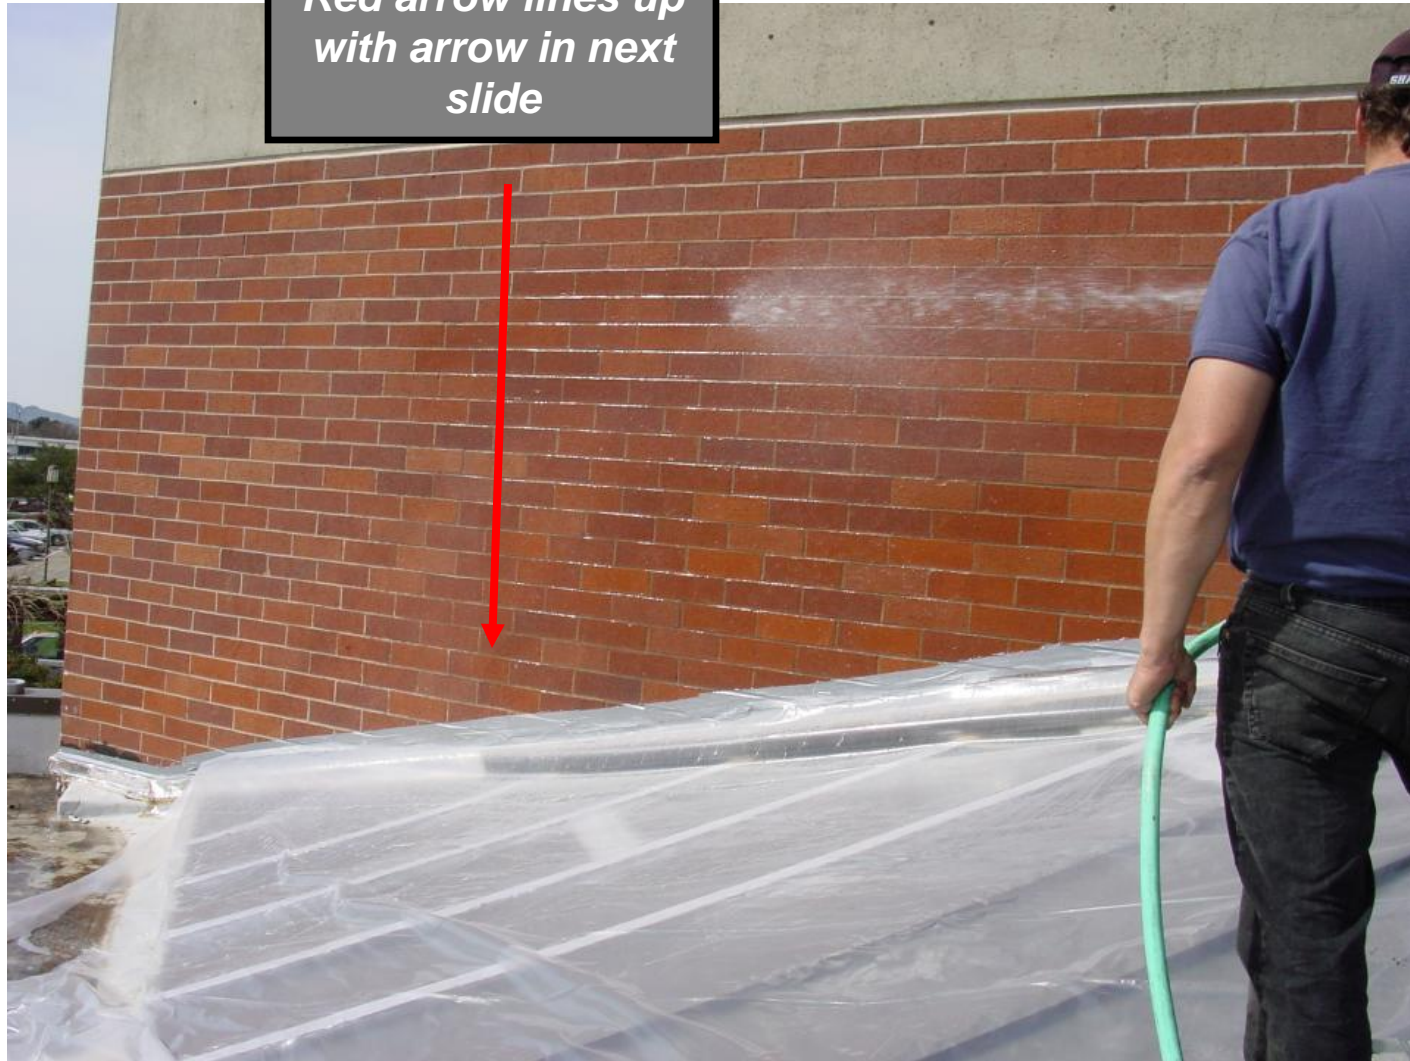
*Prepare for testing  
of one possible leak  
source - walls*

*Red arrow lines up  
with arrow in next  
slide*

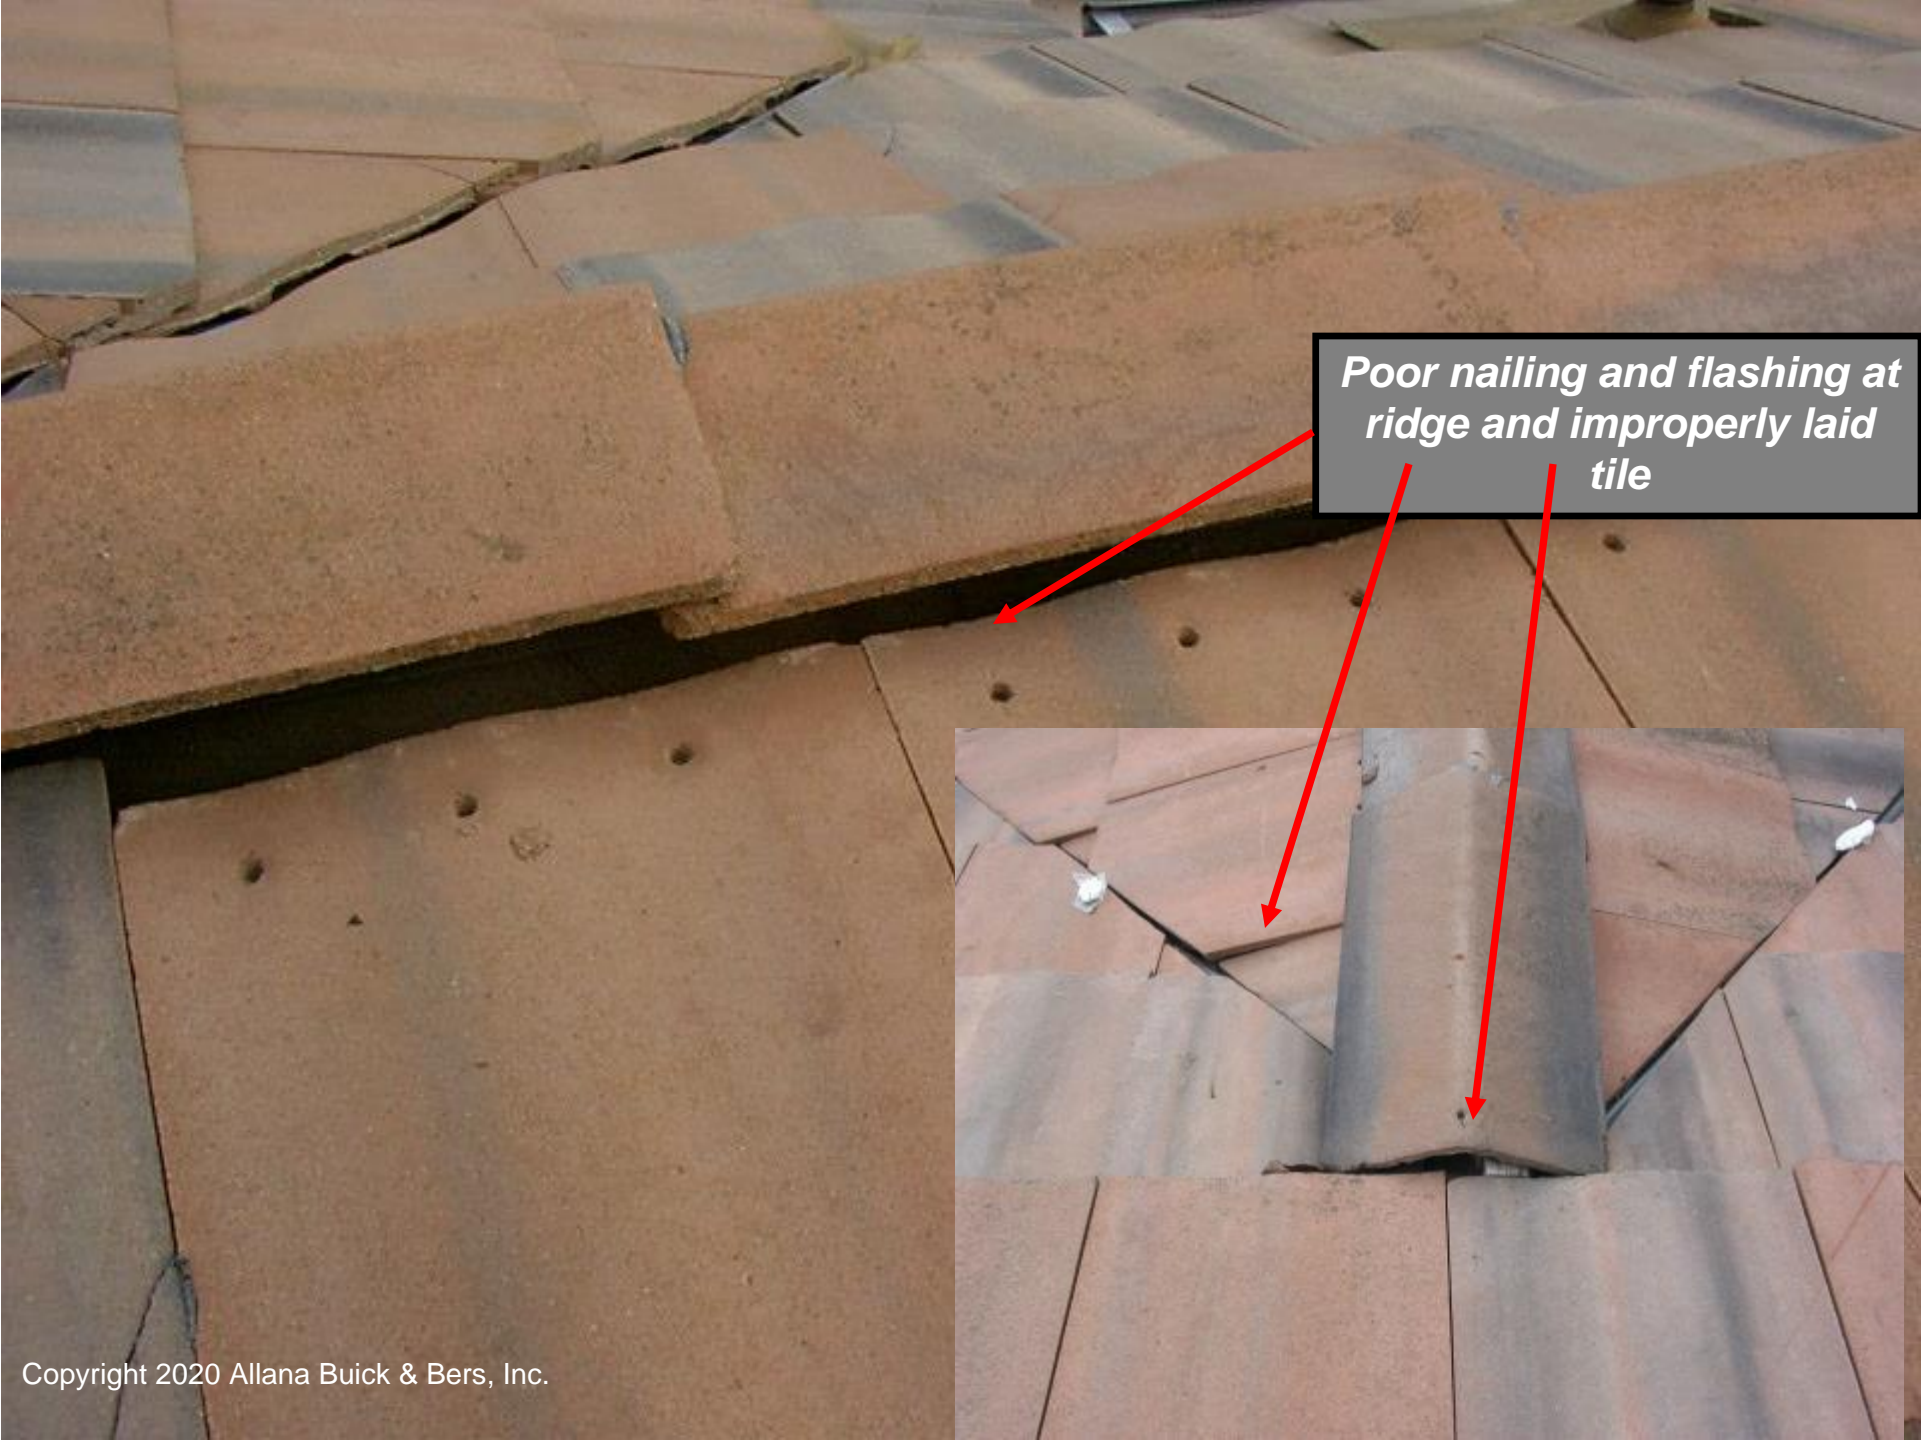
*Exposed fastener. Ridge tile is not lapped properly.*

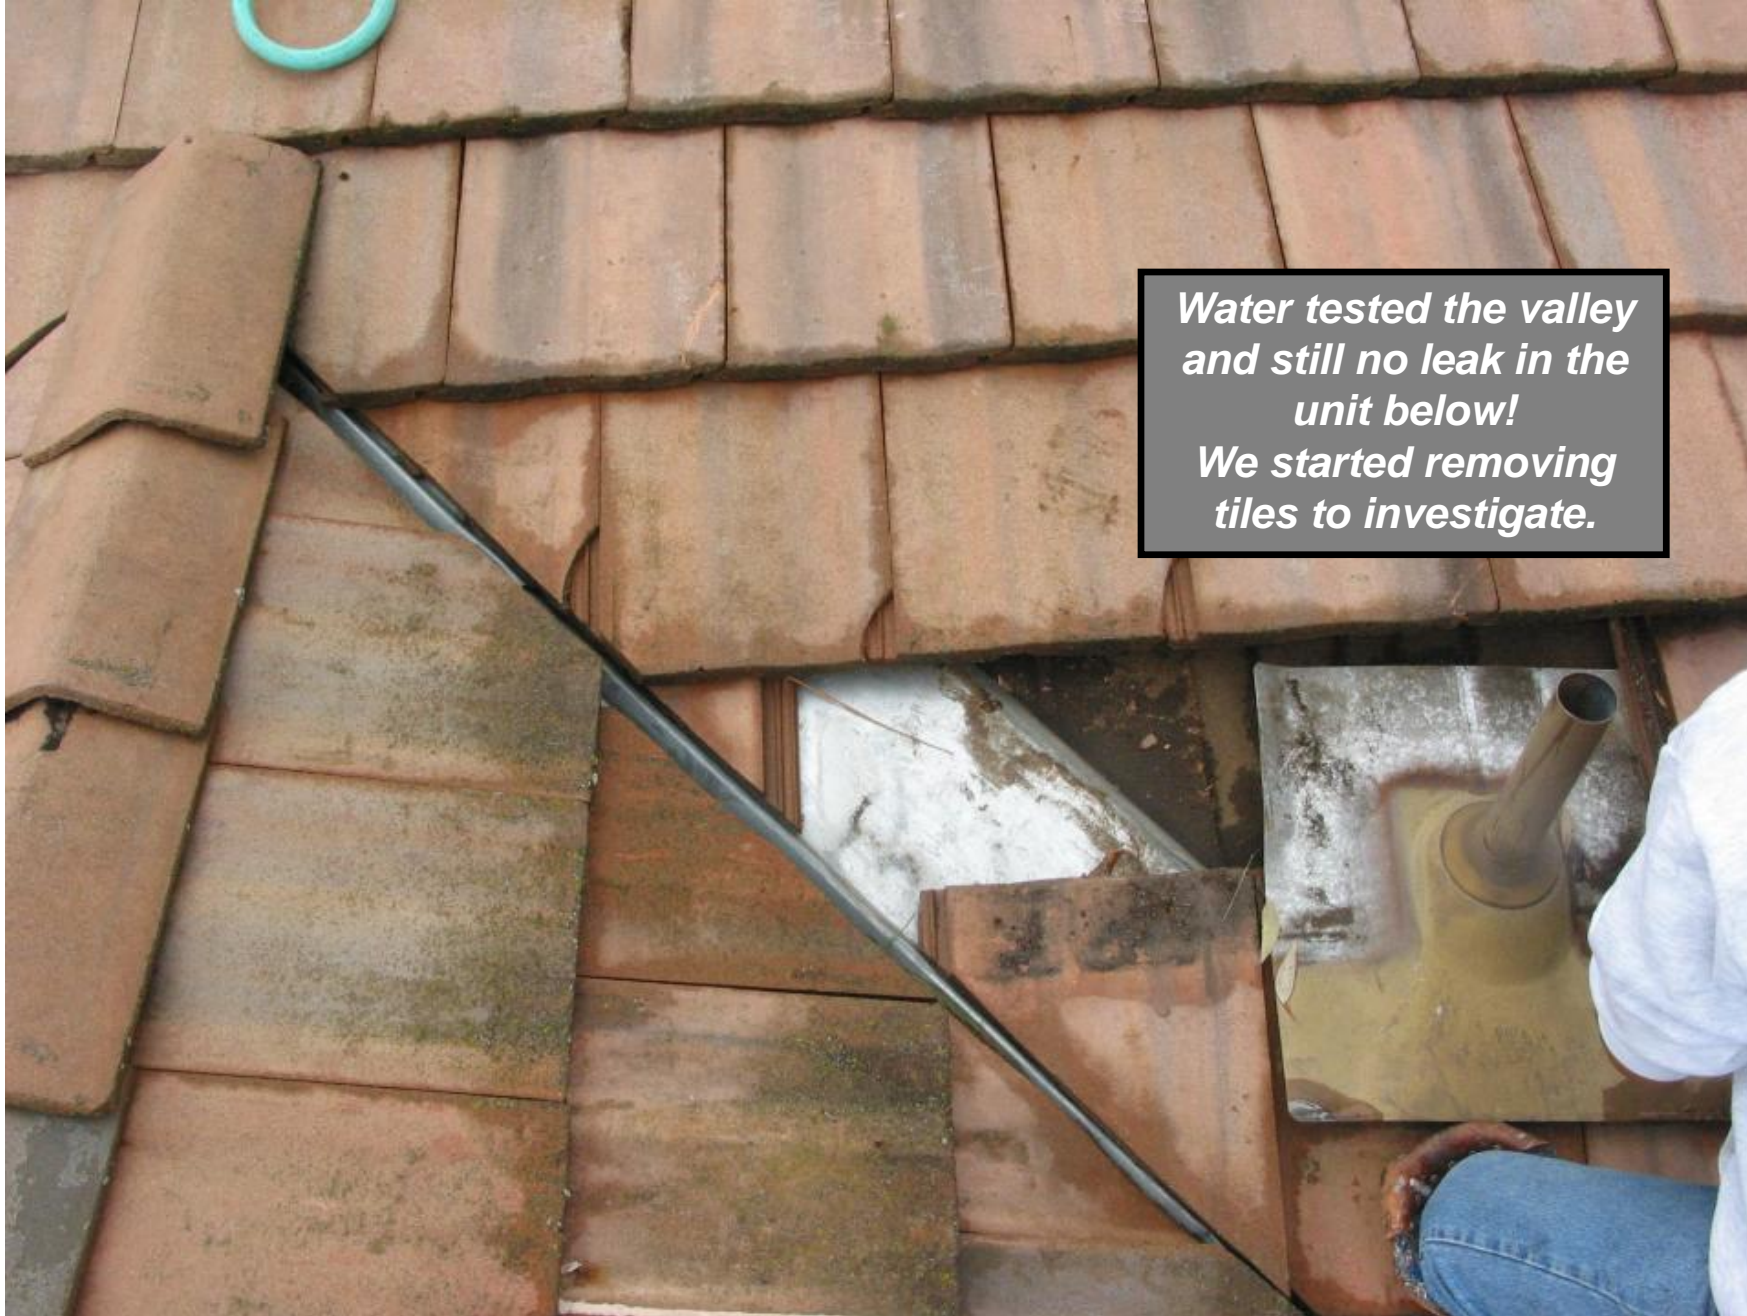
Water had been leaking through the tiles however, could not reproduce the leak was because the owner's last attempt at repairs included replacing the deteriorated felt underlayment and mastic seal.

*Much of the tile was installed with staggered joints. We observed a very high incidence of broken tile corners, which was primarily the source of leaks.*

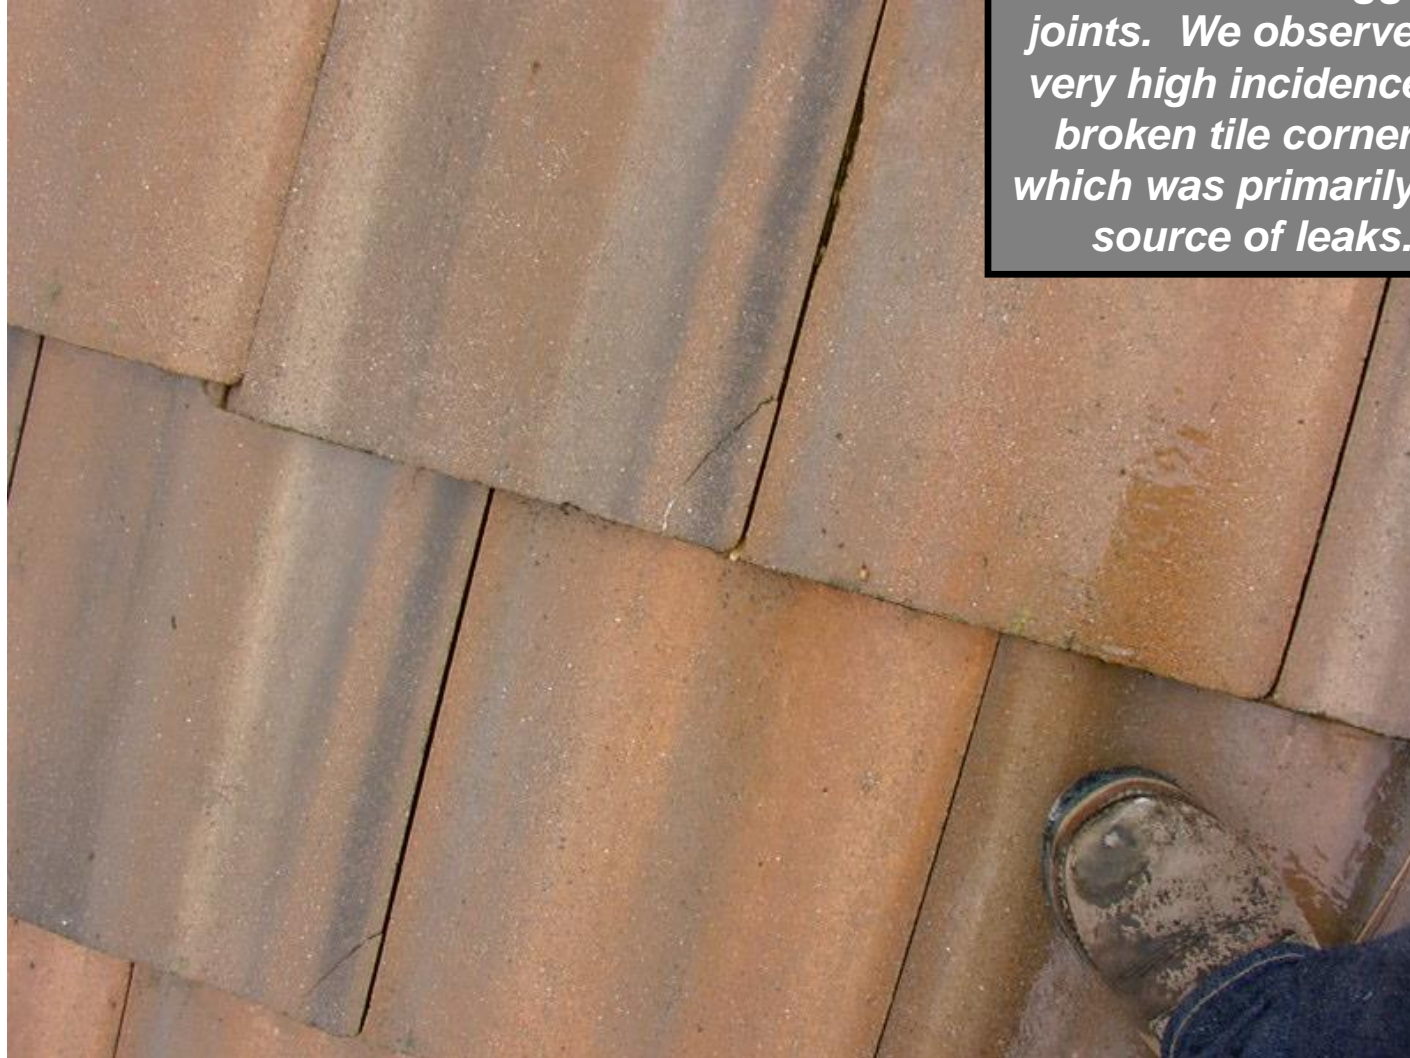
*Some roofs had tile laid in straight bond method, which had fewer broken tiles but instinctively seemed wrong*

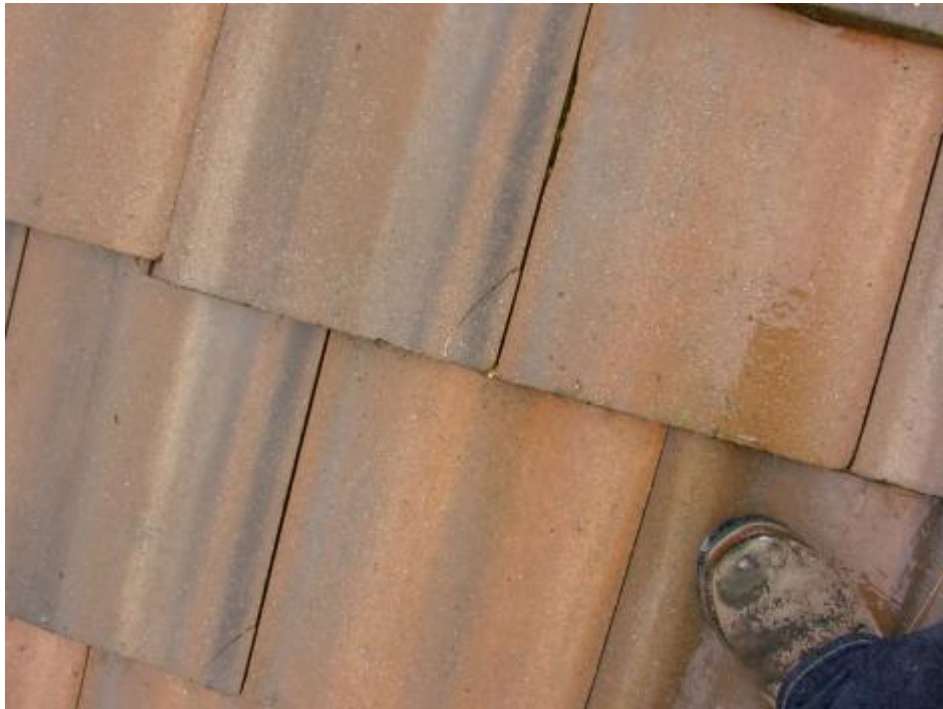
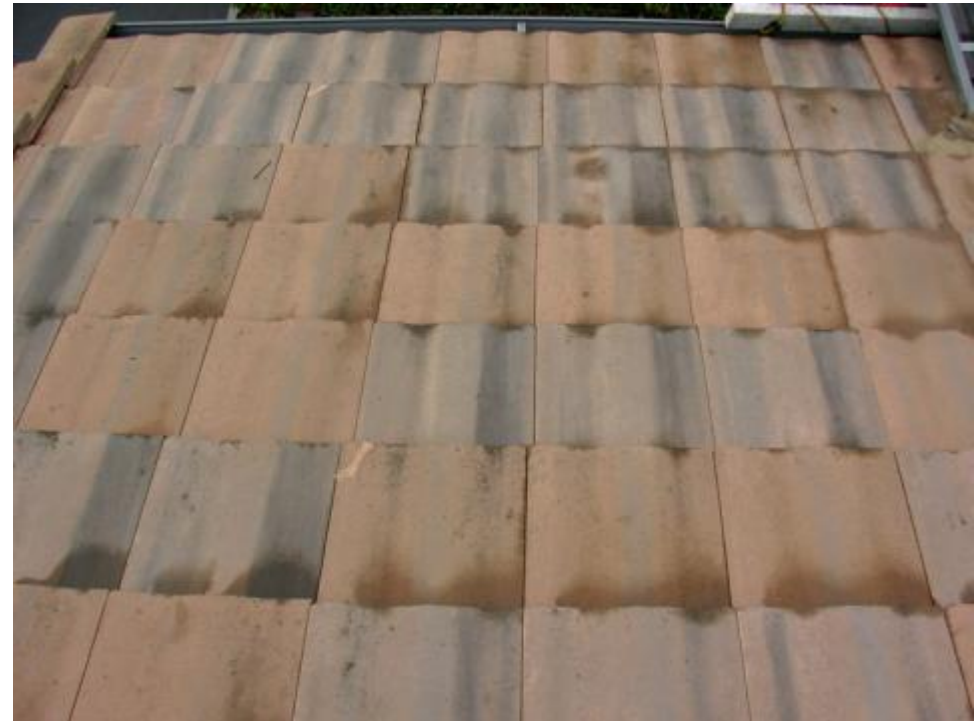
What is the correct way to install this tile, broken bond or straight bond?

# ANSWER: The manufacturer of this time recommends the straight bond method.

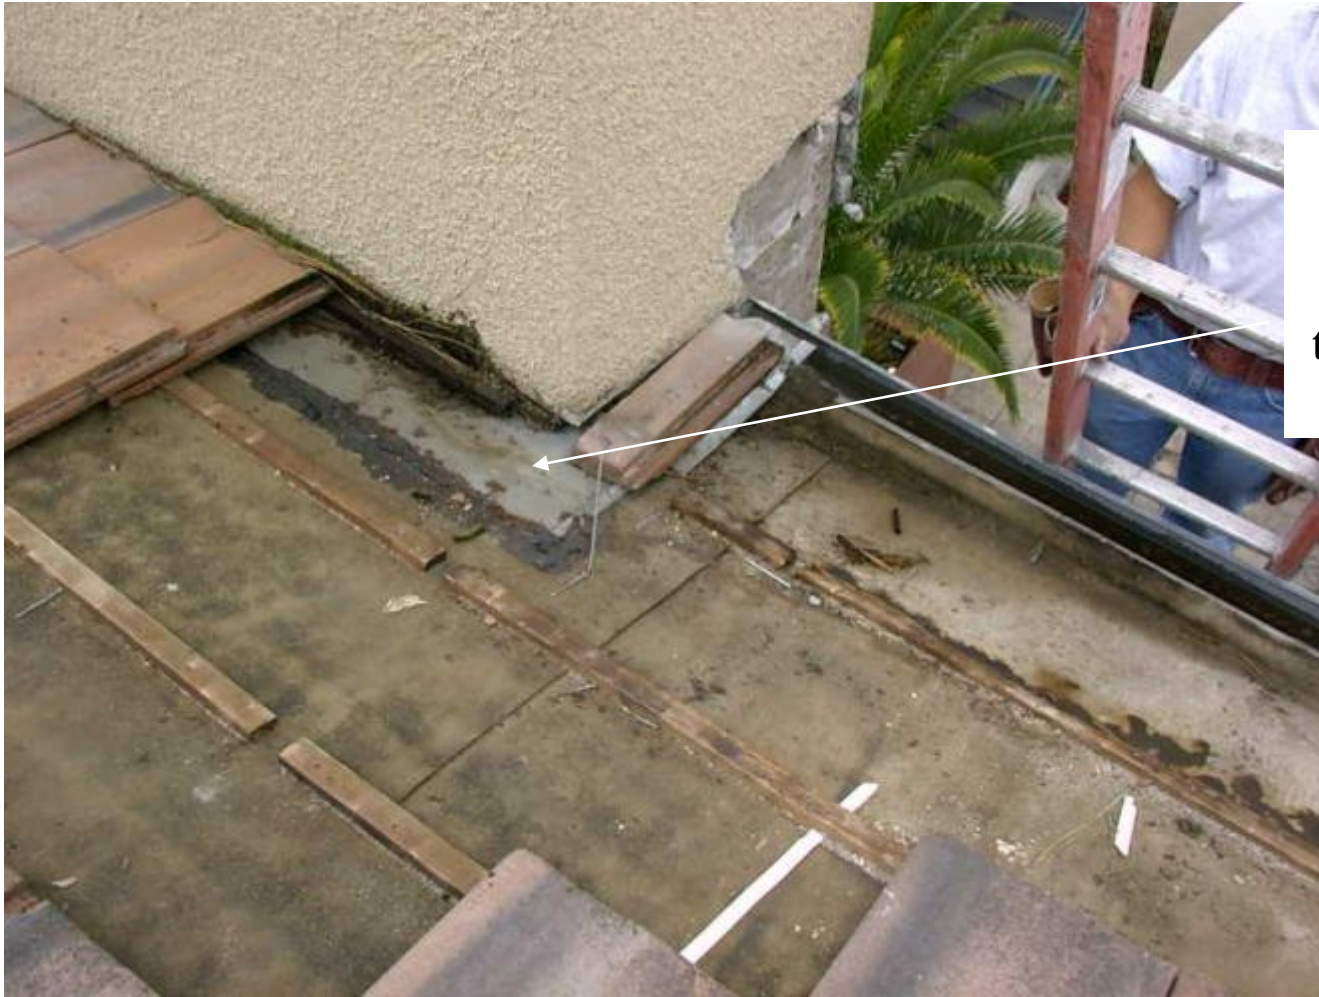
Roof to wall  
flashing installed  
as an after  
thought, on top of  
felts

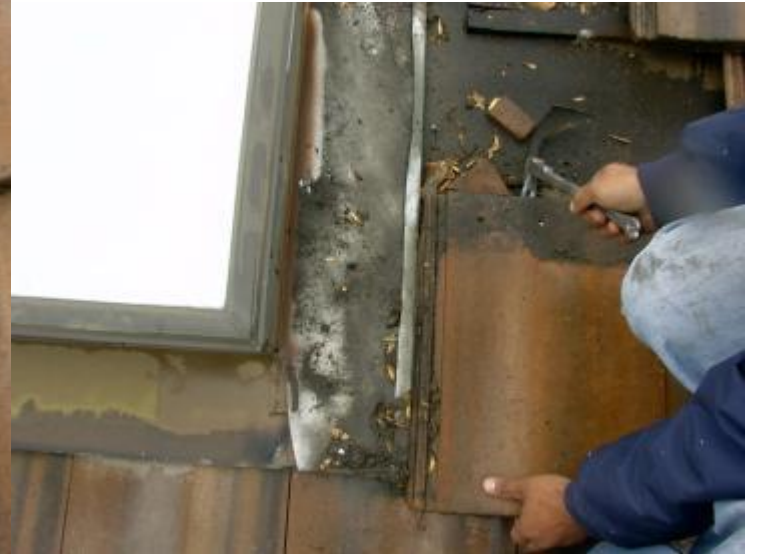
*Battens were too short,  
causing tiles to fall in  
wrong direction*

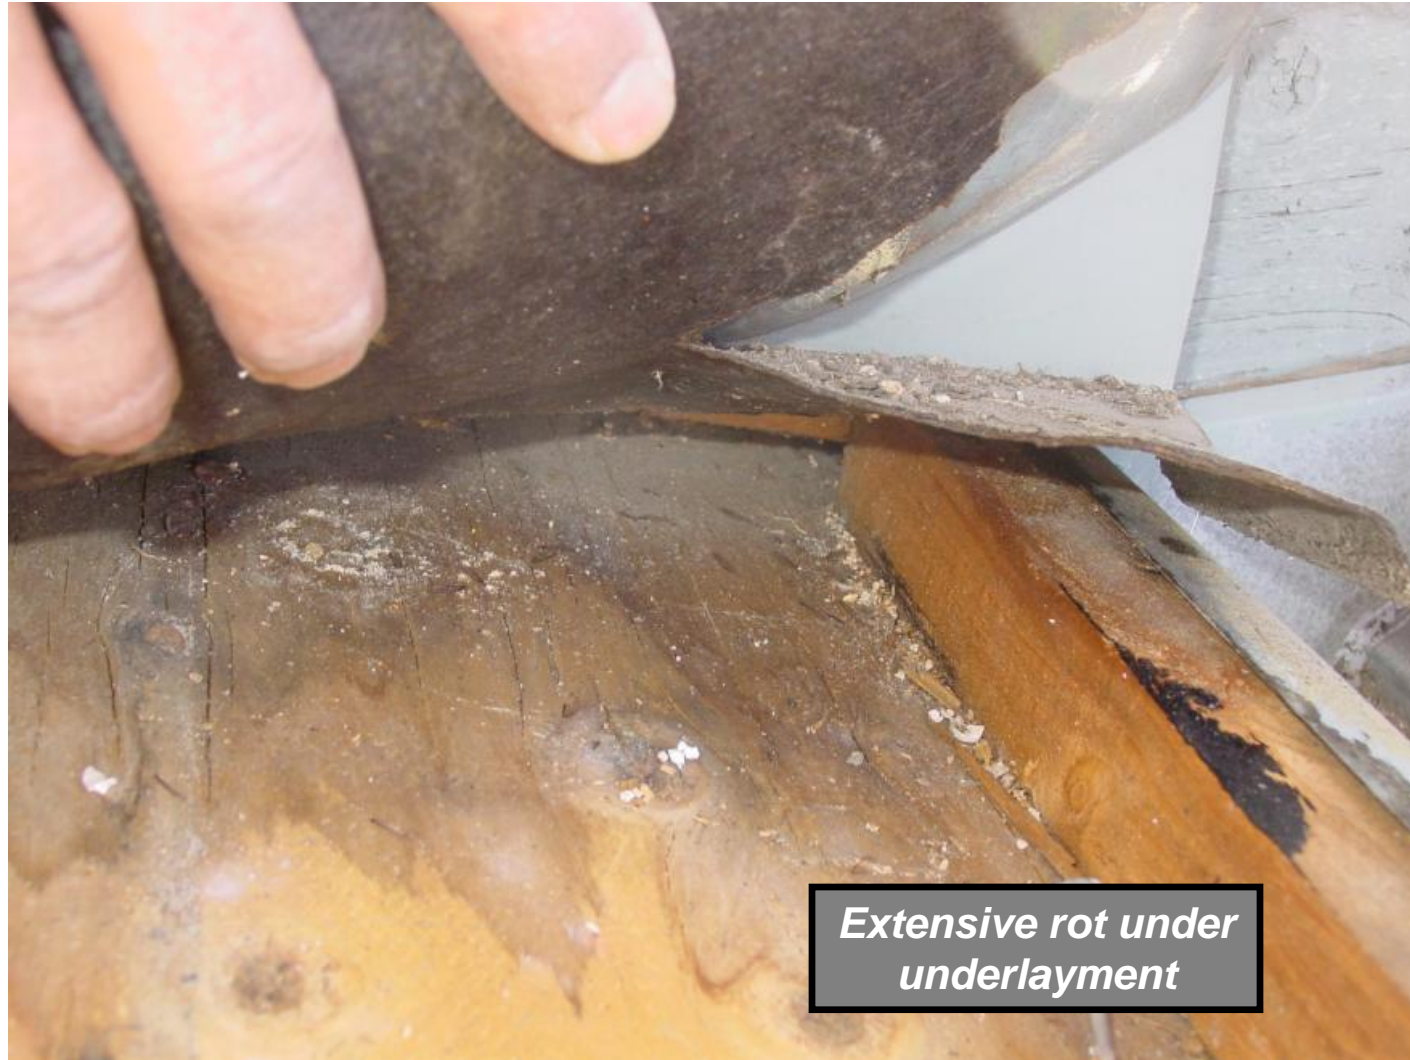
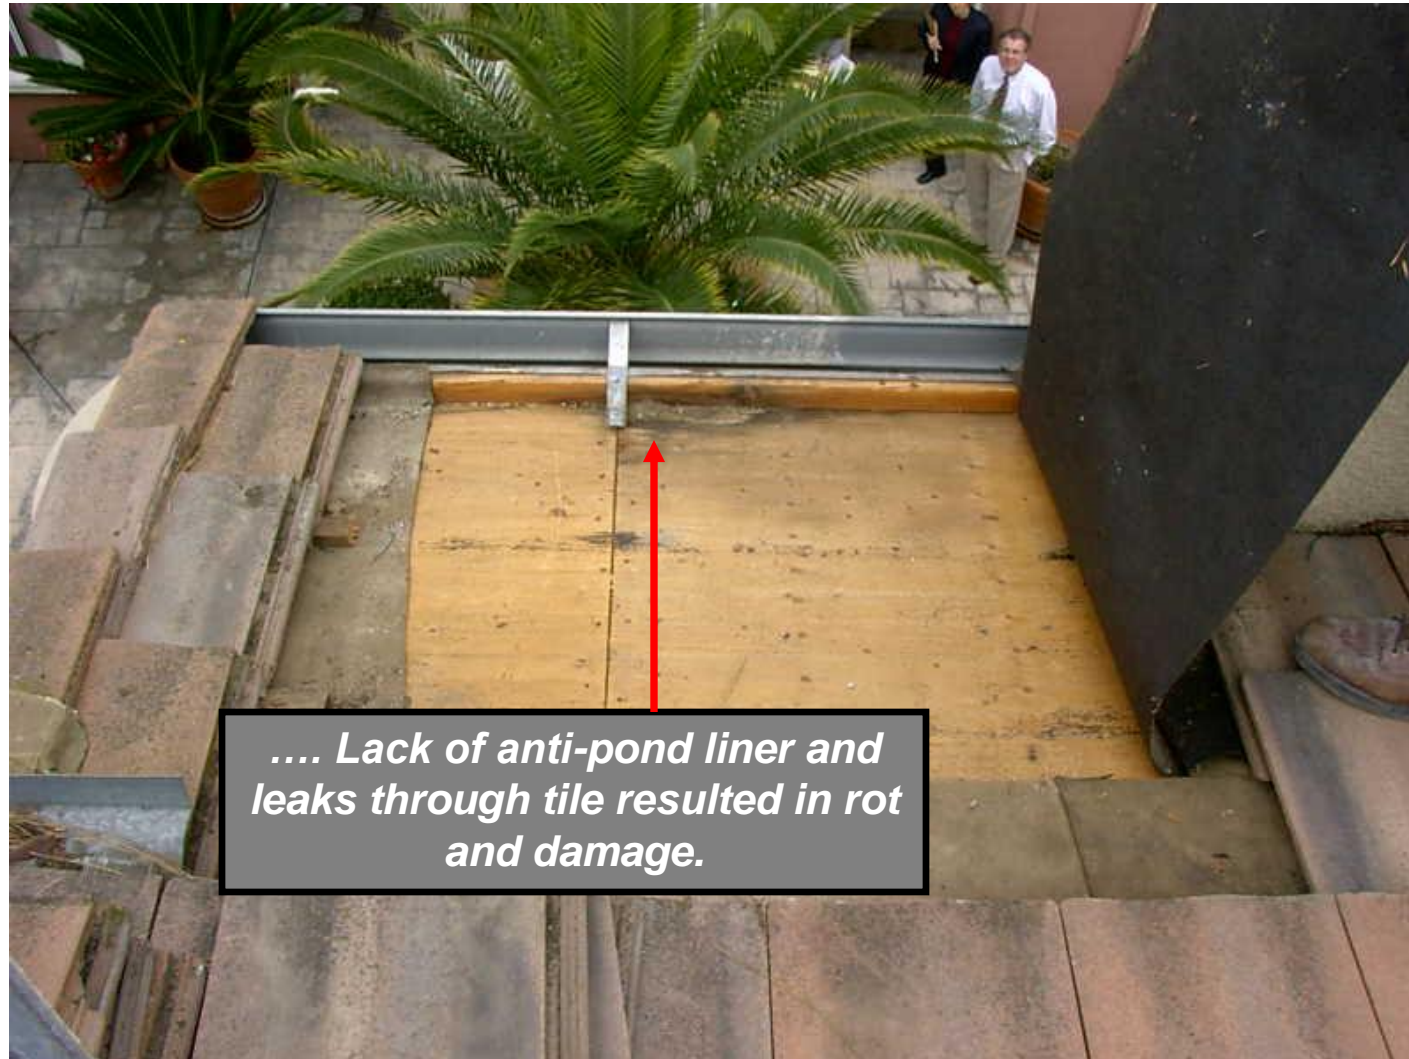
*Excess water under the tiles results in rotted felt and.....*

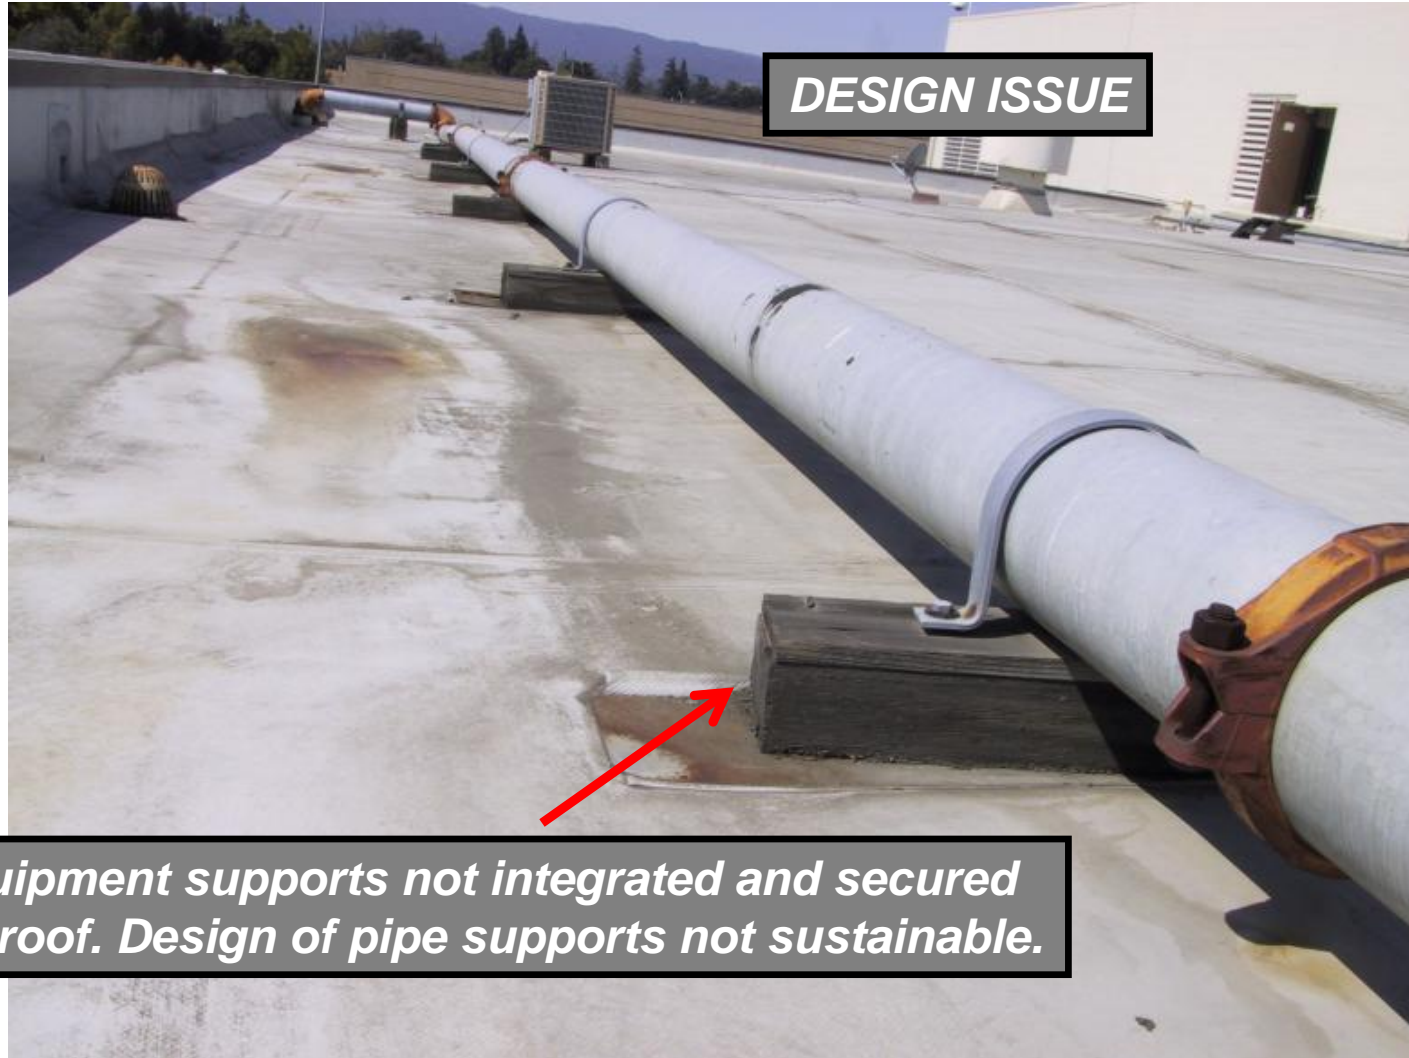
**DESIGN ISSUE**

***Equipment supports not integrated and secured into roof. Design of pipe supports not sustainable.***

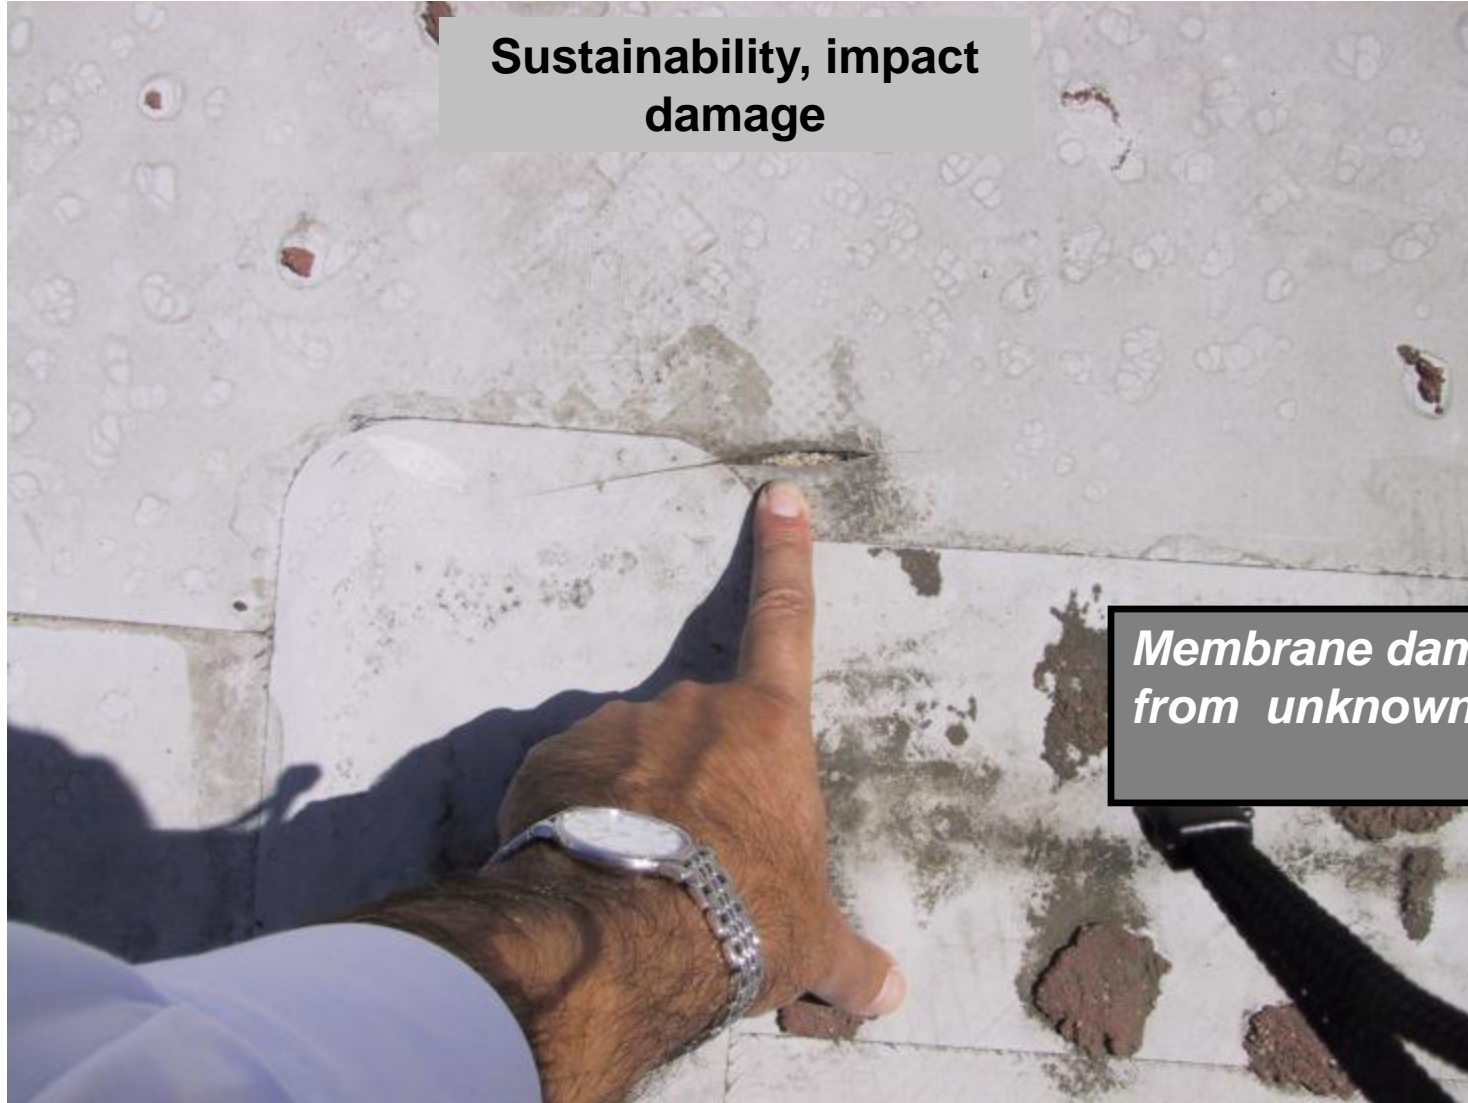
*Membrane damage  
from unknown source*

**Tenant Improvement  
Work**

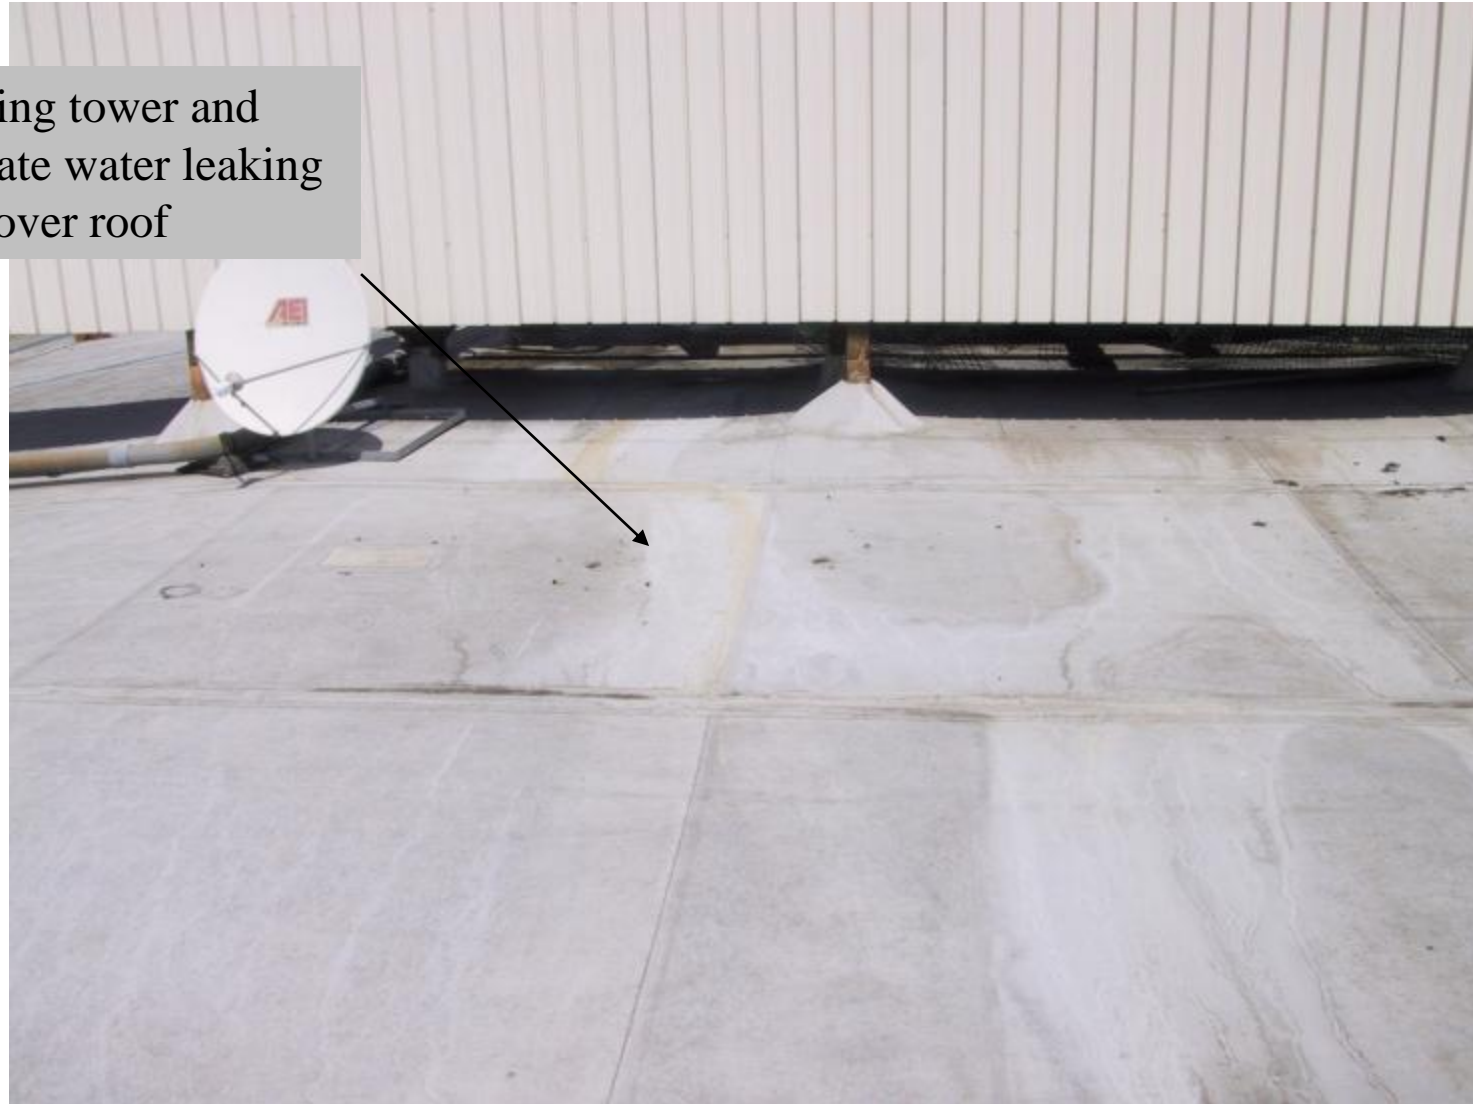
Cooling tower and  
condensate water leaking  
over roof

Sustainability, ponding  
water and chemicals
