# Understanding Common Roofing Issues & Replacement Options

Allana Buick & Bers, Inc.

# Understanding Common Glazing Issues & Replacement Options

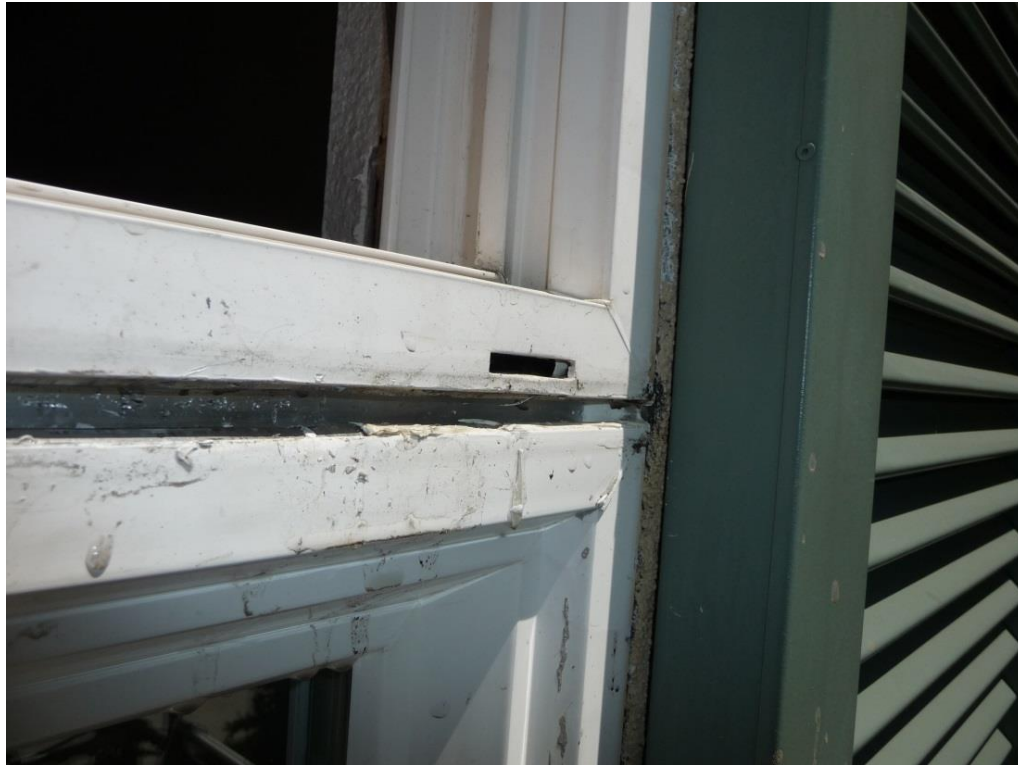
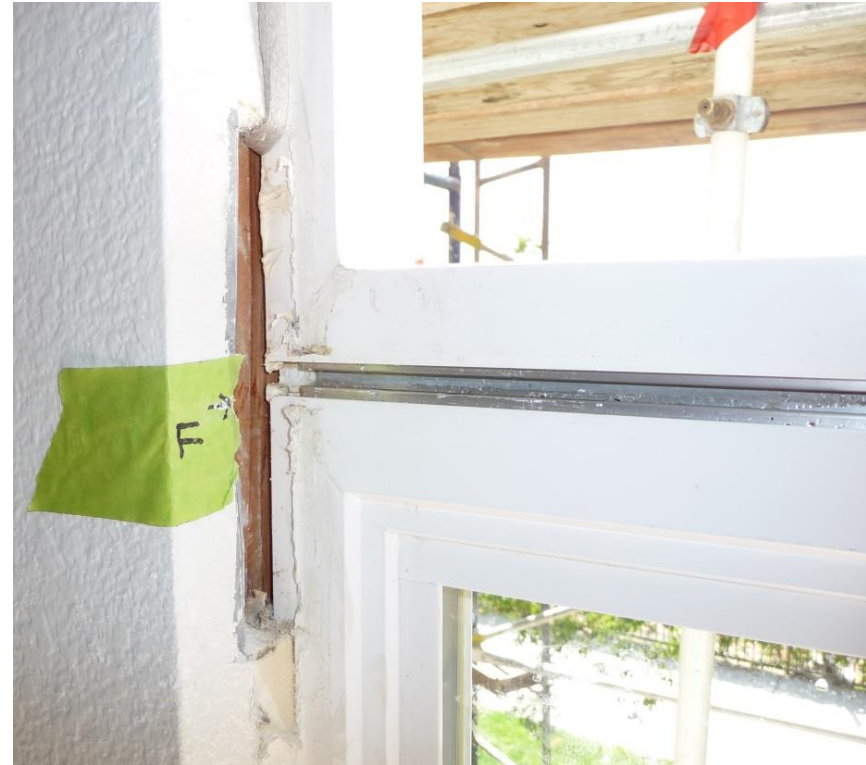
# Mulled Windows

- Muller joint cap has been removed

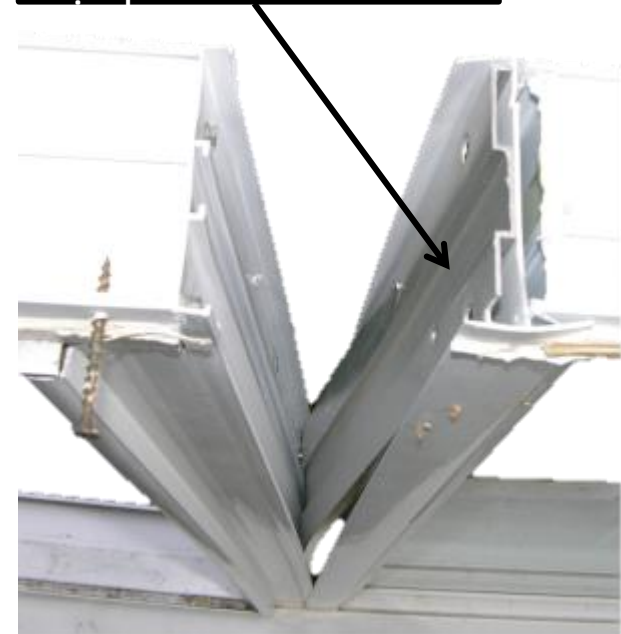
- Mullion is a stiffener used to join window frames together
- Mulled joints can inherently allow water intrusion due to a number of issues
- Often only single windows are tested under AAMA 501 protocol and not the “mulled” configuration
- If you have mulled windows, high likelihood of leaks

Aluminum stiffener.  
Note an absence of sealant between the aluminum and the

Mulled windows separated

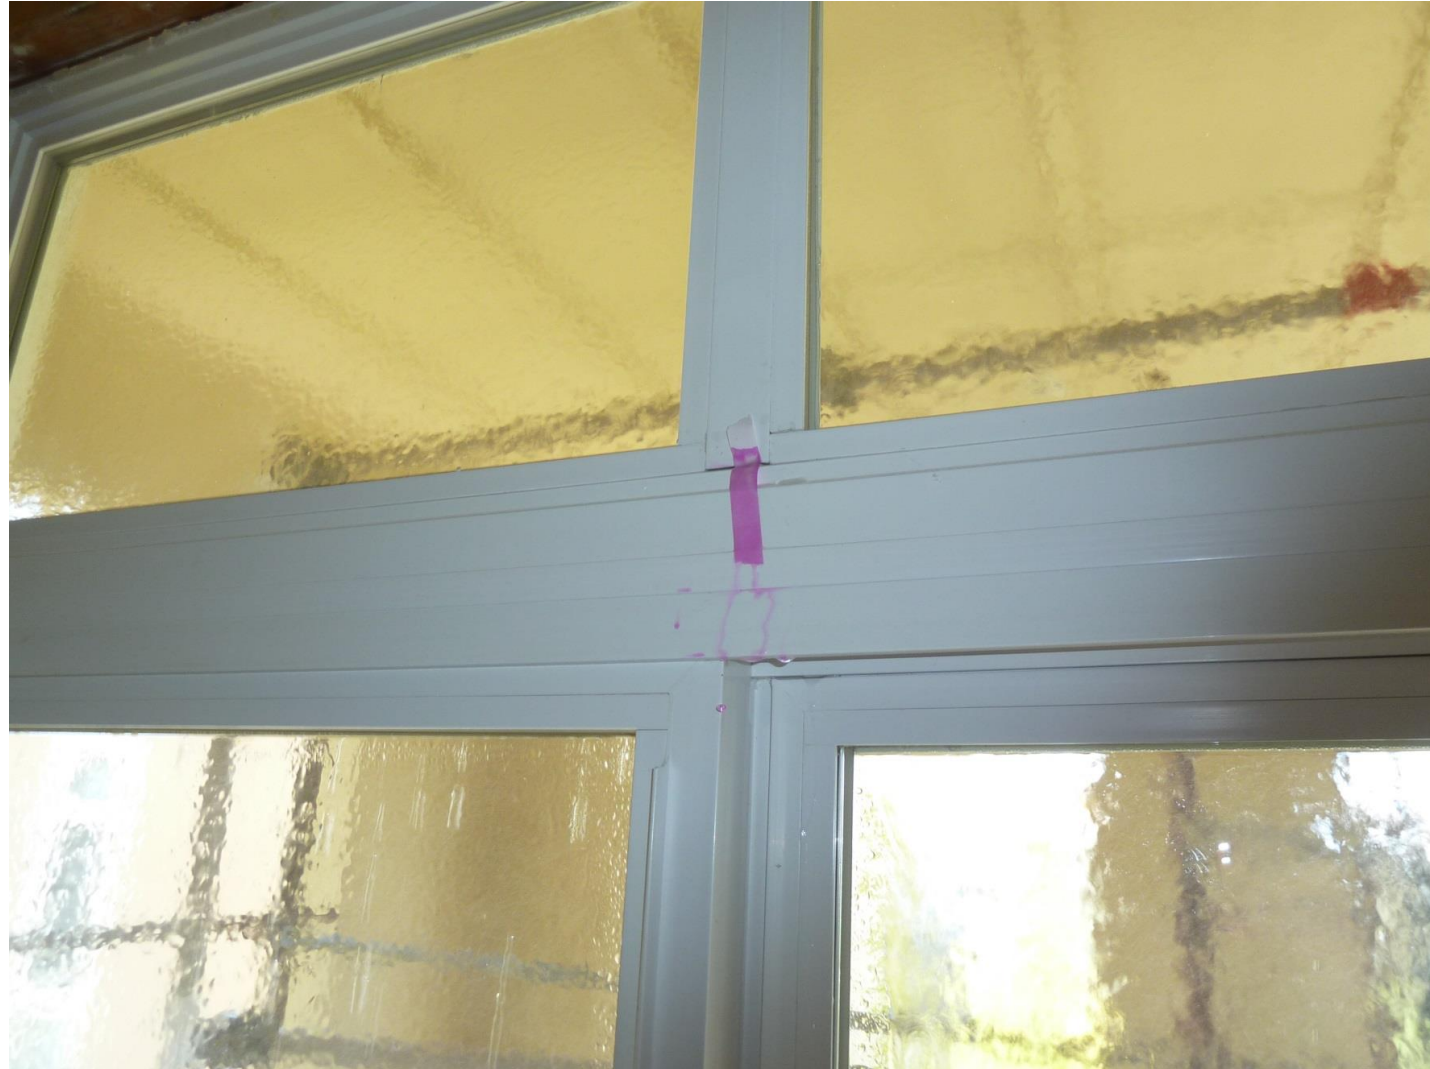
# Horizontal and Vertical Mullion Failures

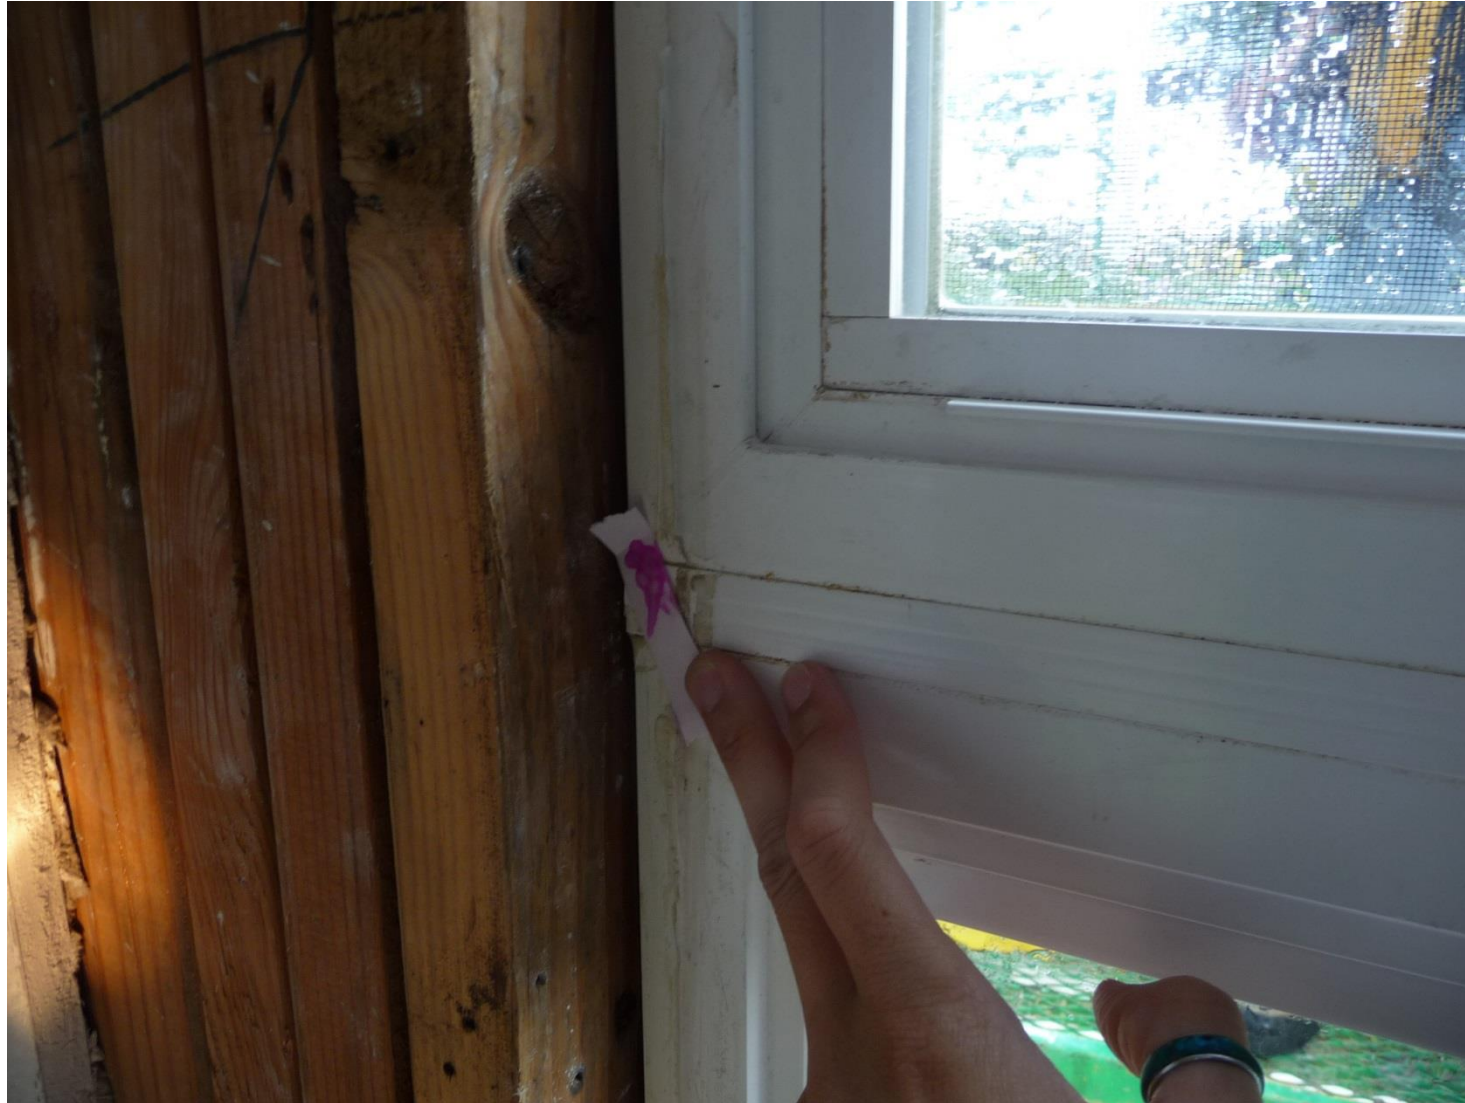
# Horizontal and Vertical Mullion Failures

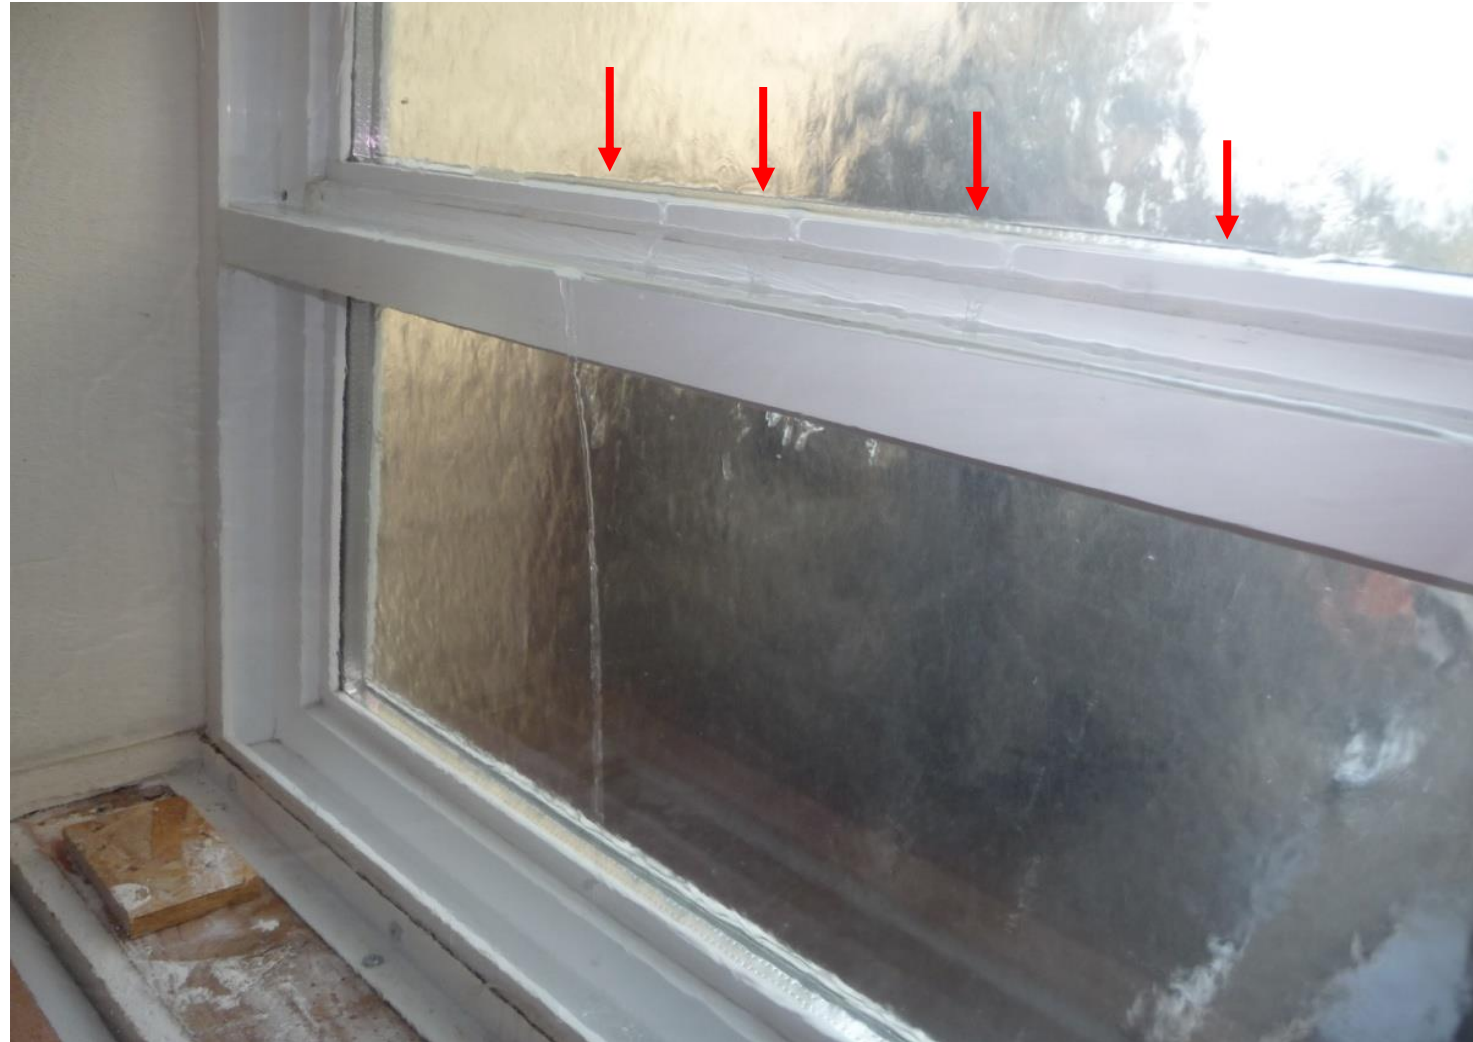
# Glazing Seal Failures And Resultant Leak

- The window manufacturer used poor quality “foam” tape as glazing seals.
- Commercial windows use tape with adhesive backing on two sides and silicone heel or cap beads for glazing seal.
- Residential “fin style” windows are generally glazed with just acrylic foam tape. The tape is susceptible to UV and heat degradation, is of inferior quality, and is not a long-term solution to this condition

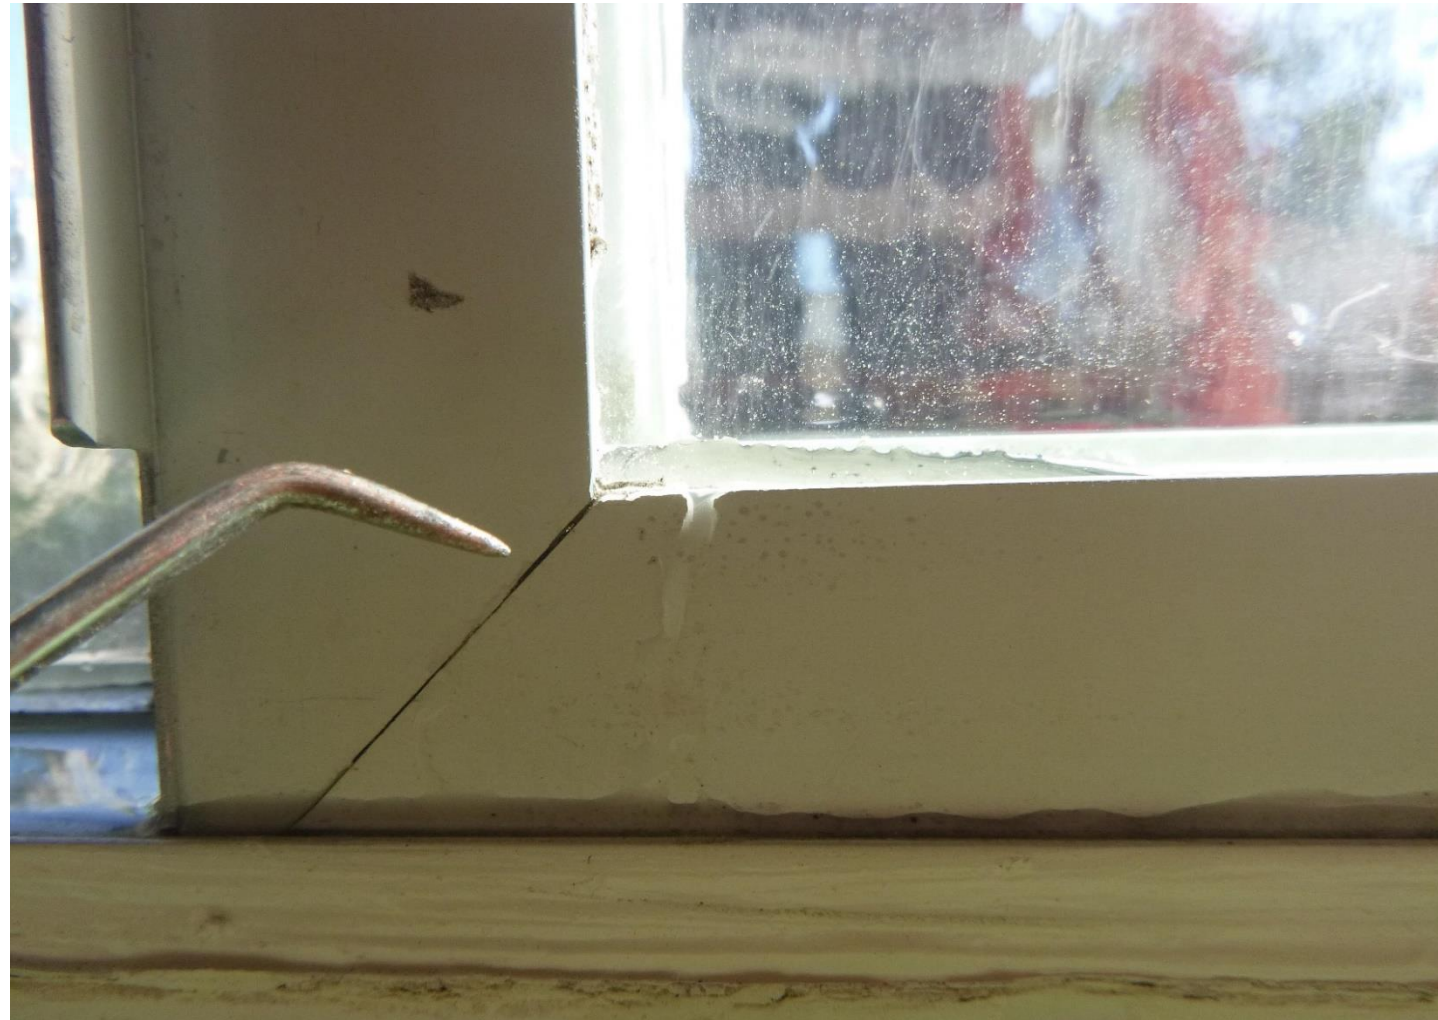
# Glazing Seal Failures And Resultant Leak

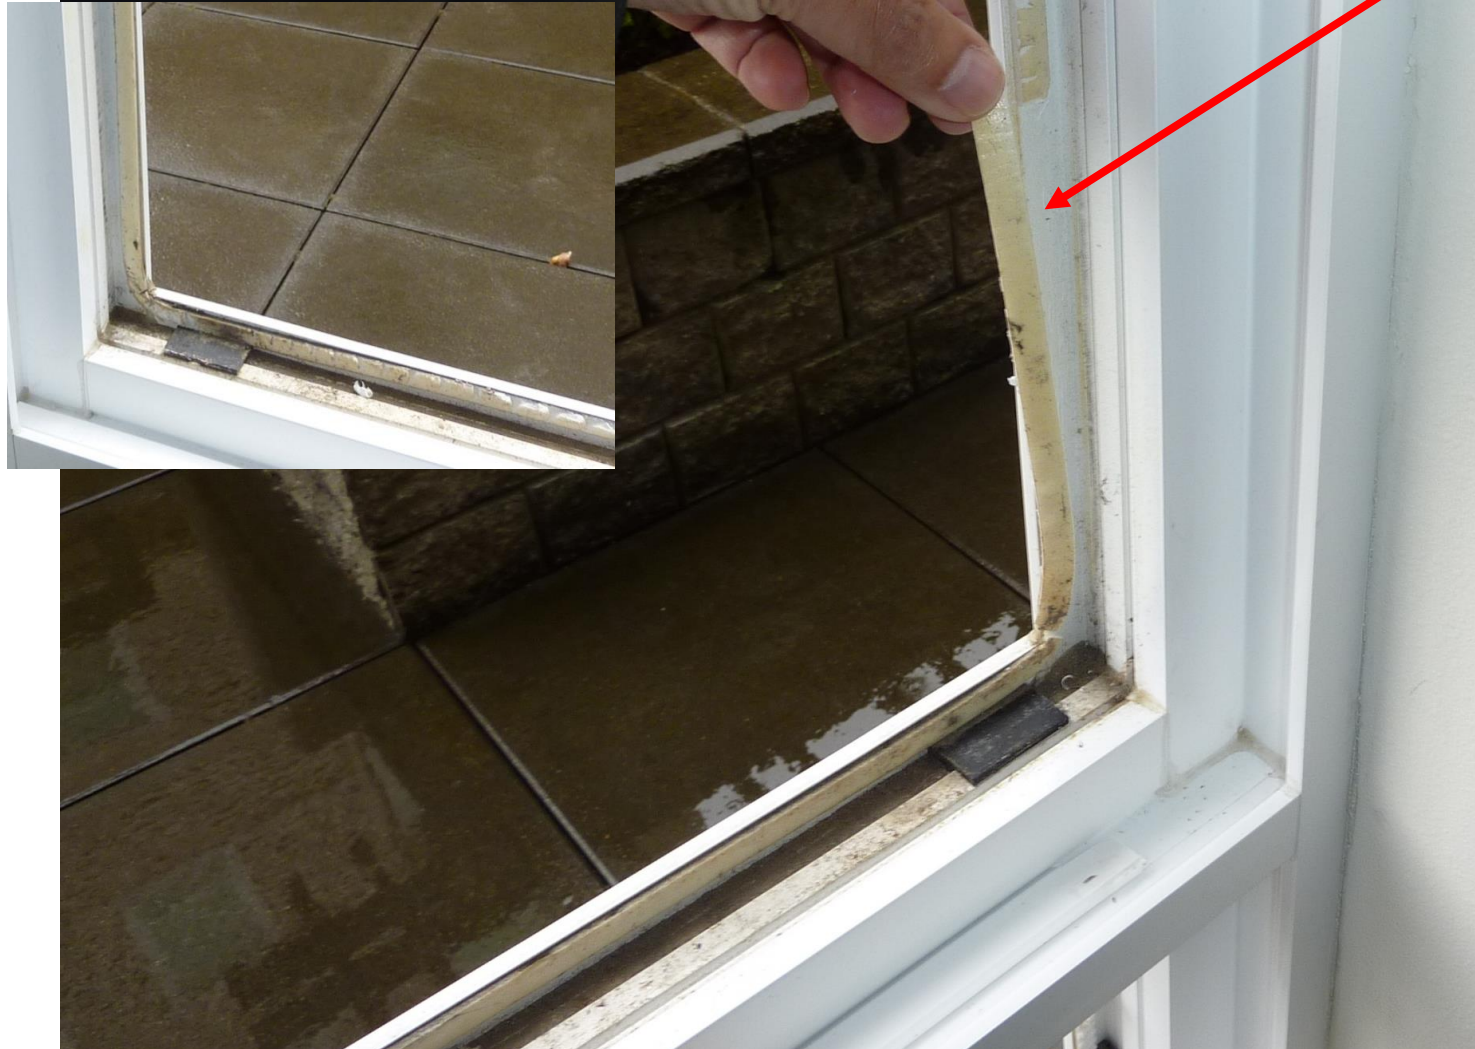
# Glazing Tape Is Discolored And Stained

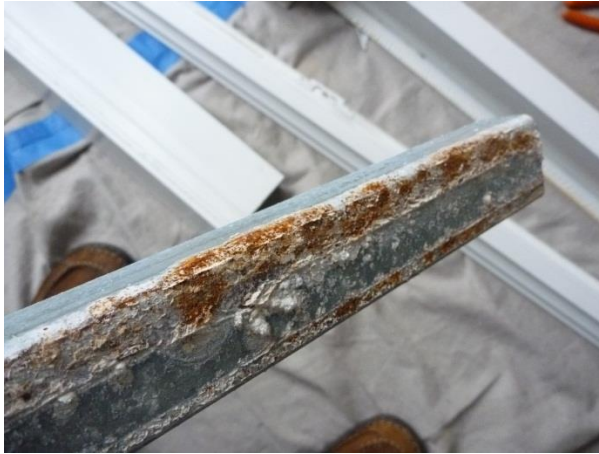
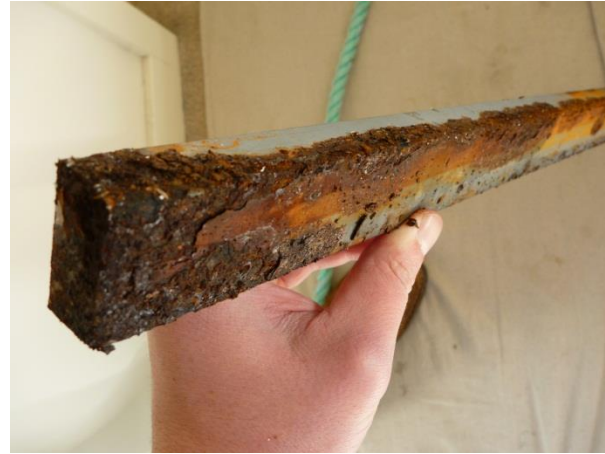
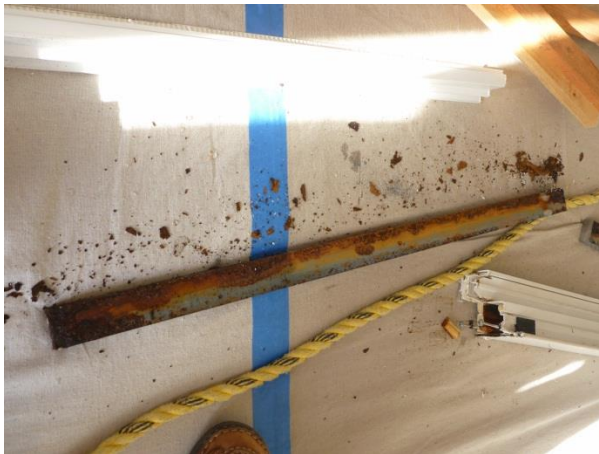
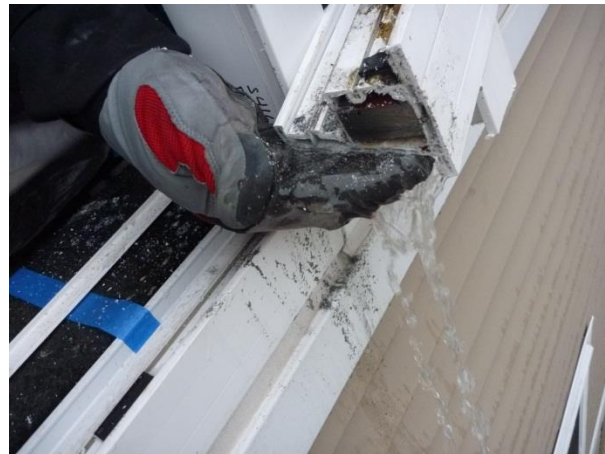
# Window Drainage To Internal Steel Reinforcement

- Water traveling down weep pathway can rust the steel bar

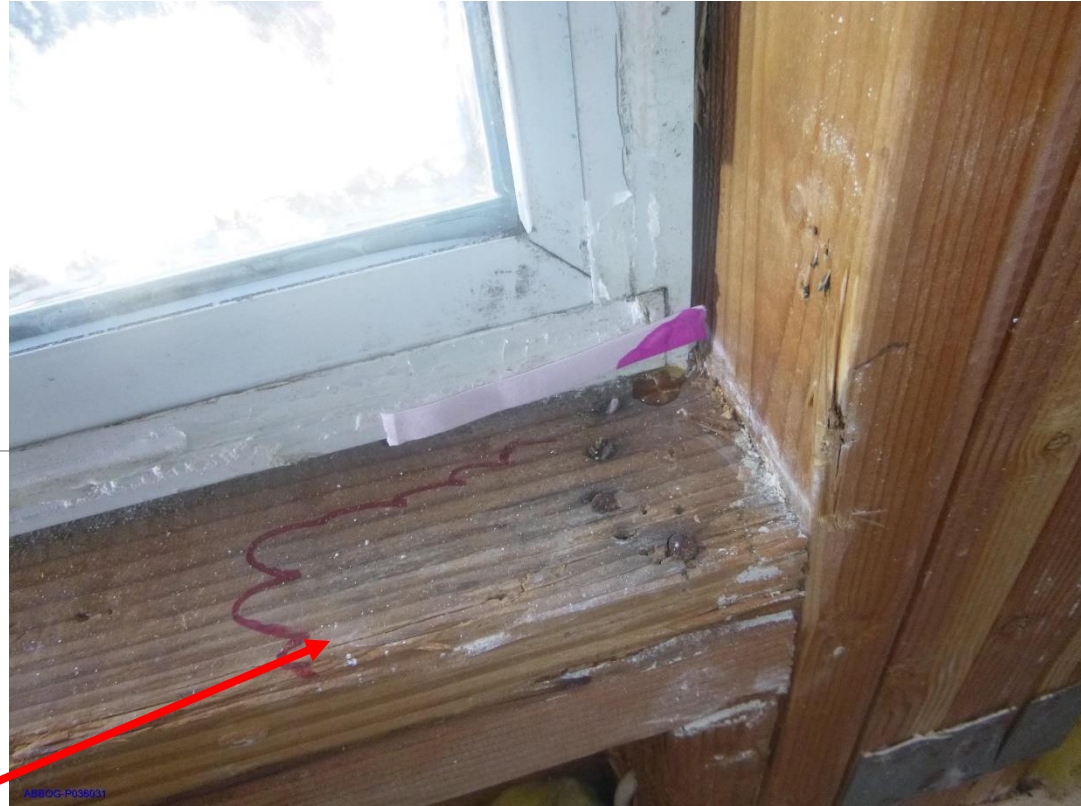
# Aluminum Fin-Style Window Leaks at Corners

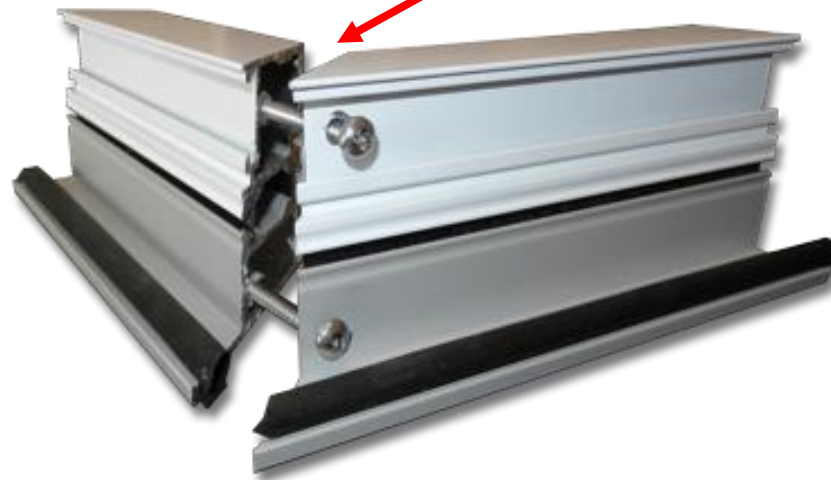
# Window Frame Corner Seals and Leaks

Aluminum Frame Corners are sealed in the factory before being screwed together. Applying sealant in place from the top doesn't work because of lack of proper geometry and profile

Sealant is applied in the frame corner joint *before* the frames are screw splined together

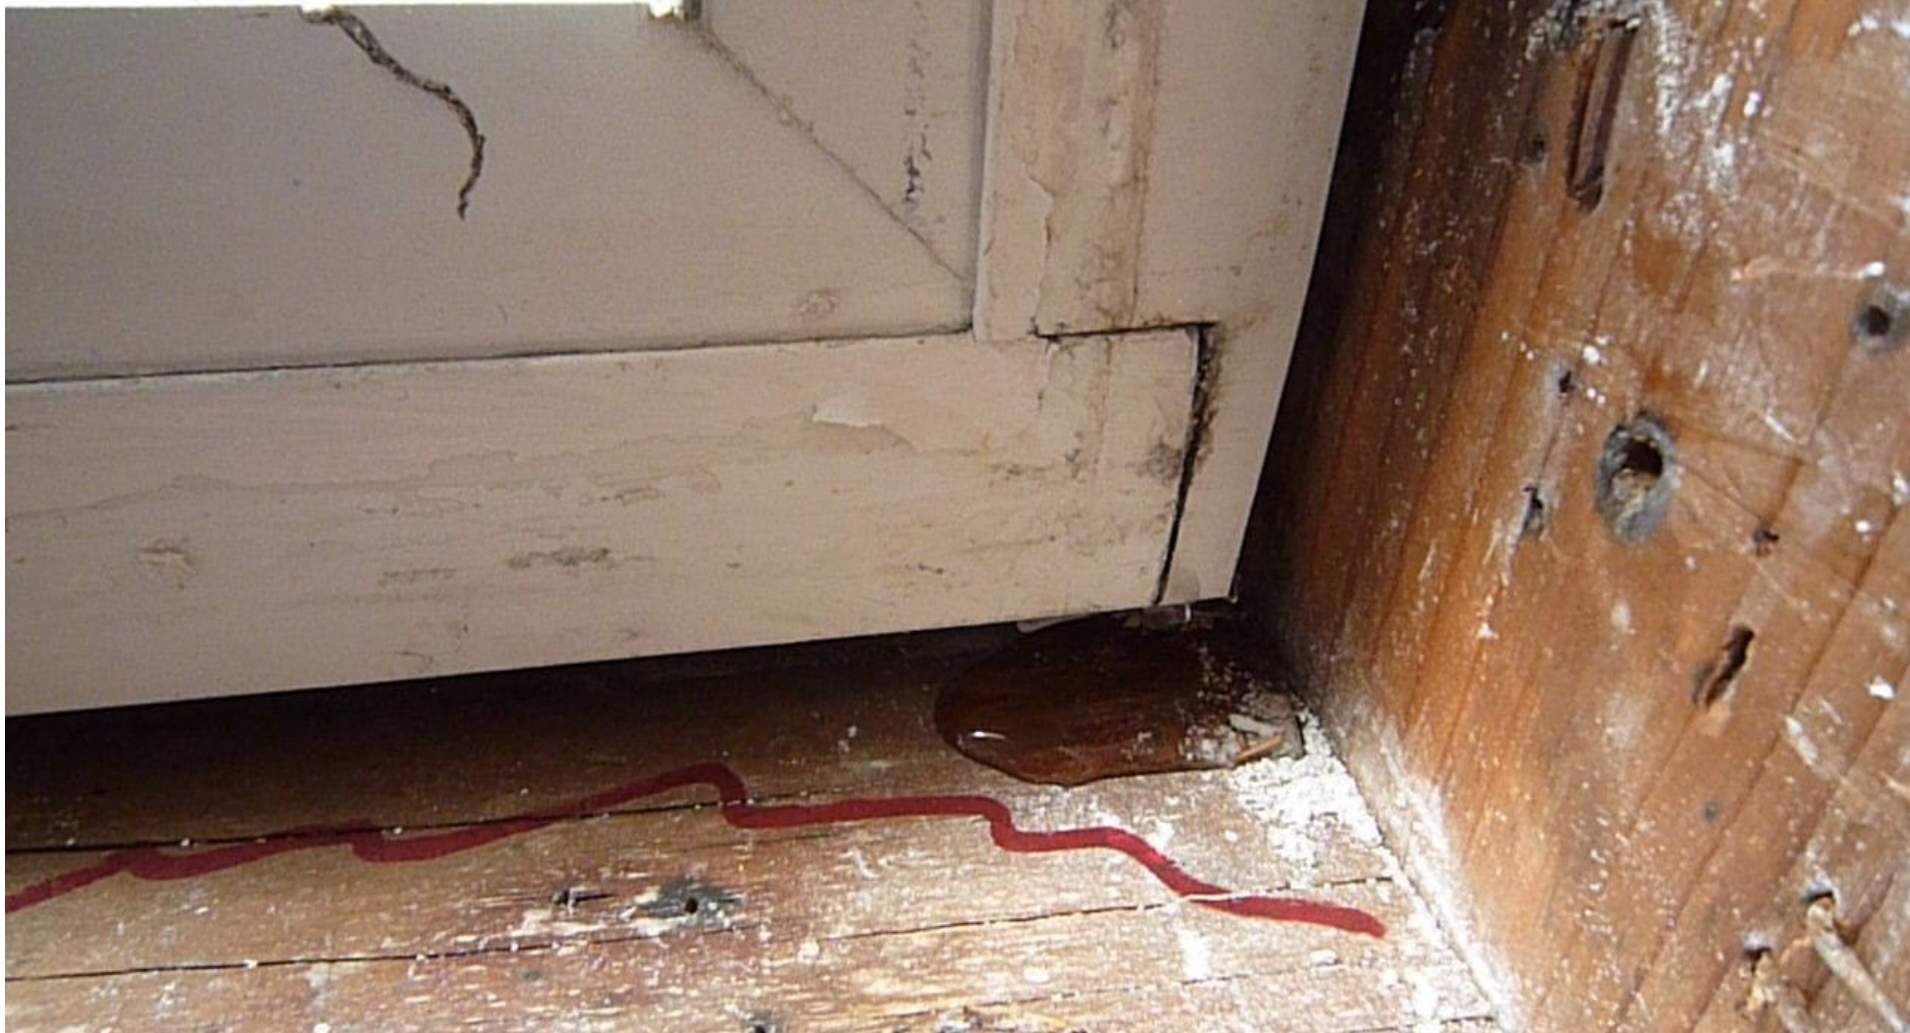
# Leak at Coped Corners Due To Failed Sealants

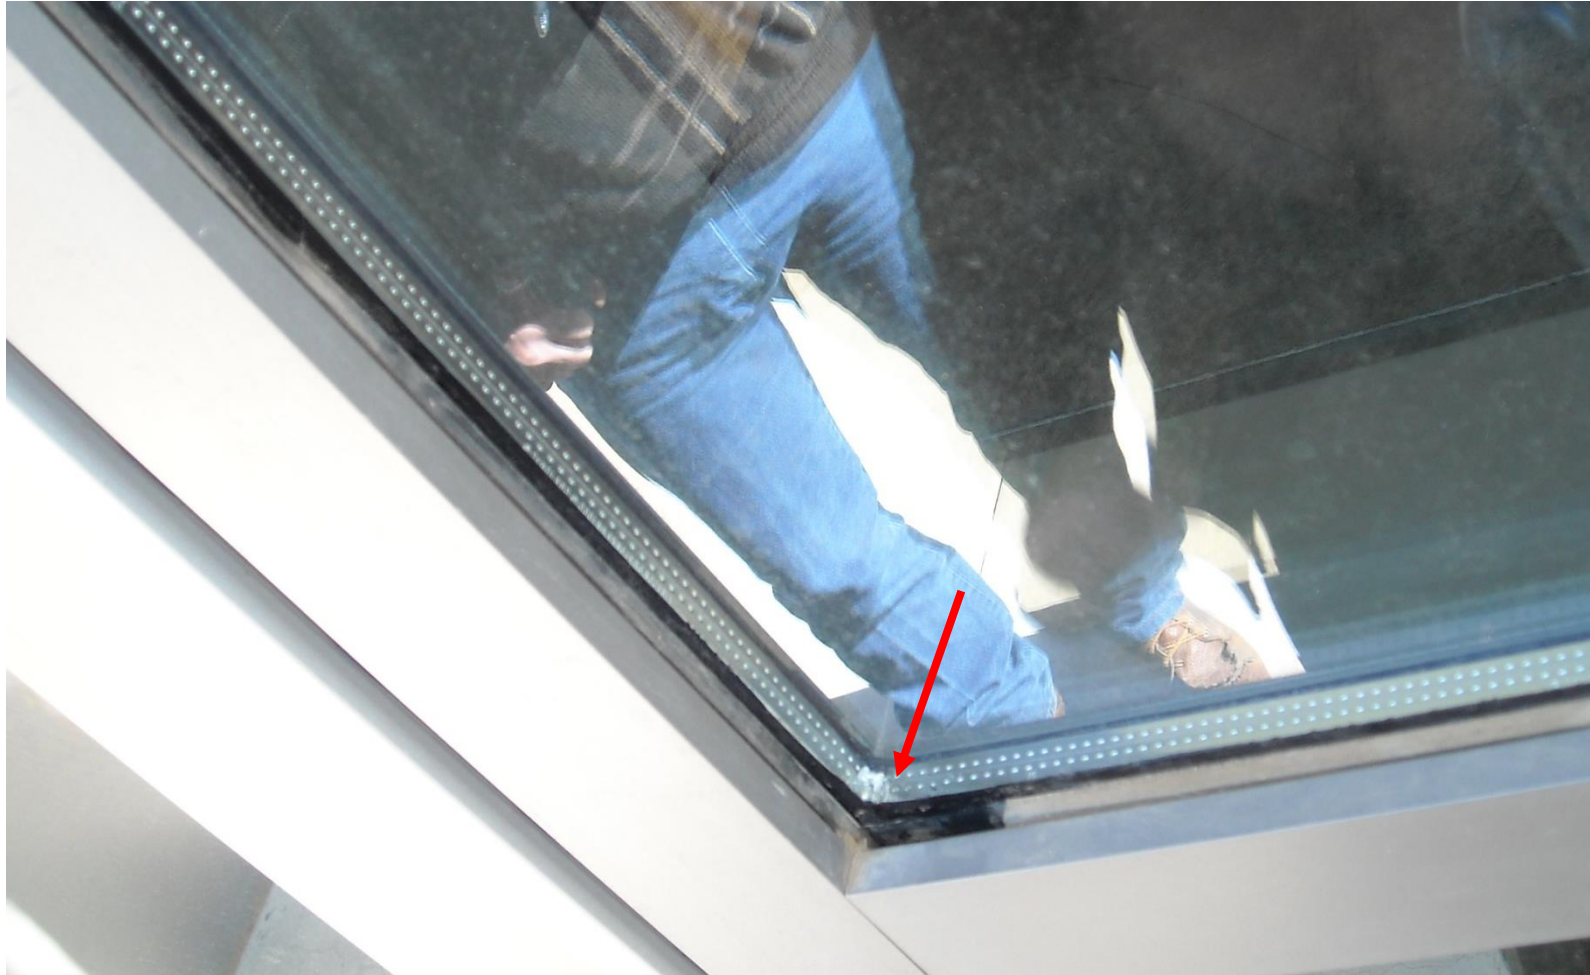
- Drying out, shrinking and cracking
- Exposure to UV radiation
- Exposure to freeze-thaw cycles
- Improper maintenance

# Mondavi Gasket Shrinkage / Failure

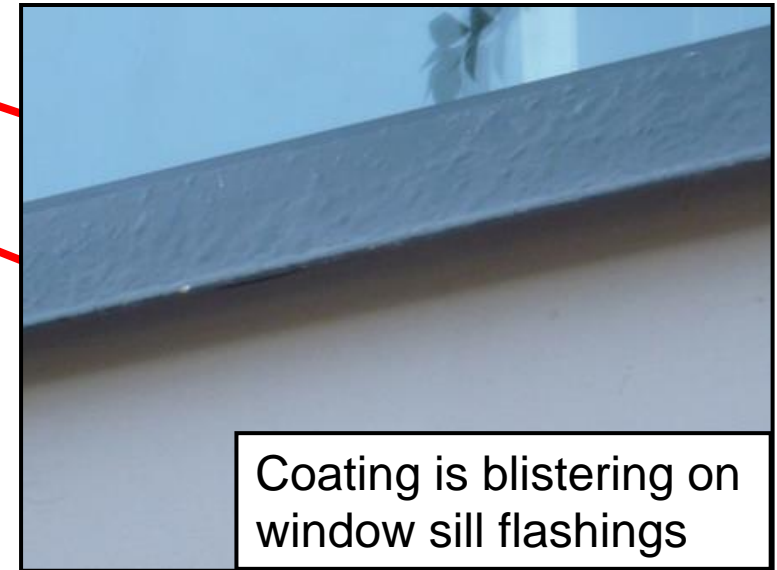
# Aluminum Coating Failure

Coating is blistering on window sill flashings

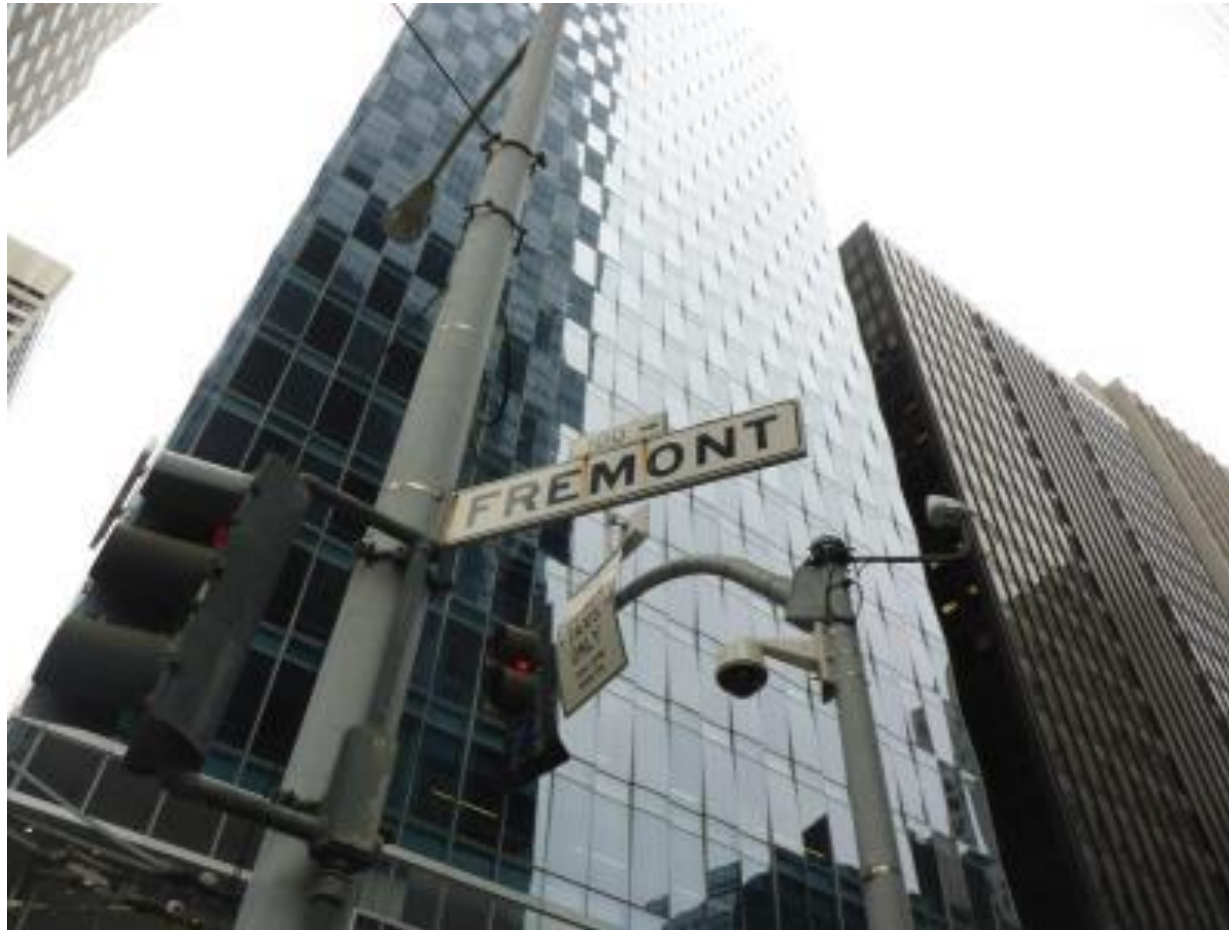
# High Rise Condominium Coating Failure

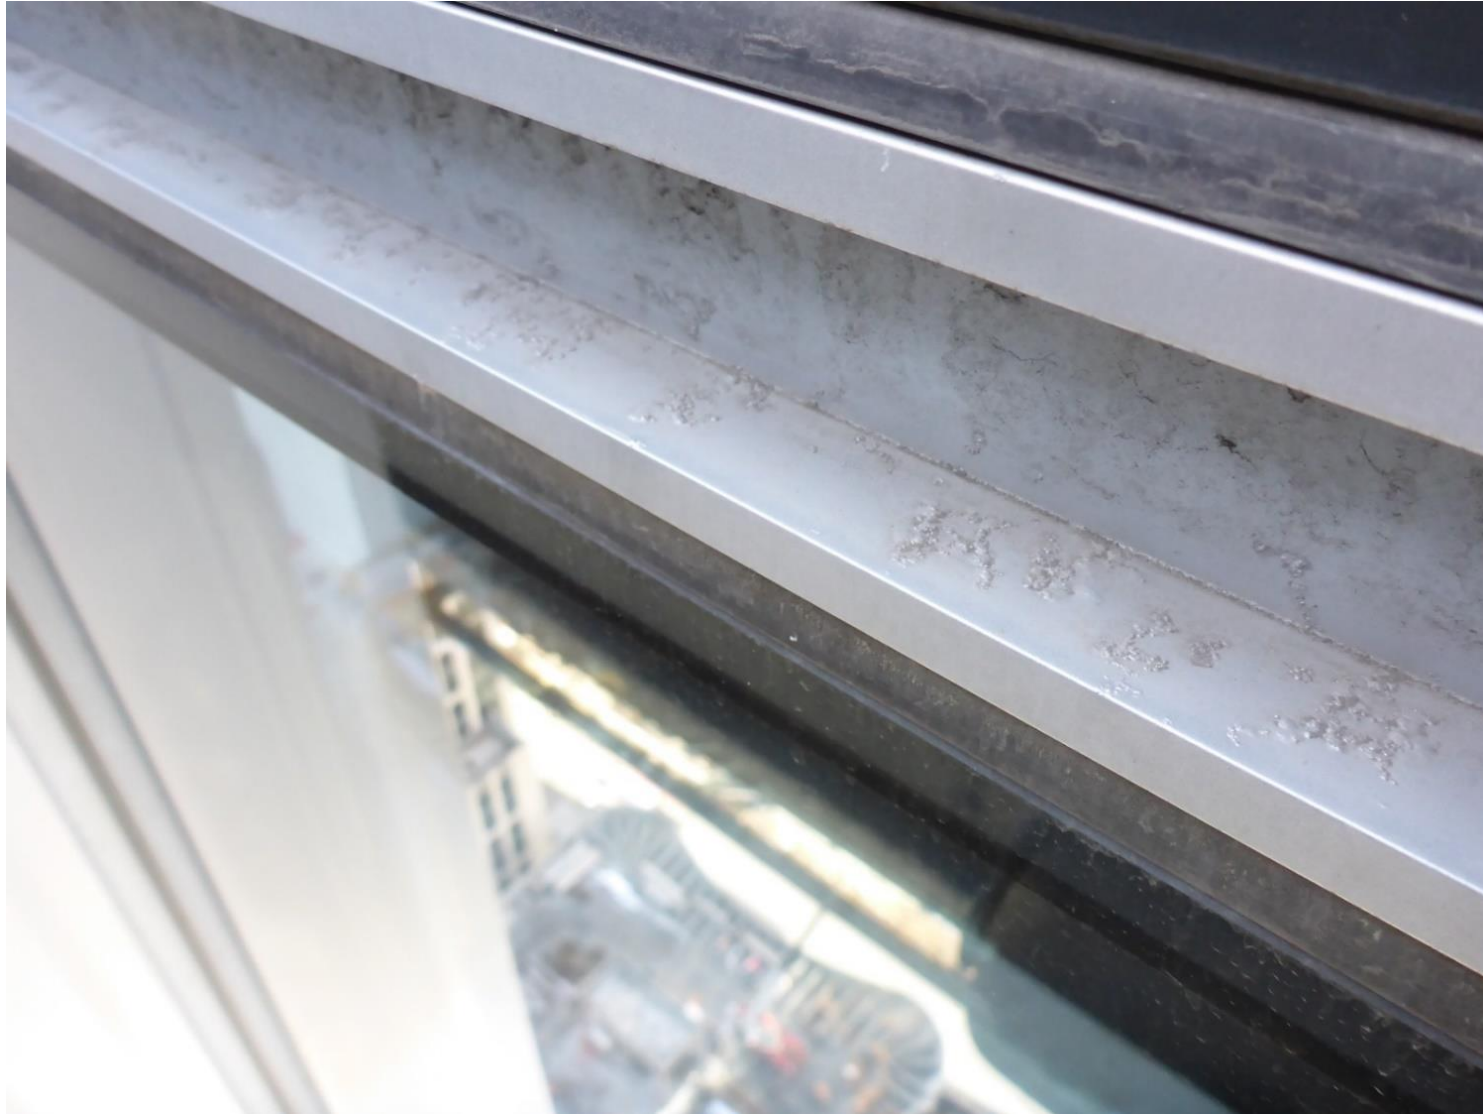
# Coating Is Erupting in Little Bubbles

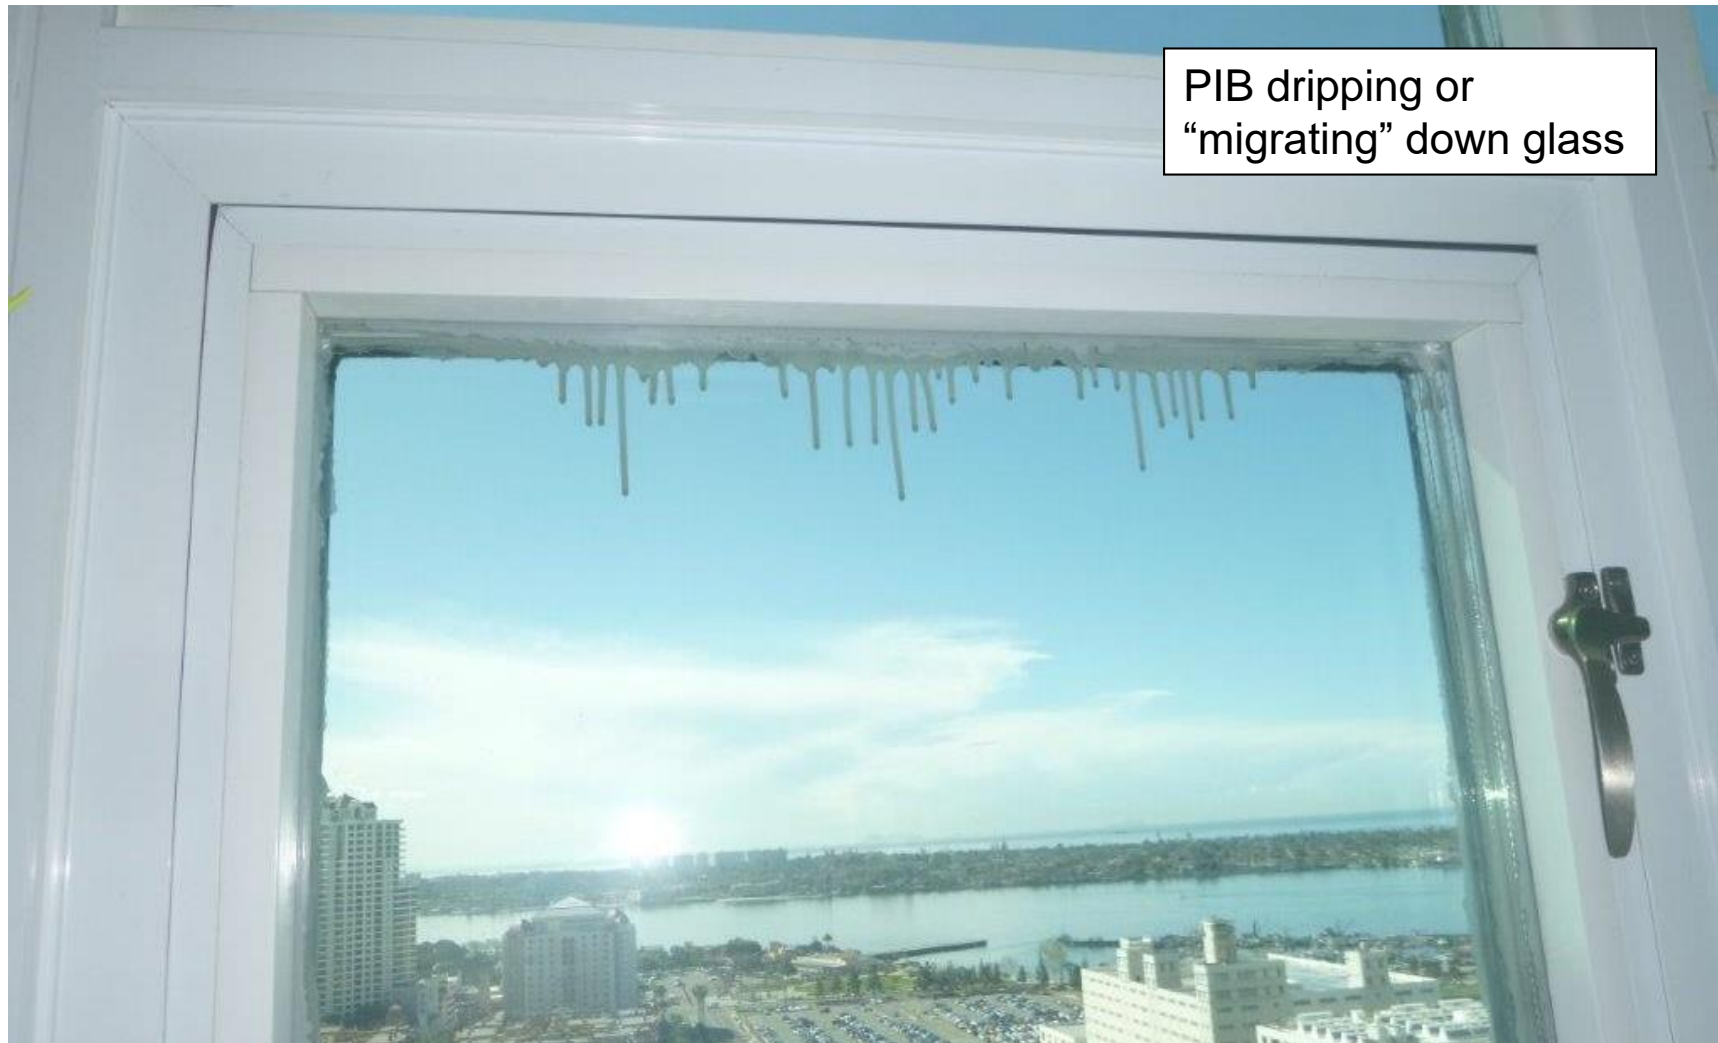
# PIB Migration/Failure in IGU

- Requires glazing replacement
- Limited to gray PIB
- Gray PIB contains 64.8% polymer with plasticizers as low as 2.6%
  - PIB control samples are 97.5% polymer

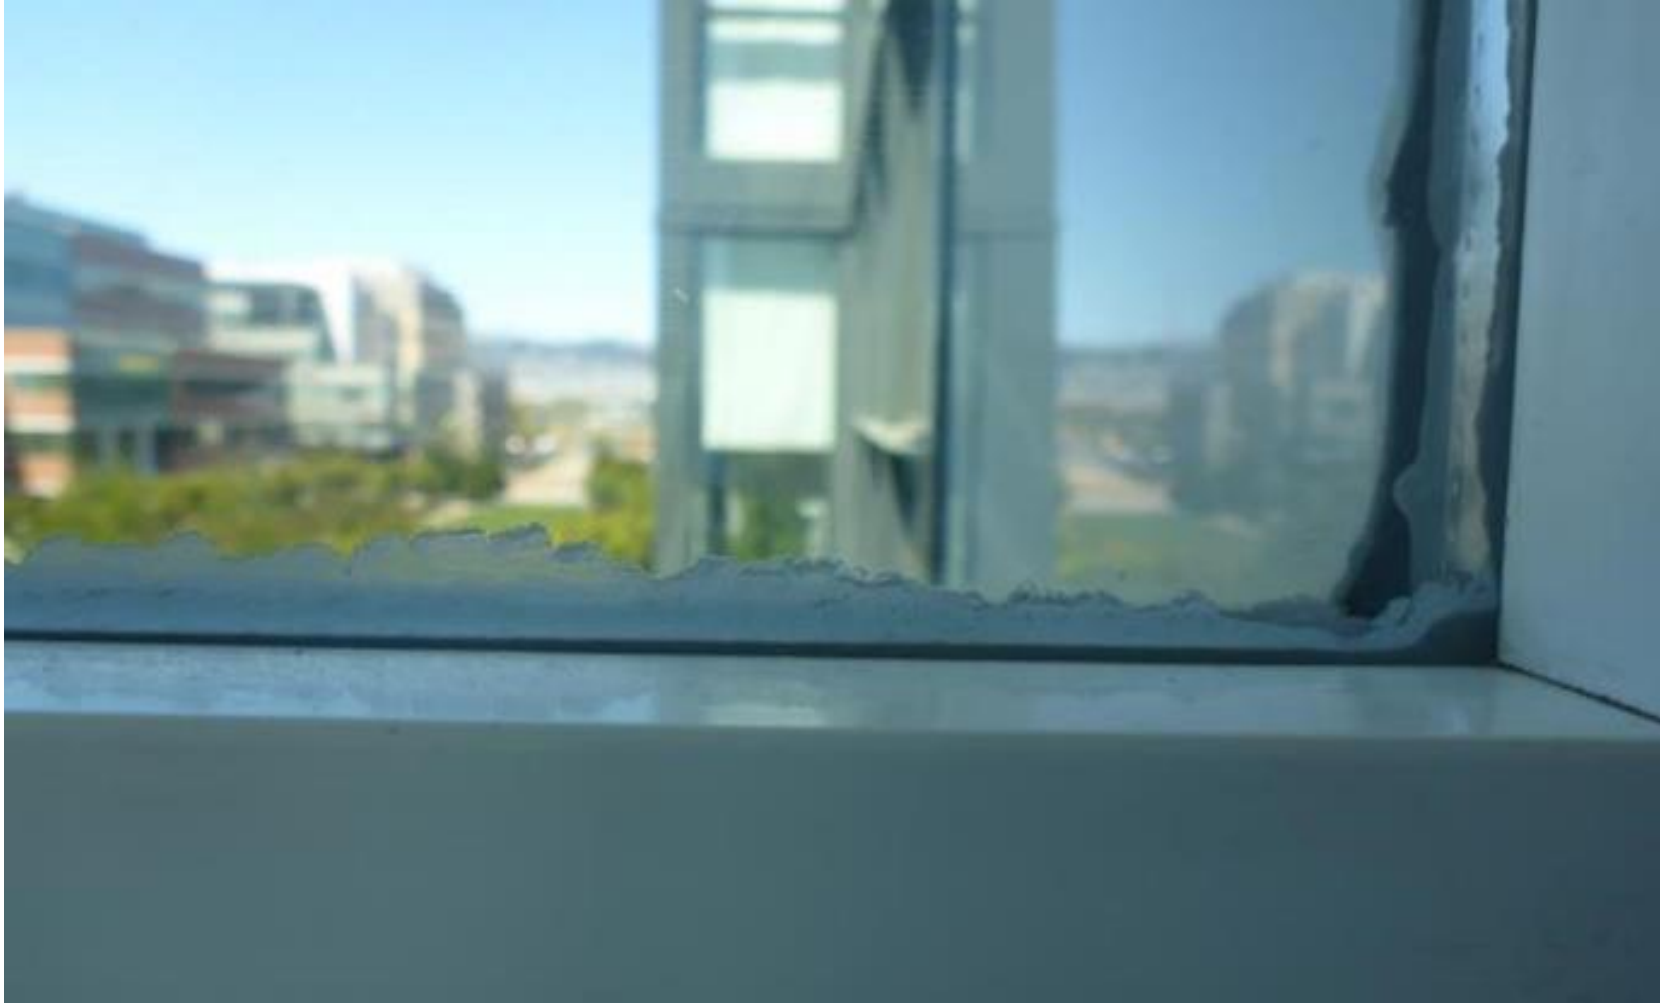
# PIB Migration, Moving/Walking Up
