# Understanding Common Roofing Issues & Replacement Options

Allana Buick & Bers, Inc.

# Understanding Common Glazing Issues & Replacement Options

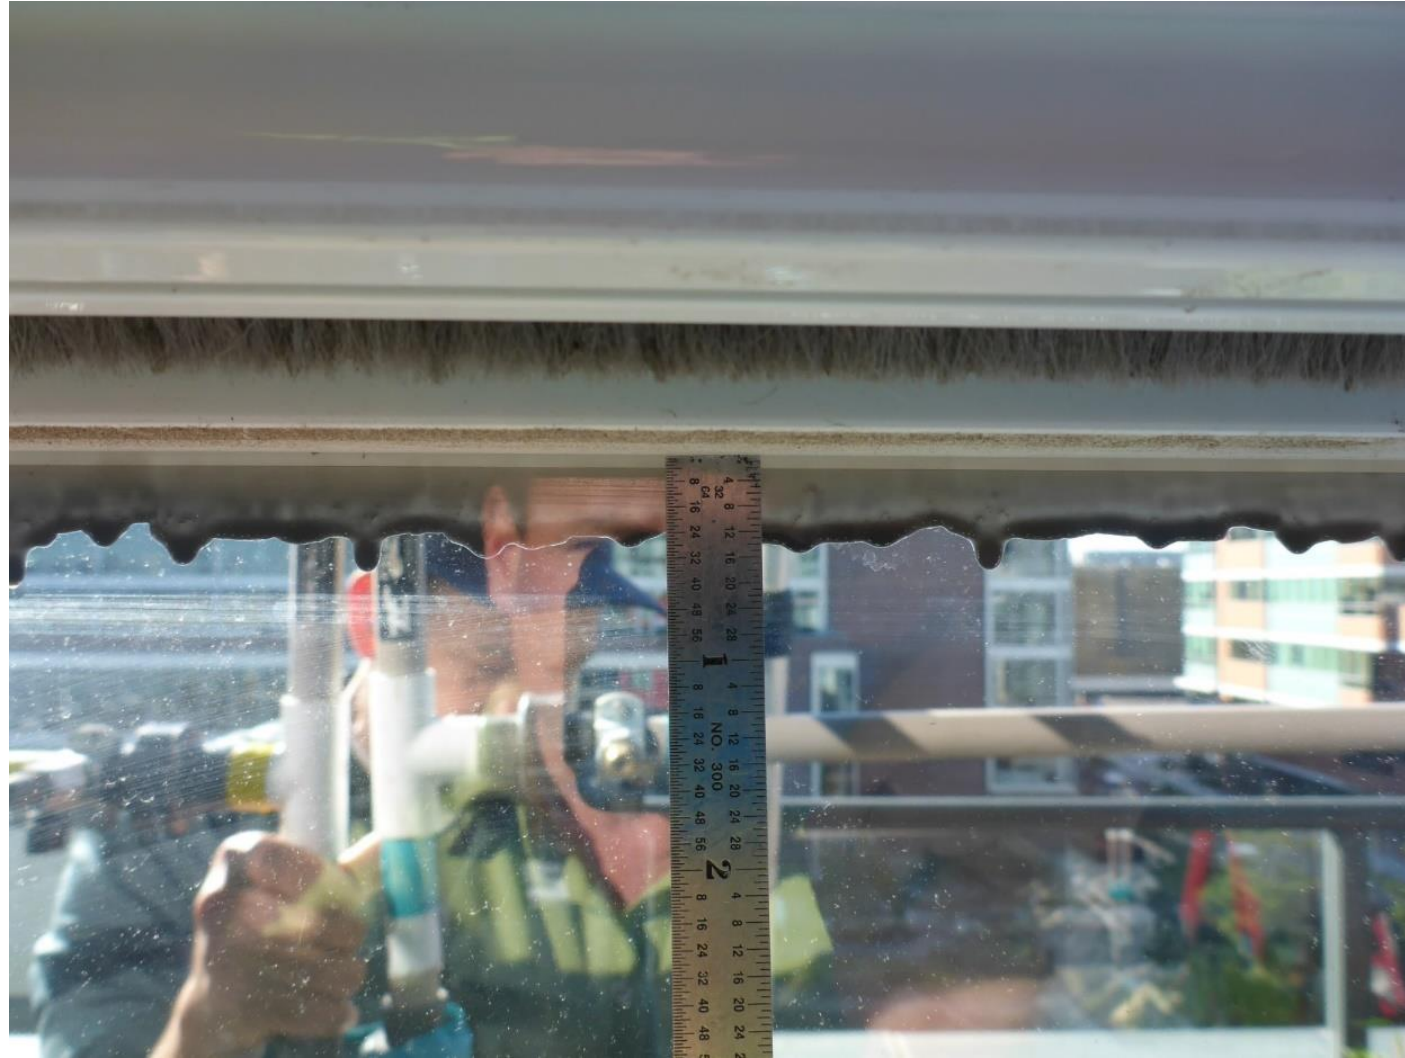
# Example of PIB Migration

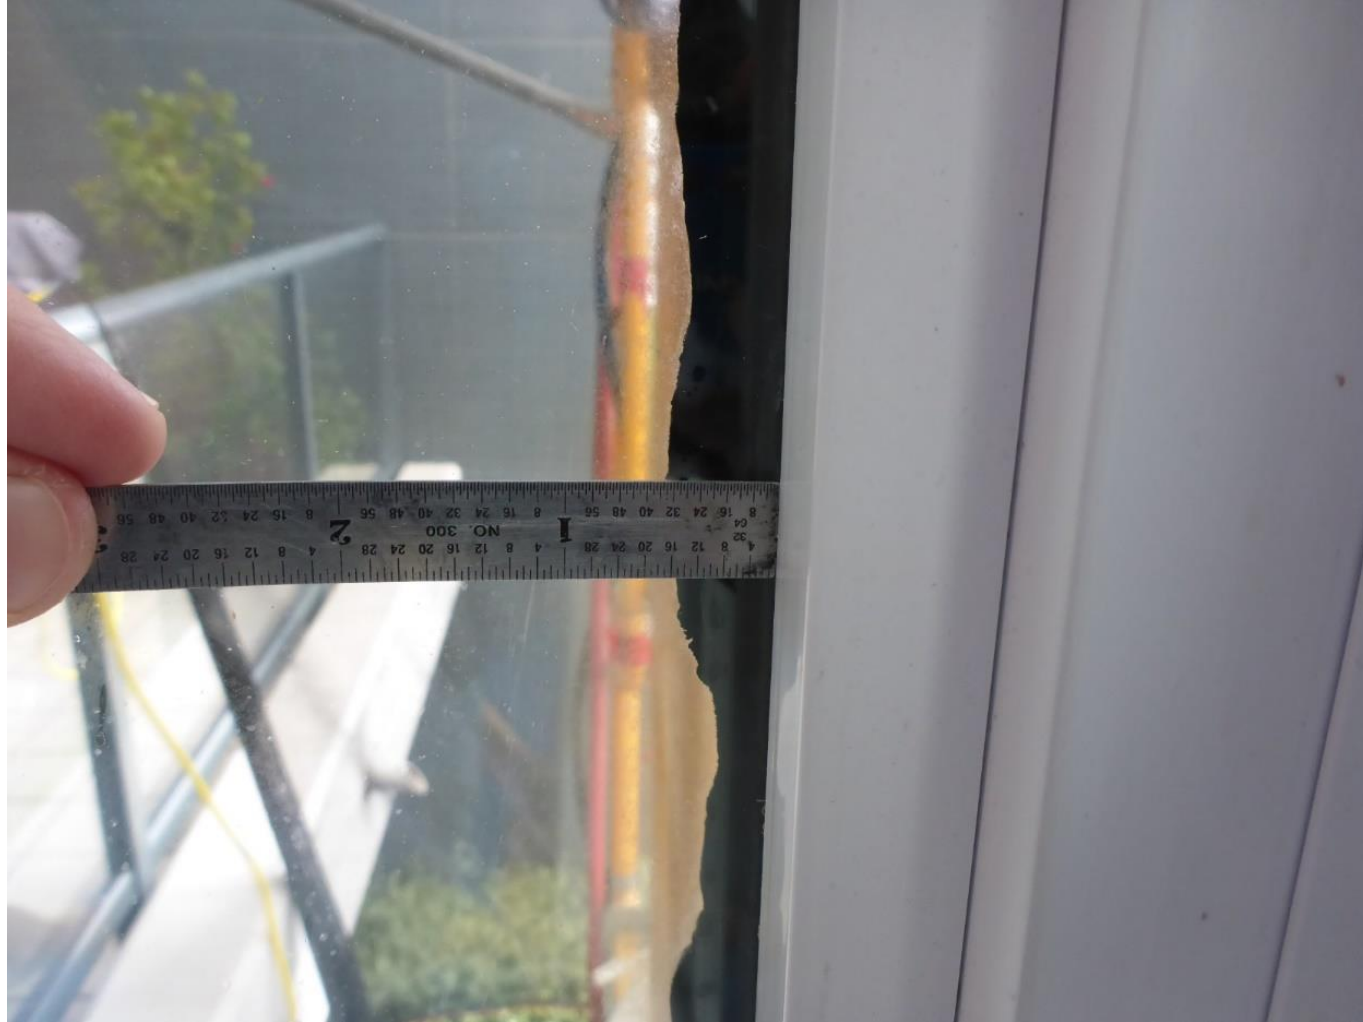
# PIB Migration Issue

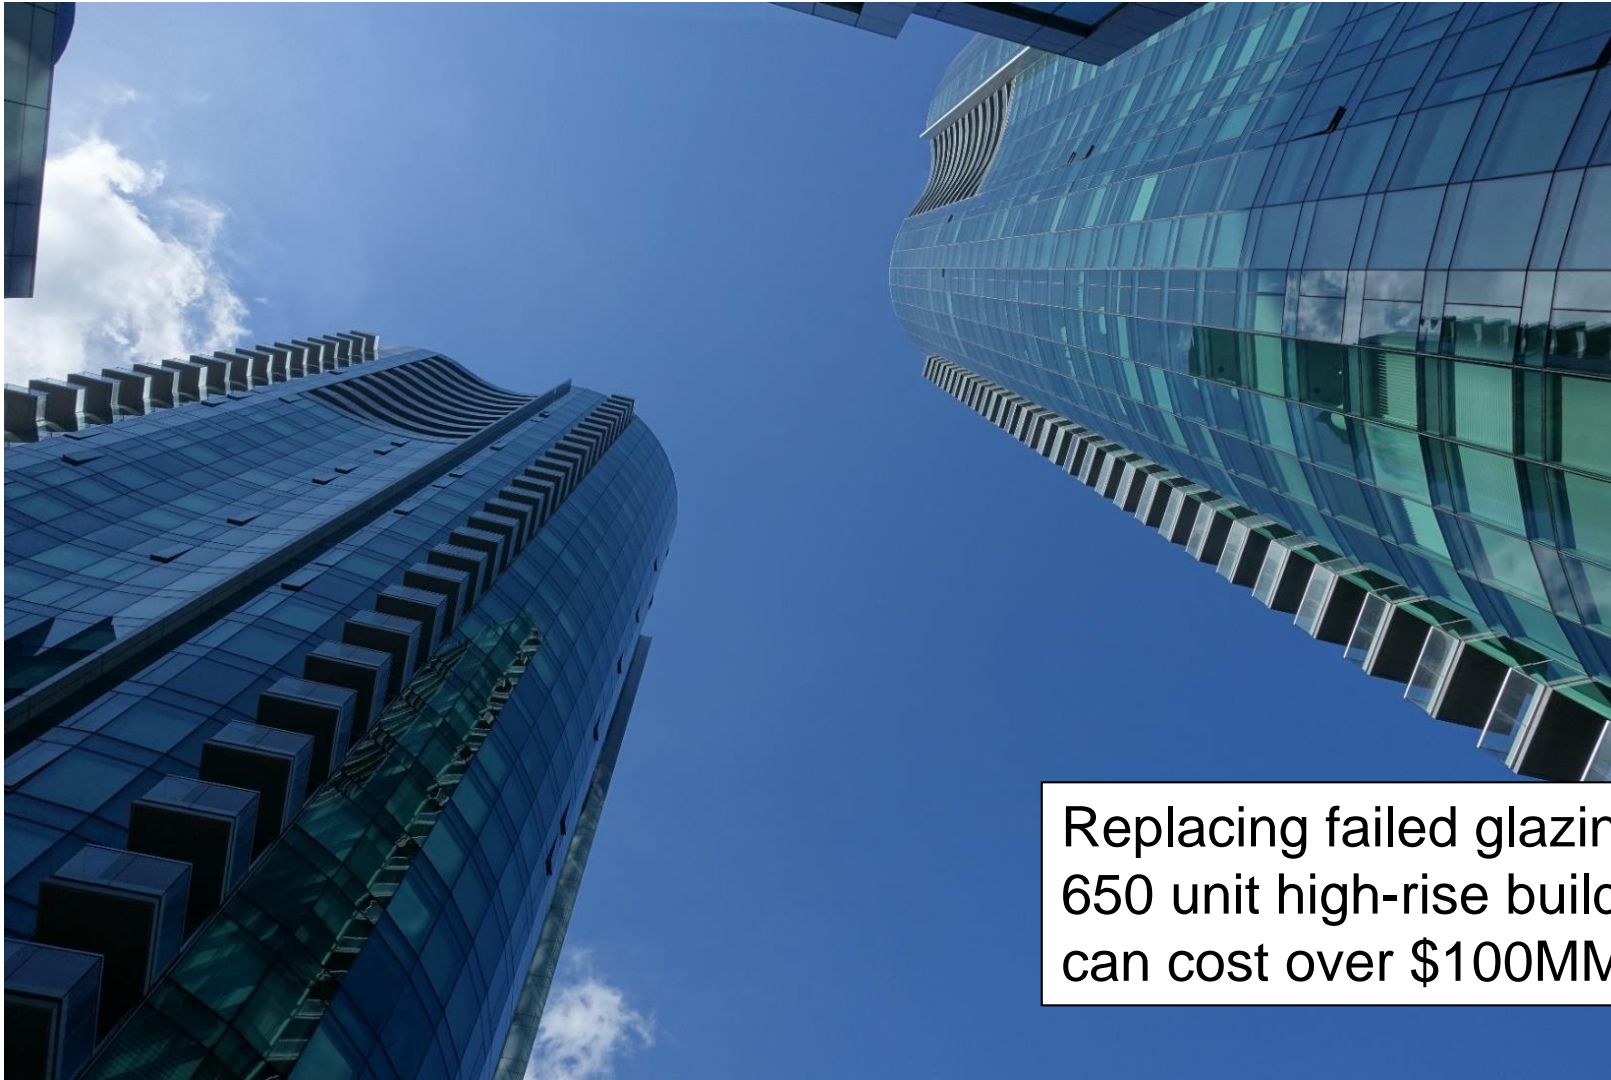
# Replacing Glass is Very Expensive!

Replacing failed glazing on  
650 unit high-rise building  
can cost over \$100MM

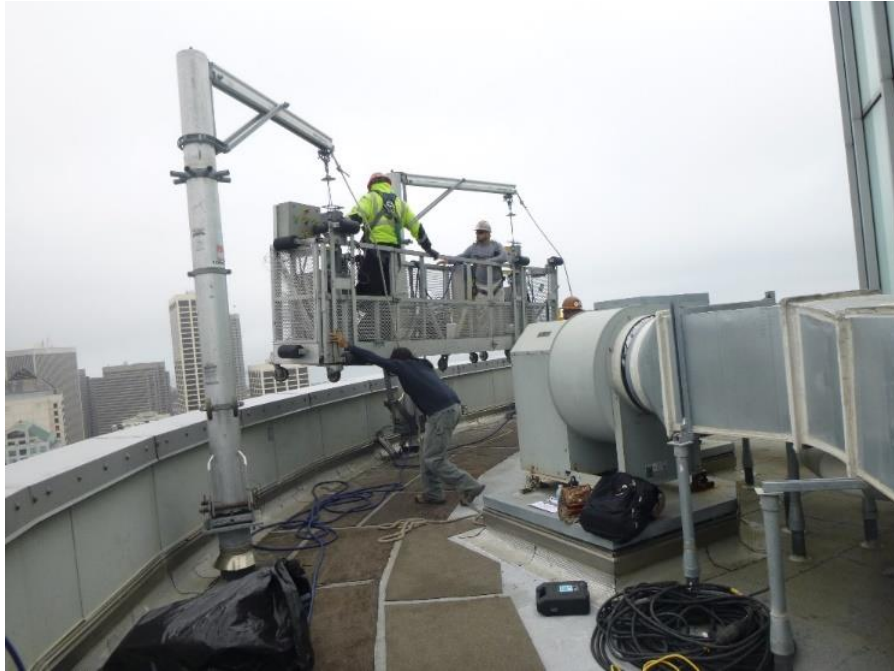
# Replacing Glass, Slow and Tedious

2 Consultants on window washing rigs

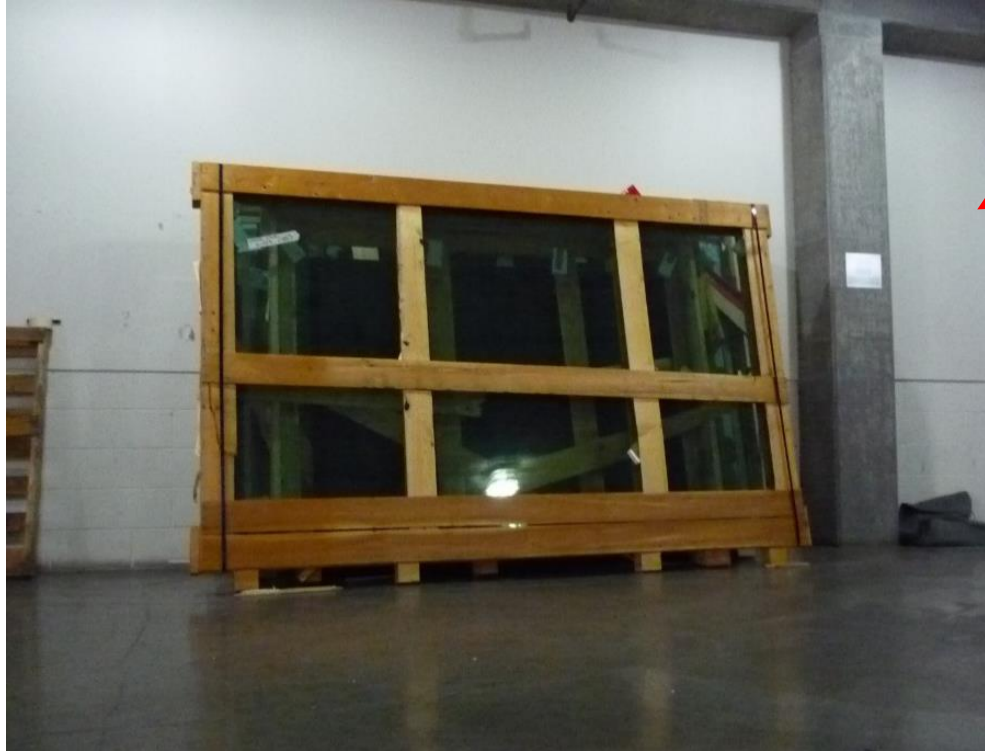
# Replacing Glass, Slow and Tedious

Removed glass from site

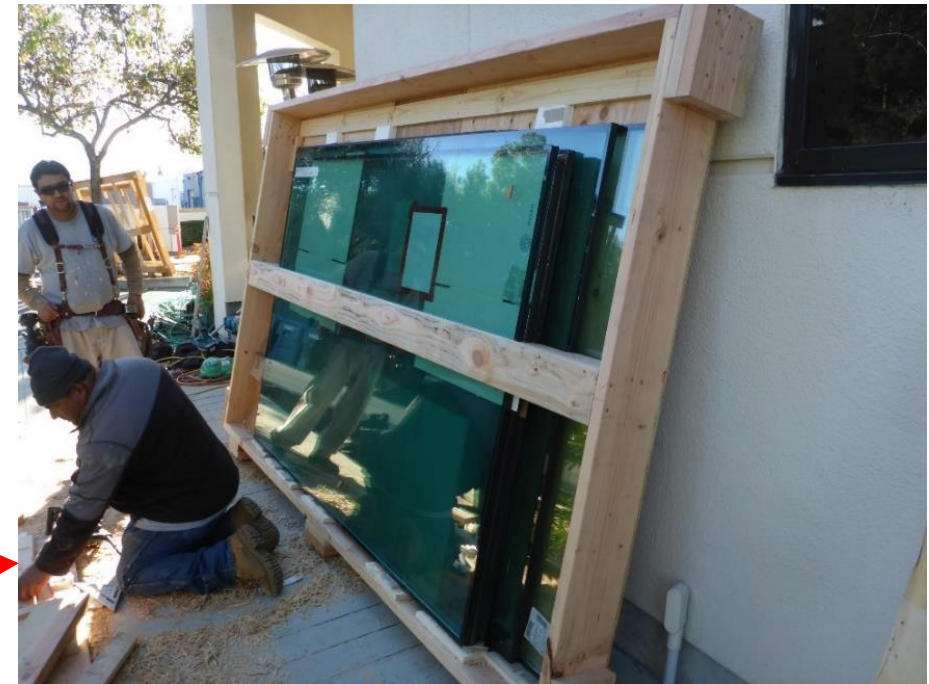
Labeled and crated, shipped to lab
