**Critical Review of the Life Span of TPO and
PVC**

WSRCA

June 8, 2011

**Karim P. Allana, P.E., RRC, RWC
Allana Buick & Bers, Inc.**

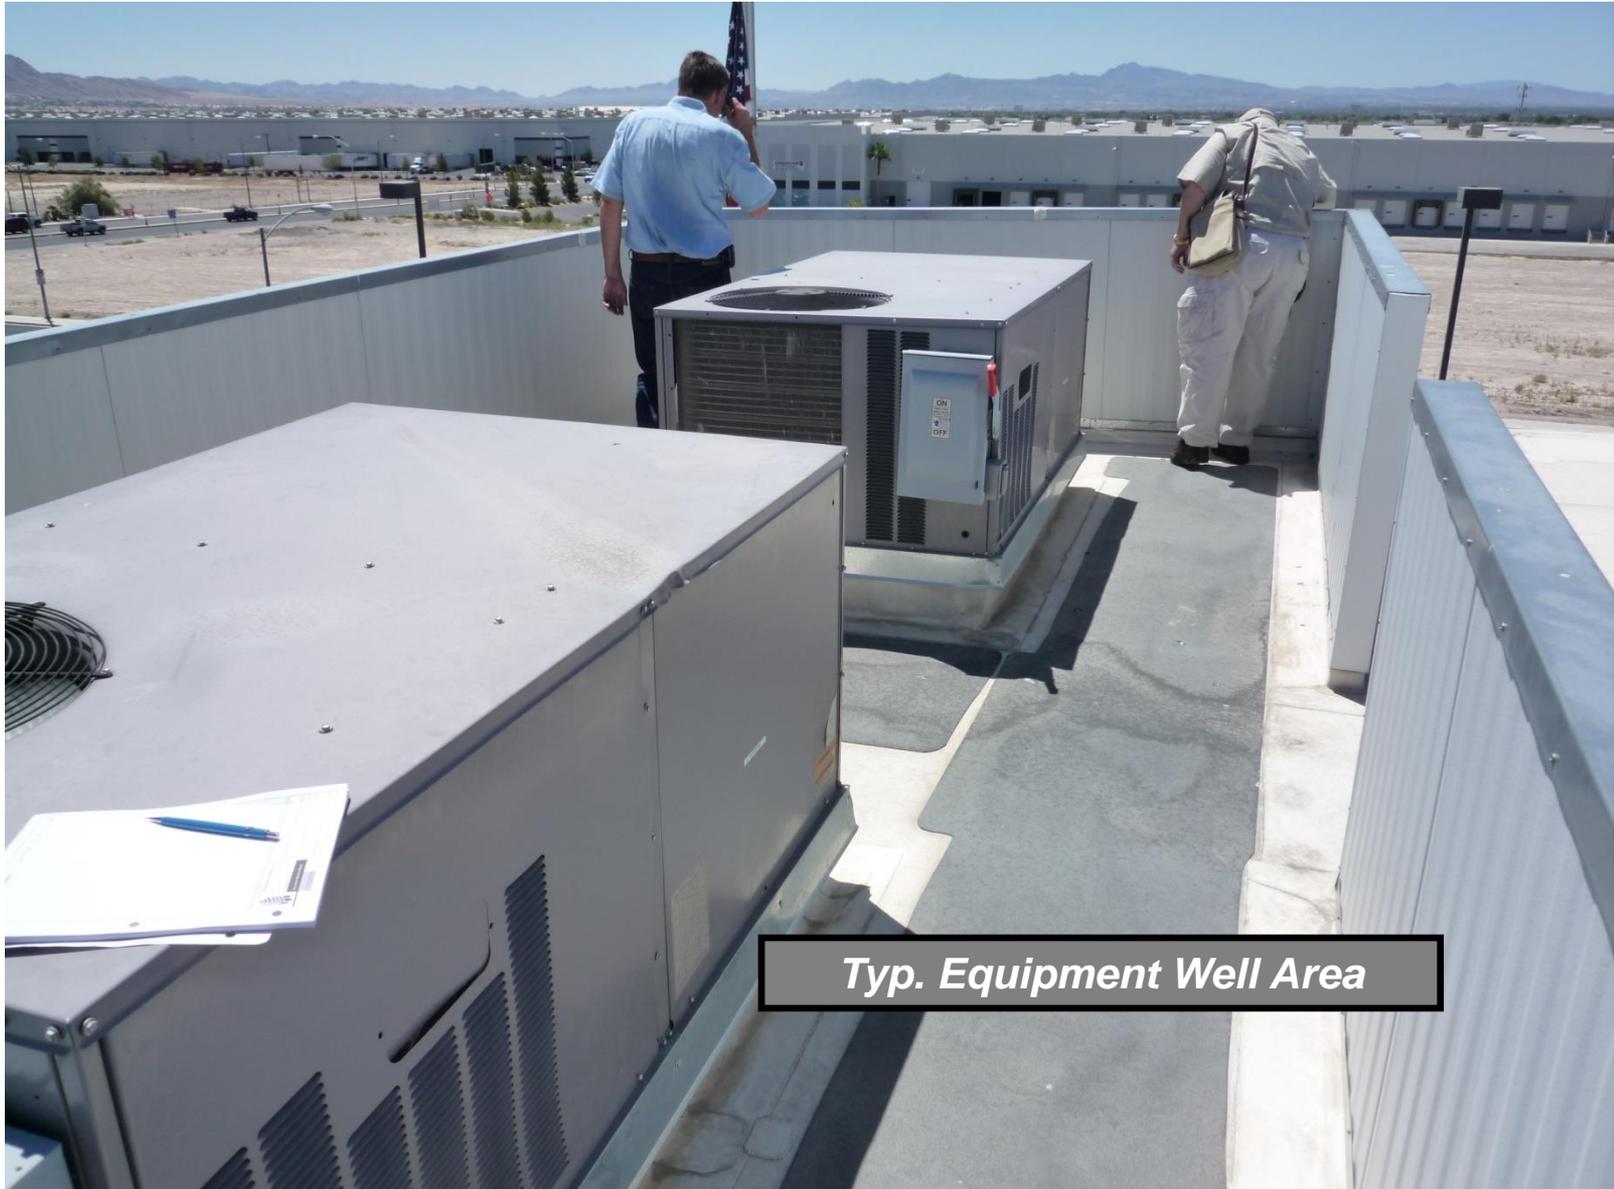
7 Years Old, Large Warehouse in Las Vegas

Typ. Equipment Well Area

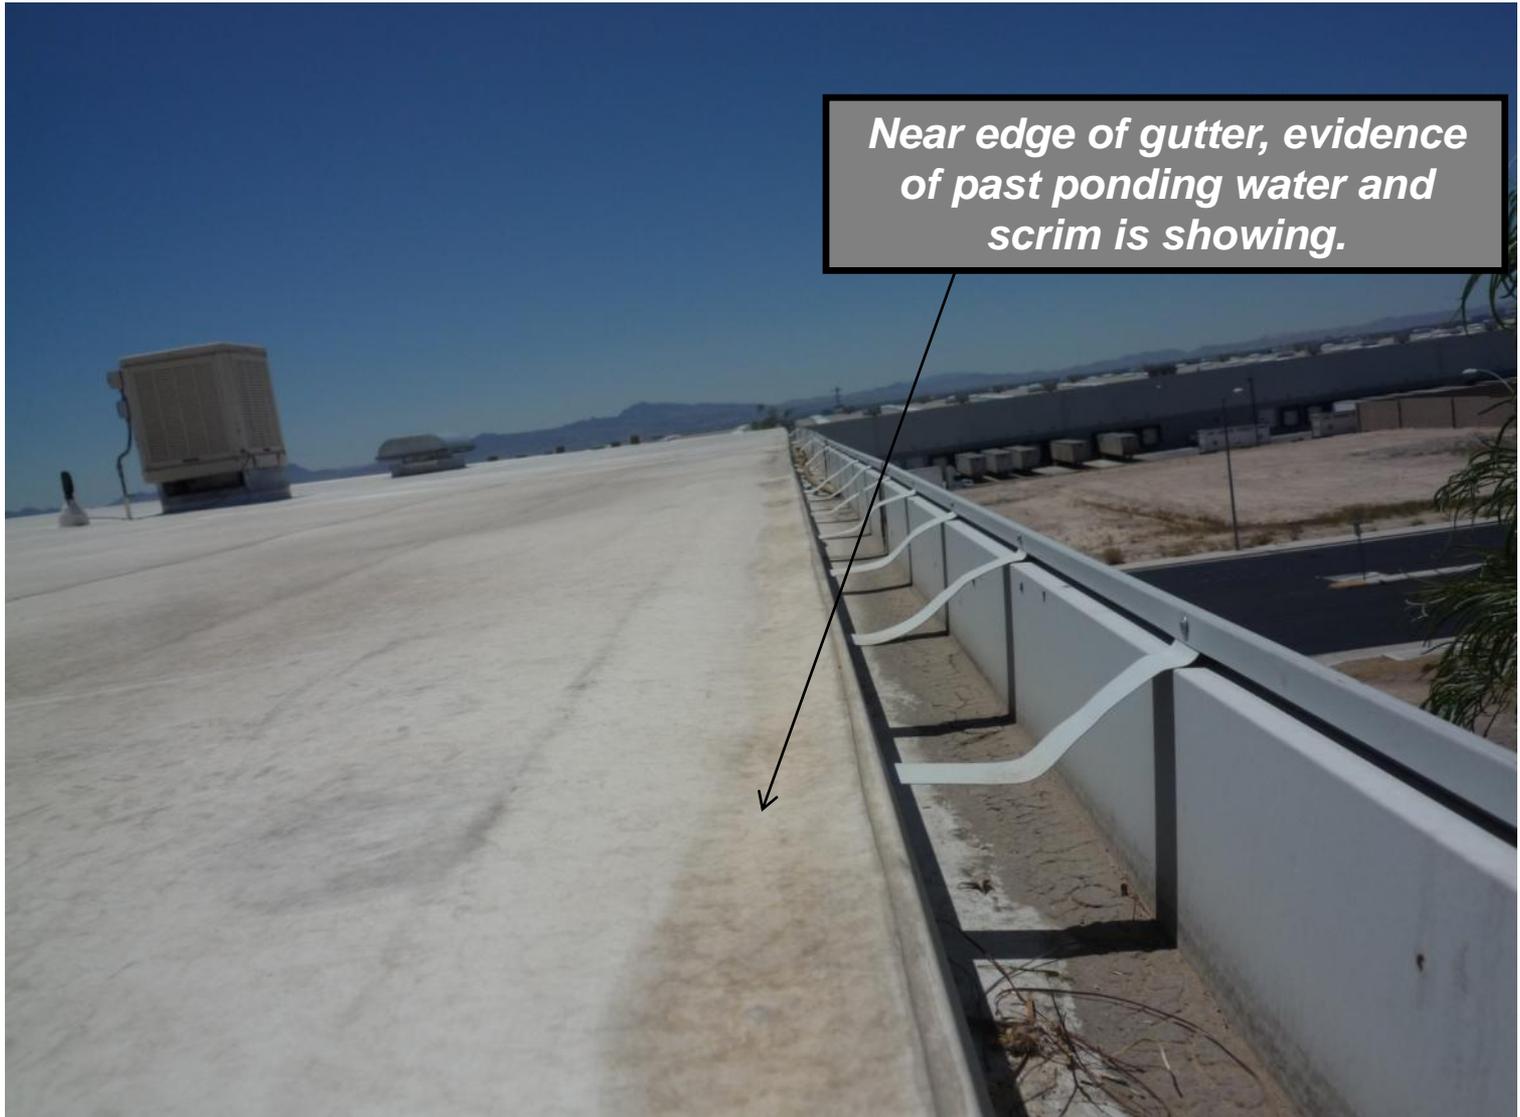
Large Warehouse in Las Vegas, Nevada

Near edge of gutter, evidence of past ponding water and scrim is showing.

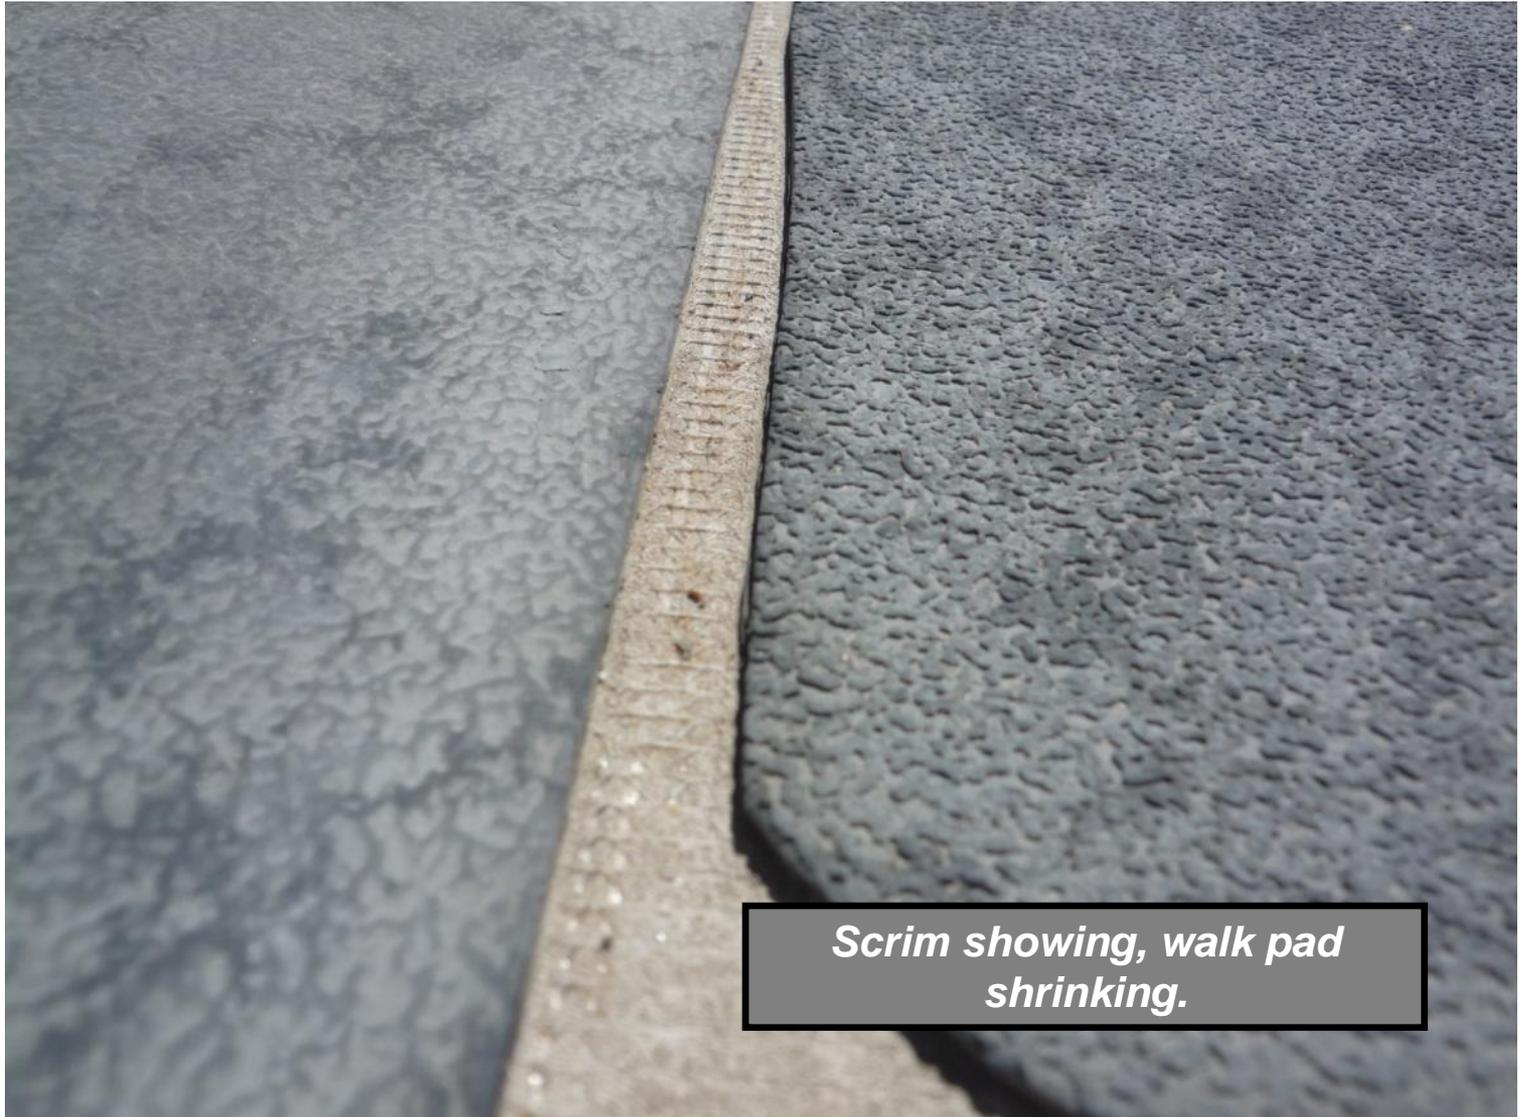
5 Years Old Carlisle, Hospital Building, Vegas

Scrim showing, walk pad shrinking.

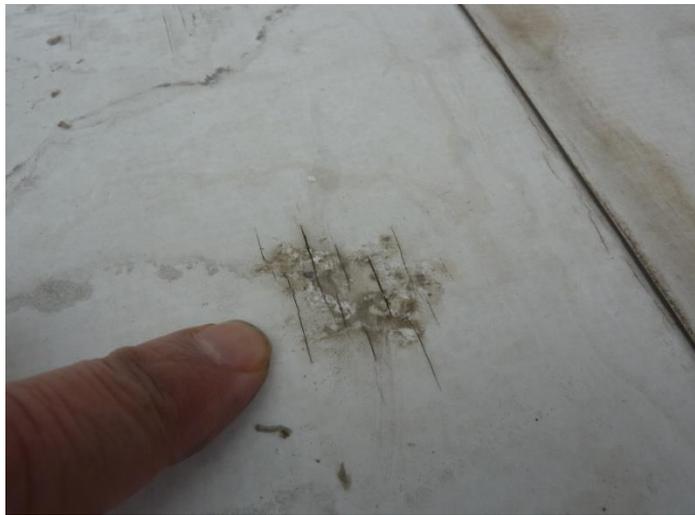
UNLV Bookstore, Firestone 11 Years Old

Roof has south facing stucco parapet. No heat related failures were observed

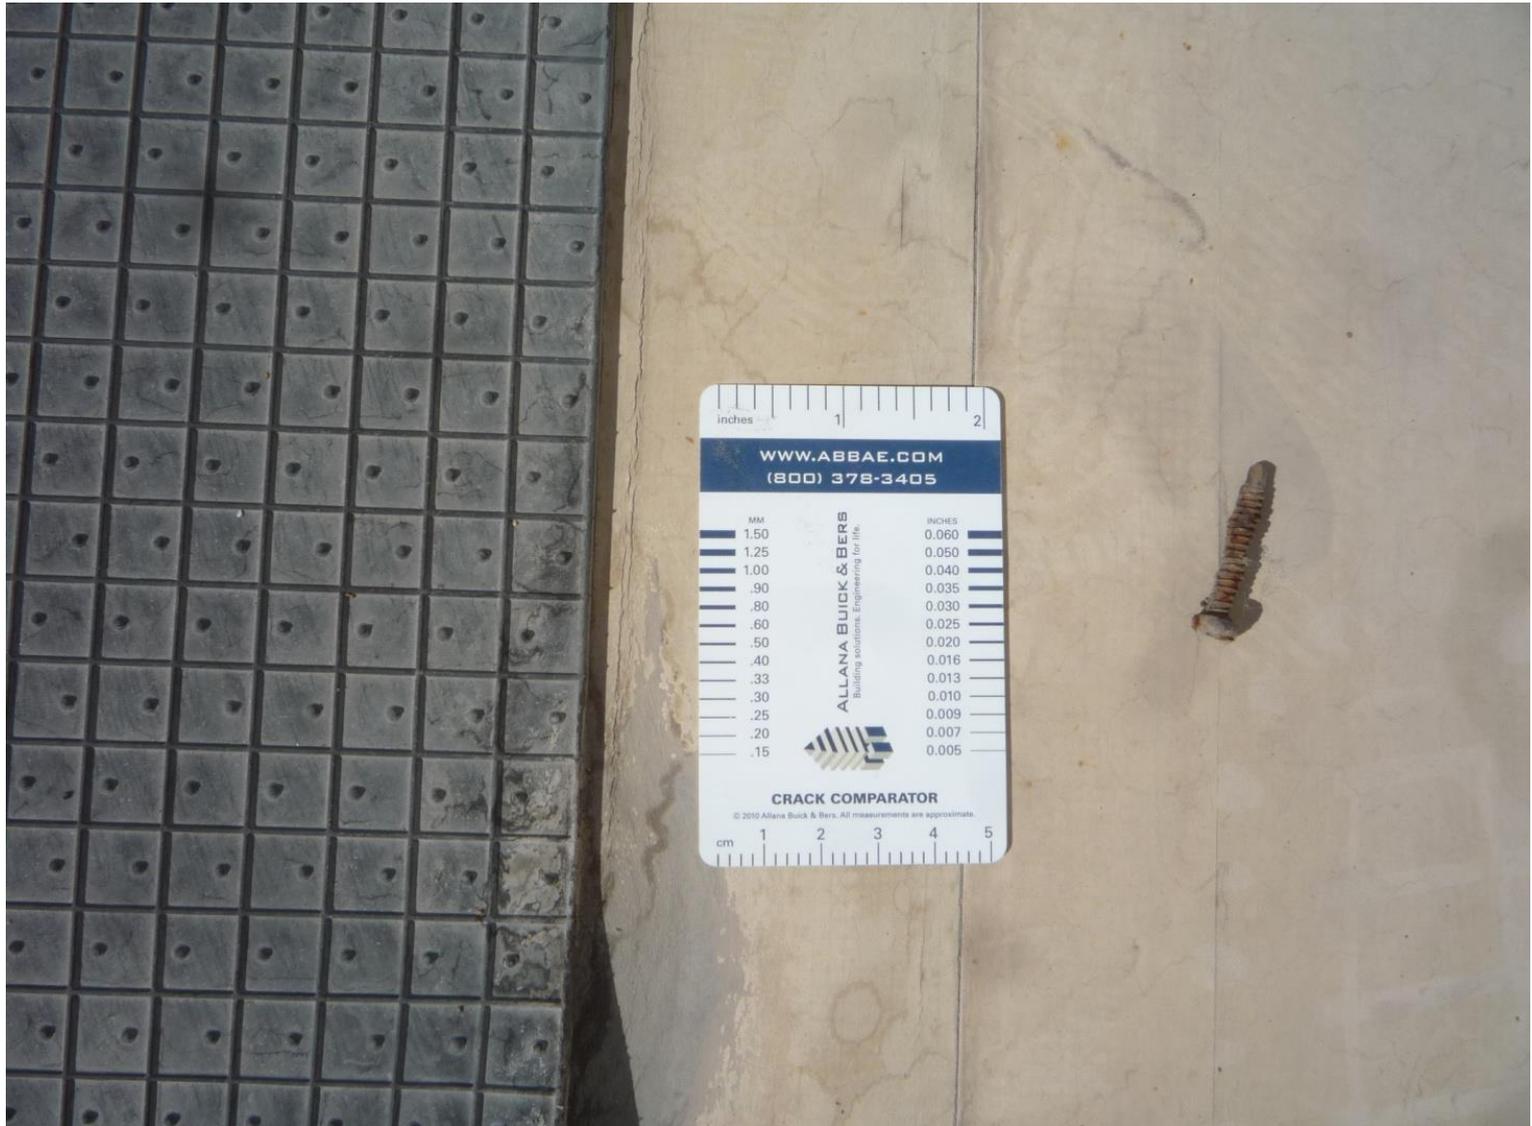
Seam and walk pad issues

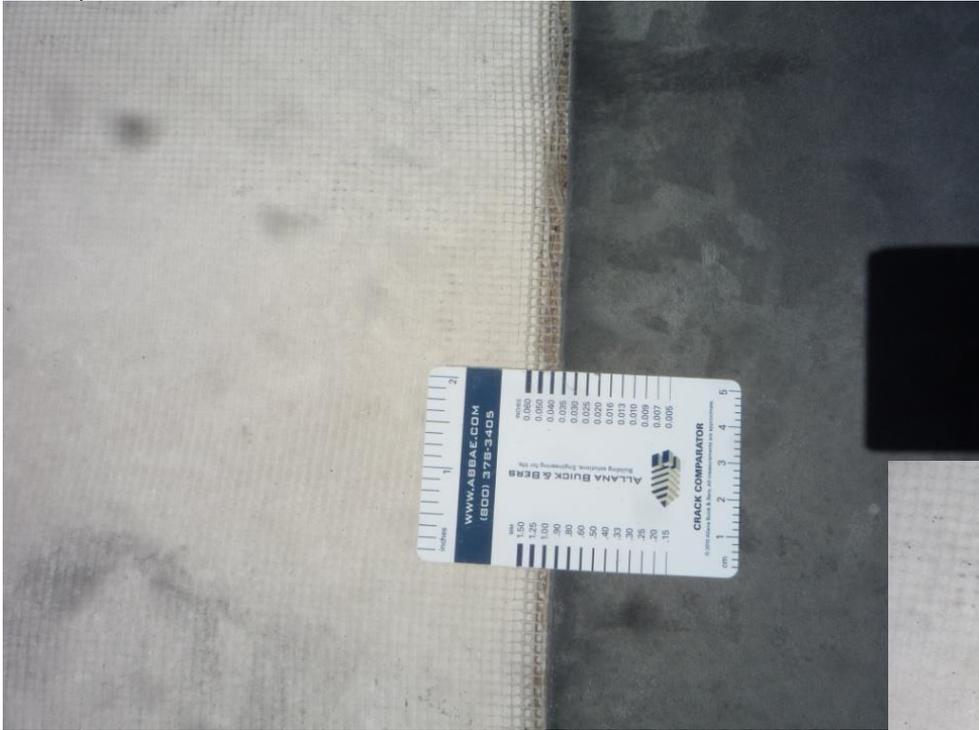
UV Damage at Edge of Walk Pad

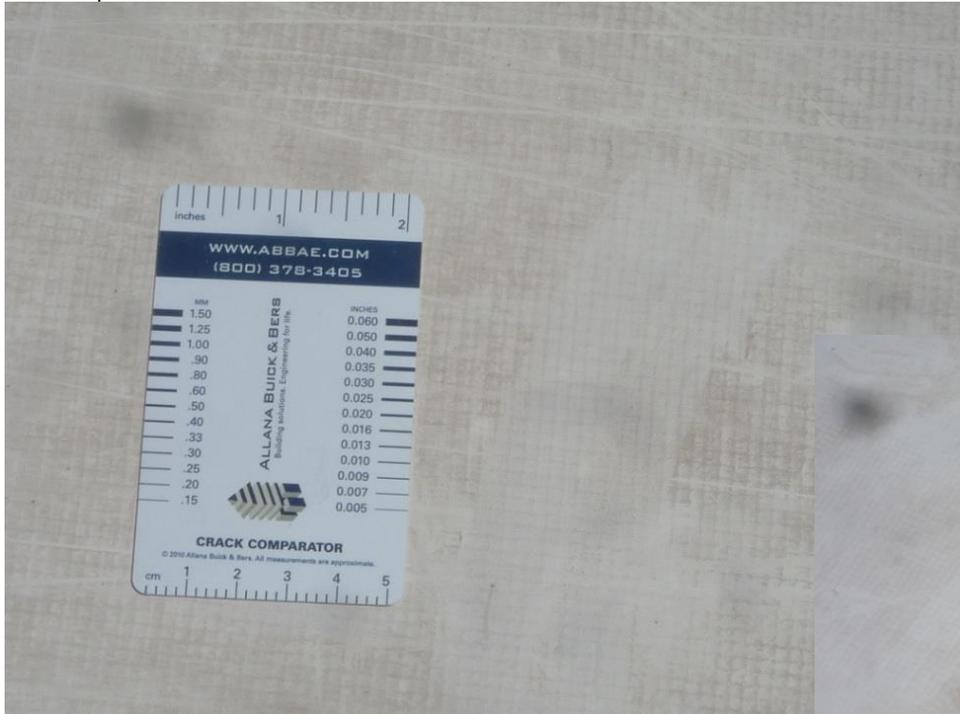
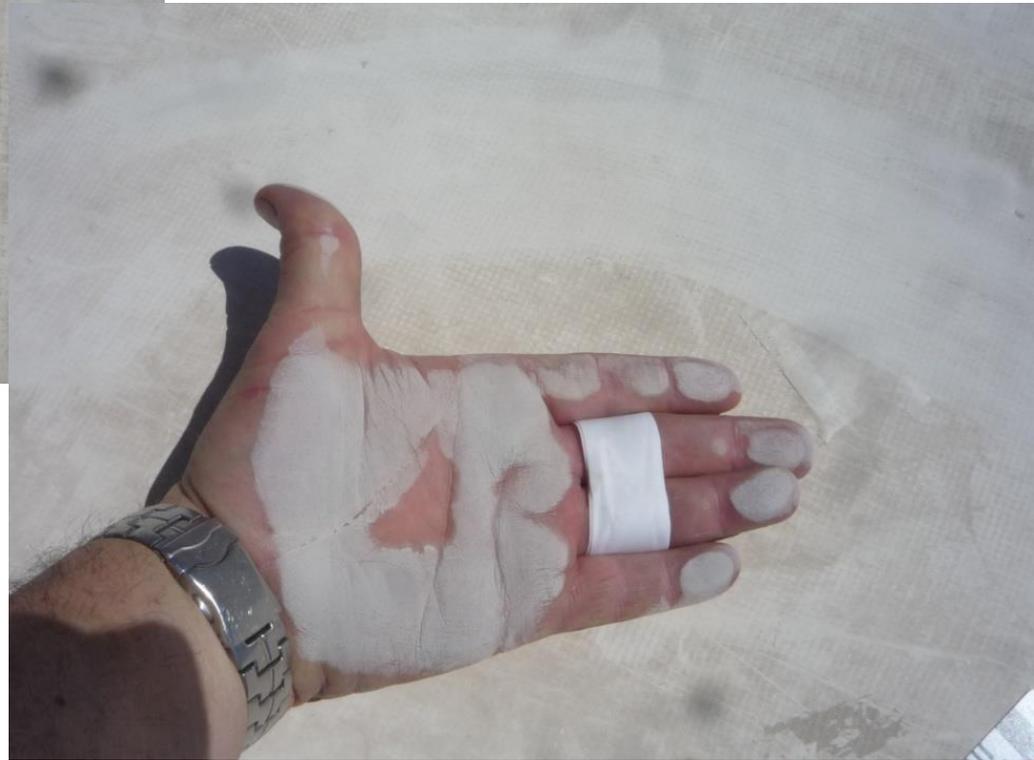
Chalking

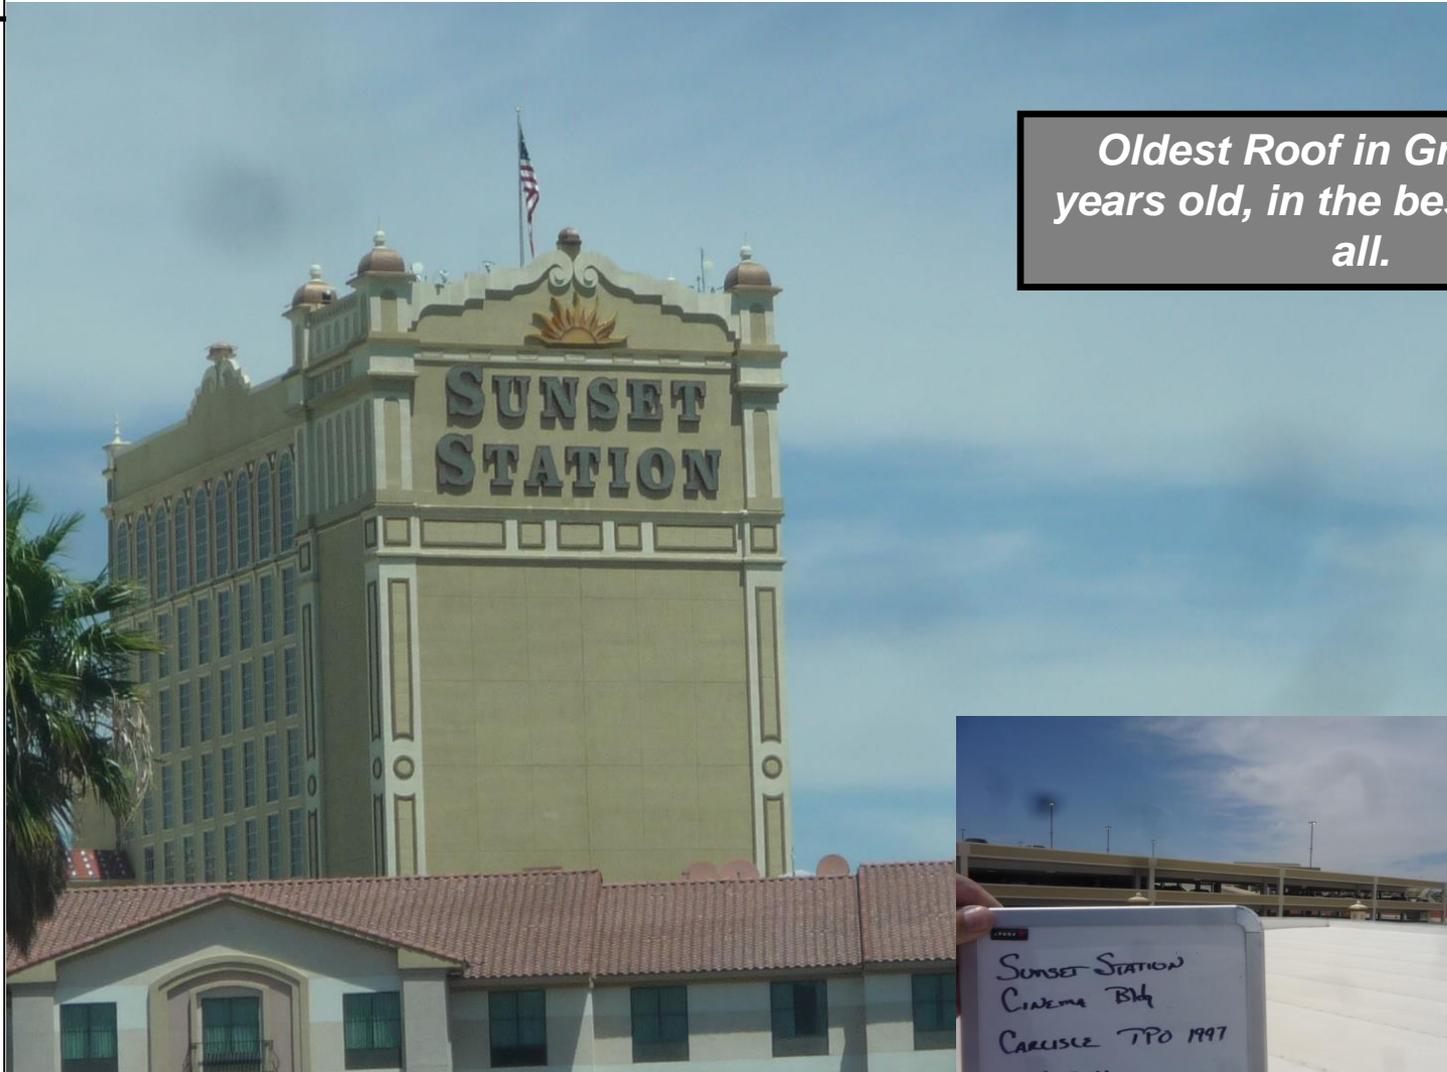
Sunset Station Casino – Cinema Area

Oldest Roof in Group – 14 years old, in the best shape of all.

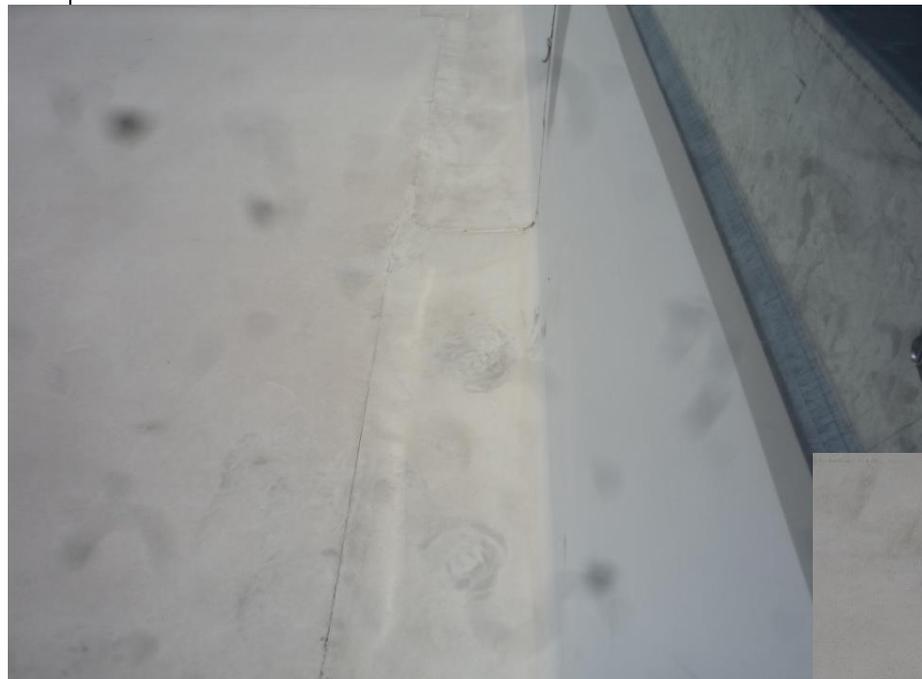
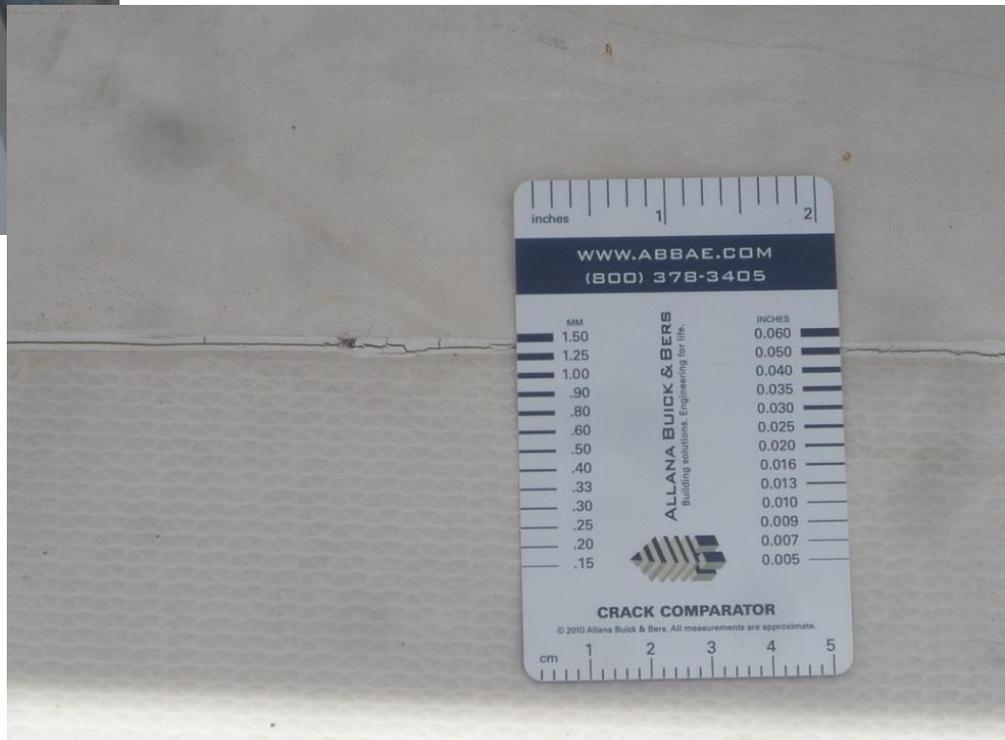
North Parapet Wall

North parapet wall shows minimal signs of change in the roof membrane.
