**Critical Review of the Life Span of
TPO and PVC**

RCI Hawaii Seminar

Case Study: PVC

Case Study: TPO

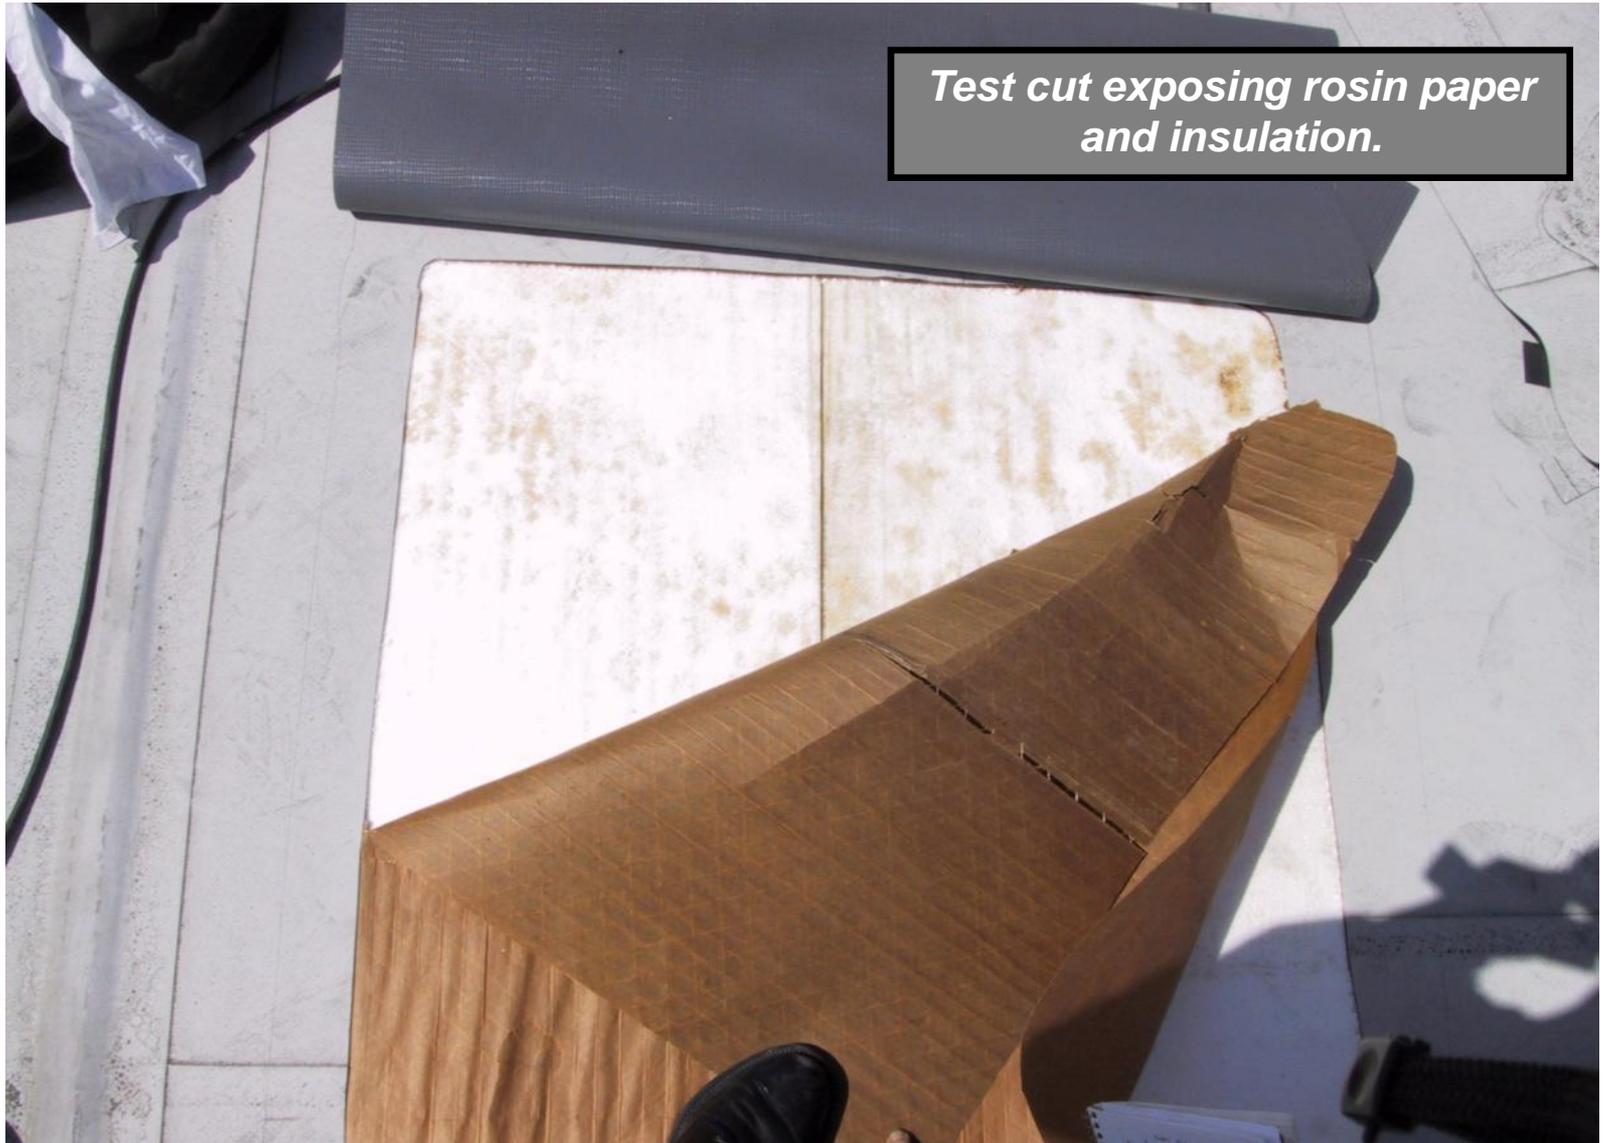
Test Cut Analysis

Test cut exposing rosin paper and insulation.

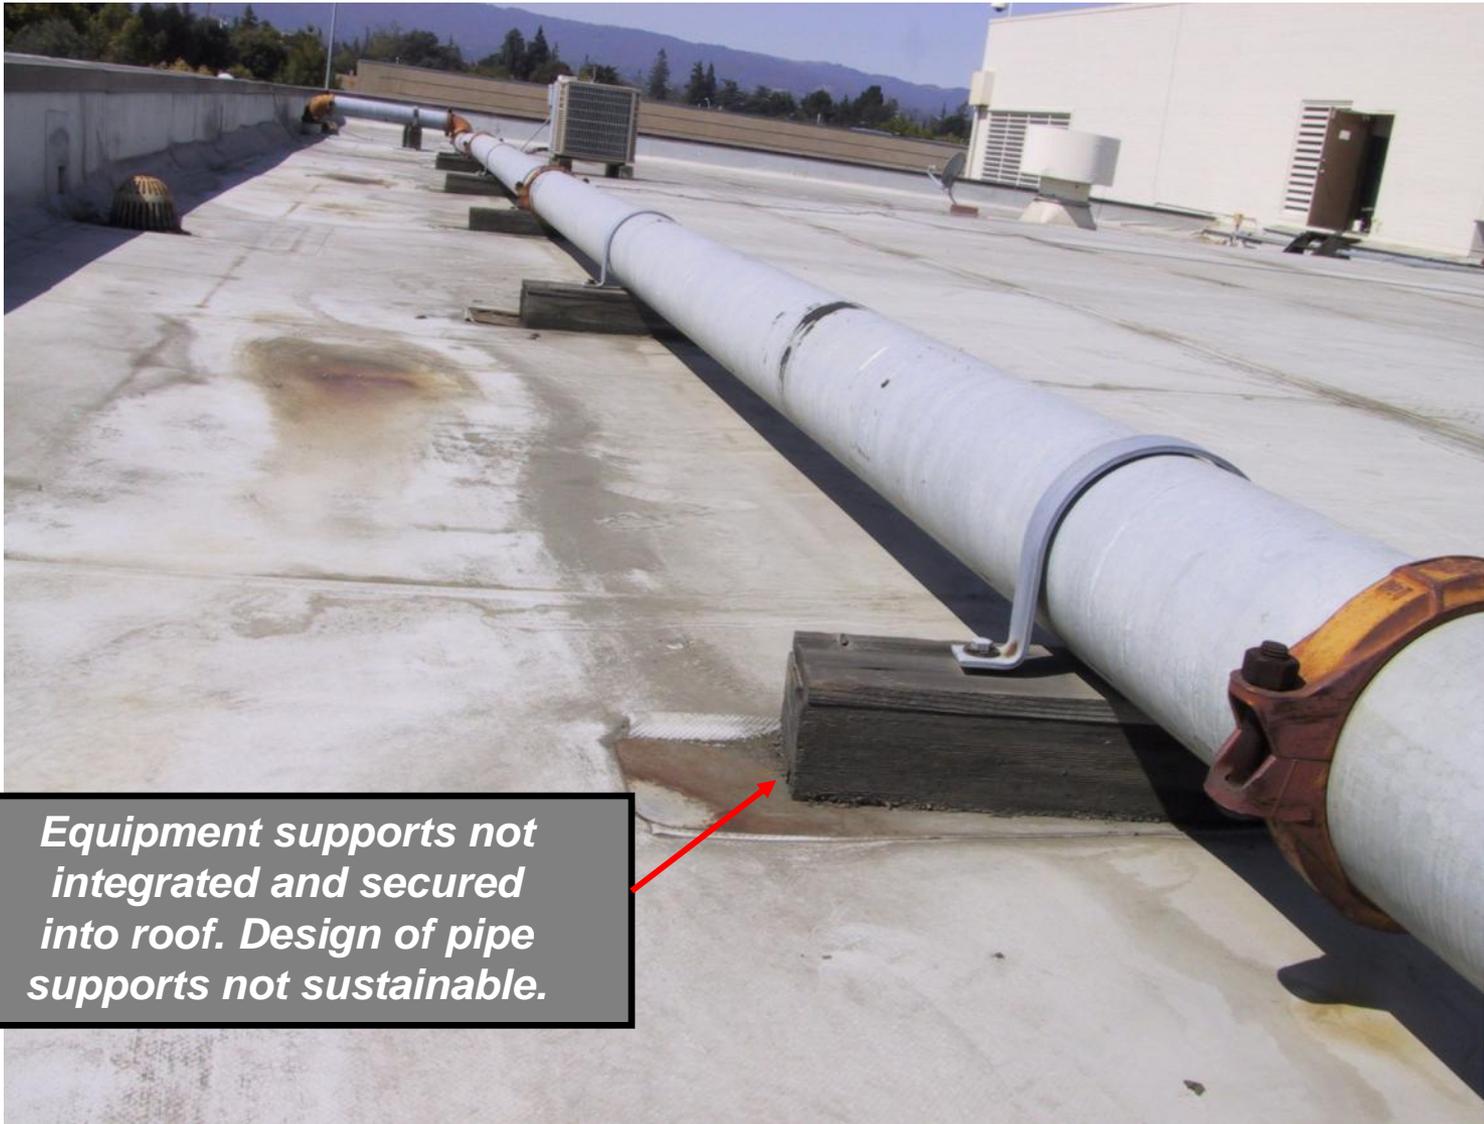
Design Issue

Equipment supports not integrated and secured into roof. Design of pipe supports not sustainable.

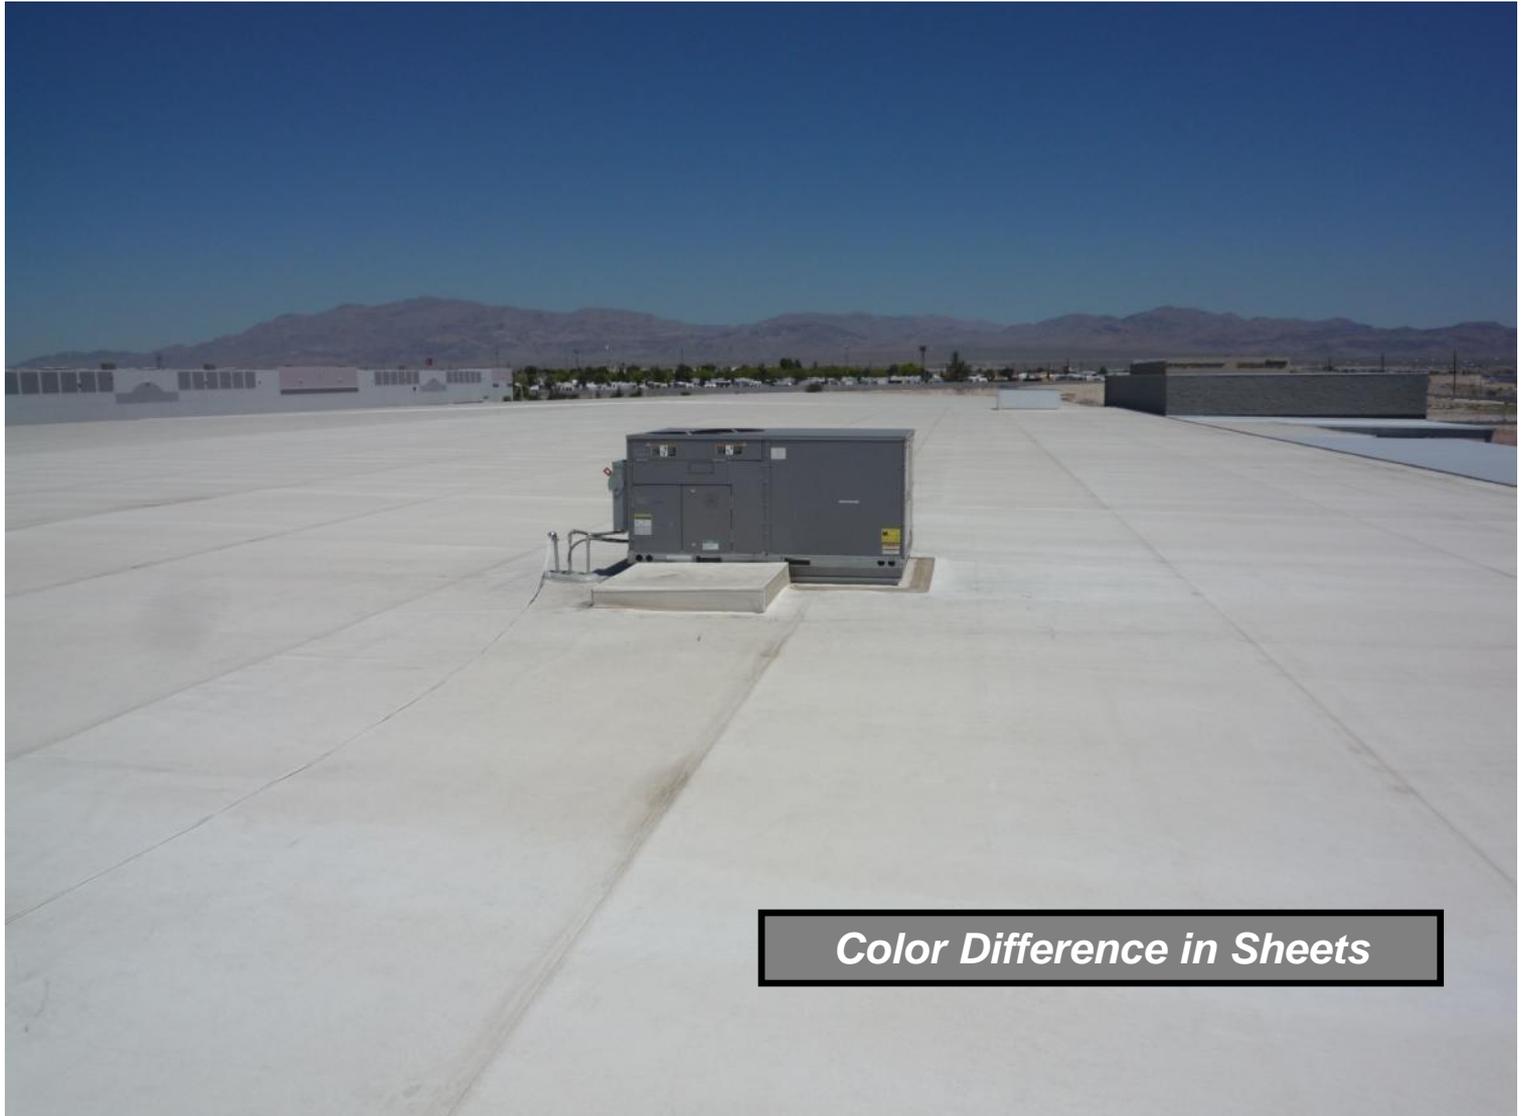
Large Warehouse in Las Vegas, Nevada

Color Difference in Sheets

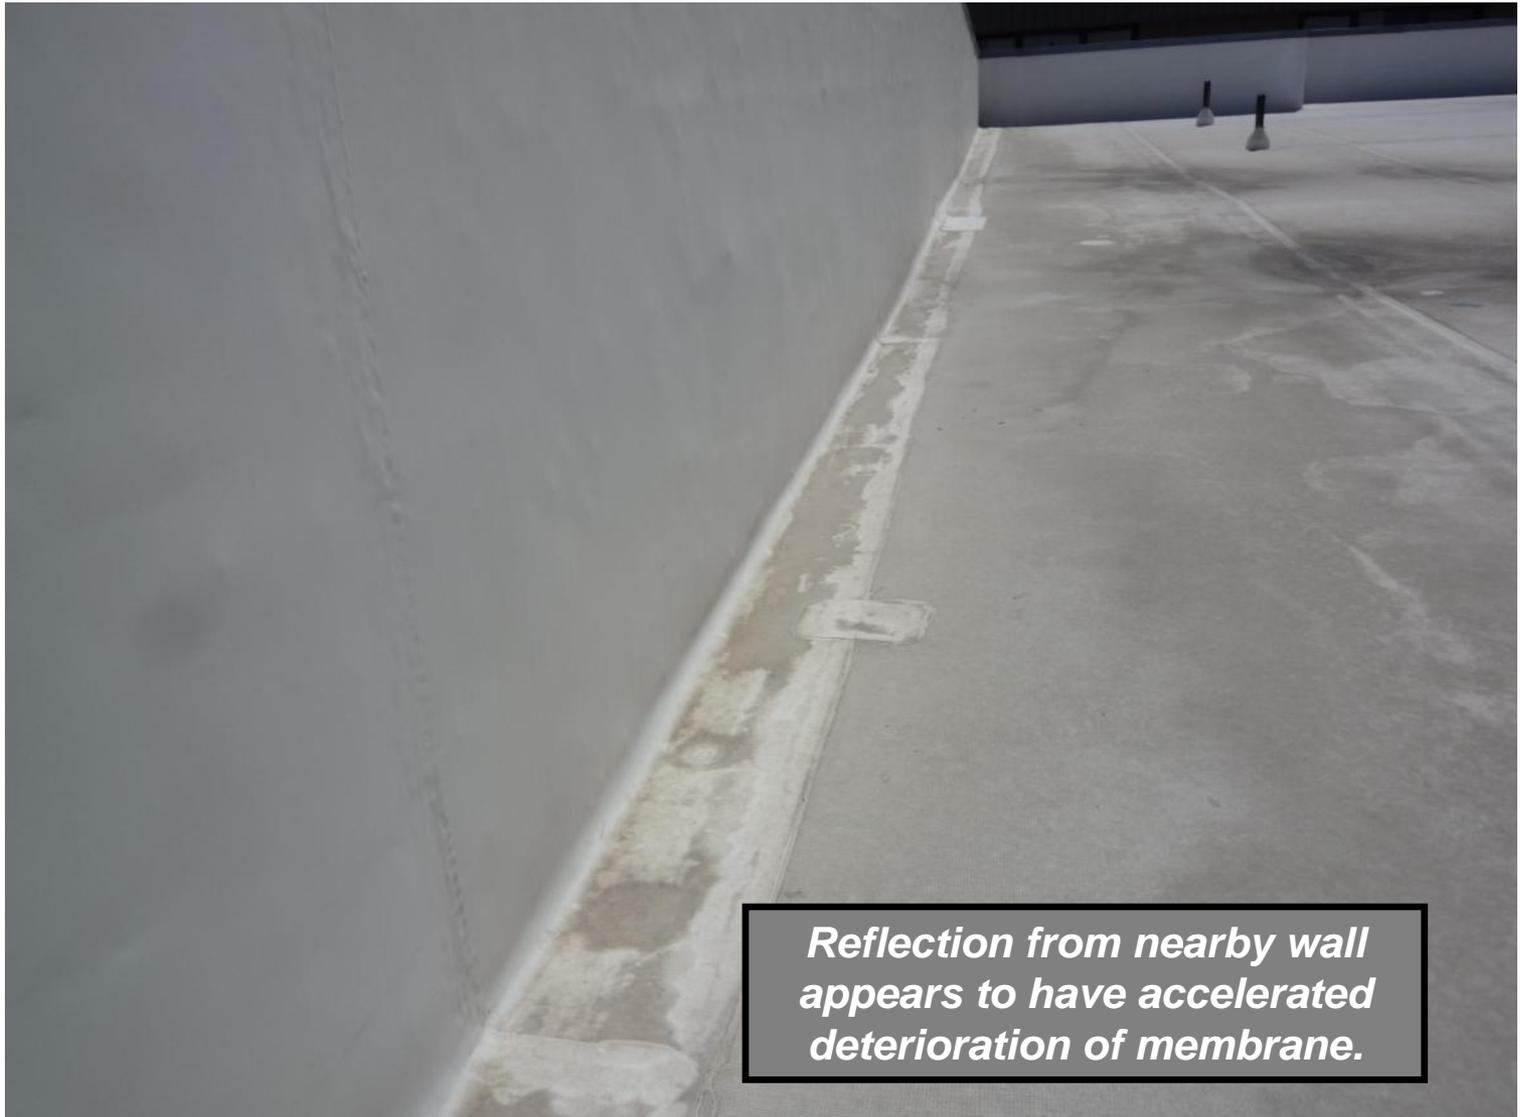
5 Years Old Carlisle, Hospital Building, Vegas

Damage next to sloping parapet wall was much worse

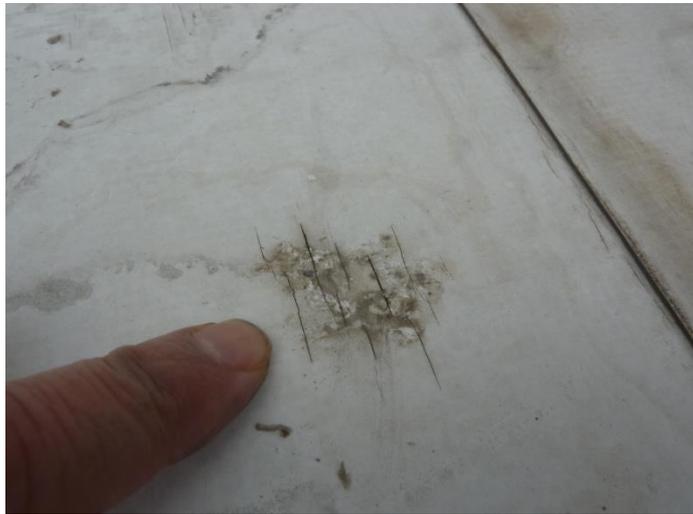
UNLV Bookstore, Firestone 11 Years Old

This replacement GAF roof is less than 3 years old!

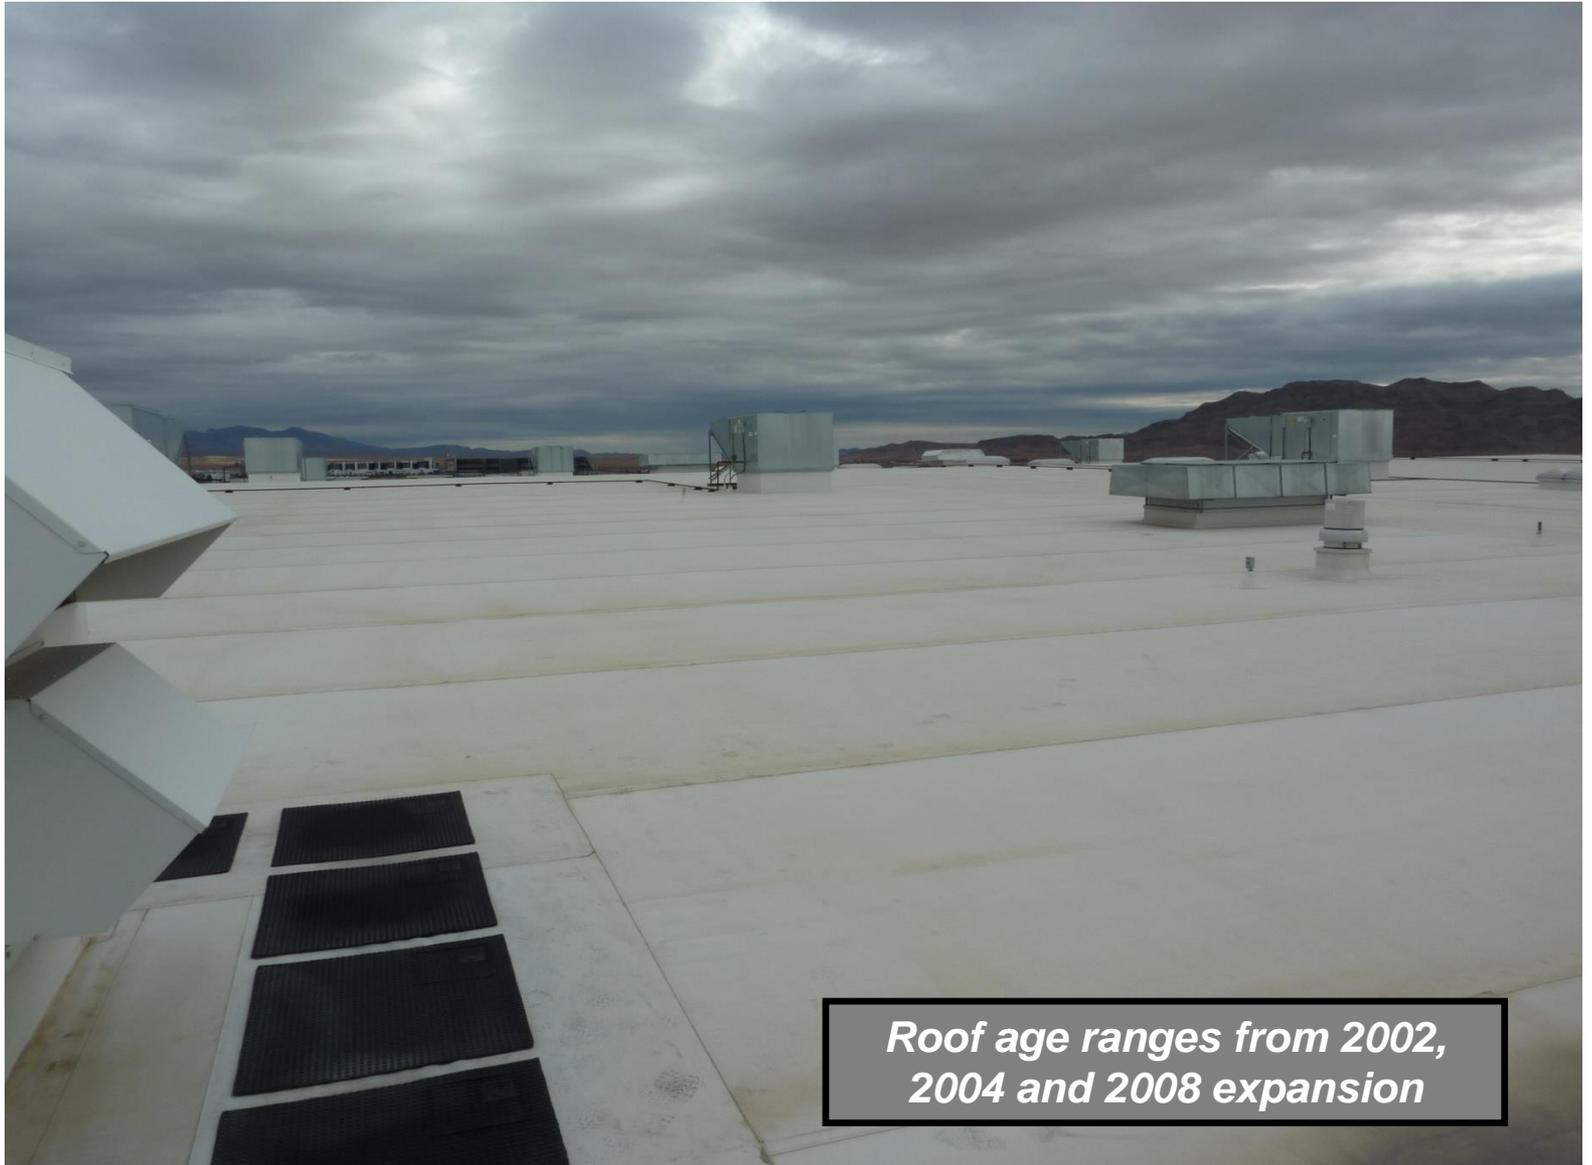
Sysco, Las Vegas, Firestone 8 Years Old

*Roof age ranges from 2002,
2004 and 2008 expansion*
